SUBMISSION TO THE AUSTRALIAN TRANSPORT SAFETY BUREAU,  
A380 INVESTIGATION

**SUBMISSION TO THE SENATE ENQUIRY INTO AIRLINE SAFETY.**

**PLEASE READ FIRSTLY THE COPY OF MY SUBMISSION TO THE ATSB REGARDING THE QANTAS A380 ENGINE DISC EXPLOSION OUT OF SINGAPORE ON NOVEMBER 4<sup>TH</sup> 2010. (ENCL)**

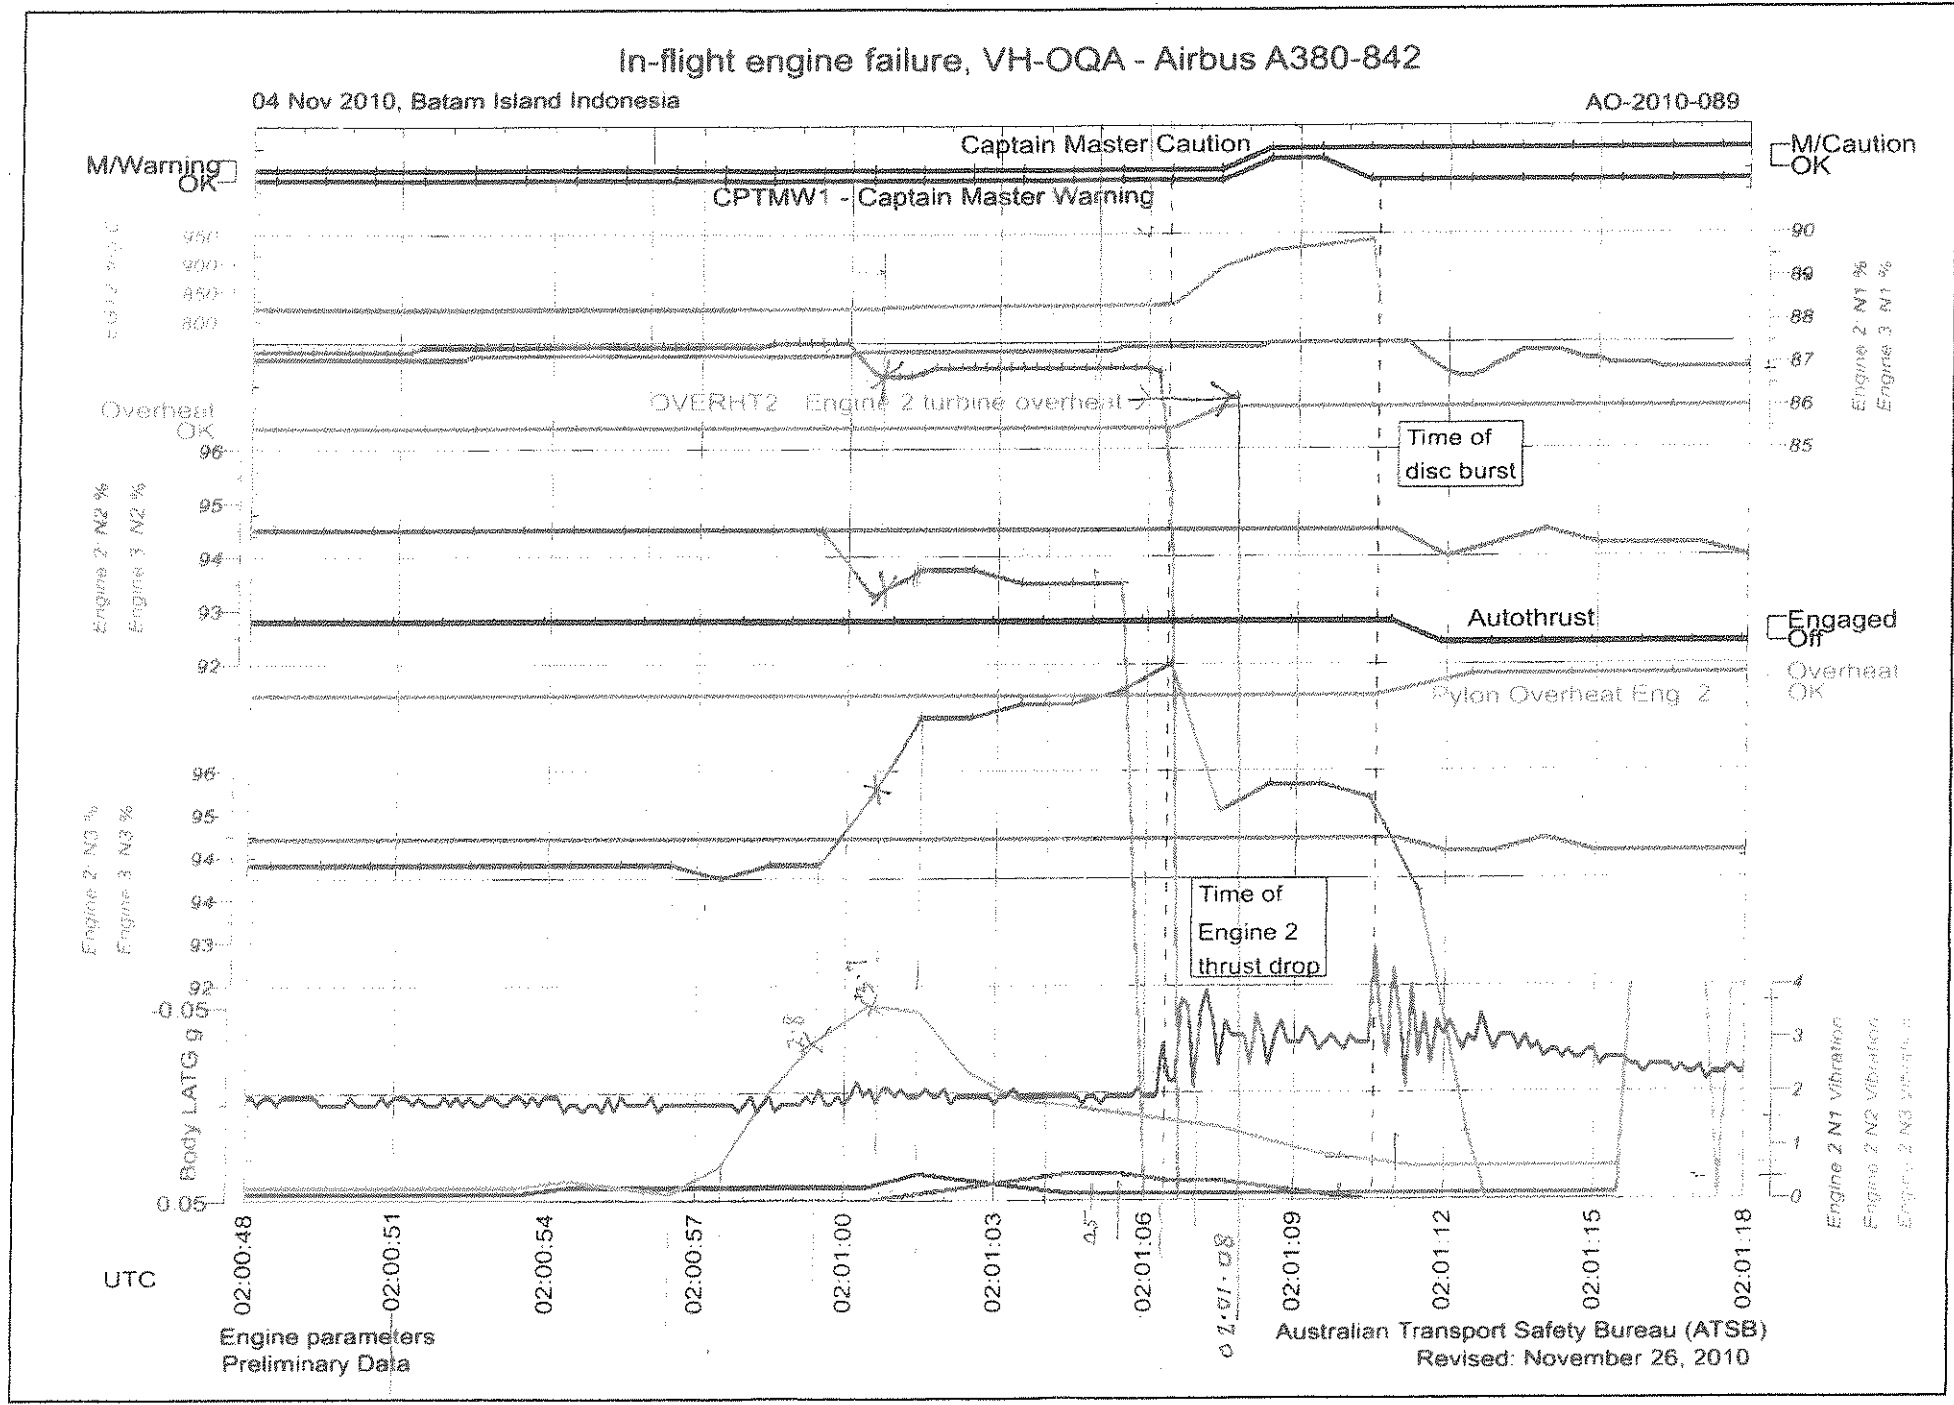
Figure A-2: Graphical representation of engine parameters around time of event

Some sudden vibration at 0200.54 is worthy of note, but not immediately serious.  
However, rapidly increasing vibration accompanied by multiple large engine spool

fluctuations commencing at 0200.59, is time to become rapidly serious about an engine shut down.

5F 177°C  
 0P 699/02:00:20  
 51  
 02:00:534  
 02:00:56 02:00:564  
 02:00:595  
 02:00:594  
 DESTINATE SHUT DOWN READ  
 RE. VIB/N1/N2/N3 PARAMETERS  
 02:01:015  
 02:01:015  
 02:01:054  
 LAST  
 00. TO SHUT DOWN  
 ENGINE  
 AND ESCAPE NOCTIC DAMAGE  
 TOO  
 LATE 02:01:11 Disc Fail

WINDOW OF OPPORTUNITY  
12 SECS. FOR  
ENGINE SHUT DOWN.  
BEFORE DISC FAILURE

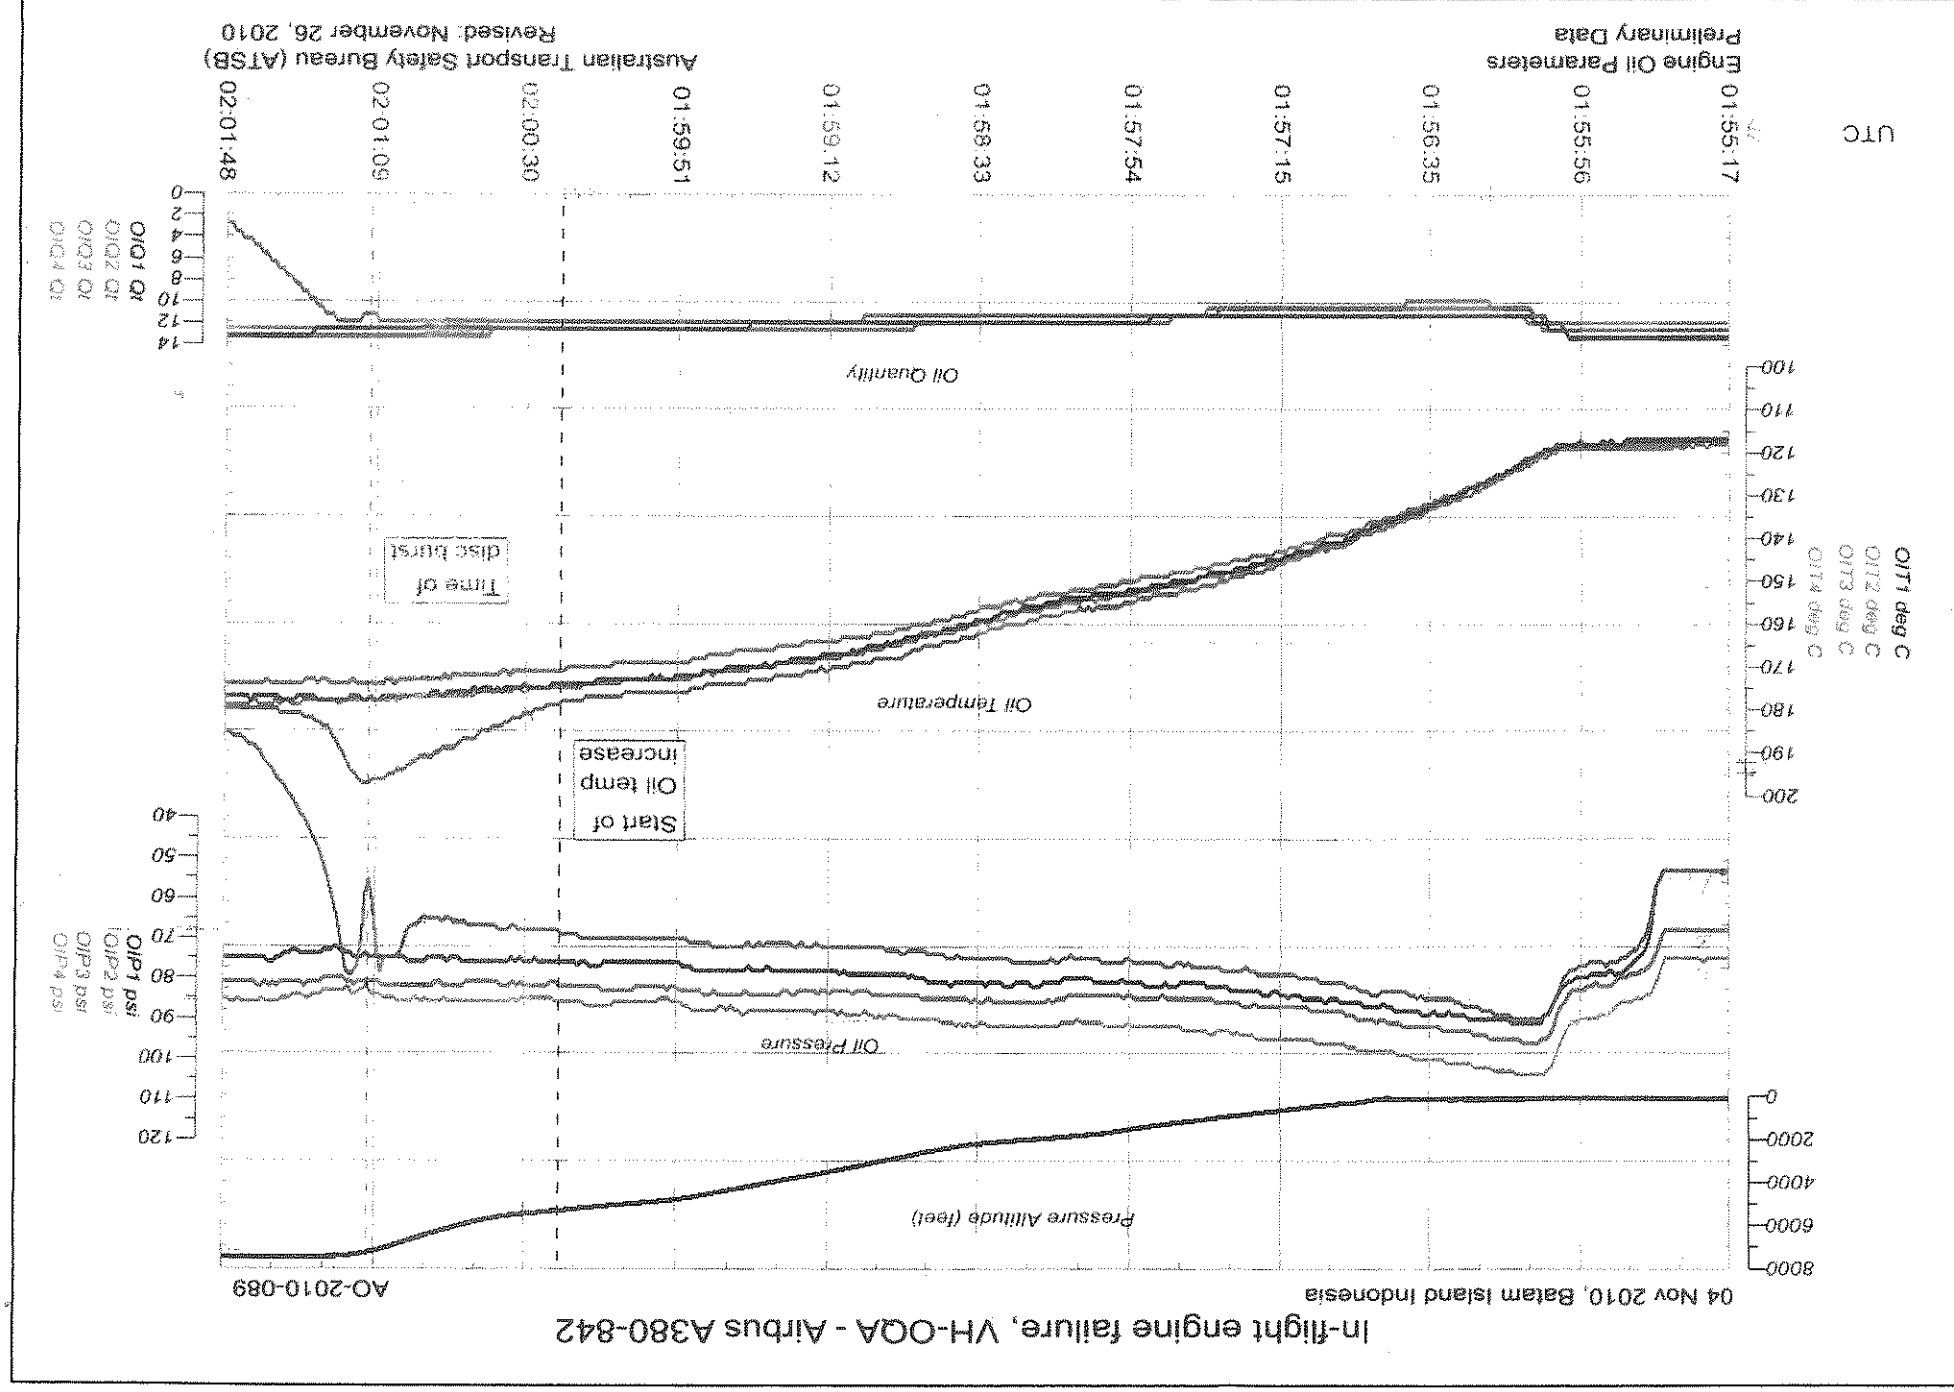
Figure A-3: Graphical representation of engine oil parameters prior to event

1. From start up #2 engine oil pressure was lower than the other 3 engines.  
0200.22 After setting 87% thrust
2. #2 Engine oil pressure began to drop further. #2 Engine oil temp rose gradually above the other 3 engines.
3. 0200.56 #2 engine Vibration started to fluctuate – then rose rapidly to 2.8
4. 0201.00 N2 and N3 changed speed at the same time as the vibration further increased to 3.7 accompanied by an uncontrolled drop in N1 of .8%.
5. (a) as result of 3 & 4 above, was reducing the thrust of #2 engine to idle considered?  
or  
(b) was an immediate shut down considered?
6. 0201.07 Did the Crew consider a 'LAST DITCH' opportunity to shut down #2 engine with - N1, N2, N3 decreasing rapidly – "2 loud bangs"/Stall.  
EGT rises rapidly due to limited fuel still supplying the engine (after P30) (fuel flow is not shown on report graphs.)

FOR SAME NI OF 87%  
OP DROPPED 3 PSI  
OT ROSE 12°C

Increasing vibration is often  
positive indication  
of a serious turbine problem  
developing.

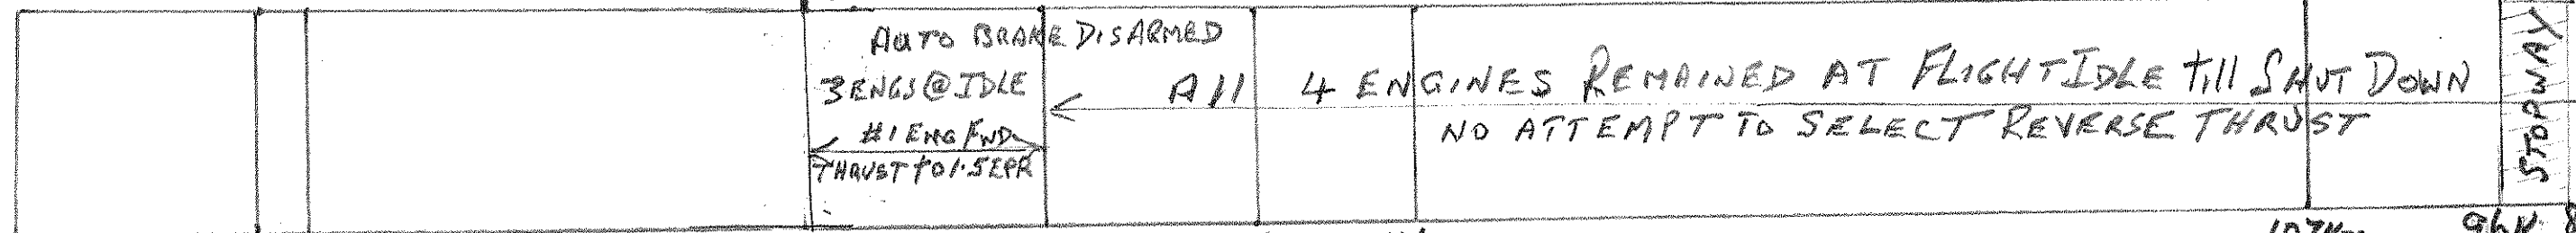
Runway 21L. 747-400 23 SEPT, 1999

TOUCH DOWN - Go Round / All 4 T. LEVERS ADV. 2246:30.1  
 Capt. reduced #2, 3 & 4 to Idle 2246:31.6  
 F/O reduced #1 " " 2246:33.0  
 2246:33.1

NO CREW NOTICED AUTO BRAKE DISARMED 33.3  
 46:33.5  
 46:38  
 46:38  
 46:41  
 All 4 Engines remained at Idle throughout the landing roll 2247:04

NO AUTO SPOILER  
 #1 lift at fwd thrust reached 1.50 EPR for 1.4 Secs  
 ACTION  
 AUTO SPOILER DEPLOYED (DUE NO. 1 TO IDLE)  
 AUTO BRAKE DISARMED (DUE #1 HAD BEEN ADVANCED)  
 T/O CONFIG. WARNING. DUE T/levers adv with flaps + SPOILER LEVER IN L/D'S POS  
 SPEED DECREASED (START) below touch down speed 1625M. from THRESHOLD.  
MANUAL Brake Commaed.  
 NOSE wheel Contacts runway.  
 A/c overman Stopway.

at no stage was Rev Idle or increased Reverse selected.
