# Post Incident Analysis Report

Lacrosse Docklands  
673-675 La Trobe Street, Docklands  
25 November 2014

Report No: **1403134A**

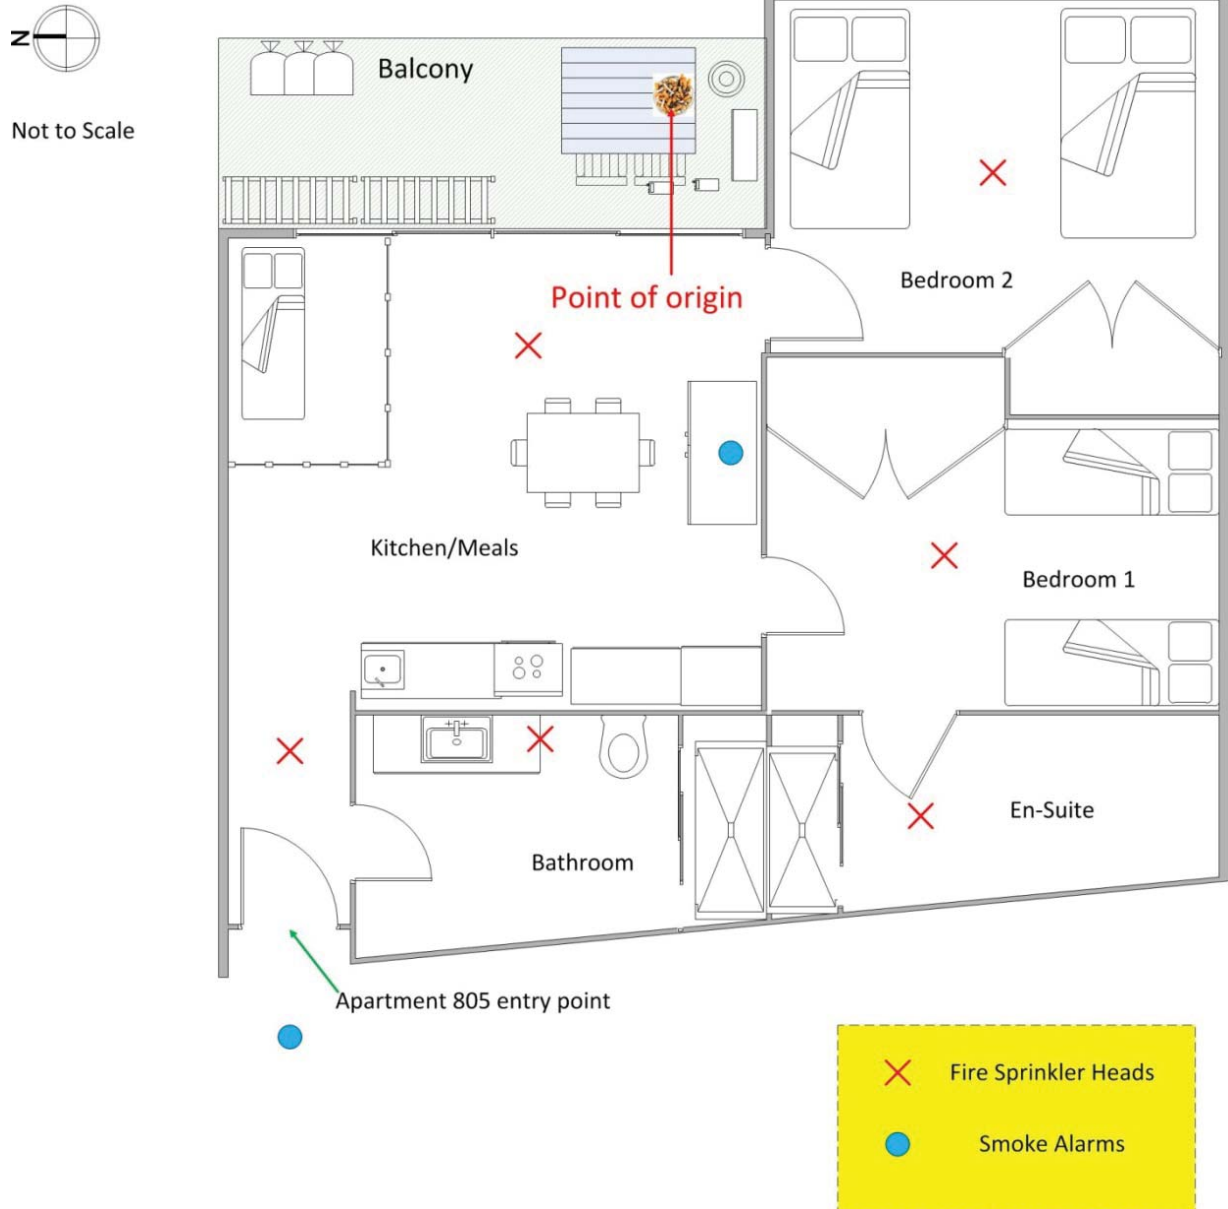
Figure 4 – Point of Origin

Positioned on the balcony approximately 200mm to the north of the A/C unit and the wire basket, were the remains of an outdoor setting with two steel framed plastic chairs and a steel framed timber slatted table. The two chairs were positioned in a north south line along the balcony and had sustained severe damage by the fire. The chair located further from the A/C unit had fire affected remains of the plastic chair still attached to it. The chair positioned closer to the A/C unit had no visible plastic remains evident. Across the back of the steel frames of the chairs was a burn pattern that was lower to floor level towards the A/C unit.

Further examination found fire debris on the floor of the balcony area, close to the first vertical upright of the balustrade; approximately 1 metre from the southern wall of the balcony revealed a number of fire affected cigarette butts. Some of these butts had been severely affected by fire, with minimal amounts of the filter section remaining and being burnt through, indicating prolonged or severe exposure to the fire.

Also located in the fire debris in this area, were the remains of matches that had been burnt. The match and some of the cigarette butts were located on top of the remains of a white plastic material. These white remains appeared to be from a plastic container and were located on the tiles of the balcony floor, with other fire affected debris around them and the fire affected glass from the balustrading on-top of them. This glass had sustained sooting to it and had been affected by the heat from the fire.

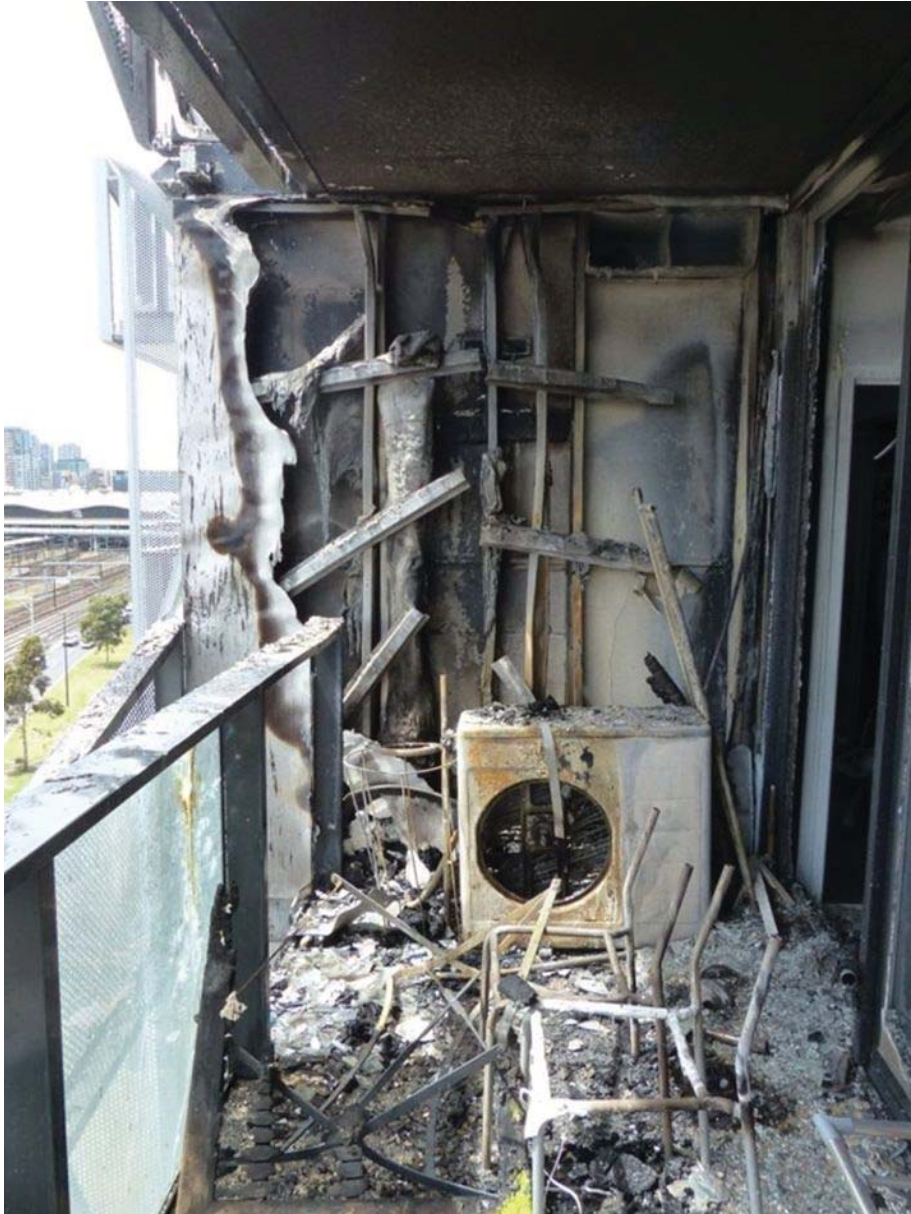
Fire damage to the southern wall was severe with consumption of almost the entire aluminium wall cladding (Alucobest). A 'V' pattern to this wall emanated from floor level of the balcony across the entire width. A small section of vertical wall, approximately 400mm protruded past the balcony balustrade allowing the fire to progress upwards to the balcony above. The section of aluminium cladding that remained outside the balcony created a 'V' pattern emanating from the balcony of this apartment.

Examination of the wall components revealed severe distortion to the steel frame and consumption of combustible components located in the wall. Severe burning to the back of the plaster had occurred with cracks and breaking down of the plaster's stability occurring. Intense burning had occurred in the area of the PVC downpipe, which had been consumed between the tiled floor and the concrete ceiling of the balcony. Prior to the fire, an exterior light had been mounted to the wall above the A/C unit. Although no remains of this light were located in the fire debris, burn patterns around the approximate mounting position on the wall do not suggest this light to be the point of origin for the fire.

The extremely vertical nature of the burn patterns to the exterior face of the wall suggest that the Alucobest aluminium cladding, along with the foam lagging and the PVC pipe of the building wall, contributed to the fire load and the rapid spread of the fire up the vertical face of the building to the floors and balcony areas located above.

**Figure 6 - Picture 5: South Wall Balcony of Apartment 805 before excavation.**

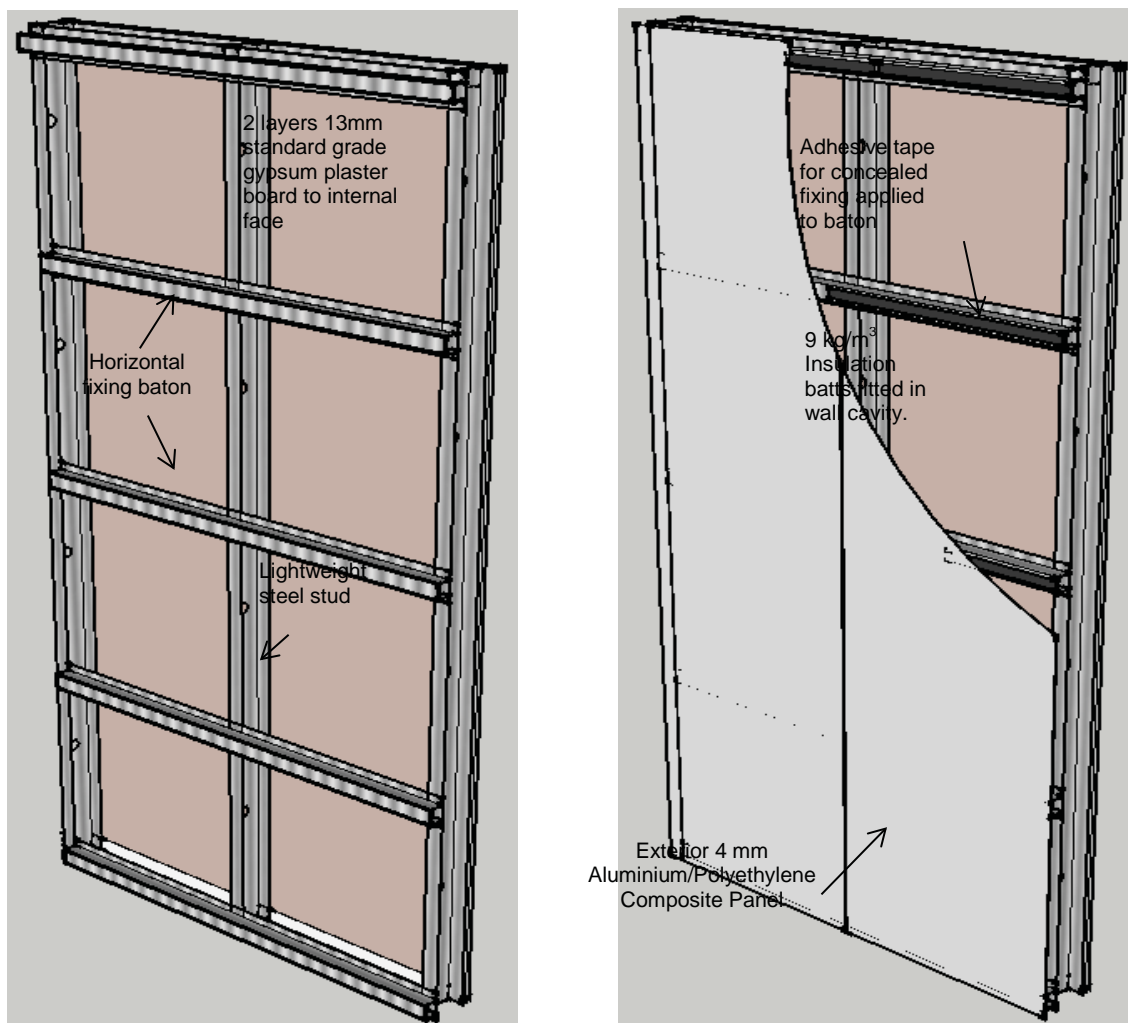
**Figure 9 - Aluminium/Polyethylene Composite Panel Façade - External Wall Cladding**

To the best of the MFB's knowledge, the labelling indicates an aluminium/polyethylene composite panel of 4mm thickness, in a colour known as Champagne Silver (*HY 103*). It is unclear what the value 11060167 represents, however, the number does loosely appear to correspond with the date and time shown at the end of the label and may indicate the number of manufacturing runs of this colour and type for the month. It is assumed this panel is the standard grade Alucobest panel, as there is nothing to indicate otherwise. The product is believed to incorporate a Polyethylene core material.

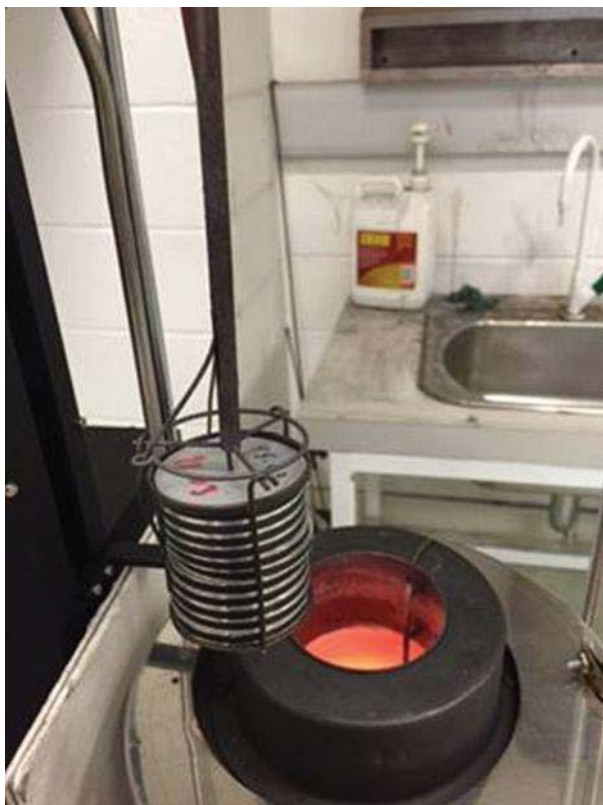
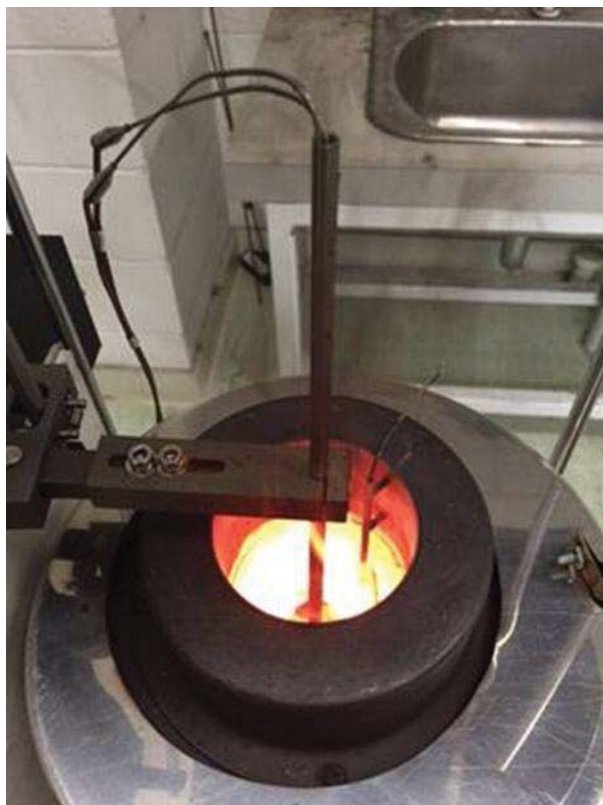
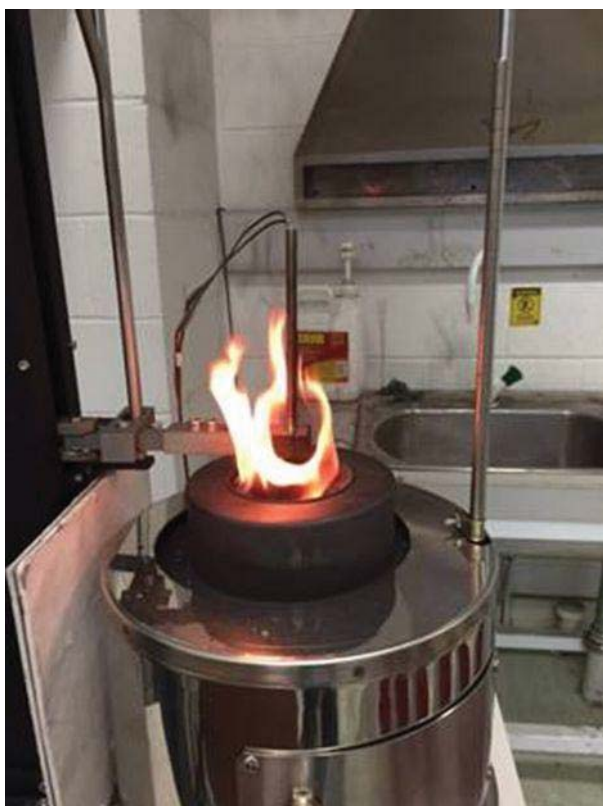
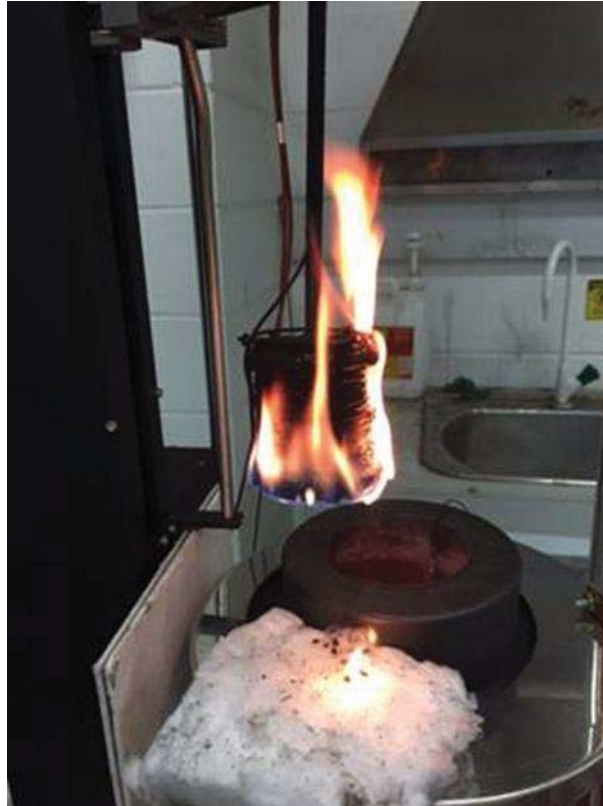
***Observations:*** Sustained flaming was observed on the specimen at 55 seconds into the test. The test was terminated at 93 seconds due to excessive flaming and smoking.

Specimen photos before, during and after the test.

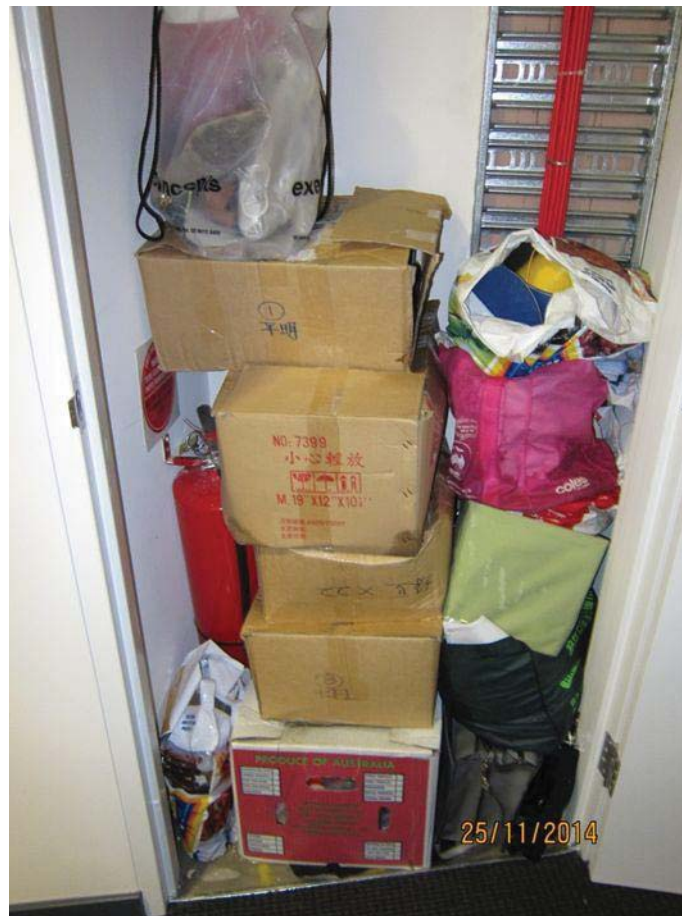
In this instance, a number of the purposely designed extinguisher enclosure housing Extinguishers 1 and 2 shown in [Figure 12 \(refer previous page\)](#), were being used by occupants as storage areas thus blocking access to the extinguishers.

**Figure 13 - Fire extinguisher cupboard on Level 6.**

The storage of goods and materials in enclosures used to accommodate fire safety equipment, delays access for occupants or fire-fighters who require the equipment in an emergency. These storage items are generally of a combustible nature and present an additional hazard.

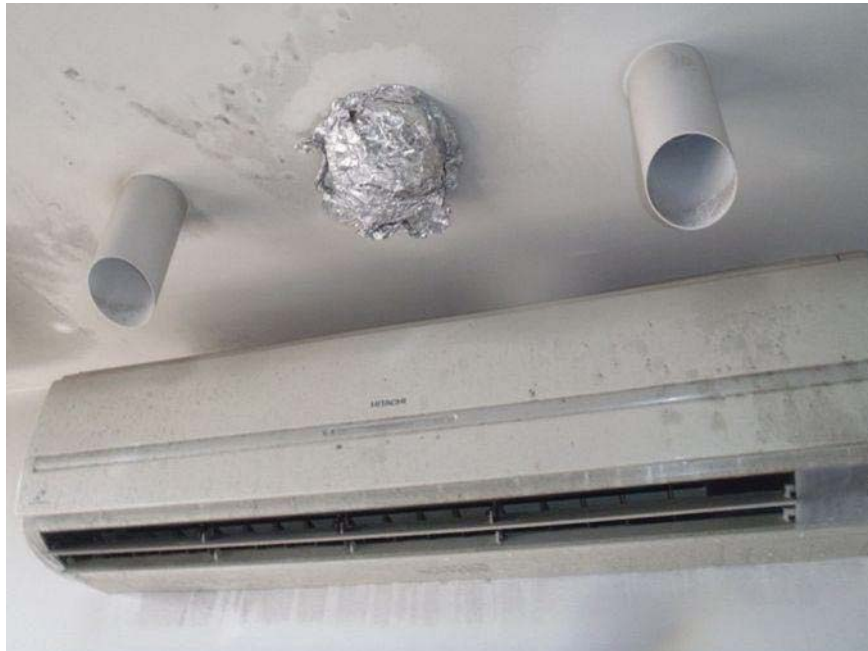
It was observed that within a number of apartments the battery had been removed from the smoke alarm. In addition some smoke alarms had been covered (Refer to Figure 14 below).

Figure 14 - An example of an obstructed Smoke Alarm – Apartment 805

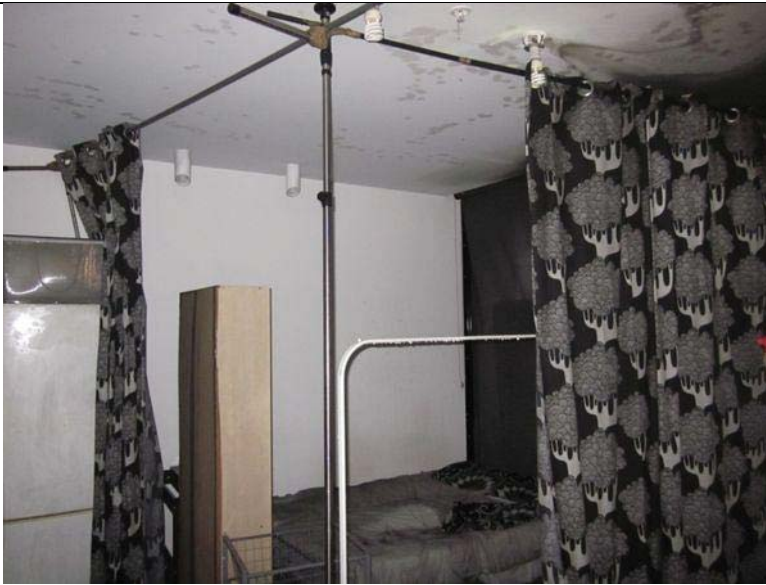
Living room cordoned off to create additional bedroom

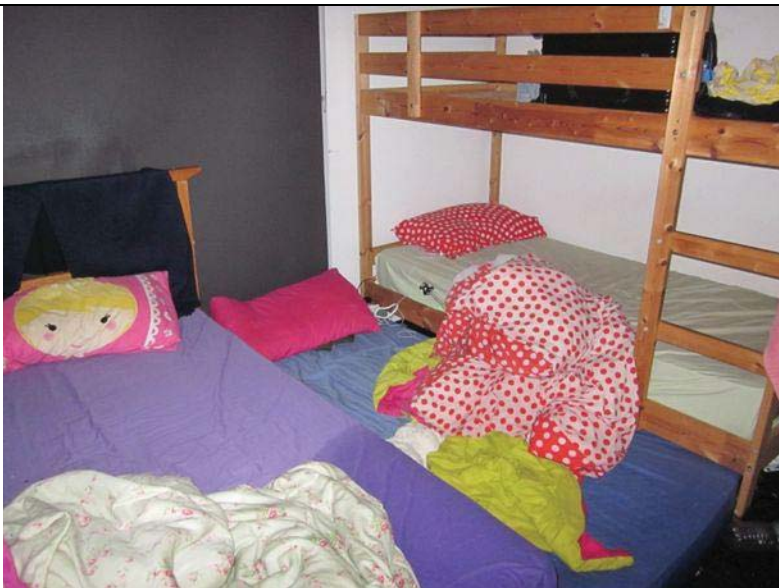
Multiple Beds in two bedroom apartment.
