Post Incident Analysis Report

Lacrosse Docklands
673-675 La Trobe Street, Docklands
25 November 2014

Report No: **1403134A**

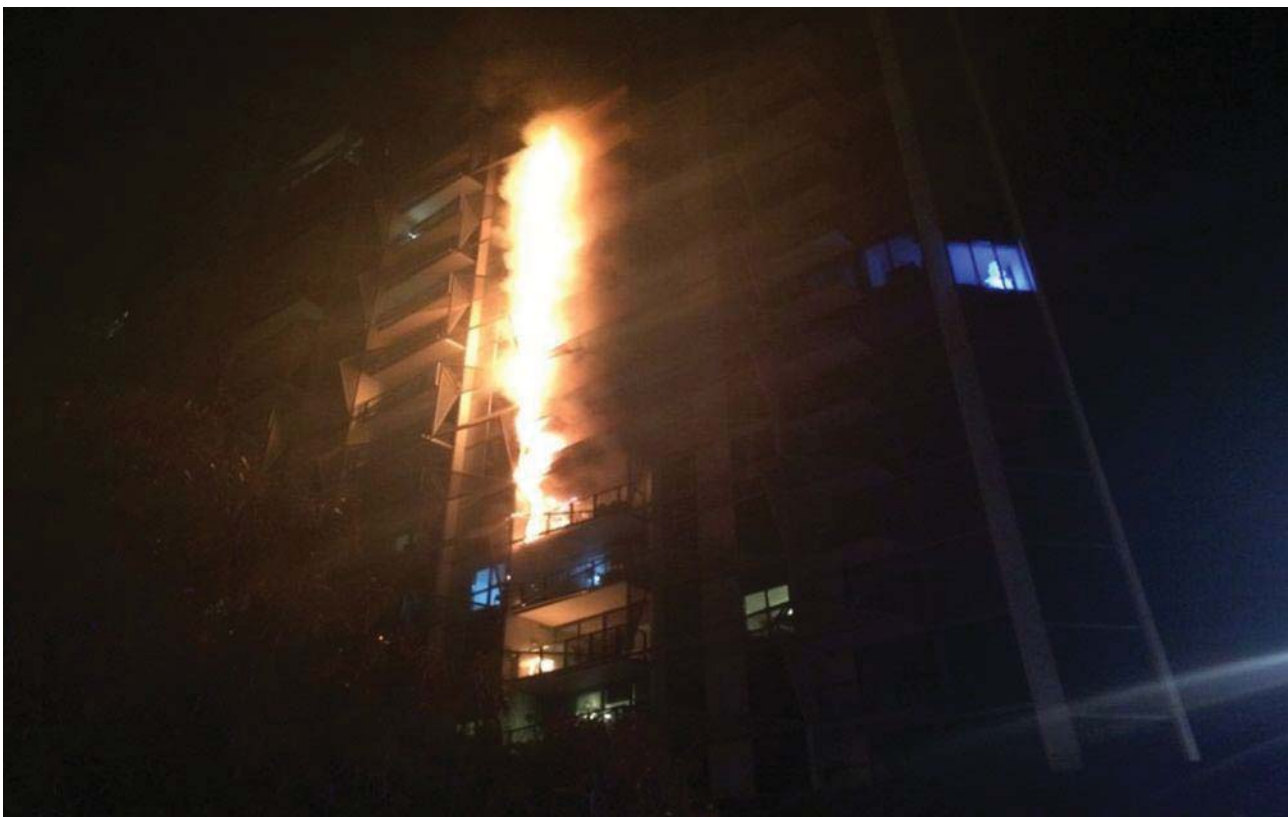
The occupants from Level 6, Apartment 605 reported later to fire-fighters, seeing fire embers and flaming debris falling from levels above their apartment and igniting materials on their balcony. They then evacuated the building. See photograph below.

Figure 2 – Shows fire on level 6 and fire on level 8 (point of origin) extending up to level 14 (02:29)

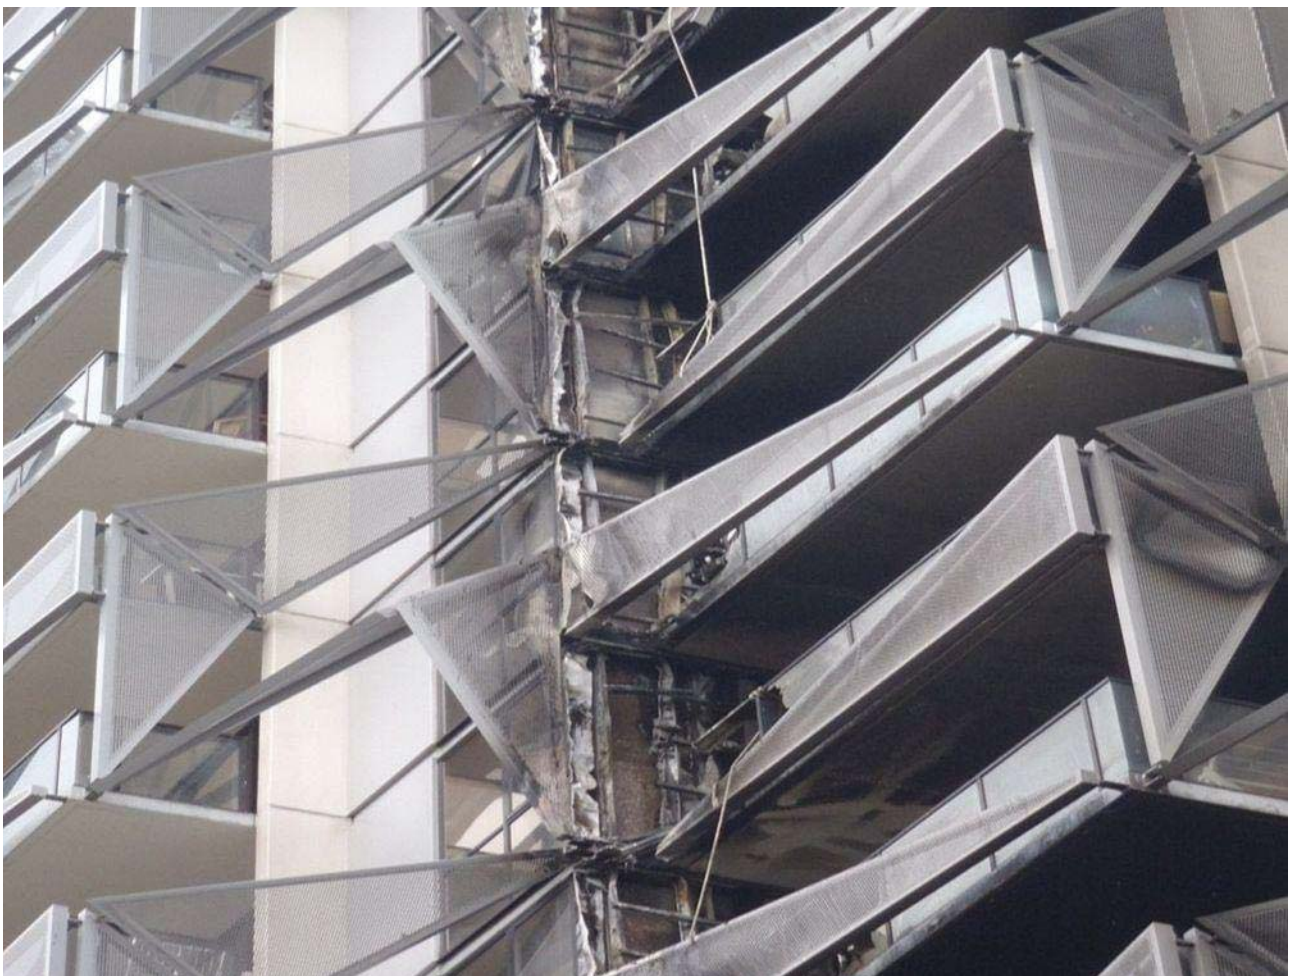
Fire damage was essentially restricted to the façade and external balcony area adjacent to Apartment 605 and Apartments 805 to 2105. Please refer to the [Fire Cause and Origin section](#) of this report for further information on fire damage.

Figure 3 - Fire damage to the external wall cladding and ornamental structures

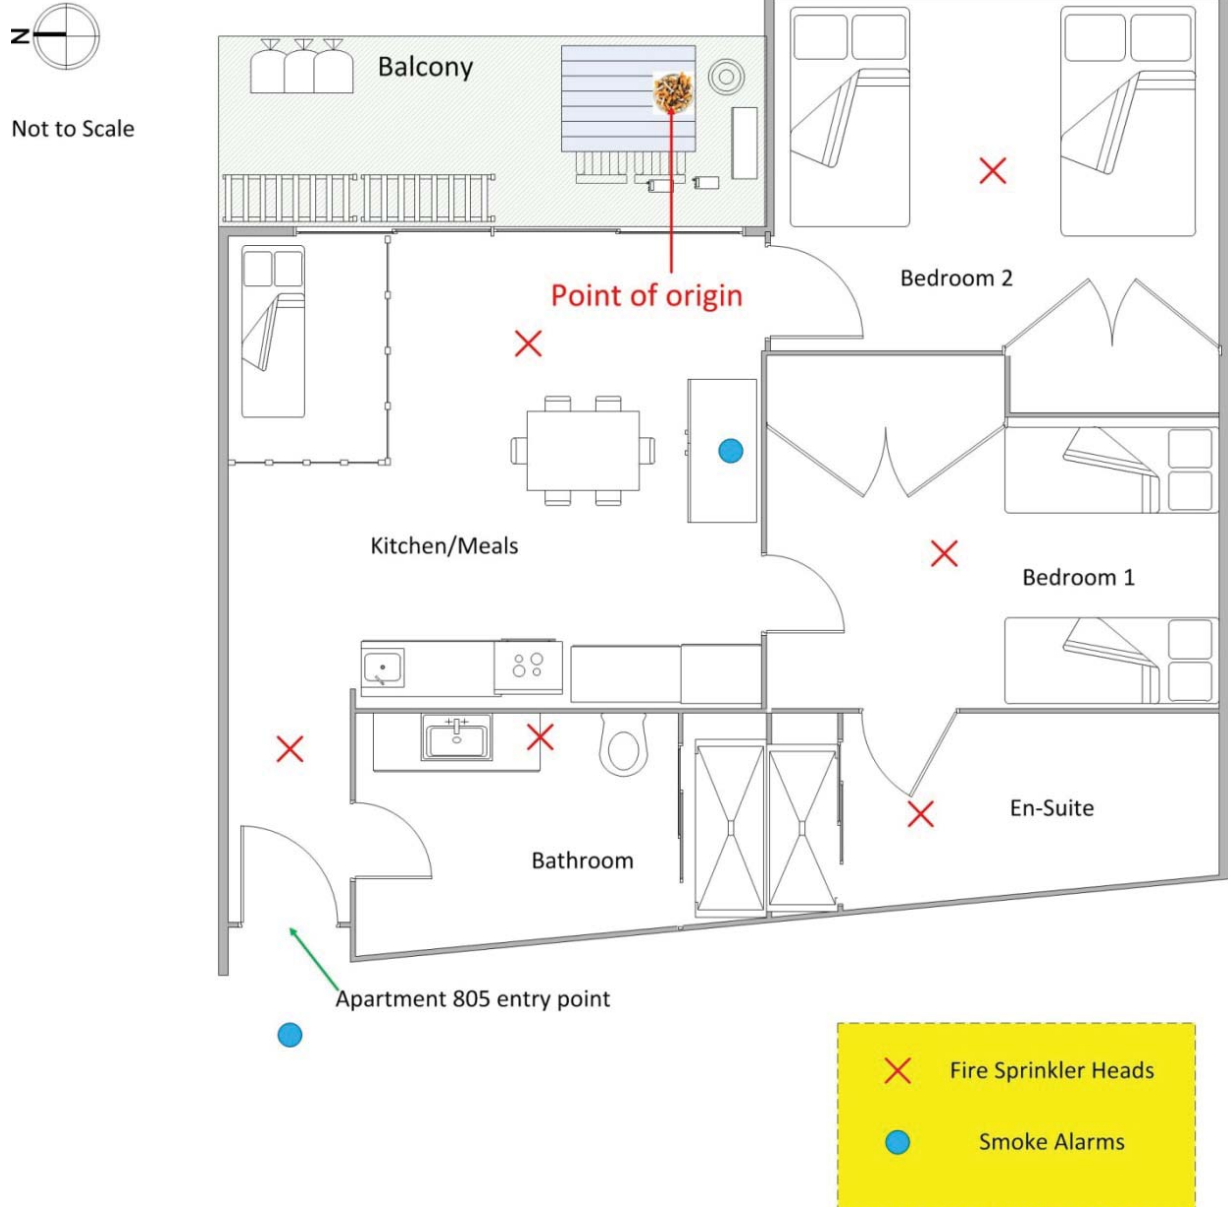
Figure 4 – Point of Origin

Positioned on the balcony approximately 200mm to the north of the A/C unit and the wire basket, were the remains of an outdoor setting with two steel framed plastic chairs and a steel framed timber slatted table. The two chairs were positioned in a north south line along the balcony and had sustained severe damage by the fire. The chair located further from the A/C unit had fire affected remains of the plastic chair still attached to it. The chair positioned closer to the A/C unit had no visible plastic remains evident. Across the back of the steel frames of the chairs was a burn pattern that was lower to floor level towards the A/C unit.

Further examination found fire debris on the floor of the balcony area, close to the first vertical upright of the balustrade; approximately 1 metre from the southern wall of the balcony revealed a number of fire affected cigarette butts. Some of these butts had been severely affected by fire, with minimal amounts of the filter section remaining and being burnt through, indicating prolonged or severe exposure to the fire.

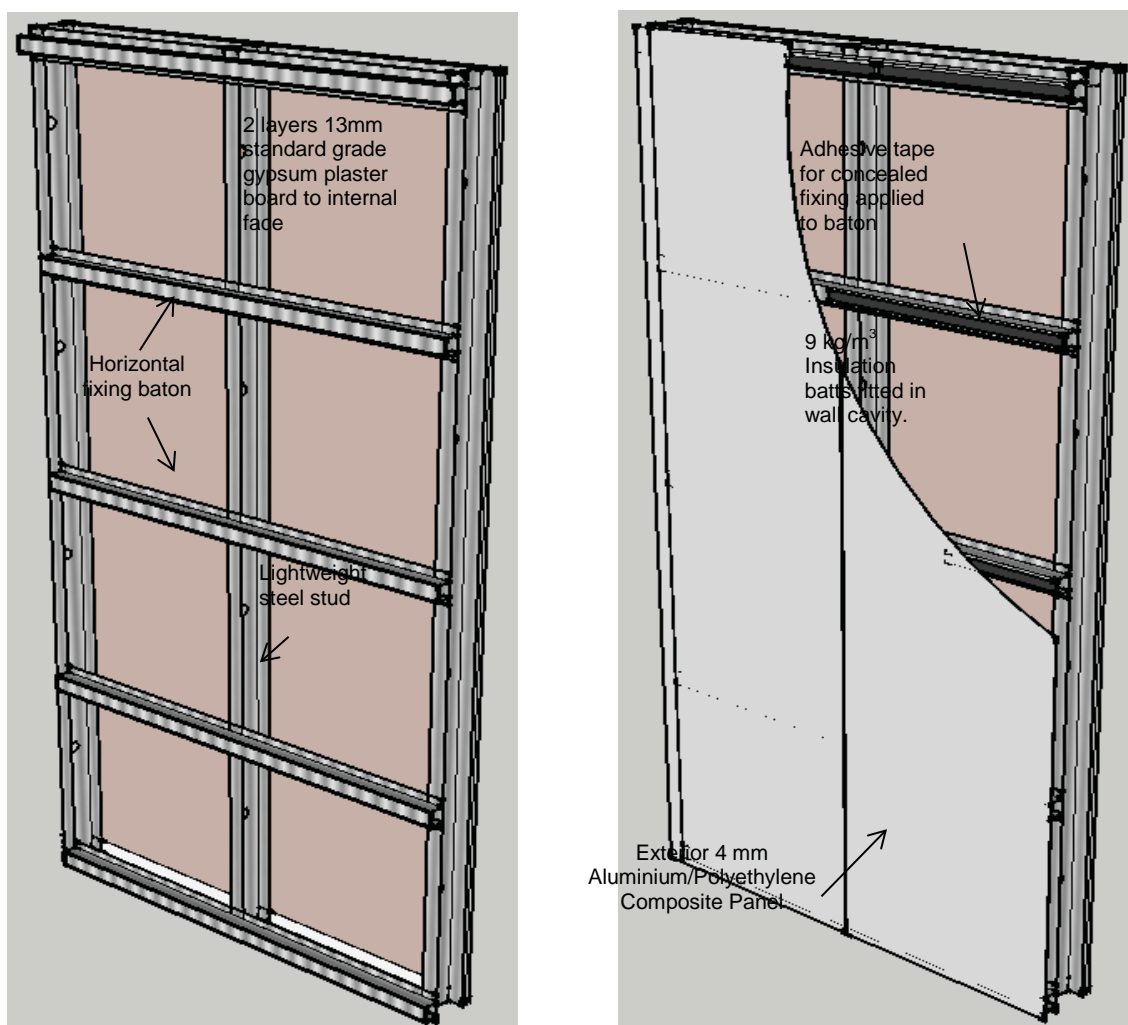
Figure 9 - Aluminium/Polyethylene Composite Panel Façade - External Wall Cladding

To the best of the MFB's knowledge, the labelling indicates an aluminium/polyethylene composite panel of 4mm thickness, in a colour known as Champagne Silver (*HY 103*). It is unclear what the value 11060167 represents, however, the number does loosely appear to correspond with the date and time shown at the end of the label and may indicate the number of manufacturing runs of this colour and type for the month. It is assumed this panel is the standard grade Alucobest panel, as there is nothing to indicate otherwise. The product is believed to incorporate a Polyethylene core material.

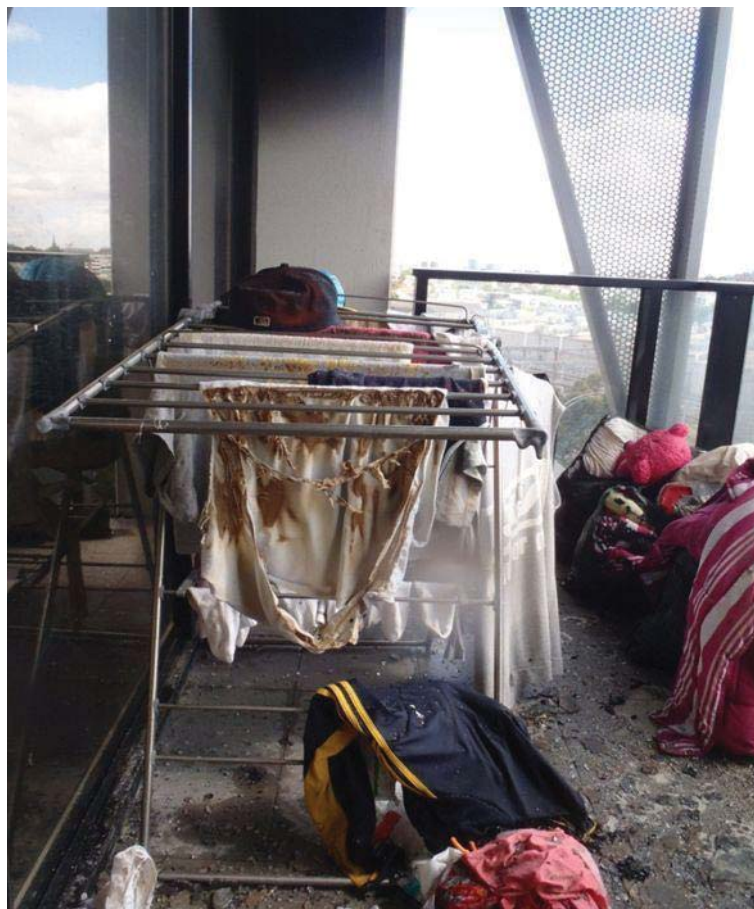
In this instance, typical combustibles identified to be present on balconies throughout the building consisted of clothing, bedding, bicycles, electrical appliances and other miscellaneous combustible materials, notwithstanding the air conditioner compressor units and other combustible furniture items. See Figure 11 below for example.

Figure 11 - Combustibles stored on one of the balconies.

High occupancy rates in apartments can lead to reliance on balconies for additional storage space, increasing the fire load.

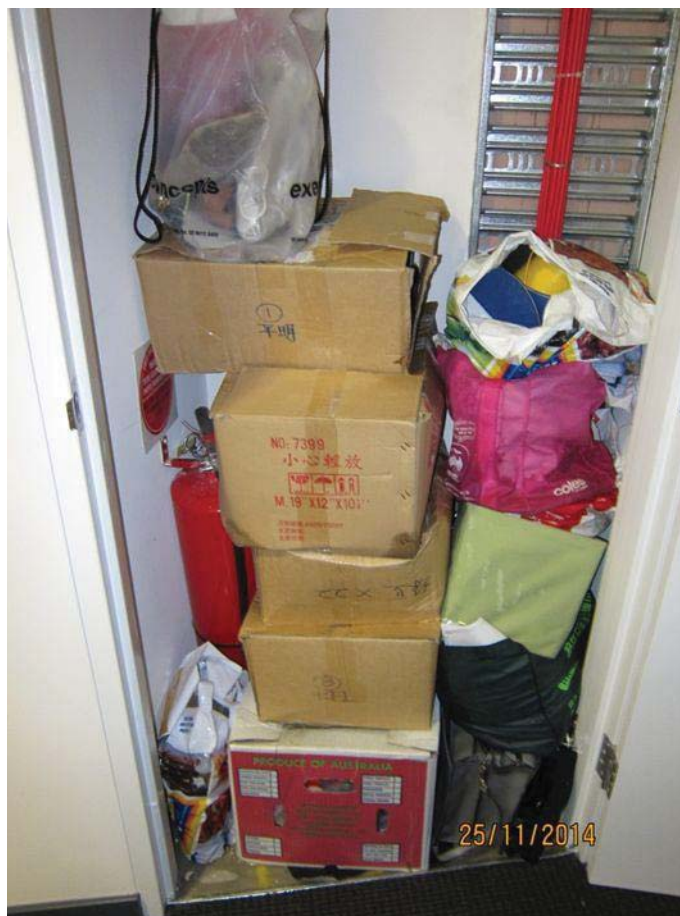
In this instance, a number of the purposely designed extinguisher enclosure housing Extinguishers 1 and 2 shown in [Figure 12 \(refer previous page\)](#), were being used by occupants as storage areas thus blocking access to the extinguishers.

Figure 13 - Fire extinguisher cupboard on Level 6.

The storage of goods and materials in enclosures used to accommodate fire safety equipment, delays access for occupants or fire-fighters who require the equipment in an emergency. These storage items are generally of a combustible nature and present an additional hazard.

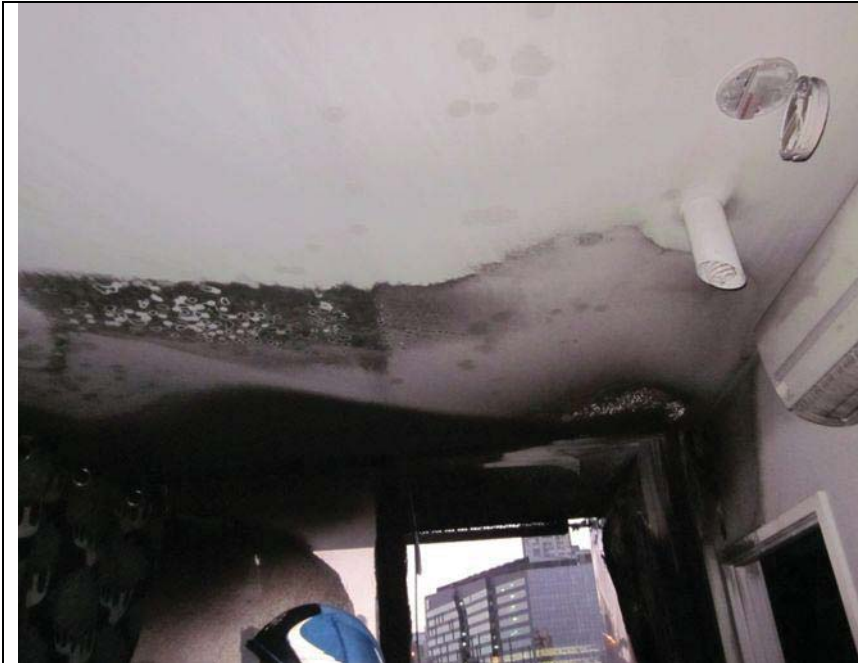
View of damaged wall and smoke detectors made inoperable. Others were covered over.
