# Post Incident Analysis Report

Lacrosse Docklands  
673-675 La Trobe Street, Docklands  
25 November 2014

Report No: **1403134A**

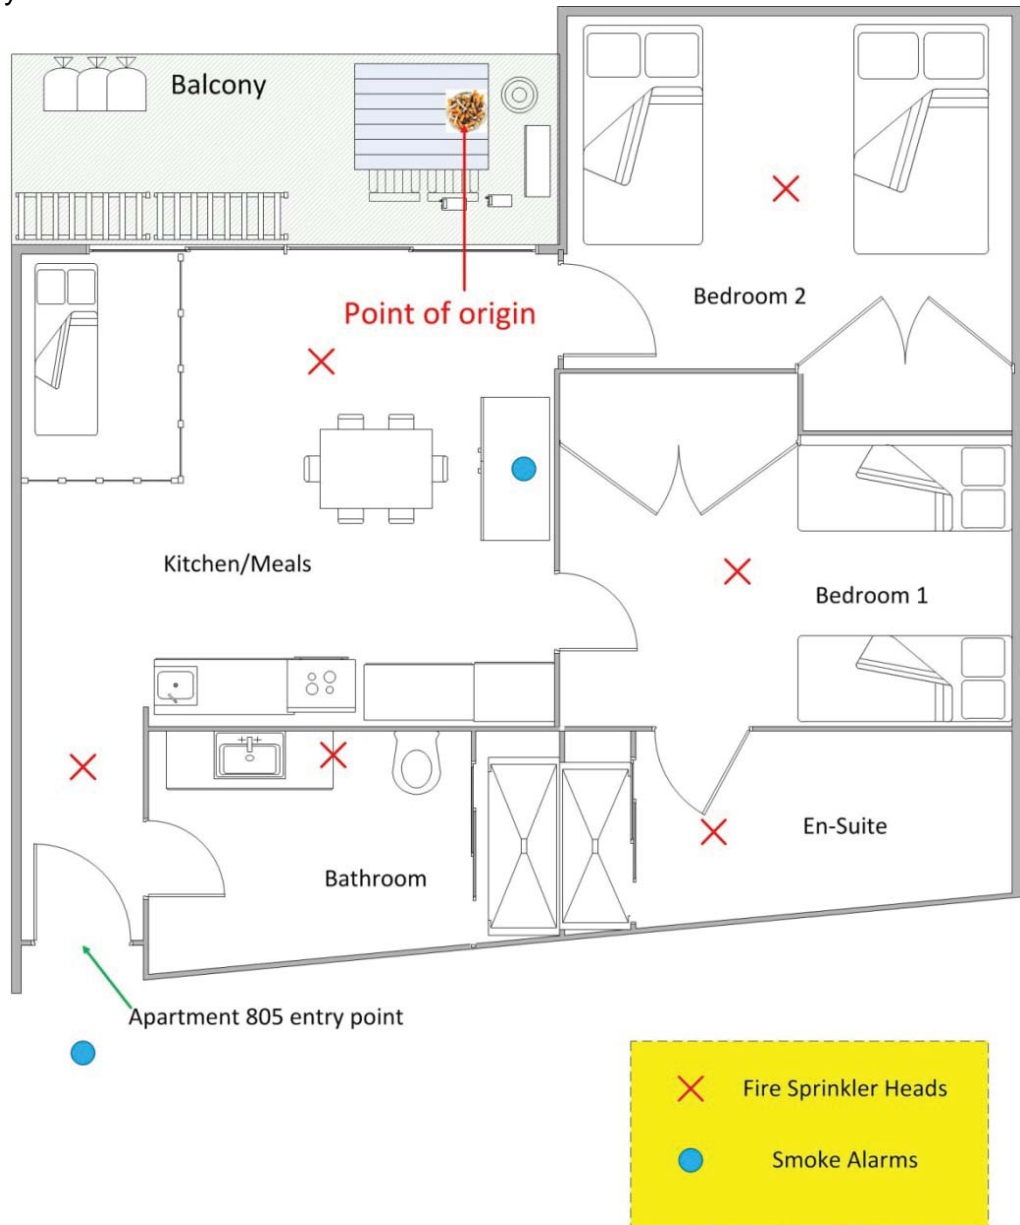
Figure 4 – Point of Origin

Positioned on the balcony approximately 200mm to the north of the A/C unit and the wire basket, were the remains of an outdoor setting with two steel framed plastic chairs and a steel framed timber slatted table. The two chairs were positioned in a north south line along the balcony and had sustained severe damage by the fire. The chair located further from the A/C unit had fire affected remains of the plastic chair still attached to it. The chair positioned closer to the A/C unit had no visible plastic remains evident. Across the back of the steel frames of the chairs was a burn pattern that was lower to floor level towards the A/C unit.

Further examination found fire debris on the floor of the balcony area, close to the first vertical upright of the balustrade; approximately 1 metre from the southern wall of the balcony revealed a number of fire affected cigarette butts. Some of these butts had been severely affected by fire, with minimal amounts of the filter section remaining and being burnt through, indicating prolonged or severe exposure to the fire.

Also located in the fire debris in this area, were the remains of matches that had been burnt. The match and some of the cigarette butts were located on top of the remains of a white plastic material. These white remains appeared to be from a plastic container and were located on the tiles of the balcony floor, with other fire affected debris around them and the fire affected glass from the balustrading on-top of them. This glass had sustained sooting to it and had been affected by the heat from the fire.

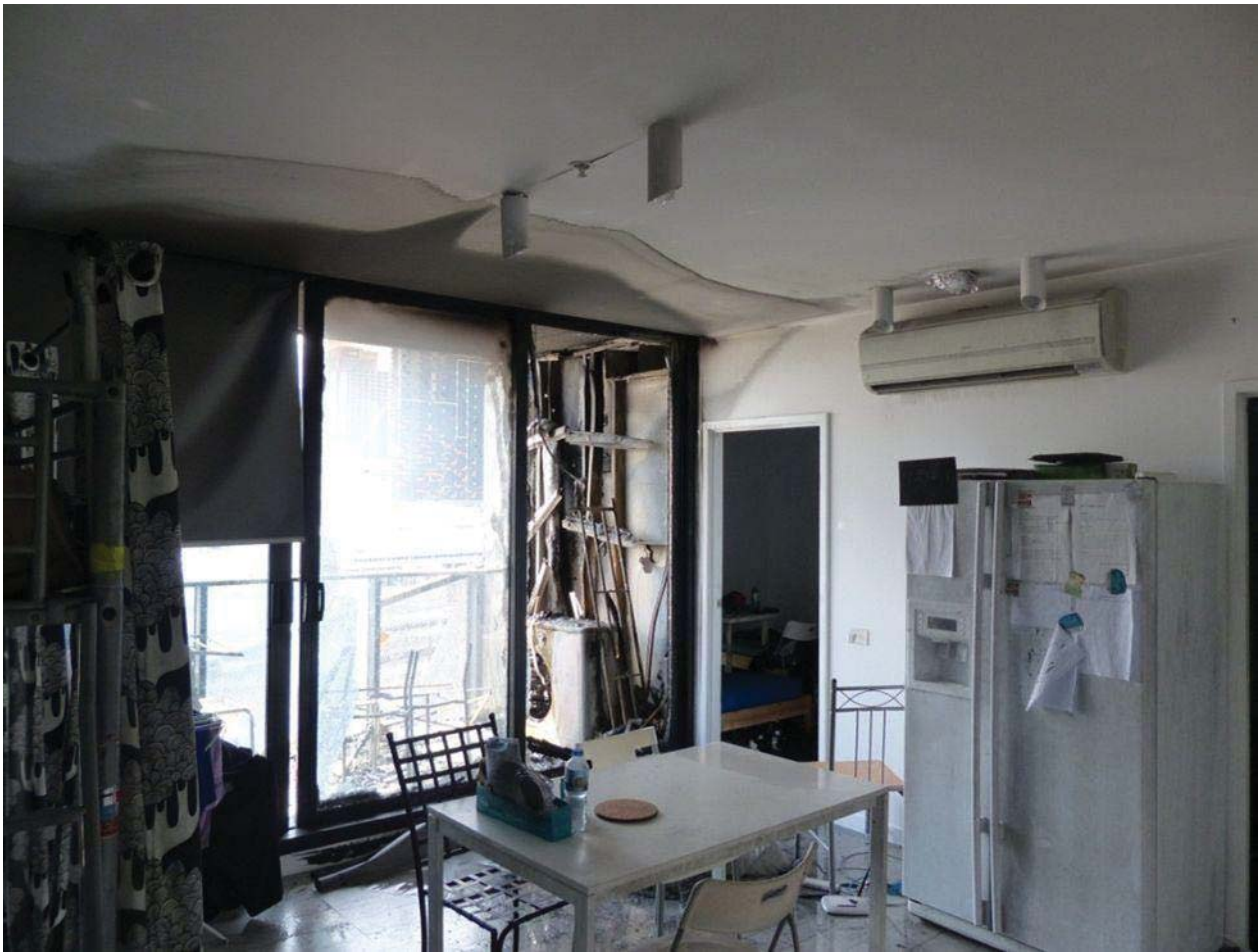
Full height glass double glazed sliding doors gave access to the balcony area from the kitchen. These had sustained heat and fire damage with the glass from the fixed panel located at the southern end of the balcony, breaking and collapsing to the floor areas of the kitchen and balcony. At the time of the investigation the double sliding doors were in the open position, with a visible gap of approximately 50mm between the two sliding doors. Access for investigation purposes was gained through the broken fixed panel at the southern end of the balcony area.

**Figure 5 – Picture 4: Inside kitchen looking towards double glass sliding doors leading to balcony area & bedroom 2.**

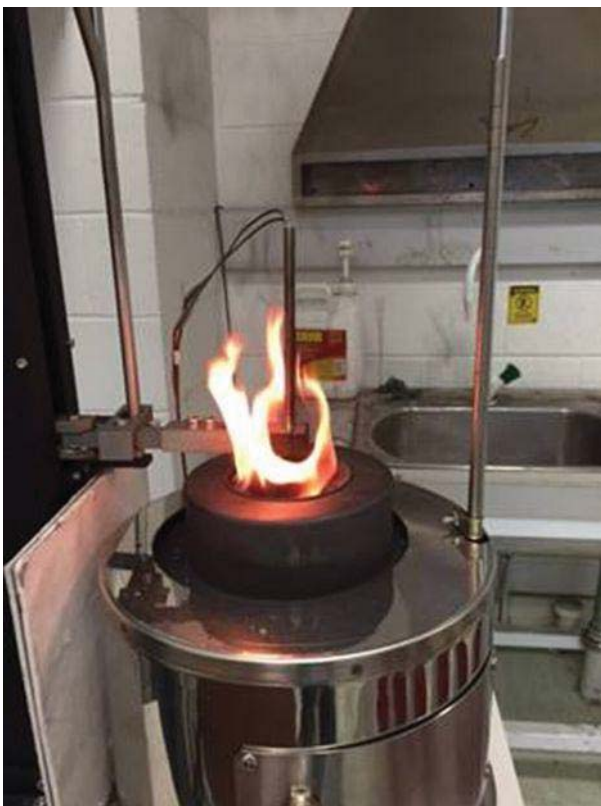
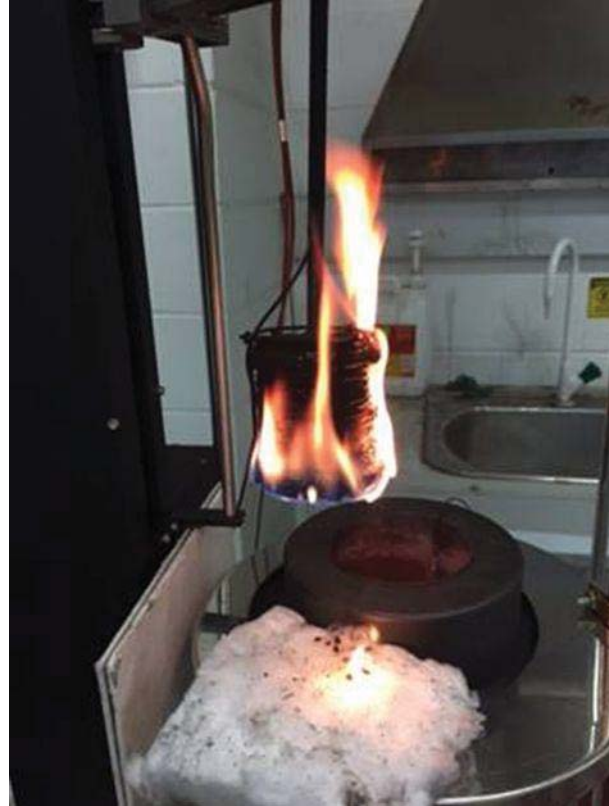
Specimen photos before, during and after the test.

***Observations:*** Sustained flaming was observed on the specimen at 55 seconds into the test. The test was terminated at 93 seconds due to excessive flaming and smoking.

- Only one sample was tested in lieu of the required five samples and for duration of less than 60 seconds, in lieu of the required 30 minute test duration. This was due to sustained flaming to the test specimen prior to 60 seconds, causing clear failure with the criteria detailed in item (a) above and therefore test failure. The test was terminated to prevent damage to the CSIRO test equipment. Due to test termination, CSIRO are unable to provide calculation for criteria (b) and (c) above.

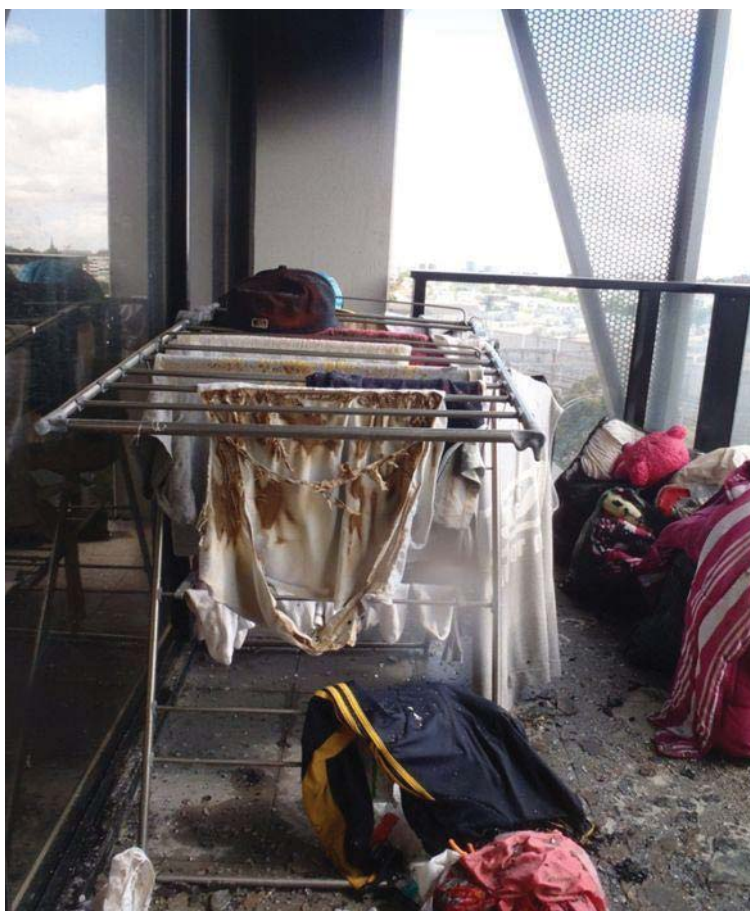
In this instance, typical combustibles identified to be present on balconies throughout the building consisted of clothing, bedding, bicycles, electrical appliances and other miscellaneous combustible materials, notwithstanding the air conditioner compressor units and other combustible furniture items. See Figure 11 below for example.

Figure 11 - Combustibles stored on one of the balconies.

High occupancy rates in apartments can lead to reliance on balconies for additional storage space, increasing the fire load.

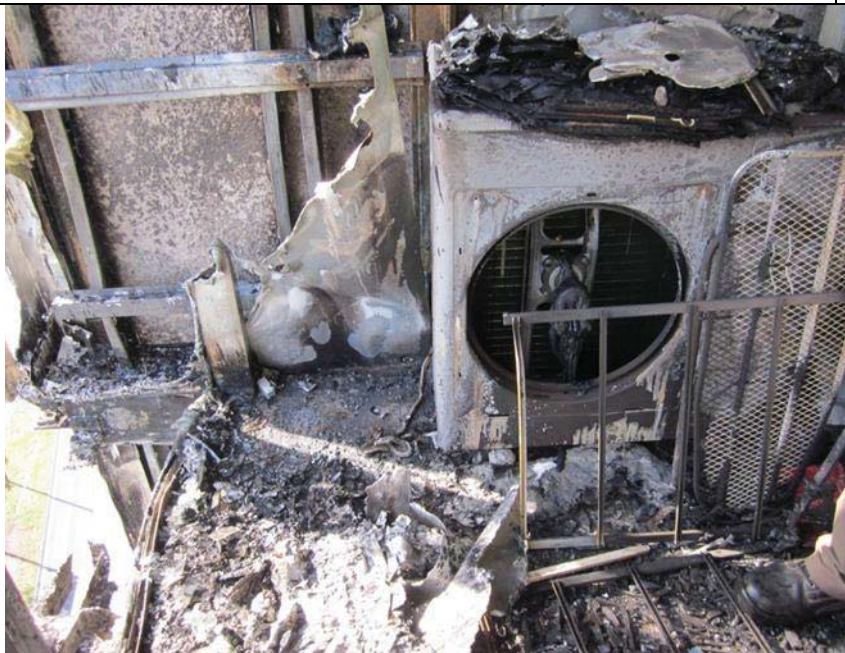
Photo of base of wall and penetrations plus overhang past balcony edge
