# Post Incident Analysis Report

**MFB Burnley Complex  
450 Burnley Street  
Richmond VIC 3121**

Lacrosse Docklands  
673-675 La Trobe Street, Docklands  
25 November 2014

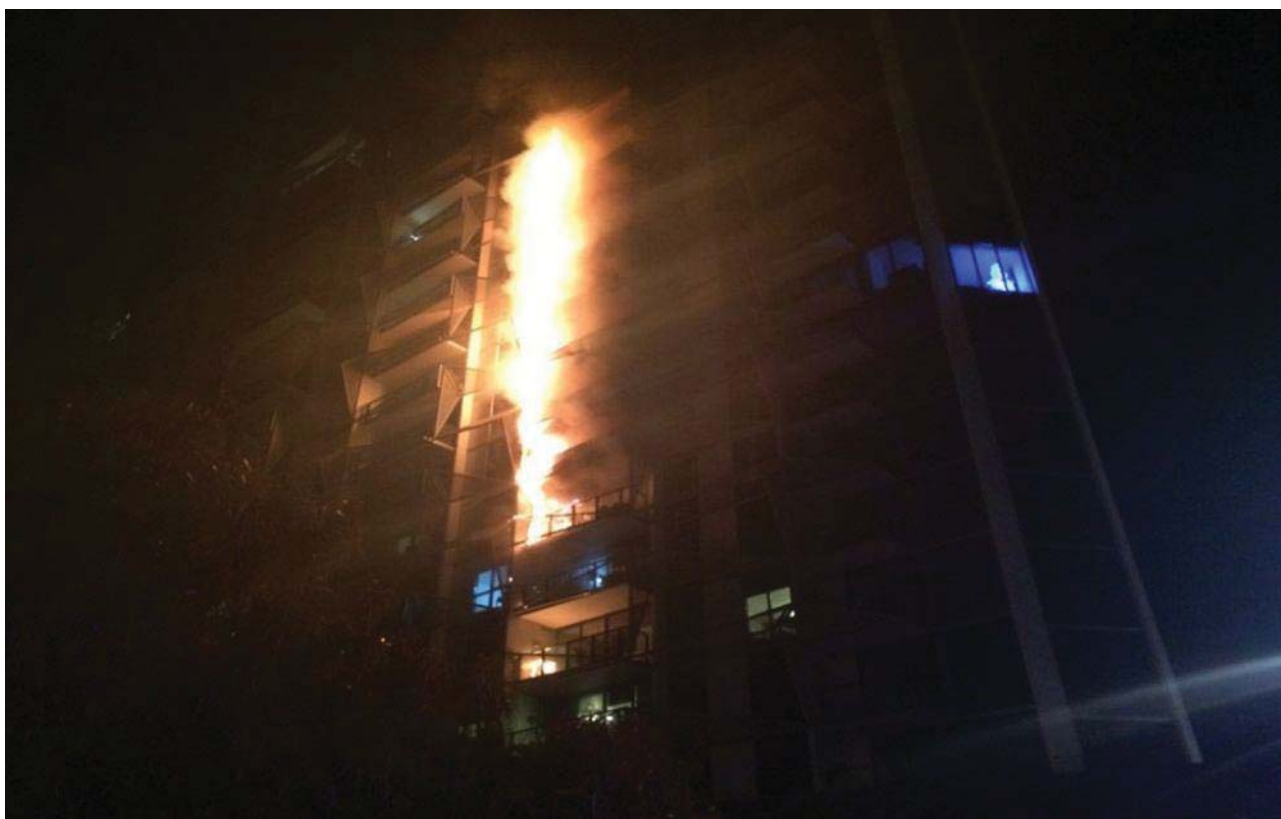
The occupants from Level 6, Apartment 605 reported later to fire-fighters, seeing fire embers and flaming debris falling from levels above their apartment and igniting materials on their balcony. They then evacuated the building. See photograph below.

**Figure 2 – Shows fire on level 6 and fire on level 8 (point of origin) extending up to level 14 (02:29)**

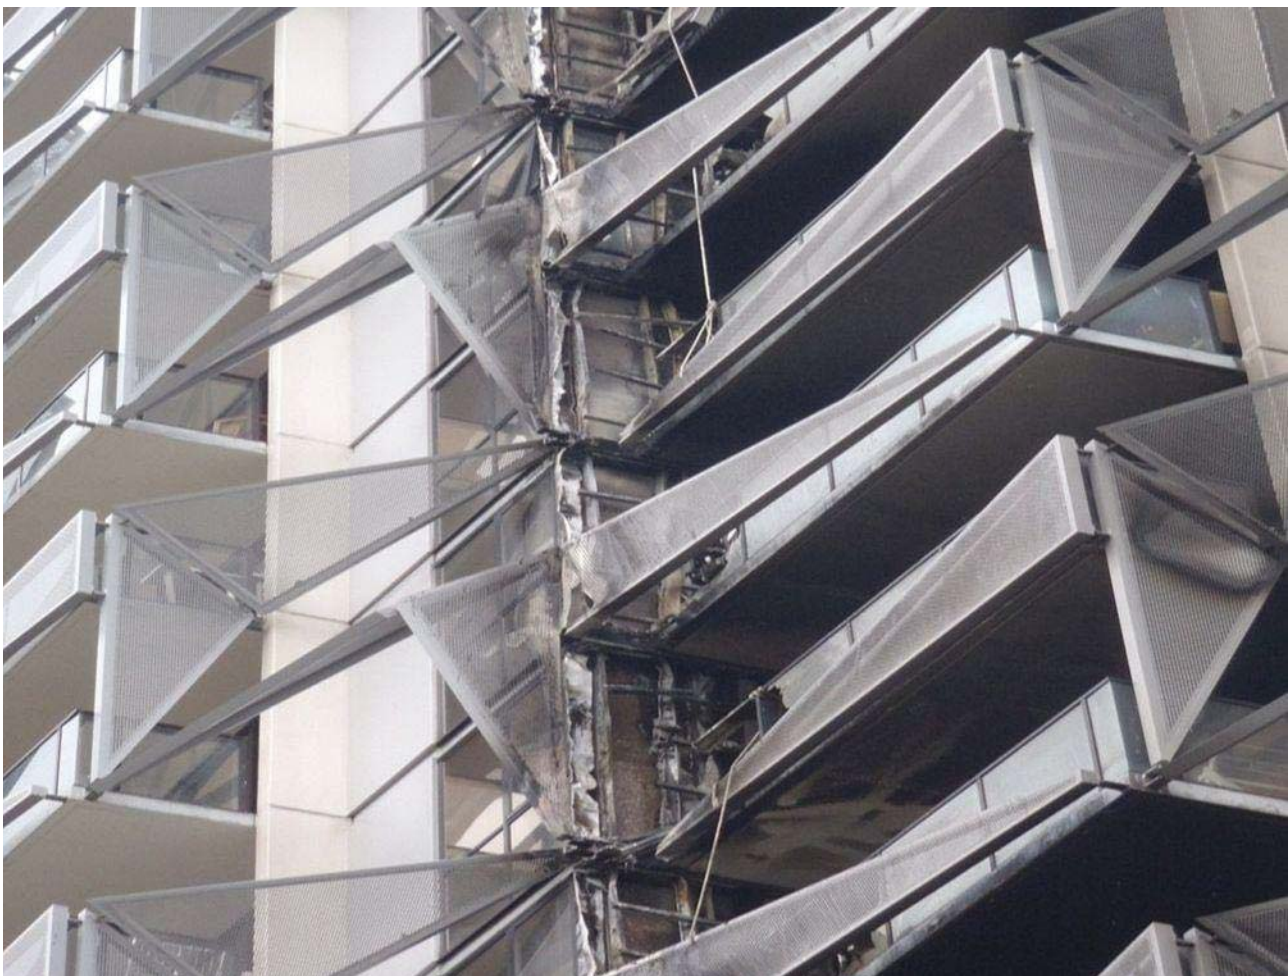
Fire damage was essentially restricted to the façade and external balcony area adjacent to Apartment 605 and Apartments 805 to 2105. Please refer to the [Fire Cause and Origin section](#) of this report for further information on fire damage.

**Figure 3 - Fire damage to the external wall cladding and ornamental structures**

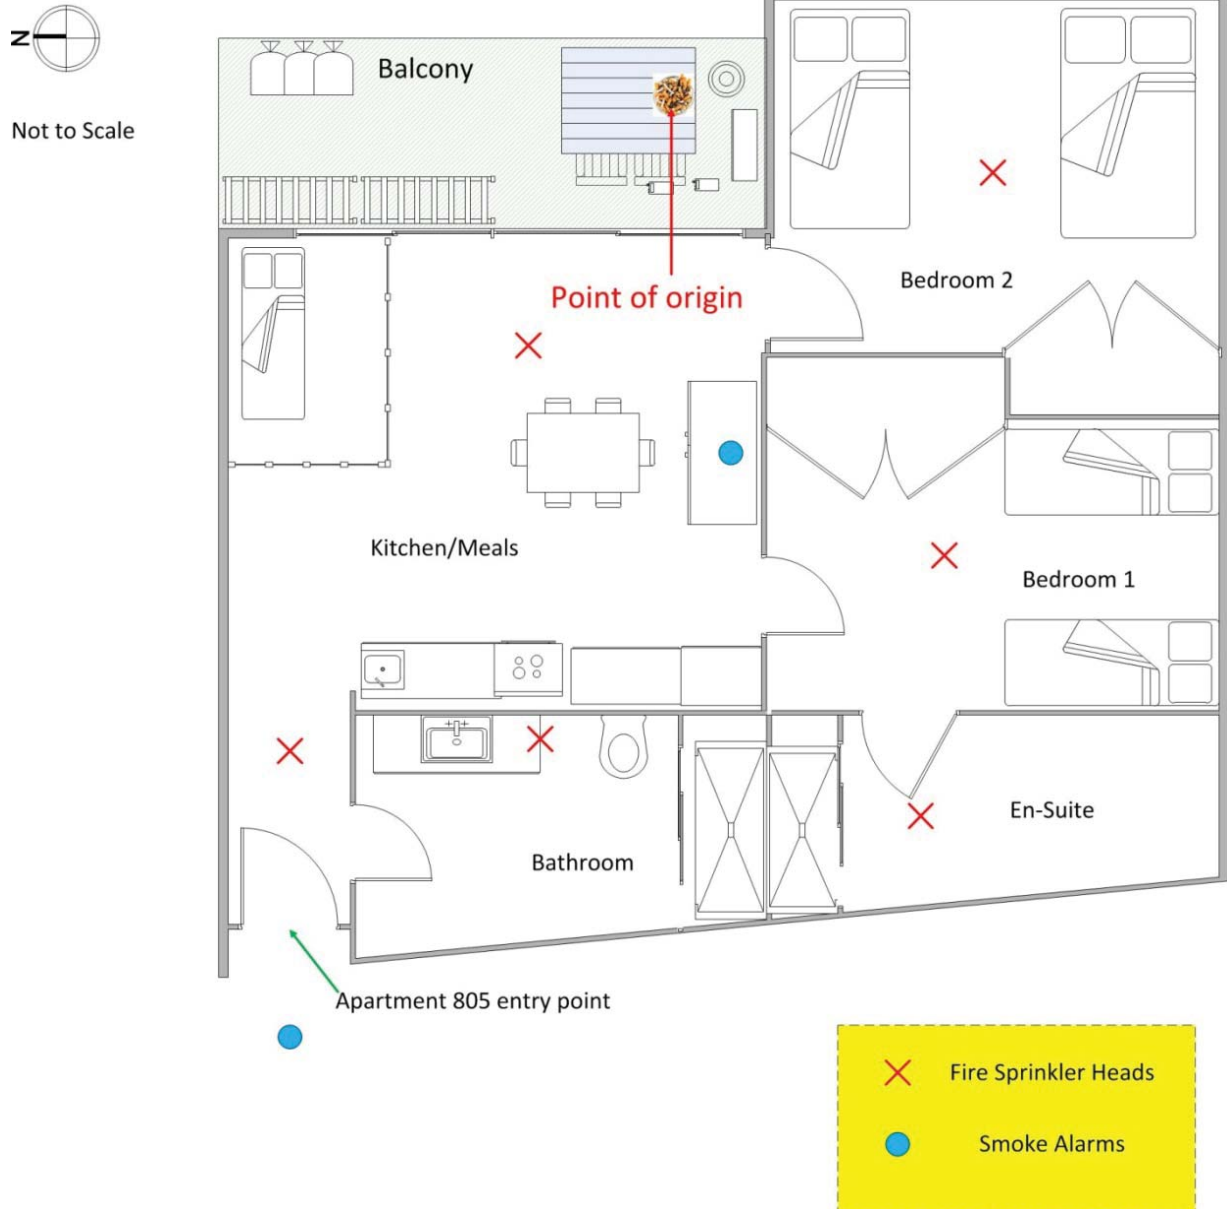
**Figure 4 – Point of Origin**

Positioned on the balcony approximately 200mm to the north of the A/C unit and the wire basket, were the remains of an outdoor setting with two steel framed plastic chairs and a steel framed timber slatted table. The two chairs were positioned in a north south line along the balcony and had sustained severe damage by the fire. The chair located further from the A/C unit had fire affected remains of the plastic chair still attached to it. The chair positioned closer to the A/C unit had no visible plastic remains evident. Across the back of the steel frames of the chairs was a burn pattern that was lower to floor level towards the A/C unit.

Further examination found fire debris on the floor of the balcony area, close to the first vertical upright of the balustrade; approximately 1 metre from the southern wall of the balcony revealed a number of fire affected cigarette butts. Some of these butts had been severely affected by fire, with minimal amounts of the filter section remaining and being burnt through, indicating prolonged or severe exposure to the fire.

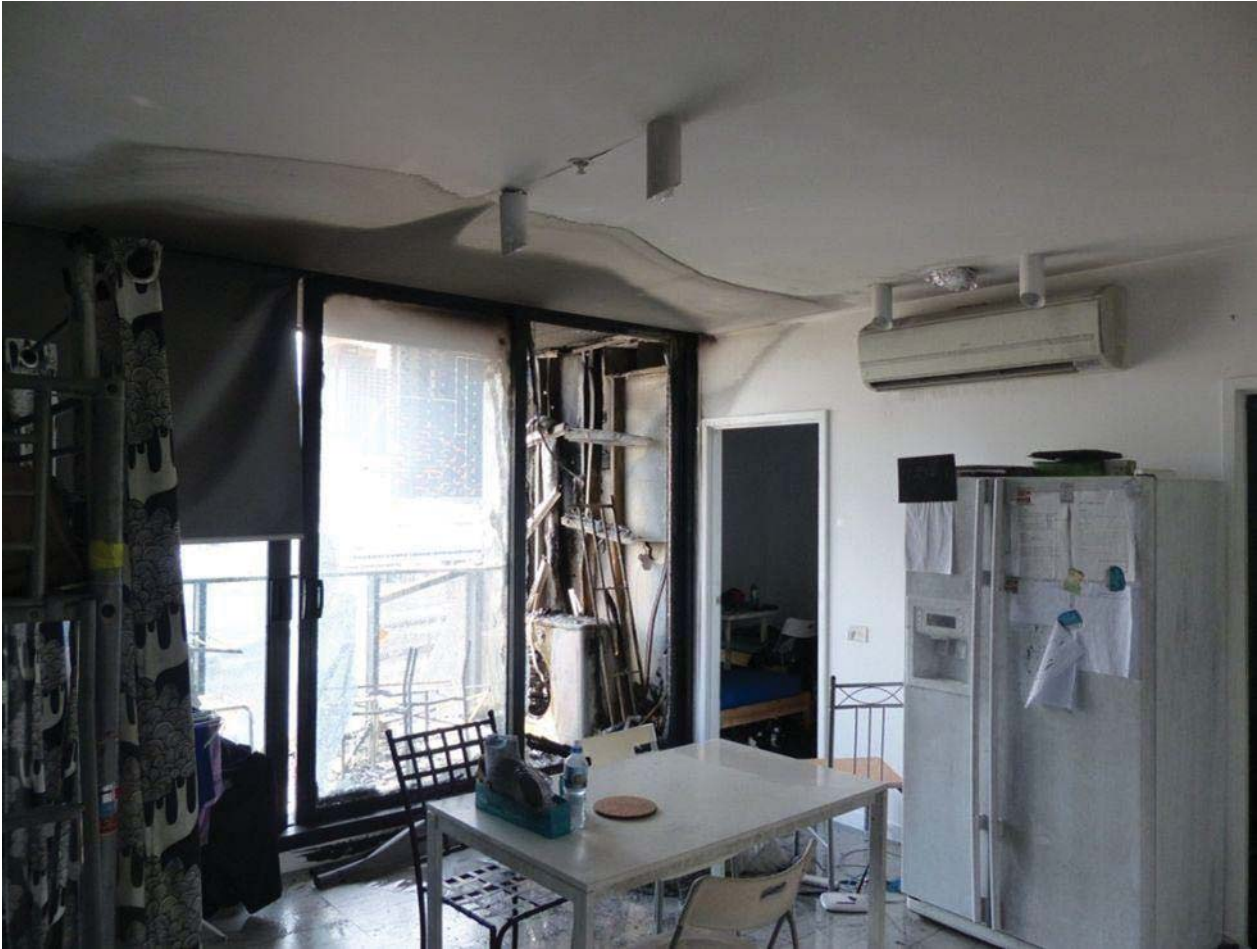
Full height glass double glazed sliding doors gave access to the balcony area from the kitchen. These had sustained heat and fire damage with the glass from the fixed panel located at the southern end of the balcony, breaking and collapsing to the floor areas of the kitchen and balcony. At the time of the investigation the double sliding doors were in the open position, with a visible gap of approximately 50mm between the two sliding doors. Access for investigation purposes was gained through the broken fixed panel at the southern end of the balcony area.

**Figure 5 – Picture 4: Inside kitchen looking towards double glass sliding doors leading to balcony area & bedroom 2.**

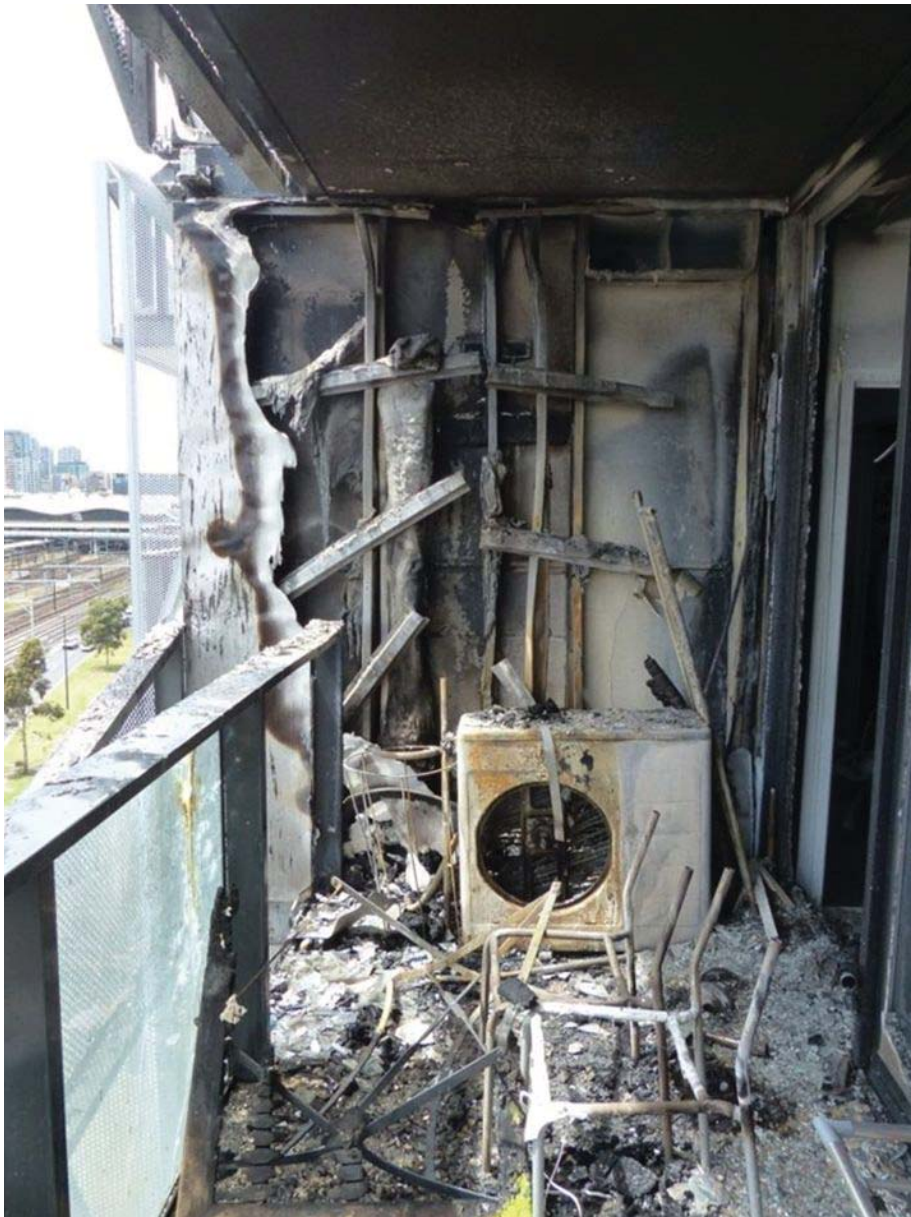
Fire damage to the southern wall was severe with consumption of almost the entire aluminium wall cladding (Alucobest). A 'V' pattern to this wall emanated from floor level of the balcony across the entire width. A small section of vertical wall, approximately 400mm protruded past the balcony balustrade allowing the fire to progress upwards to the balcony above. The section of aluminium cladding that remained outside the balcony created a 'V' pattern emanating from the balcony of this apartment.

Examination of the wall components revealed severe distortion to the steel frame and consumption of combustible components located in the wall. Severe burning to the back of the plaster had occurred with cracks and breaking down of the plaster's stability occurring. Intense burning had occurred in the area of the PVC downpipe, which had been consumed between the tiled floor and the concrete ceiling of the balcony. Prior to the fire, an exterior light had been mounted to the wall above the A/C unit. Although no remains of this light were located in the fire debris, burn patterns around the approximate mounting position on the wall do not suggest this light to be the point of origin for the fire.

The extremely vertical nature of the burn patterns to the exterior face of the wall suggest that the Alucobest aluminium cladding, along with the foam lagging and the PVC pipe of the building wall, contributed to the fire load and the rapid spread of the fire up the vertical face of the building to the floors and balcony areas located above.

**Figure 6 - Picture 5: South Wall Balcony of Apartment 805 before excavation.**

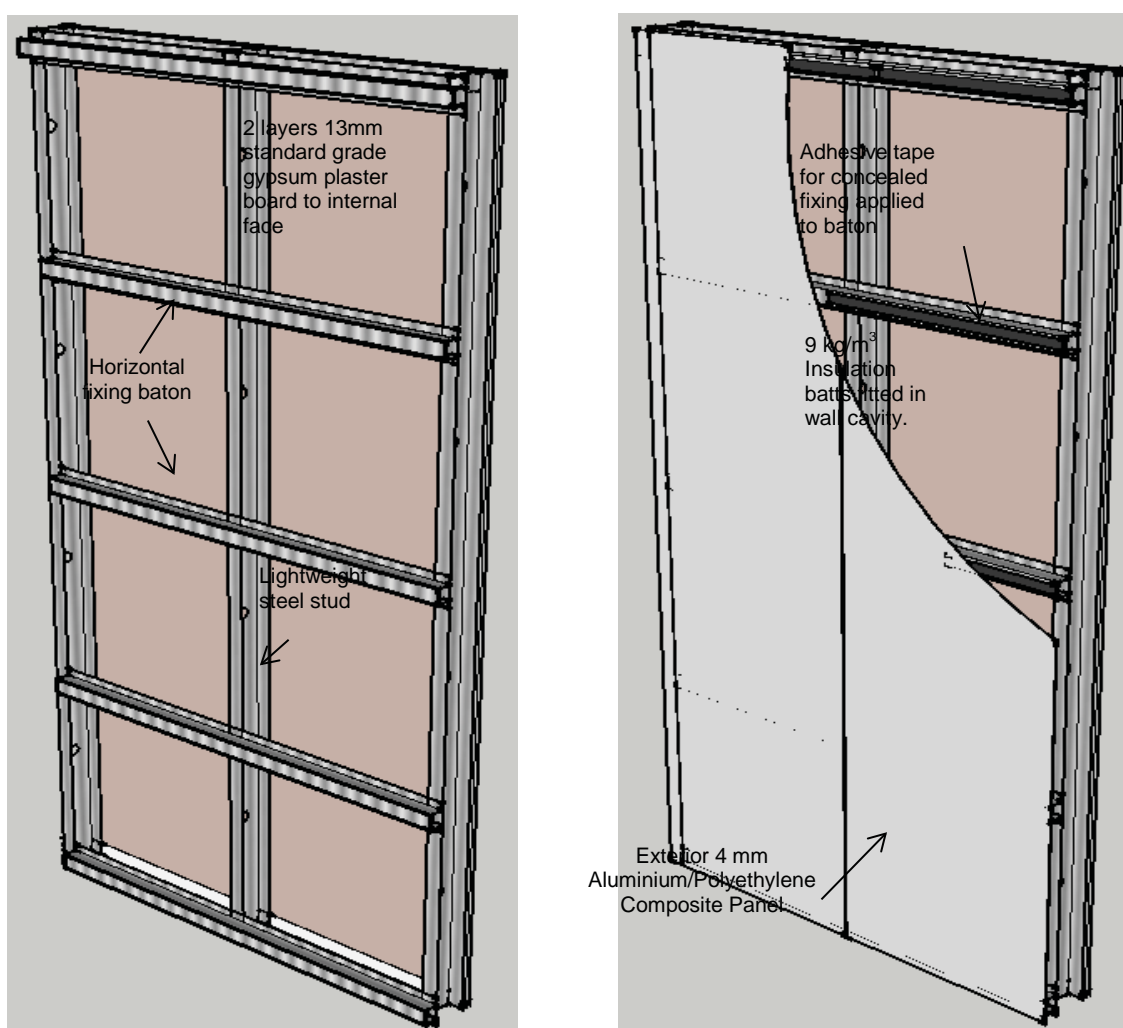
**Figure 9 - Aluminium/Polyethylene Composite Panel Façade - External Wall Cladding**

To the best of the MFB's knowledge, the labelling indicates an aluminium/polyethylene composite panel of 4mm thickness, in a colour known as Champagne Silver (*HY 103*). It is unclear what the value 11060167 represents, however, the number does loosely appear to correspond with the date and time shown at the end of the label and may indicate the number of manufacturing runs of this colour and type for the month. It is assumed this panel is the standard grade Alucobest panel, as there is nothing to indicate otherwise. The product is believed to incorporate a Polyethylene core material.

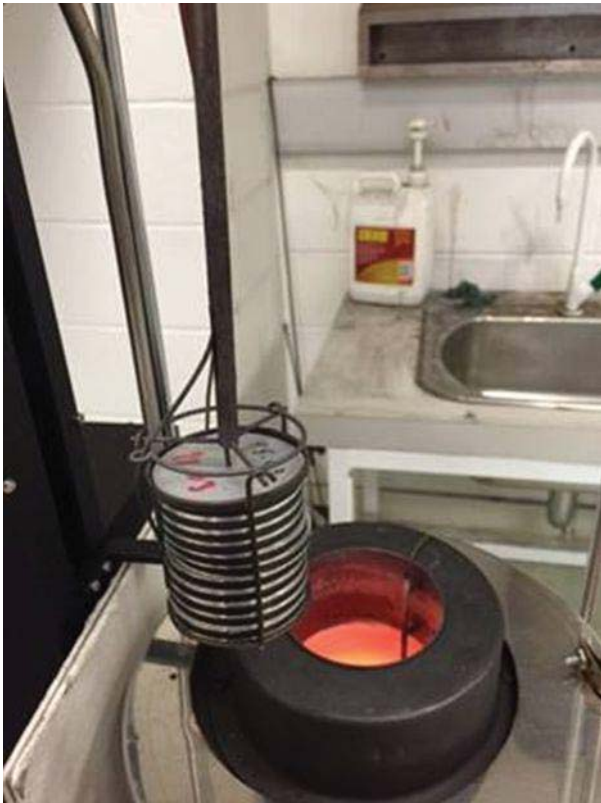
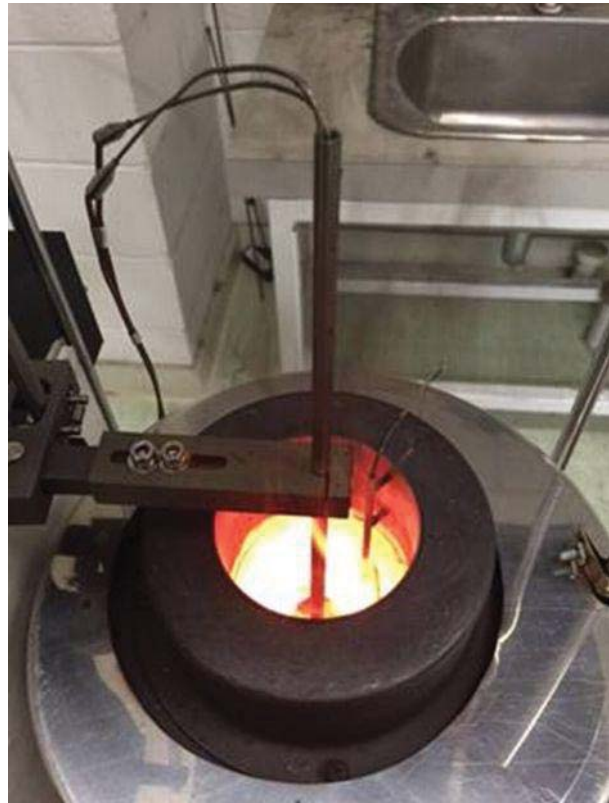
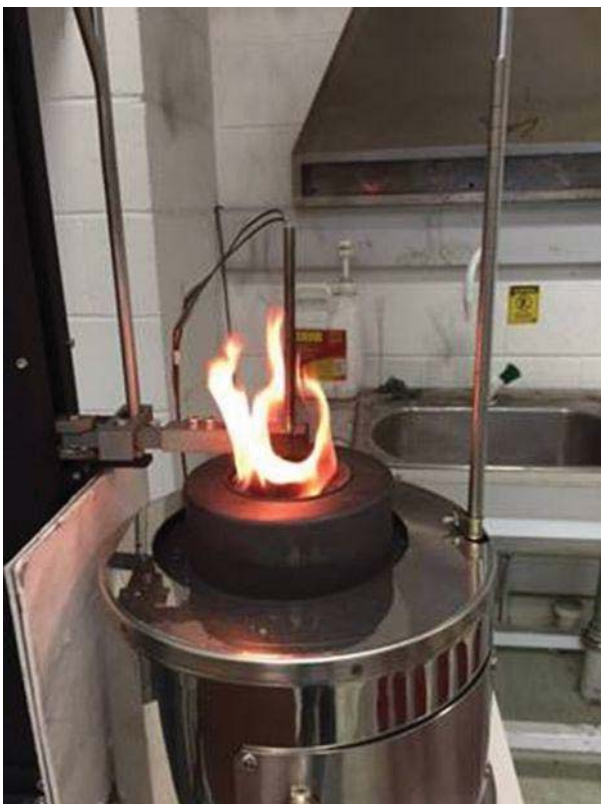
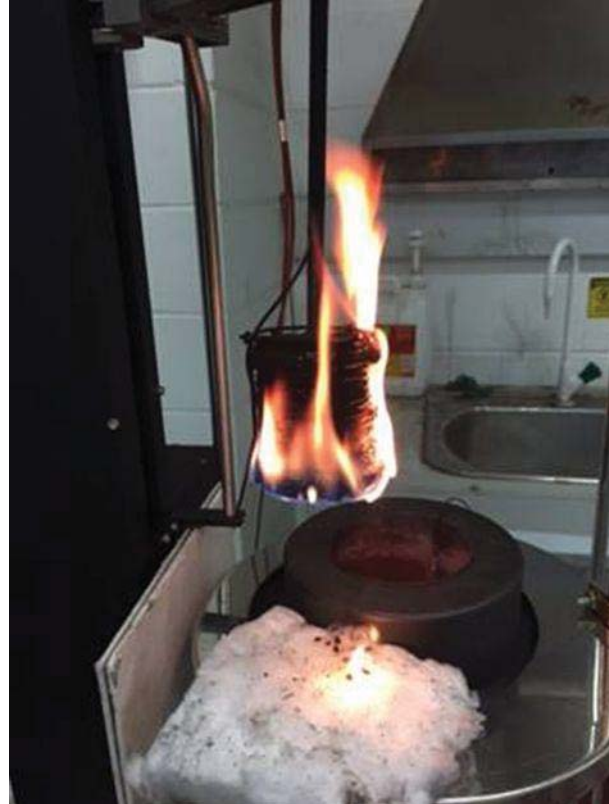
***Observations:*** Sustained flaming was observed on the specimen at 55 seconds into the test. The test was terminated at 93 seconds due to excessive flaming and smoking.

Specimen photos before, during and after the test.

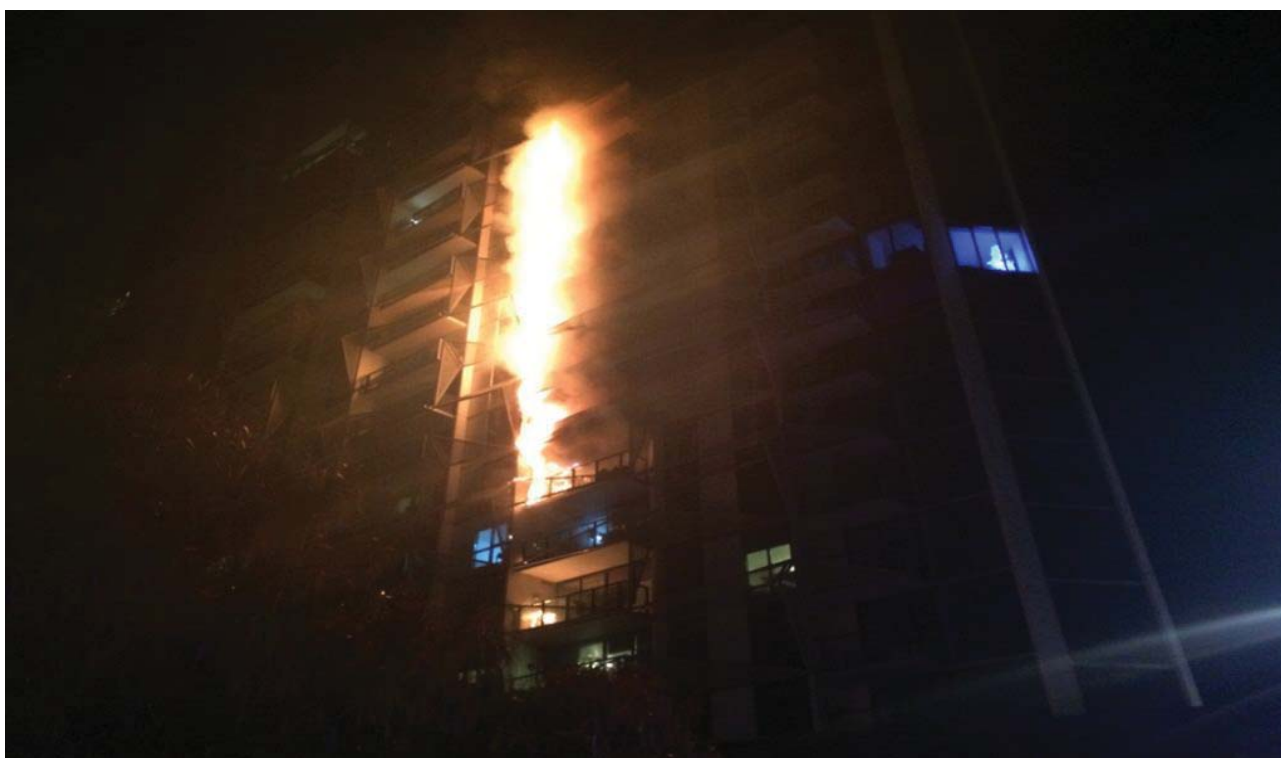
**Figure 10 - Time 02:29. Photo depicts the rapid vertical fire spread, only 4 minutes after level 8 sprinkler activation**

The MFB Fire Investigation team have determined that the fire originated on the balcony of the 8<sup>th</sup> floor. The FIP history log shows activation of the Level 8 sprinkler flow switch at 02.25 hours, one minute later than an exchange call received by the MFB. Fire crew arrived on scene at 02.29 hours, some five minutes later and reported vertical fire spread to approximately the 14<sup>th</sup> floor. At 02.35 hours, MFB crew reported that the vertical fire spread had reached the roof.

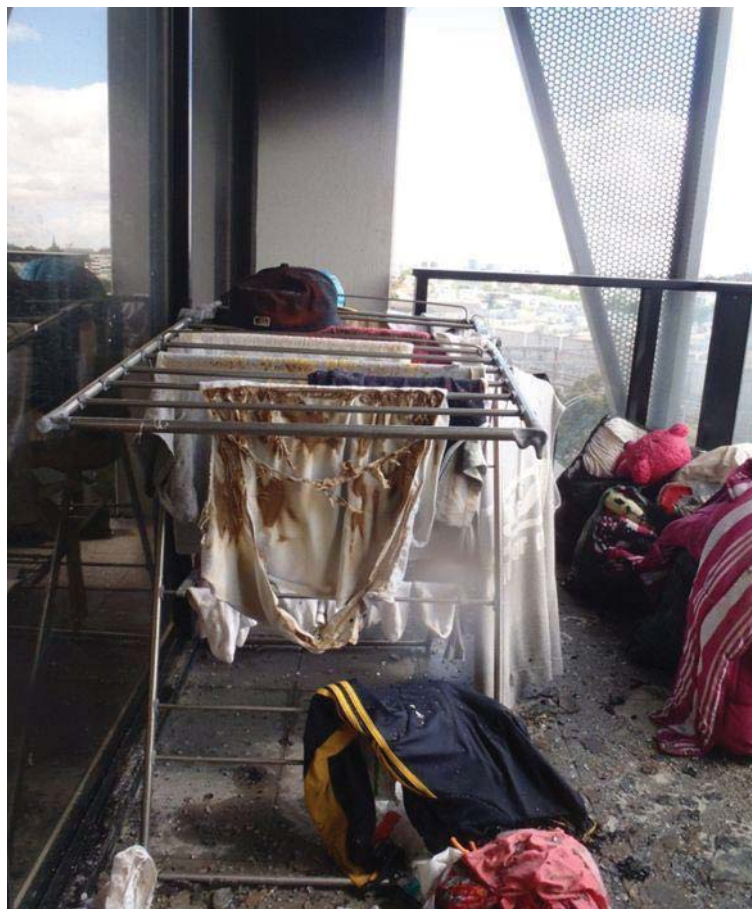
In this instance, typical combustibles identified to be present on balconies throughout the building consisted of clothing, bedding, bicycles, electrical appliances and other miscellaneous combustible materials, notwithstanding the air conditioner compressor units and other combustible furniture items. See Figure 11 below for example.

Figure 11 - Combustibles stored on one of the balconies.

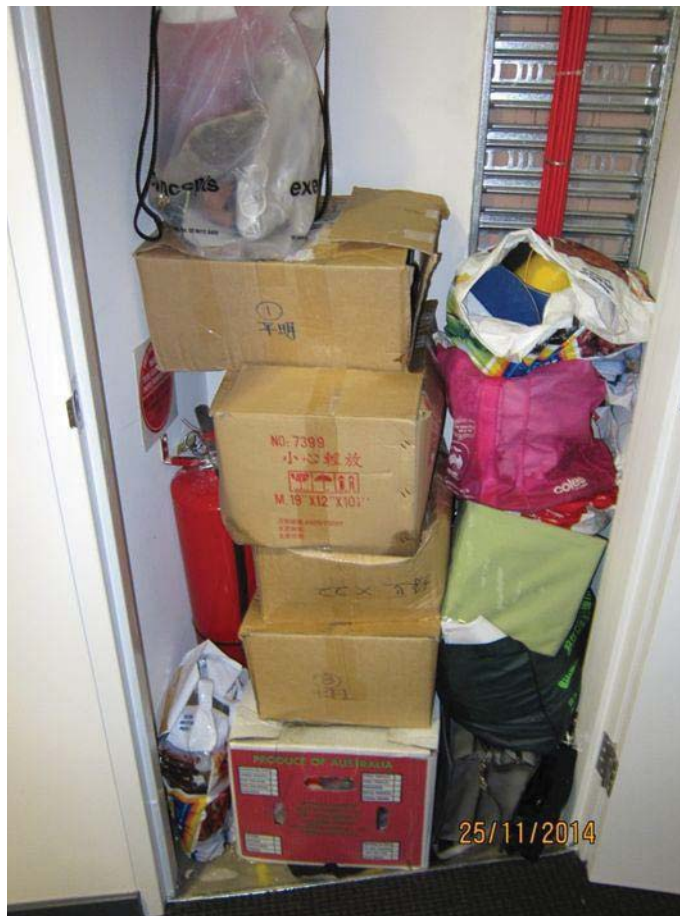
In this instance, a number of the purposely designed extinguisher enclosure housing Extinguishers 1 and 2 shown in [Figure 12 \(refer previous page\)](#), were being used by occupants as storage areas thus blocking access to the extinguishers.

**Figure 13 - Fire extinguisher cupboard on Level 6.**

The storage of goods and materials in enclosures used to accommodate fire safety equipment, delays access for occupants or fire-fighters who require the equipment in an emergency. These storage items are generally of a combustible nature and present an additional hazard.

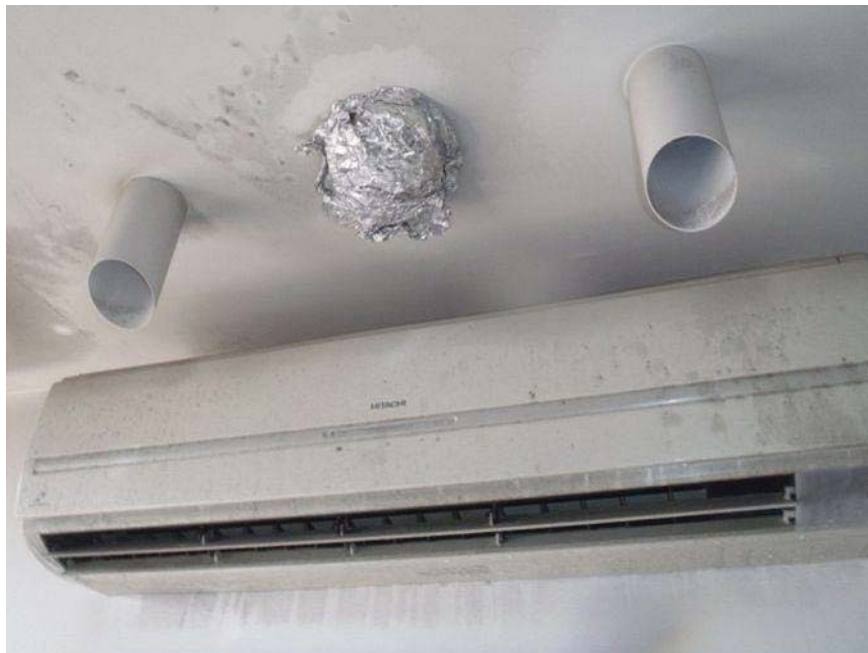
It was observed that within a number of apartments the battery had been removed from the smoke alarm. In addition some smoke alarms had been covered (Refer to Figure 14 below).

Figure 14 - An example of an obstructed Smoke Alarm – Apartment 805

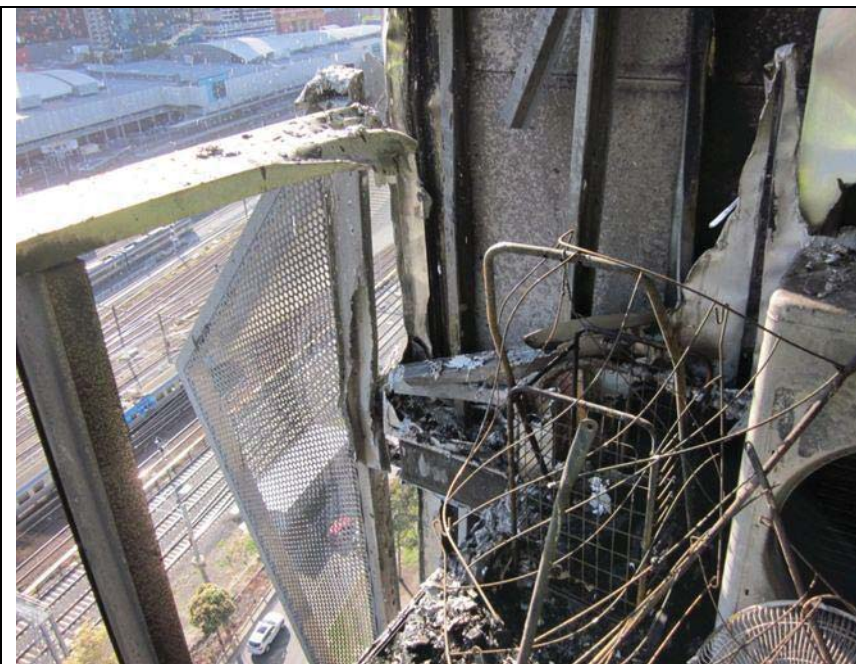
Wall between bedroom and balcony. Construction lightweight wall with steel studs, aluminium type external cladding plasterboard to internal. Material stored on balcony.

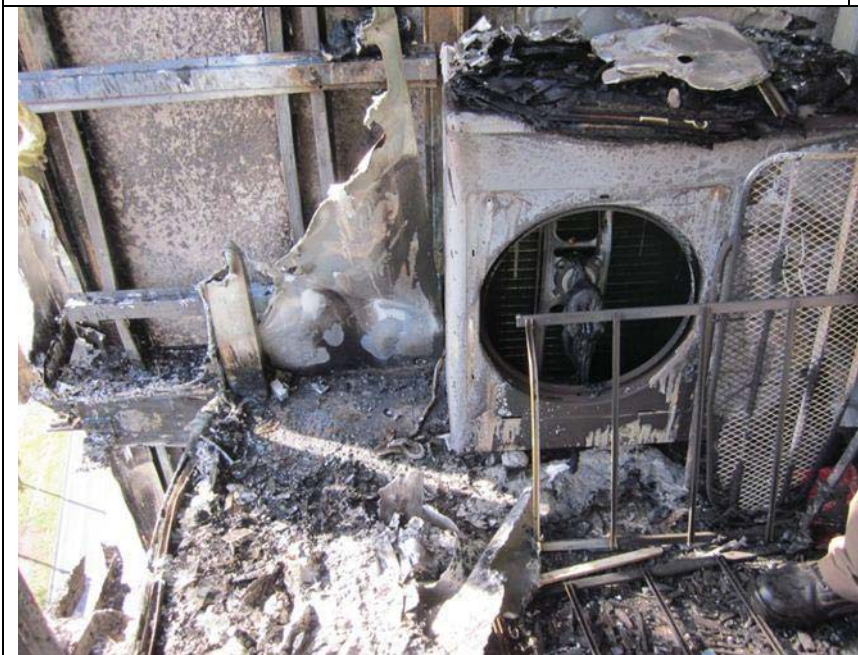
Photo of base of wall and penetrations plus overhang past balcony edge

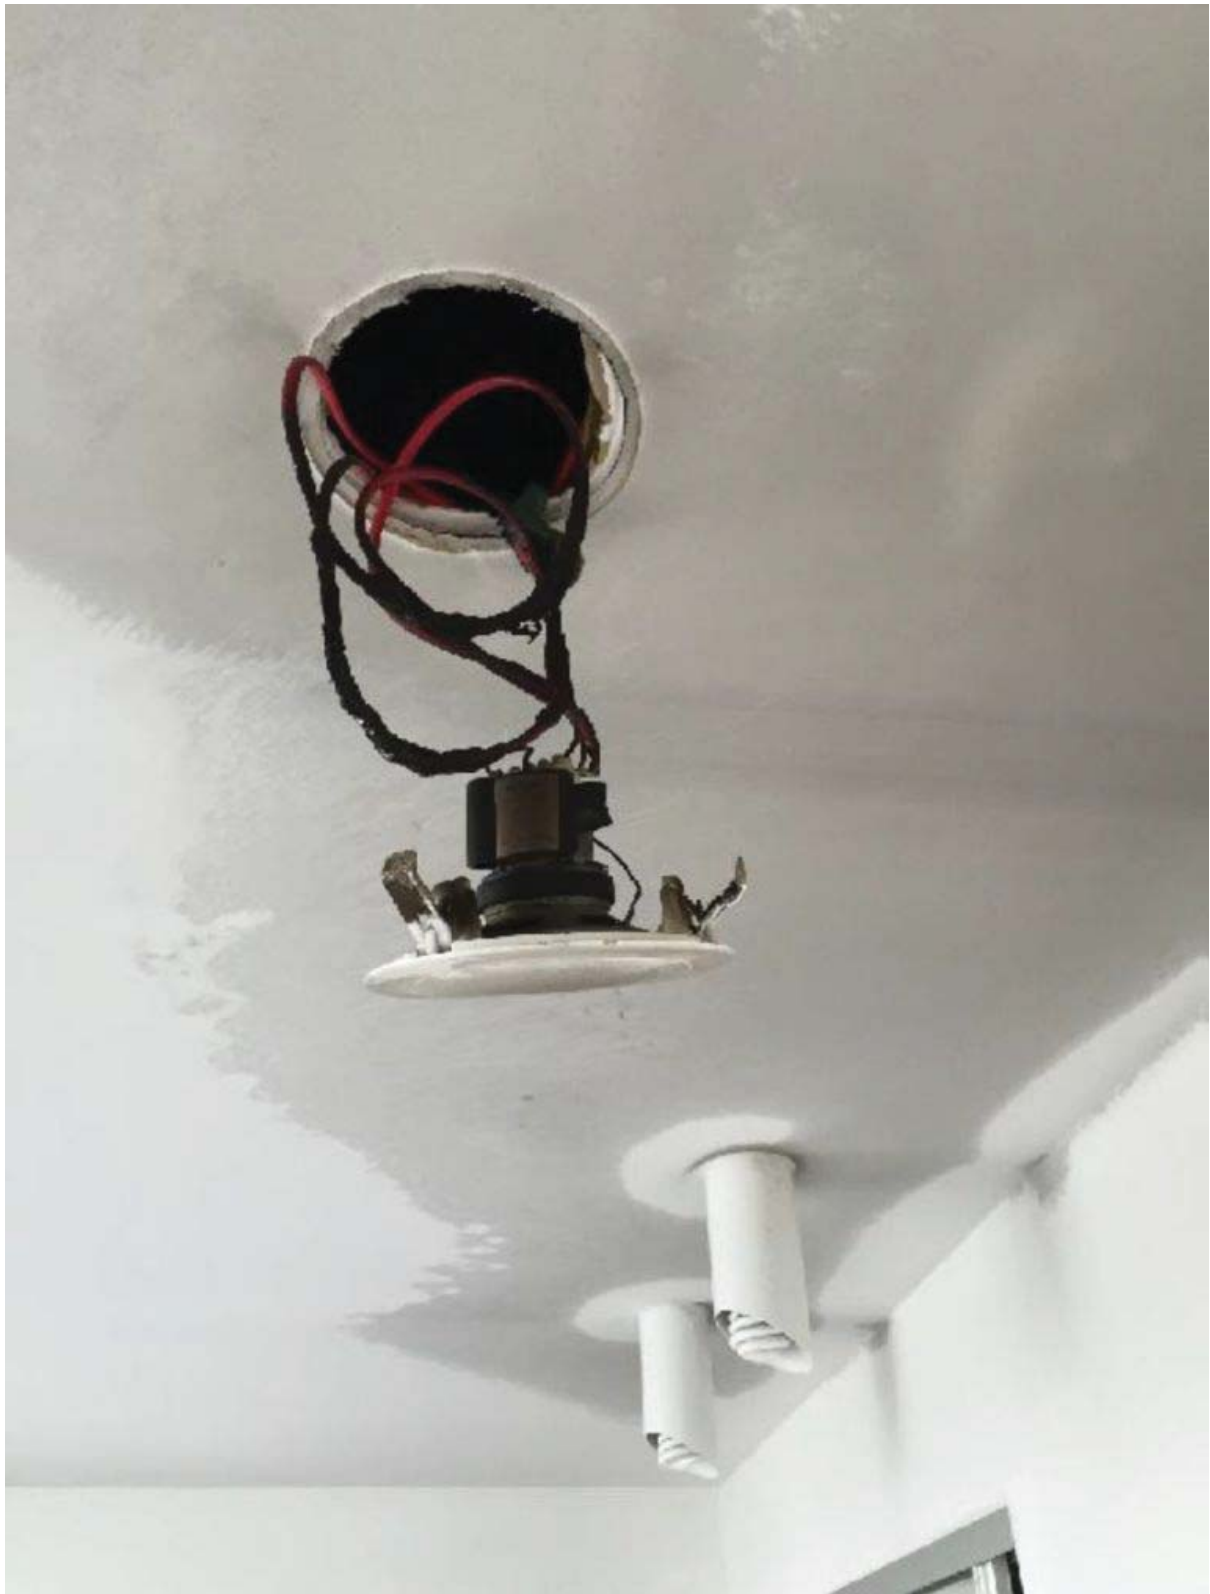
Image depicts the damaged caused to the EWIS speaker cables in Bedroom 2 of the 05 Series Apartments.

**Figure 20 - EWIS Speaker and wiring**
