Senate Rural and Regional Affairs and Transport References Committee

**Questions on Notice – Monday, 19 November 2012
Committee Room 2S1, Parliament House, Canberra**

Inquiry into aviation accident investigations

Ditching – Israel Aircraft Industries Westwind 1124A, VH-NGA

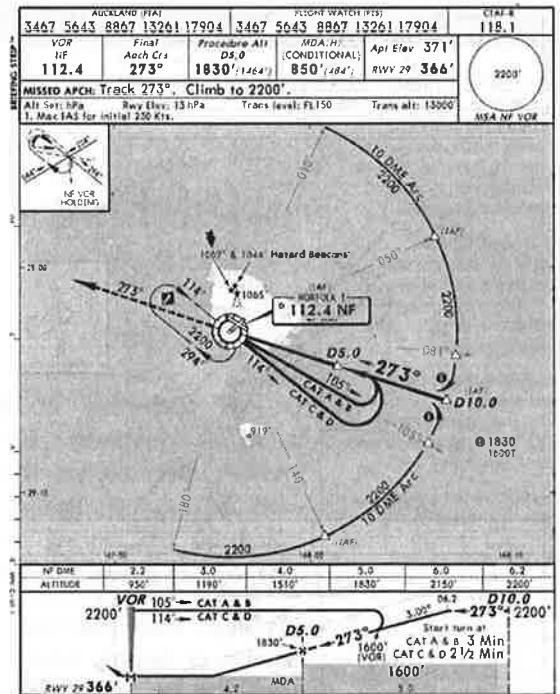
Figure 1: Runway 29 VOR/DME instrument approach procedure

Upon arrival at Norfolk Island, the copilot conducted a very high frequency omnidirectional radio range/distance measuring equipment (VOR/DME) instrument approach procedure⁶ for a landing on runway 29 (Figure 1). However, the flight crew was not 'visual' at the missed approach point,^{7,8} and a missed approach was carried out at 1004. At that time, it was dark and raining with low cloud and poor visibility.

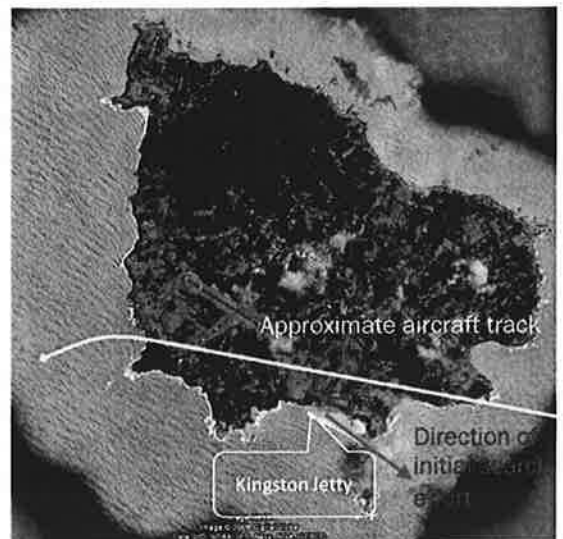
Figure 4: Approximate runway 29 VOR/DME final approach and overshoot track (Kingston Jetty highlighted)

The Norfolk Unicom operator had alerted the Norfolk Island emergency response agencies to a local standby condition when the weather first deteriorated to the extent that the Unicom operator felt it might be difficult for an aircraft to land. The Unicom operator subsequently initiated a deployment of the emergency services following the aircraft's second missed approach. In addition, two local boat owners prepared to launch their fishing vessels at Kingston Jetty to search for the ditched aircraft and its occupants (Figure 4).

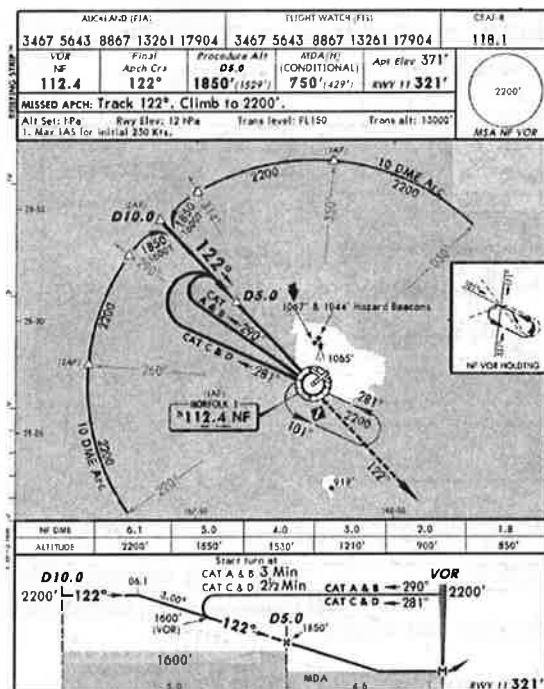
Figure 2: Runway 11 VOR/DME instrument approach procedure

The crew did not gain visual reference with runway 11 and conducted a third missed approach at about 1019, before reporting to Norfolk Unicom that they were planning to ditch because the aircraft was running out of fuel. The crew then conducted a third instrument approach for runway 29 (four approaches in total), but again did not visually acquire the runway.

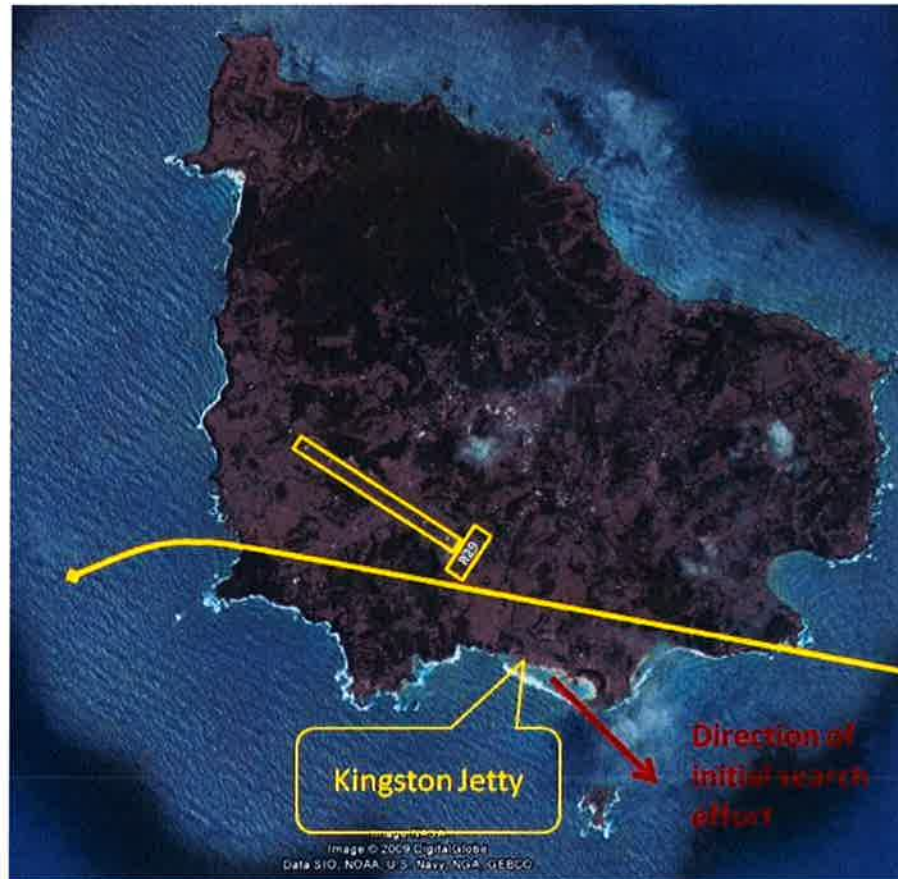
Figure 5: Approximate aircraft track before the ditching

The crew indicated that they climbed the aircraft to 1,200 ft above mean sea level (AMSL), turned left in a south-westerly direction (Figure 5), and configured the aircraft to land without extending the landing gear. The flight crew descended towards the water while monitoring the digital height readout from the aircraft's radar altimeter (RADALT)²⁸, which was mounted near the attitude indicator in the cockpit instrumentation.

The crew reported initiating a landing flare at about 40 ft RADALT and that the aircraft first contacted the water at an airspeed of about 100 kts. The flight crew recalled that, although they had selected the landing lights ON, they did not see the sea before impacting the water. Although there was no recorded MAYDAY or other radio call coincident with the ditching, a short unintelligible radio transmission was recorded on the Unicom frequency at 1026:02.

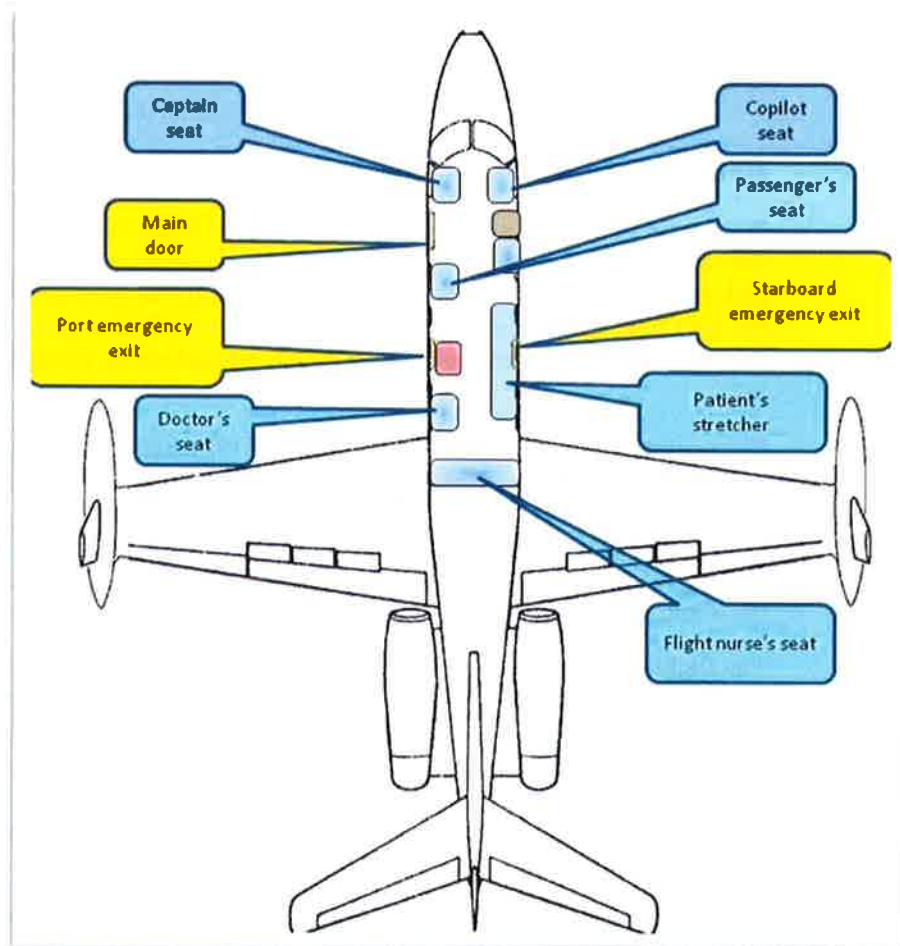
Figure 7: Seating positions at the time of the ditching

The life rafts were reported removed from their normal stowed position and placed in the aircraft's central aisle ready for deployment after the ditching.

The aircraft occupants recalled two or three large impacts when the aircraft contacted the water. Those in the front of the aircraft described the impact forces acting in a horizontal, decelerating direction. The flight nurse, who was seated in the rearmost seat in the aircraft (Figure 7), reported far stronger vertical accelerations during the deceleration sequence compared with the other aircraft occupants. That was consistent with the nature of the injuries sustained by the nurse.
