Deepwater Horizon Accident Investigation Report

September 8, 2010

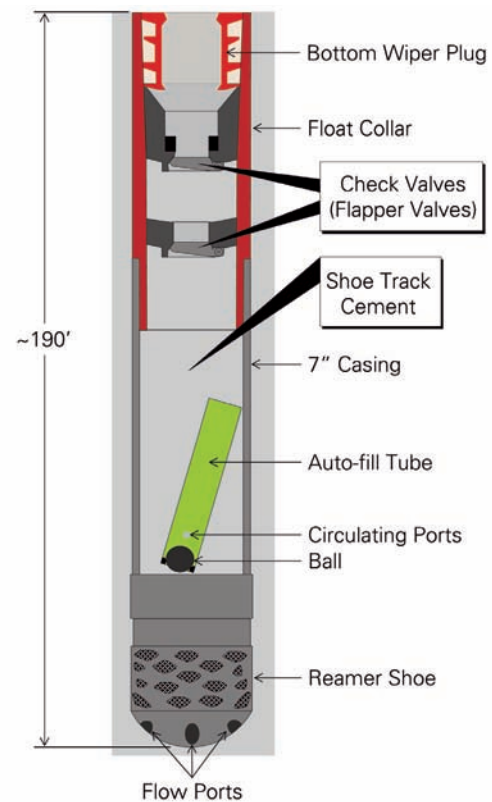
Figure 2. Shoe Track Barriers.

Based on available evidence, hydrostatic pressure calculations, OLGA[®] well flow modeling and analysis of data from the Macondo well static kill on August 4, 2010, hydrocarbons entered the casing through the shoe track. Therefore, the shoe track cement and the float collar must have failed to prevent this ingress. The investigation team has not established whether this failure was attributable to the design of the cement, contamination of the cement by mud in the wellbore, commingling of cement with nitrogen due to nitrogen breakout from the nitrified foam cement slurry, swapping of the shoe track cement with the mud in the rathole (bottom of the well) or some combination of these factors.

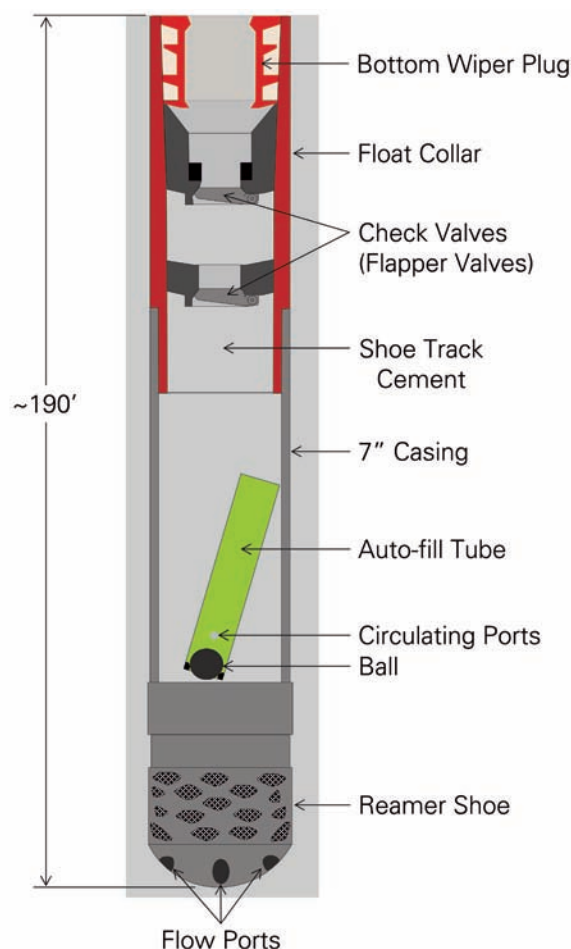
Figure 4. Shoe Track.

Based on available evidence, hydrostatic pressure calculations, OLGA® well flow modeling and analysis of data from the Macondo well static kill on August 4, 2010, hydrocarbons entered the casing through the shoe track. Therefore, the shoe track cement and the float collar must have failed to prevent this ingress. The investigation team has not

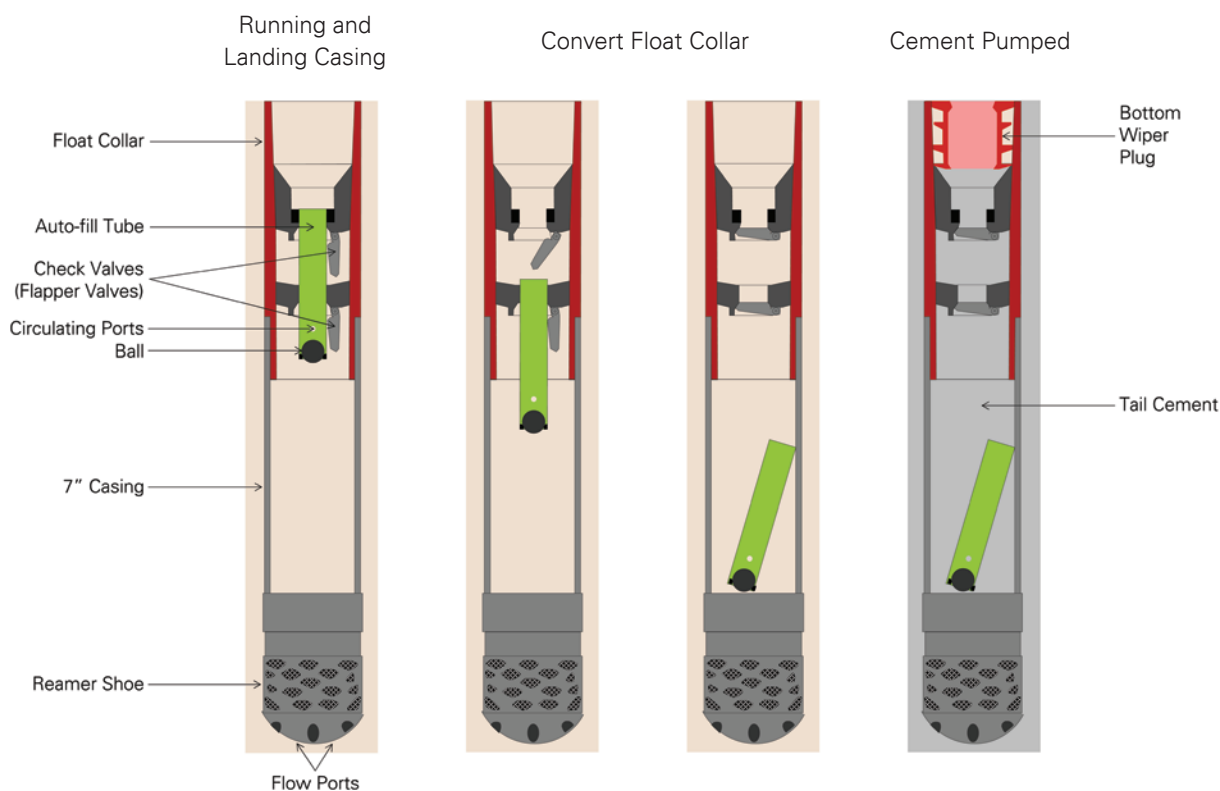
Figure 5. Float Collar Conversion.

The BP Macondo well team interpreted the float collar testing after cement placement as successful. This was further documented in the Halliburton post-job report, which indicated that the float collar was holding backpressure. (Backpressure is the difference between hydrostatic pressure in the annulus and hydrostatic pressure inside the casing, which results from different fluid densities and heights.) However, the investigation team concluded that, with the 38 psi backpressure predicted in the Halliburton April 18, 2010, OptiCem™ program, the backpressure test that was conducted was not a reliable indicator that the float collar sealed.

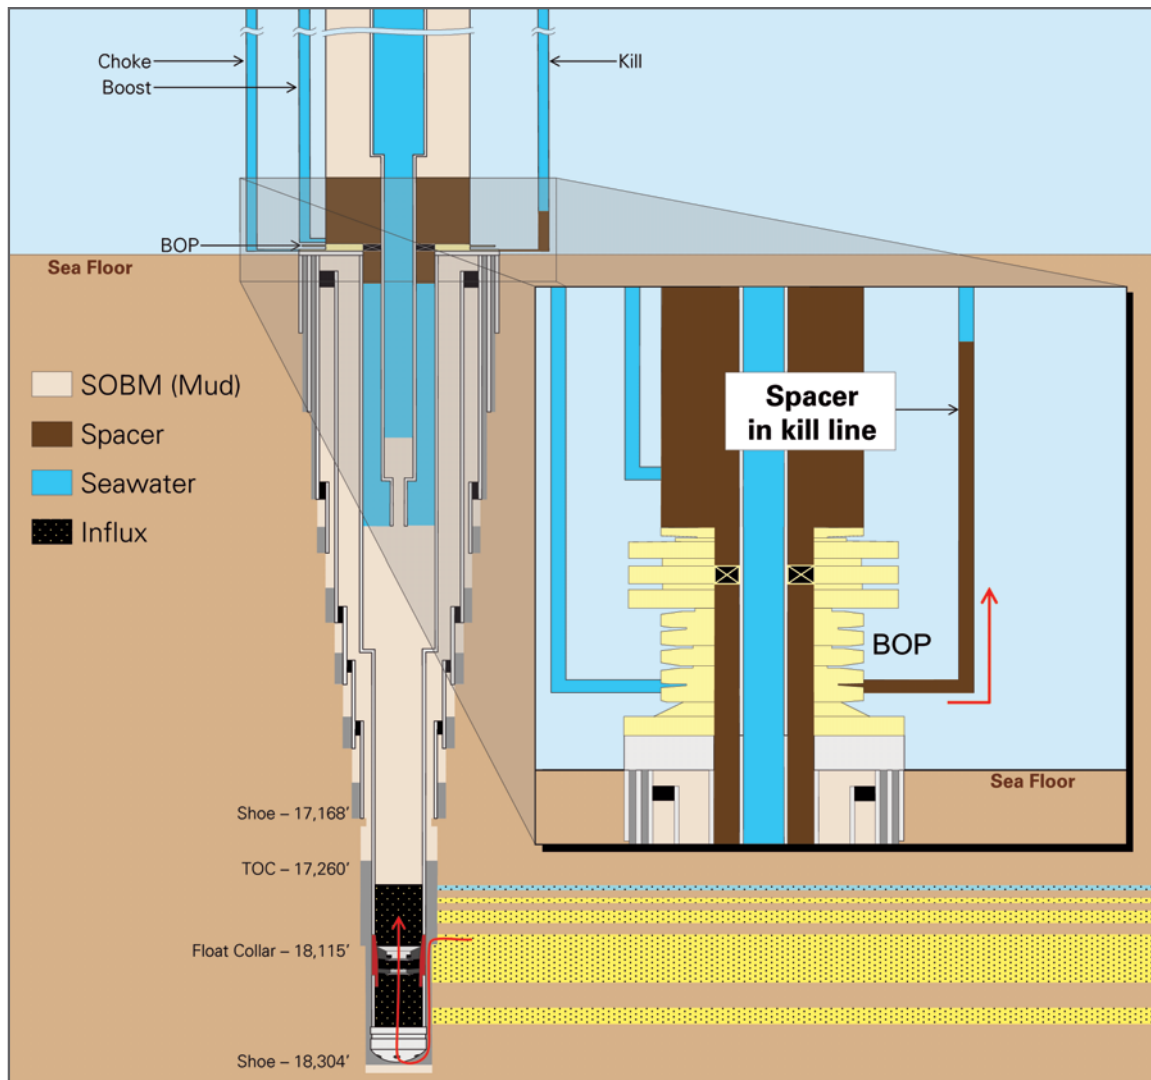
Figure 3. Possible Movement of Spacer into Kill Line.

As previously discussed in *2.2 Displaced Mud to Seawater* of this analysis, spacer material was unintentionally placed across the kill line at the BOP. At least 3 bbls of highly viscous fluid (occupying approximately 150 ft. in the kill line) could have been drawn into the kill line during this part of the test. (Refer to Figure 3.)

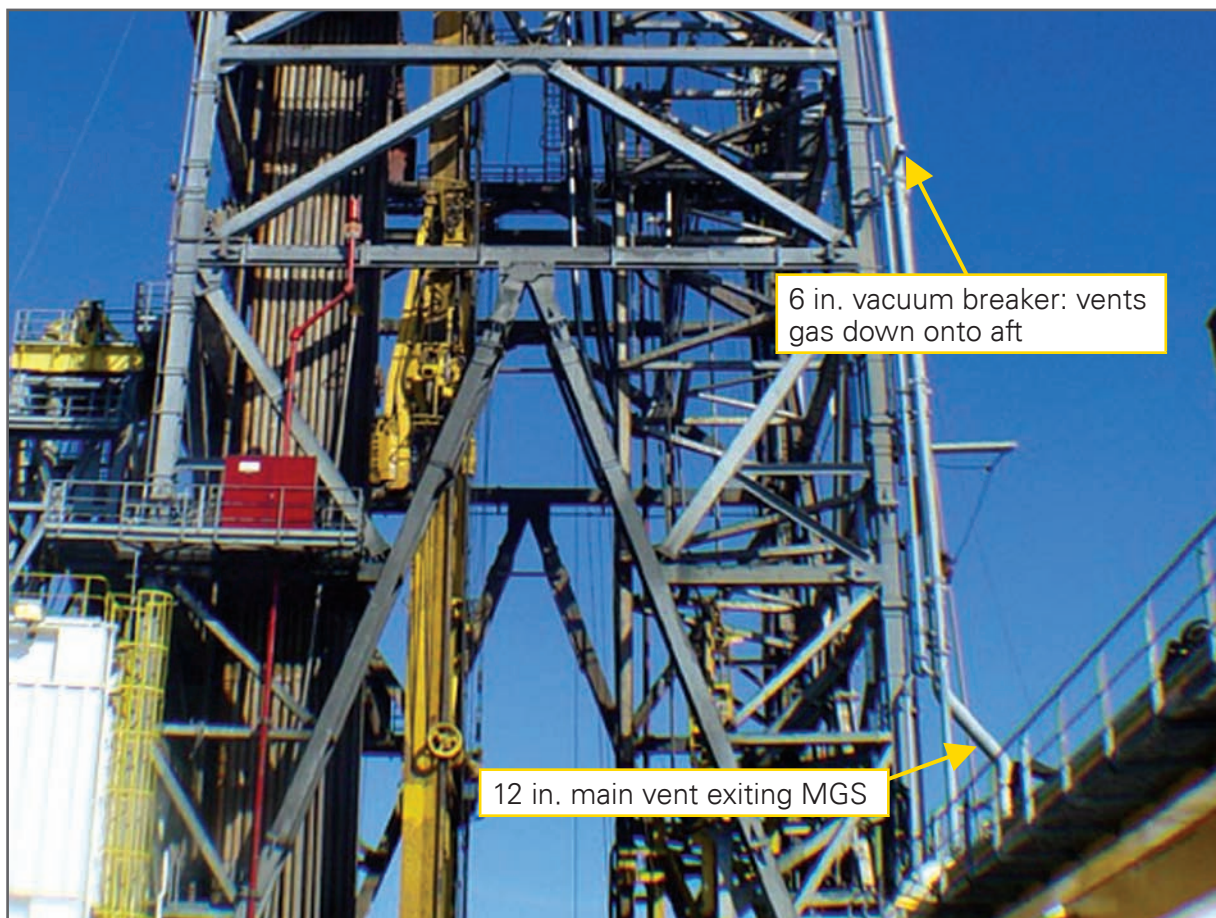
Figure 5. Photograph of 6 in. Vacuum Breaker Line Gooseneck Vent.

- 6 Diversion to the mud gas separator resulted in gas venting onto the rig.** Once diverted to the MGS, hydrocarbons were vented directly onto the rig through the 12 in. goosenecked vent exiting the MGS, and other flow-lines also directed gas onto the rig. This increased the potential for the gas to reach an ignition source. *The design of the MGS system allowed diversion of the riser contents to the MGS vessel although the well was in a high flow condition. This overwhelmed the MGS system.*
