QUALITY SYSTEM COMPLIANCE VENDOR / SUPPLIER AUDIT REPORT

Qantas Airways Limited

**Contracted Maintenance – SIAEC Singapore "D" Check on
Qantas Aircraft VH-OJO V/C: T7105**

AQD Audit ID: 06/SPT/10

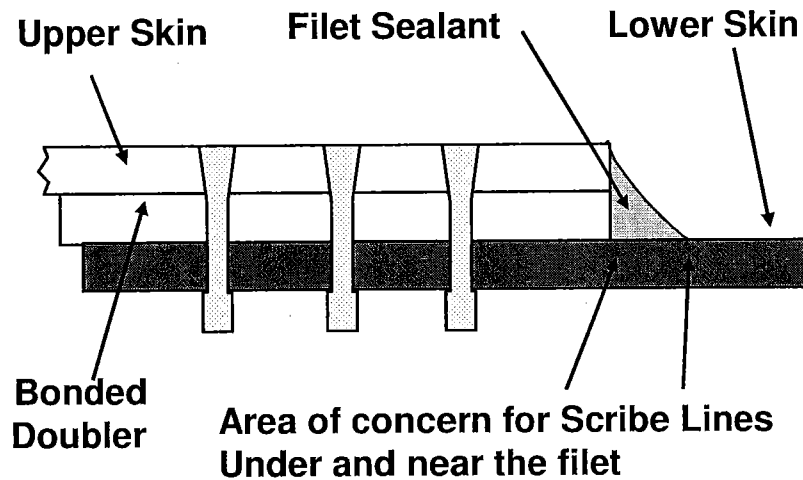
Drawing 1

Typical 737 Lap Joint Detail

The above shows the structure of the bonded doubler on a 737 Lap Joint, on the 737-700 each sheet is close to 40 thou in thickness, the step should therefore be in the order of 80 thou, NOT 25 thou as per **Image 1**.

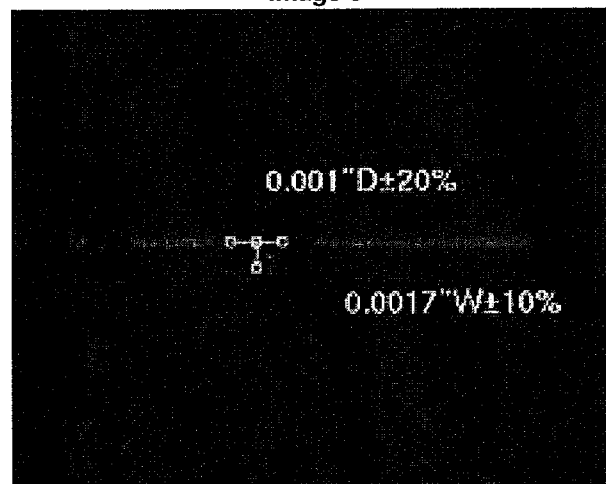
The errors in the above Image 3 are:-

The use of "D" is NOT recommended. (The "D" command was used in Image 3; the small square at the junction shows that clearly!)

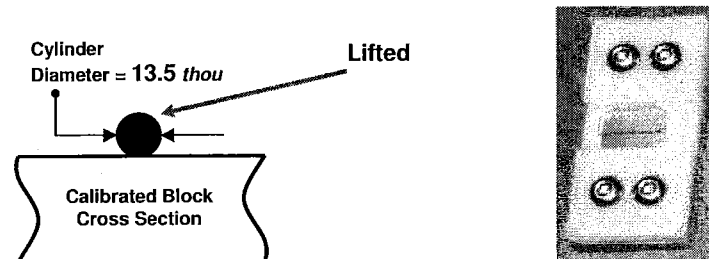
- a)
On first testing the Calibration Block S/N 197 was found to be faulty! It should have been 13.5 thou (WORST CASE +/- 3%) It was measured to be 14.1 thou! This is an error of over +4%. The block showed no sign of physical damage, but on close inspection it was found that the 13.5 thou steel wire had a "bow" in it, lifting it about 0.6 thou of the surface. The block cannot be easily repaired and was therefore destroyed! (As per the internal QC requirements of both STTR and Hextronics).

A new Calibration Block was manufactured, S/N 421.

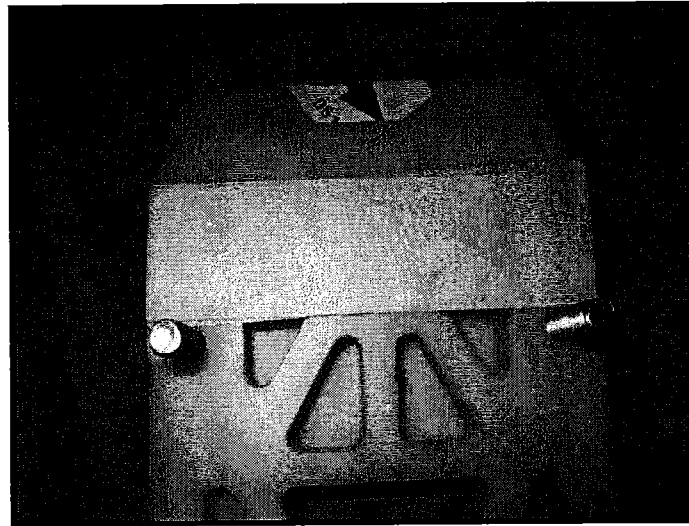
Tape on the Dings Plate!

b)
When we tried to make a Calibration measurement we found that the "Dings" Plate set
had a broken Slider. See below!

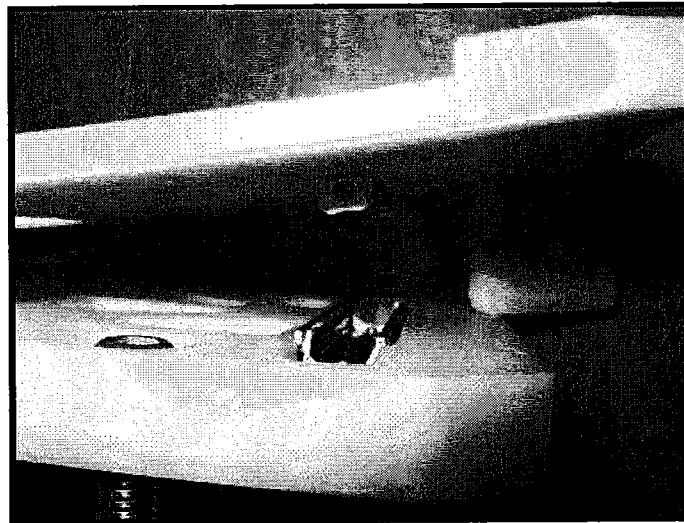
The Broken Slider!

I have sought feedback from ST Aerospace as to whether there are any reports the
system was dropped! No reply!
The Slider was replaced!

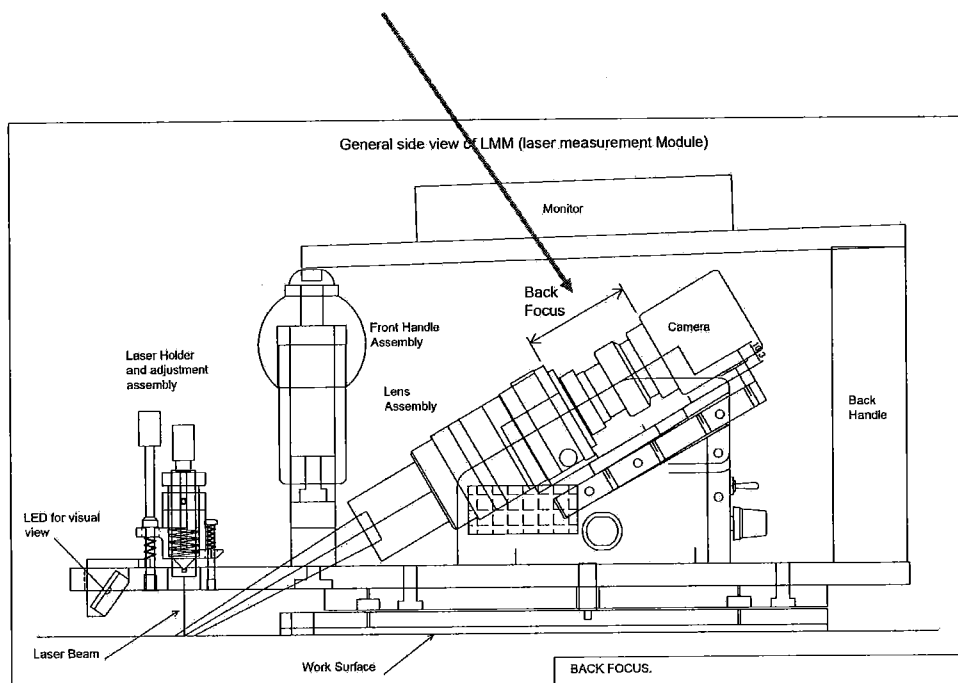
From our internal notes this should have been 50.4mm, I measured 50.9mm on the system as returned. Unfortunately it is not simple to just change this back to 50.4mm. Although we measured 50.4mm during production of this system, the actual dimension is much more critical. It required the lens/camera assembly to be put into our alignment jig! We decided to wait for the new Calibration Block before doing this.

On close inspection it was the Camera that had moved backwards by about 0.5mm. But I found the lock screw to be tight! This suggests a drop or VERY hard knock!

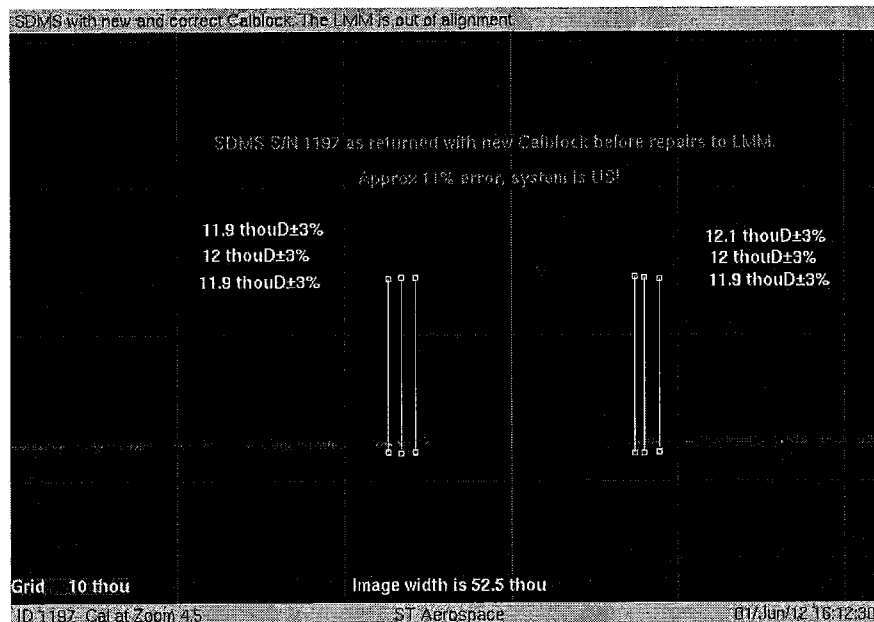
First result with new calblock 421. This is SDMS system AS RETURNED!
The Calblock 421 was known to be 13.5 thou! Taking 12 thou as the average for the 6 measurements below we have a measurement error of approximately of 11%.

In this condition the system is Un-Serviceable! And should not be used for an Inspection!

The Lens/Camera was removed, placed in a jig and realigned!
