# **QUALITY SYSTEM COMPLIANCE VENDOR / SUPPLIER AUDIT REPORT**

**Qantas Airways Limited**

**Contracted Maintenance – SIAEC Singapore "D" Check on  
Qantas Aircraft VH-OJO V/C: T7105**

**AQD Audit ID: 06/SPT/10**

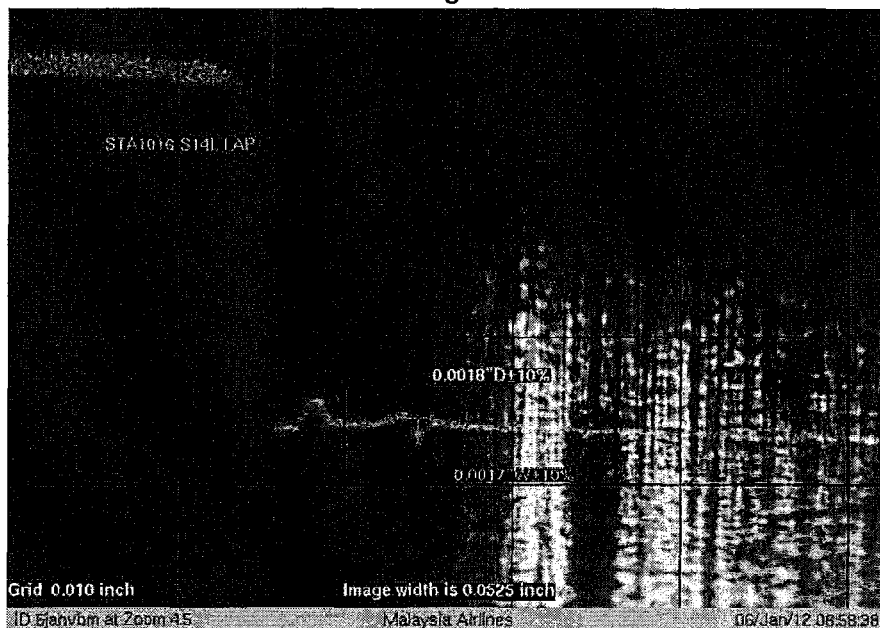
Image 1

**2a)** The Image shown below (from ID 6thjanvbm) was captured and measured with a software zoom setting of 4.5. This is the requirement of all Boeing documentation for the 1 thou scribe line limit (0.001"). The image CLEARLY showed that the lens WAS NOT set to match the Software setting of 4.5.

The Step in the Lap Joint is approximately 25 thou, (from the grid on the Image). See Drawing 1 below for what this should be.

The above shows the structure of the bonded doubler on a 737 Lap Joint, on the 737-700 each sheet is close to 40 thou in thickness, the step should therefore be in the order of 80 thou, NOT 25 thou as per **Image 1**.

It is my considered opinion that this error should have been rapidly noted by the personal conducting the Inspection. Also QC at MAS should have detected the error.

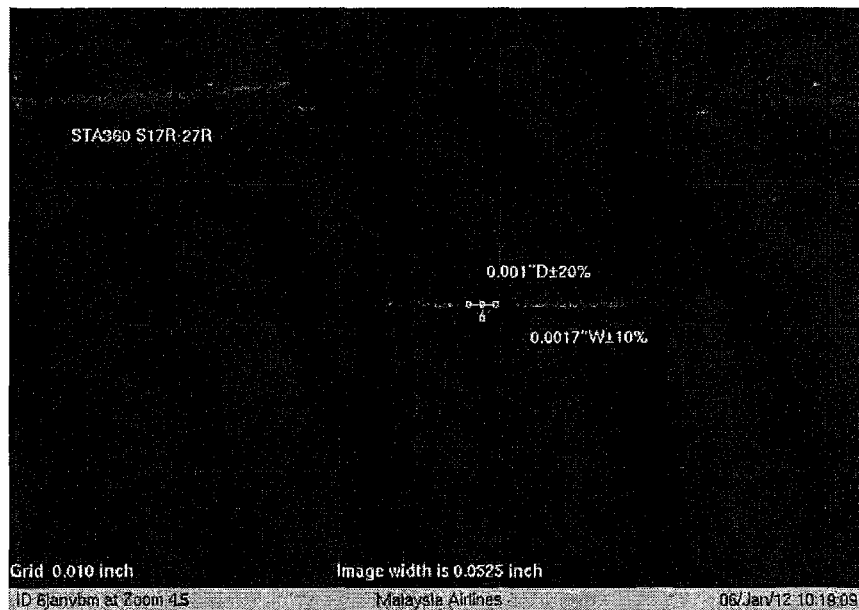
Image 2

2b) A second fundamental error can be established via the image below.

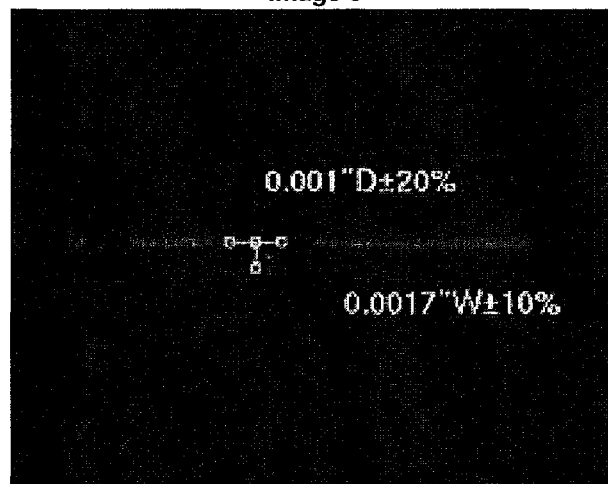
The errors in the above Image 3 are:-

The use of "D" is NOT recommended. (The "D" command was used in Image 3; the small square at the junction shows that clearly!)

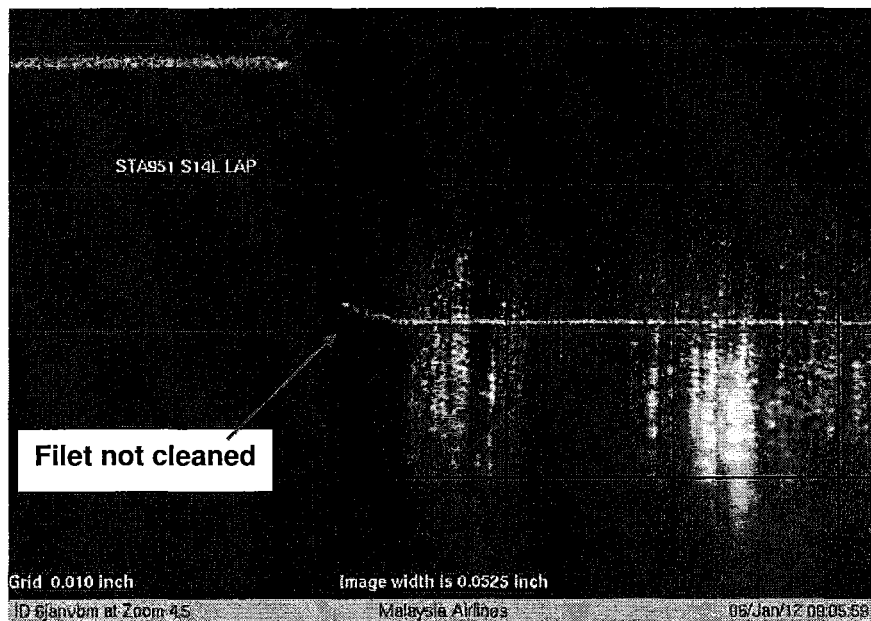
Image 4

The first and most important step in Scribe Line Inspection is Surface Preparation. This was clearly not carried out correctly at MAS for the Jan 6<sup>th</sup> Inspection. The area that **MUST** be observed very closely, is right up to the edge of the Lap Joint! The Sealing Filet must be removed. The Image below shows that was not the case. The image clearly shows a substantial amount of the filet still in place. This Image also shows, once again; incorrect setting of the Hardware Zoom. The image magnification should be about 4.3 times larger. This would give a filet of at least 18 thou width. Plenty of room to hide a Scribe Line! On all the areas Inspected on Thurs 1<sup>st</sup> Mar I carefully checked for this problem. All were clean. The question remains, how was the rest of the Aircraft? This is a concern!

Areas of the Butt points clearly showed a high level of surface working. I believe that NONE of the surfaces that I saw on the 1<sup>st</sup> Mar were the same surfaces as per the Jan 6<sup>th</sup> Inspection. Very substantial "Cleaning" had occurred since 6<sup>th</sup> Jan.

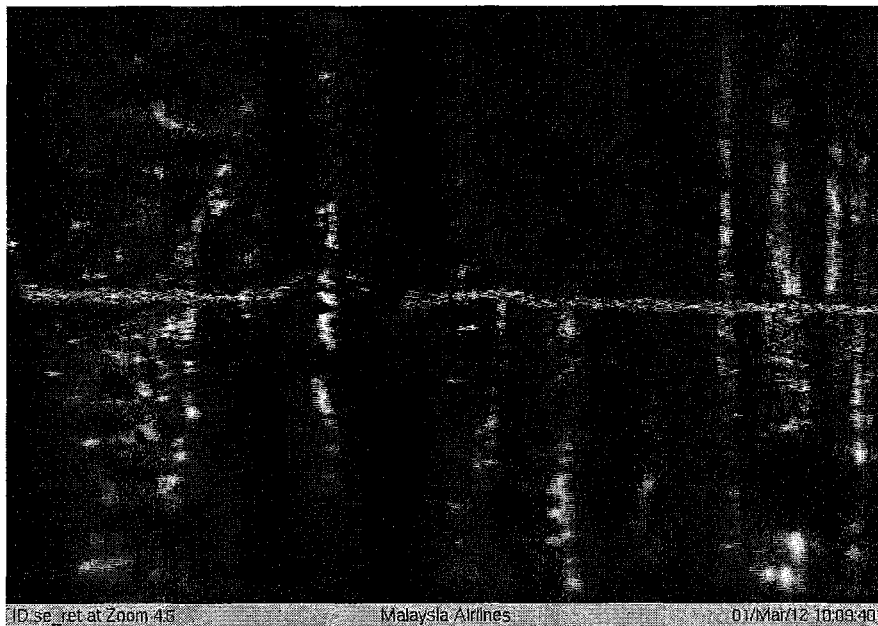
Image 5

This image shows a high level of "Surface Work". The surface shows that extensive rubbing has occurred, most likely with Scotch Brite. The "Land" is well rounded, a feature of Scotch Brite.

Remove paint and sealant from the inspection surface so as to not damage the part. Do not use abrasives such as abrasive paper or Scotch Brite pads. The use of Abrasives can cause the scribe line inspection or depth measurement to be incorrect. etc.

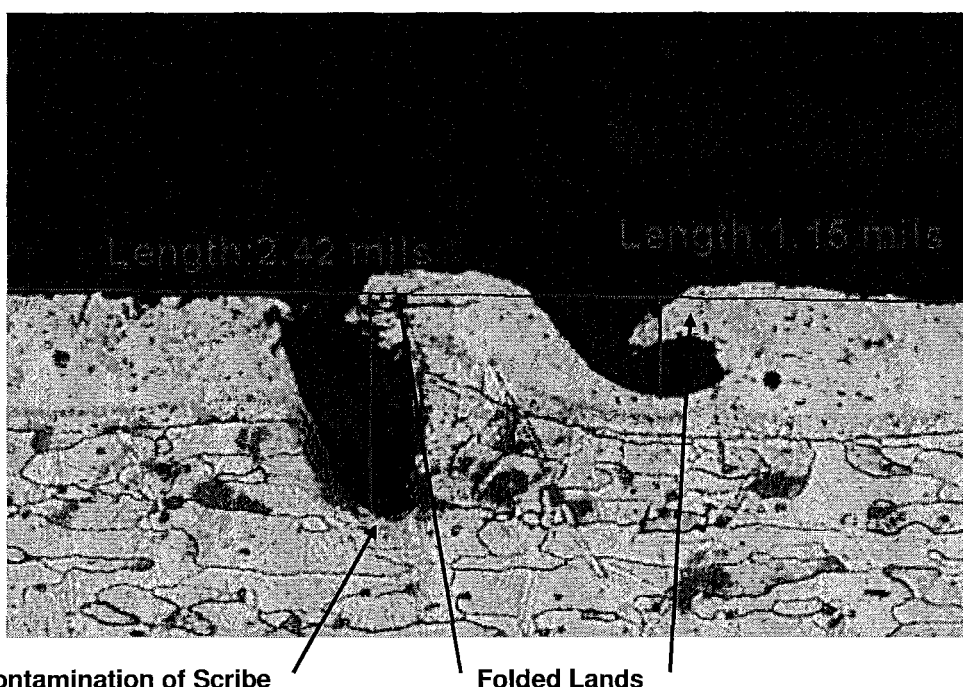
Image 6

The above image shows why Scotch Brite etc are such a problem. They cause the lands to collapse and fold over. This can trap contaminants in the scribe line as well as moisture. Also the folded lands can prevent the Laser seeing the true bottom. Therefore the depth reading will always be too low! No Scotch Brite is ALWAYS covered in detail during training on the SDMS.

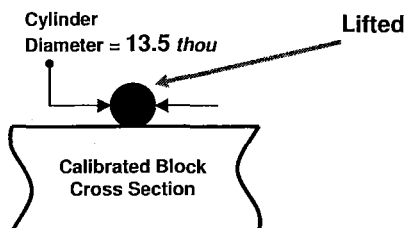
On first testing the Calibration Block S/N 197 was found to be faulty! It should have been 13.5 thou (WORST CASE +/- 3%) It was measured to be 14.1 thou! This is an error of over +4%. The block showed no sign of physical damage, but on close inspection it was found that the 13.5 thou steel wire had a "bow" in it, lifting it about 0.6 thou of the surface. The block cannot be easily repaired and was therefore destroyed! (As per the internal QC requirements of both STTR and Hextronics).

A new Calibration Block was manufactured, S/N 421.

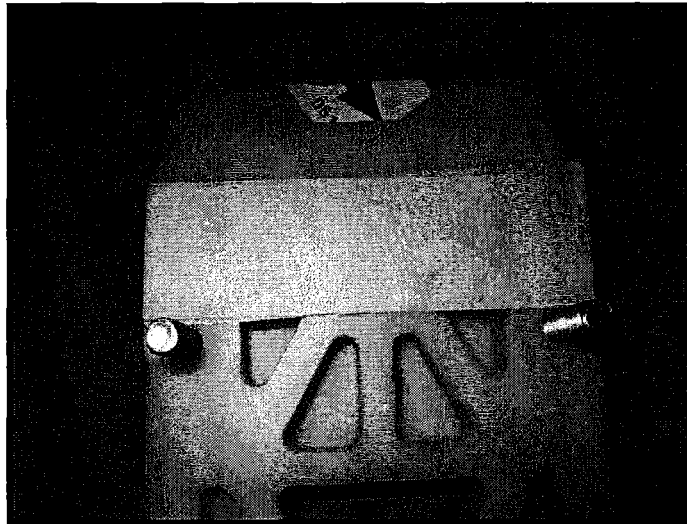
b)  
When we tried to make a Calibration measurement we found that the "Dings" Plate set had a broken Slider. See below!

**Tape on the Dings Plate!**

I have sought feedback from ST Aerospace as to whether there are any reports the system was dropped! No reply!  
The Slider was replaced!

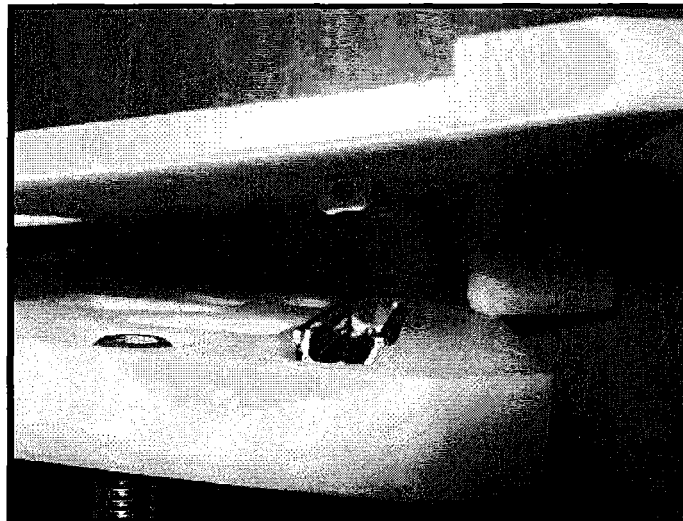
**The Broken Slider!**

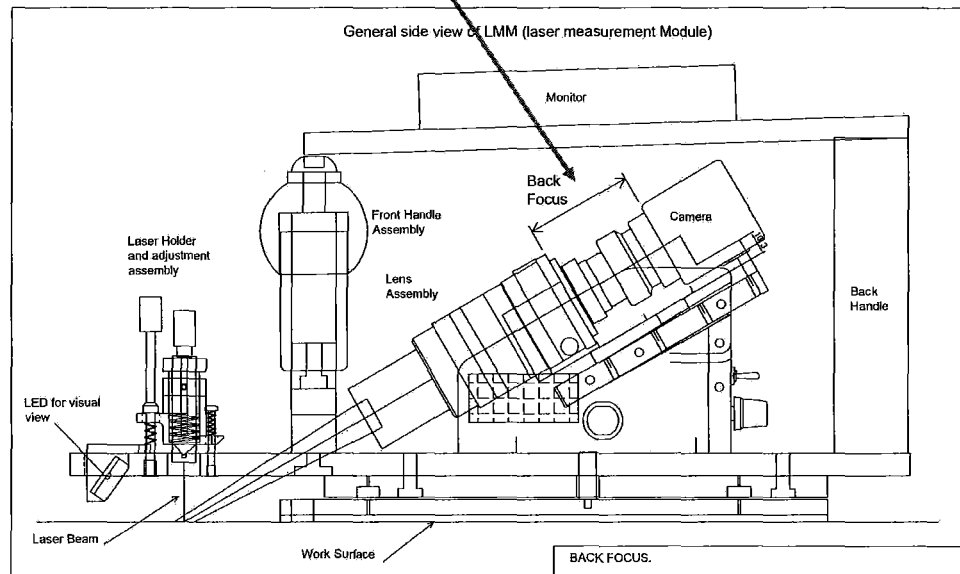
Please see drawing below. Back Focus,

From our internal notes this should have been 50.4mm, I measured 50.9mm on the system as returned. Unfortunately it is not simple to just change this back to 50.4mm. Although we measured 50.4mm during production of this system, the actual dimension is much more critical. It required the lens/camera assembly to be put into our alignment jig! We decided to wait for the new Calibration Block before doing this.

On close inspection it was the Camera that had moved backwards by about 0.5mm. But I found the lock screw to be tight! This suggests a drop or VERY hard knock!

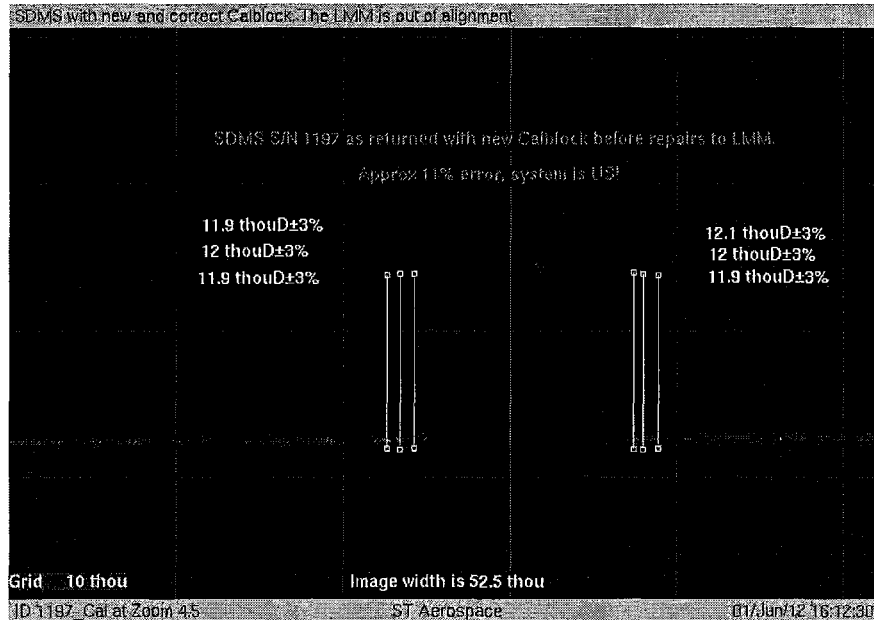
First result with new calblock 421. This is SDMS system AS RETURNED!  
 The Calblock 421 was known to be 13.5 thou! Taking 12 thou as the average for the 6  
 measurements below we have a measurement error of approximately of 11%.

In this condition the system is Un-Serviceable! And should not be used for an  
 Inspection!

The Lens/Camera was removed, placed in a jig and realigned!

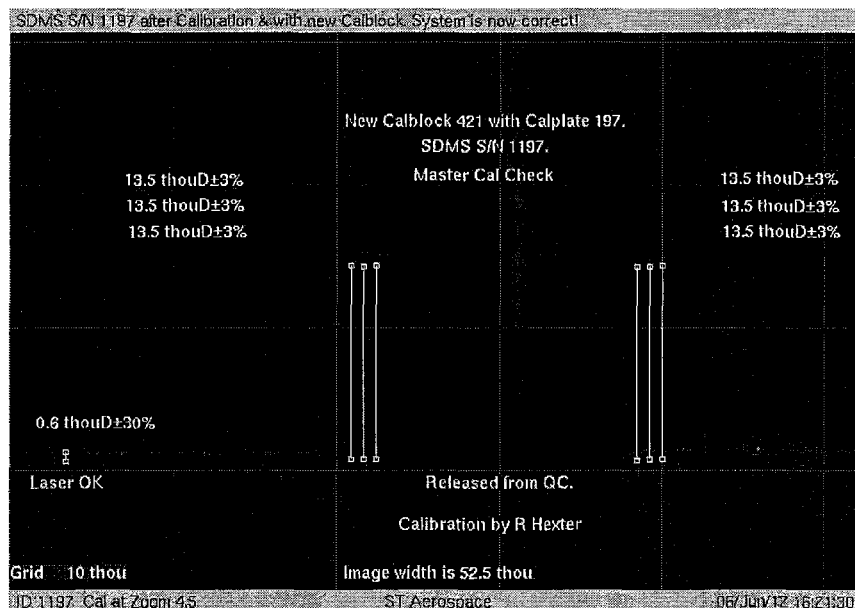
After repair with New CalBlock 421!
