QUALITY SYSTEM COMPLIANCE VENDOR / SUPPLIER AUDIT REPORT

Qantas Airways Limited

**Contracted Maintenance – SIAEC Singapore "D" Check on
Qantas Aircraft VH-OJO V/C: T7105**

AQD Audit ID: 06/SPT/10

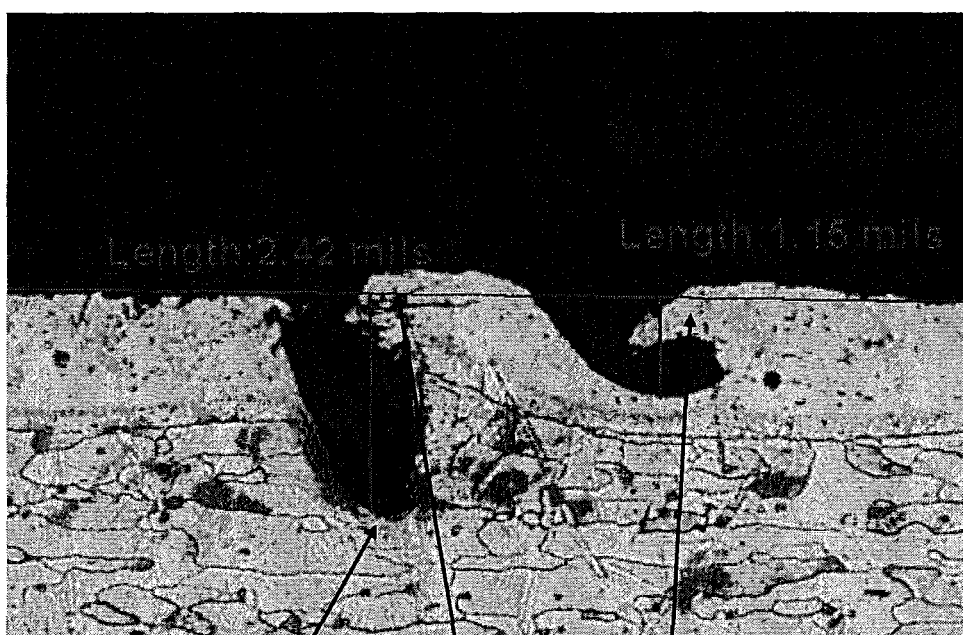
Image 6

**Contamination of Scribe
Impossible to Clean**

Folded Lands

On the basis of the above I would consider that NO SCRIBES found on VH-VBM can fall into the "allowable damage" category. This would mean VH-VBM is LRTS.

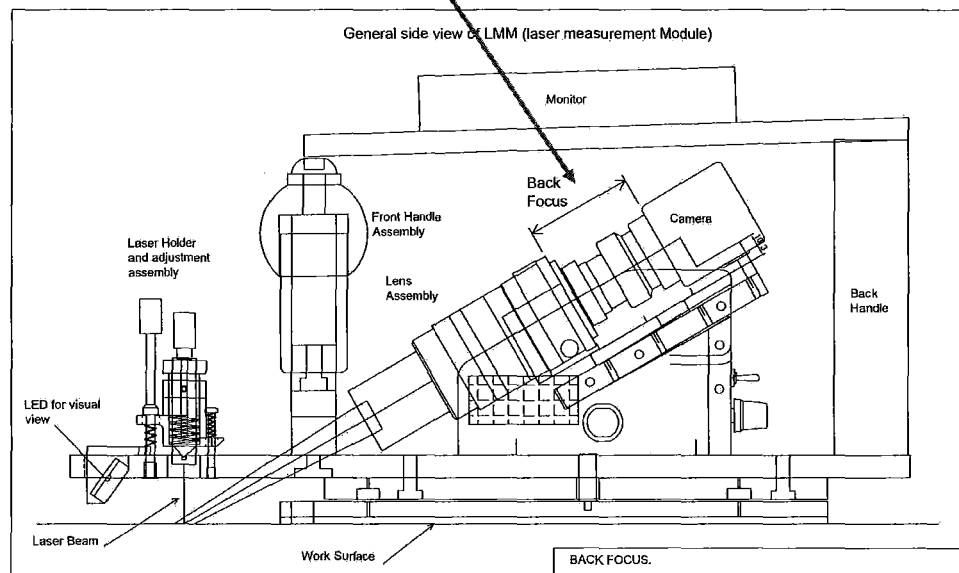
From our internal notes this should have been 50.4mm, I measured 50.9mm on the system as returned. Unfortunately it is not simple to just change this back to 50.4mm. Although we measured 50.4mm during production of this system, the actual dimension is much more critical. It required the lens/camera assembly to be put into our alignment jig! We decided to wait for the new Calibration Block before doing this.

On close inspection it was the Camera that had moved backwards by about 0.5mm. But I found the lock screw to be tight! This suggests a drop or VERY hard knock!
