Cairns Base Hospital - District  
Disaster Planning Committee

**Cairns Base Hospital**

Cyclone Resilience Study -  
Structural and Building Envelope

CSRR/206509-81/R001

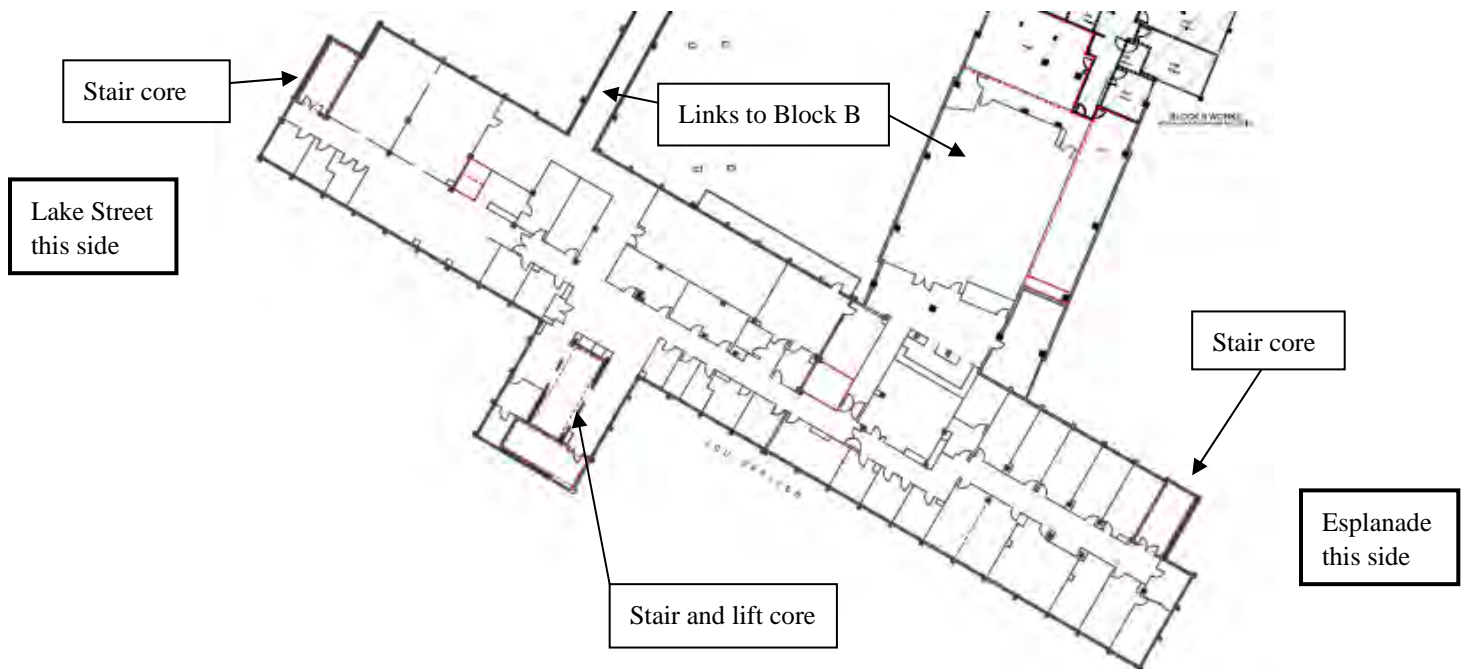
**Figure 1: General layout of a typical level in Block A (Level 2 shown).**

- Numerous roof-mounted extraction fans. These could be a potential path for water ingress during a cyclone and are reasonably exposed to storm debris, which may cause the fans to be damaged or even torn off, leaving a hole for ensuing damage to occur.
- Lift core located external to main structure with original steel-framed glass windows to lift lobby area. This older glass is not considered very resilient and therefore the use of these lifts may be more risky during a cyclone because of the risk of window damage.
