8th May 2013

James Billamoria
Visionstream

Local CEPU Official Michael Anderson and I attended 13 Visionstream sites yesterday that had contractors undertaking work for the NBN rollout. We have found that there are serious OH &S breaches occurring and no onsite leadership from Visionstream at all.

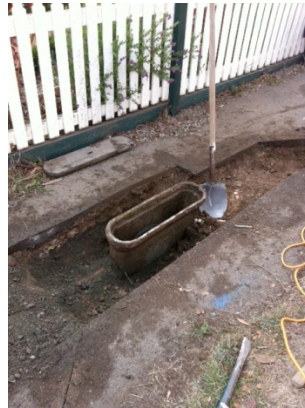
- Bellerive – Point Construction. No NBN ACM training. Had cleared around pit and were going to leave site to attend VPL yard for the ACM Training leaving the pit exposed. They said they were leaving immediately.

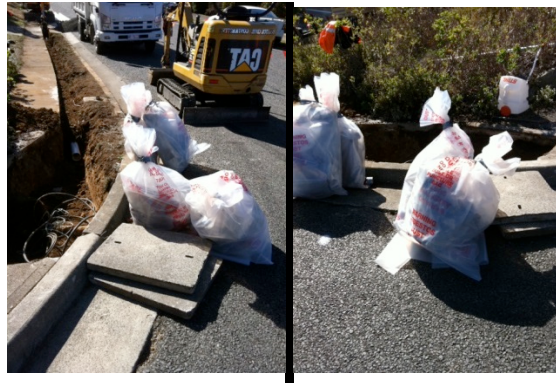
- Clarence Street Bellerive– Landworks. Had ACM training
- Redwood Rd Kingston – 20th Century Plumbing. No NBN ACM training. Had just removed and bagged an ACM Pit. They had a Leighton Contracting Safety Handbook that they were following as the process for removing the ACM Pit.
- Balamara Street Rosny – Bullock Contracting. Toolbox talk at casino about asbestos.
