8th May 2013

James Billamoria
Visionstream

Local CEPU Official Michael Anderson and I attended 13 Visionstream sites yesterday that had contractors undertaking work for the NBN rollout. We have found that there are serious OH &S breaches occurring and no onsite leadership from Visionstream at all.

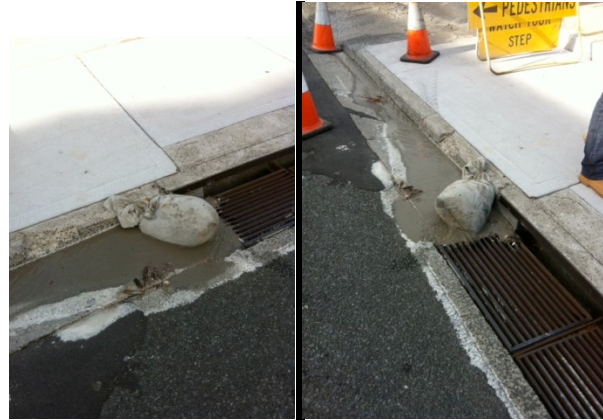
- Percy Street Bellerive– Spectran. 3 blokes , one ACM Trained. The contractor was cutting the concrete footpath to install pit & pipe. They had blocked off the council car park as they were cutting the driveway/ crossover. We observed that they were hosing the slurry and run off into the gutter that was then running into the storm water drain. The only environmental bund that was in place was insufficient for the task. When I pointed this out they threw a hessian bag over the storm water grate!!
