# Post Incident Analysis Report

**MFB Burnley Complex  
450 Burnley Street  
Richmond VIC 3121**

**Lacrosse Docklands  
673-675 La Trobe Street, Docklands  
25 November 2014**

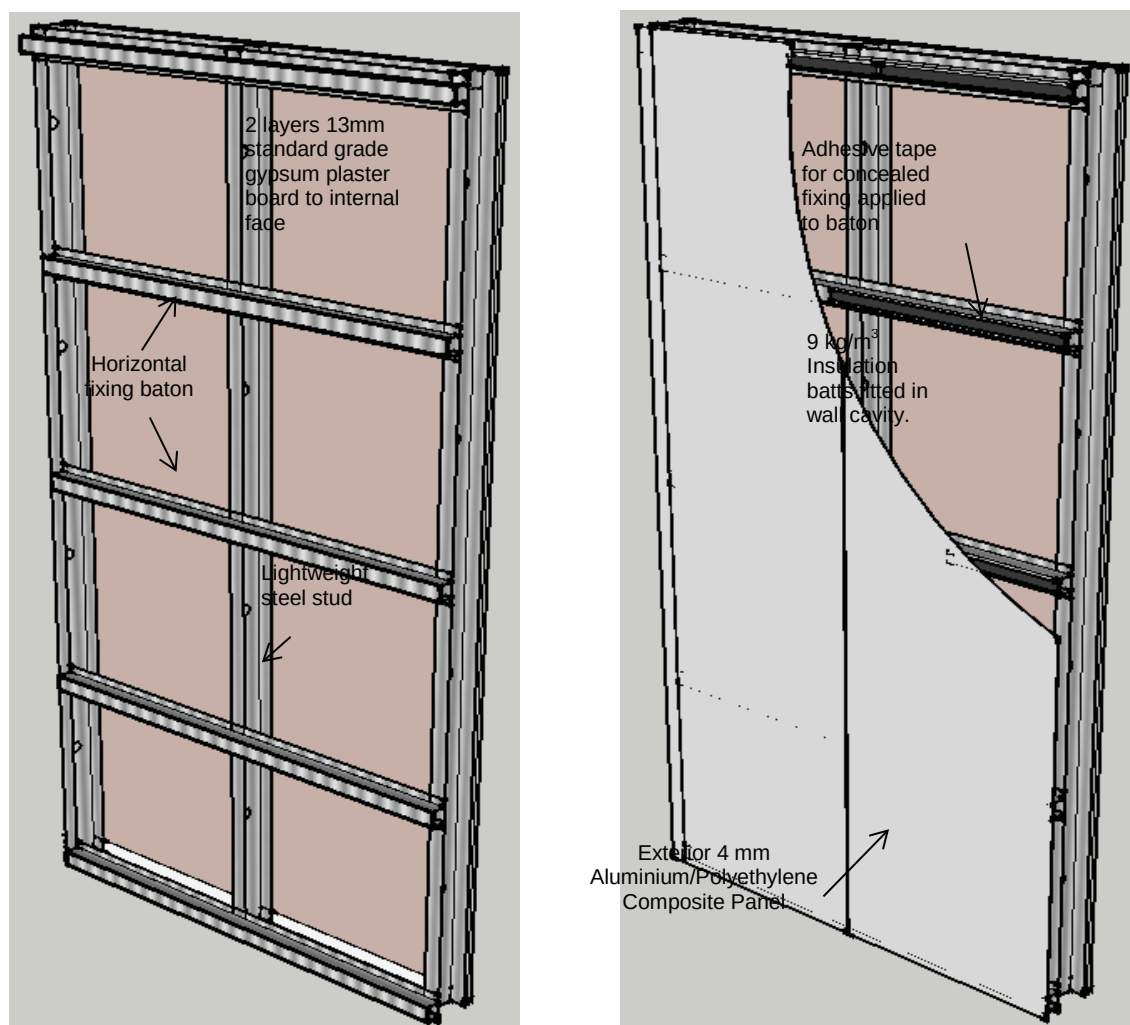
**Figure 9 - Aluminium/Polyethylene Composite Panel Façade - External Wall Cladding**

To the best of the MFB's knowledge, the labelling indicates an aluminium/polyethylene composite panel of 4mm thickness, in a colour known as Champagne Silver (*HY 103*). It is unclear what the value *11060167* represents, however, the number does loosely appear to correspond with the date and time shown at the end of the label and may indicate the number of manufacturing runs of this colour and type for the month. It is assumed this panel is the standard grade Alucobest panel, as there is nothing to indicate otherwise. The product is believed to incorporate a Polyethylene core material.

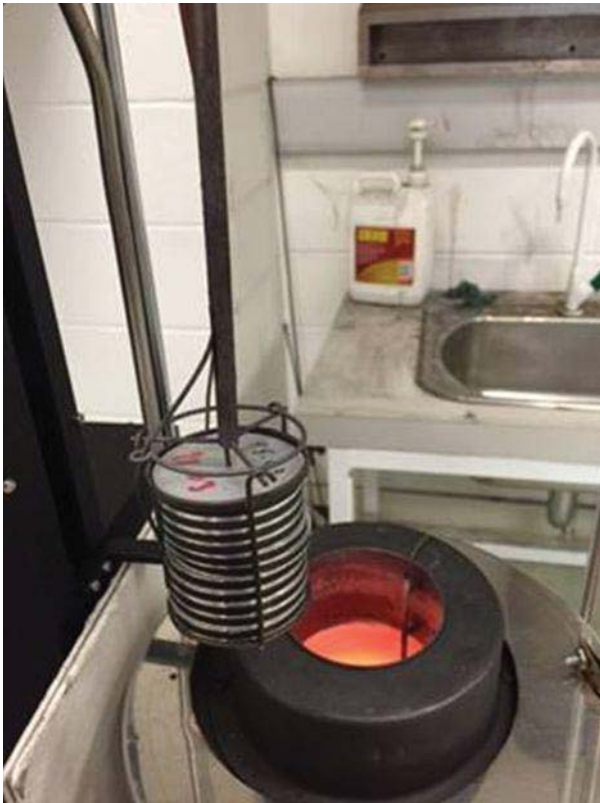
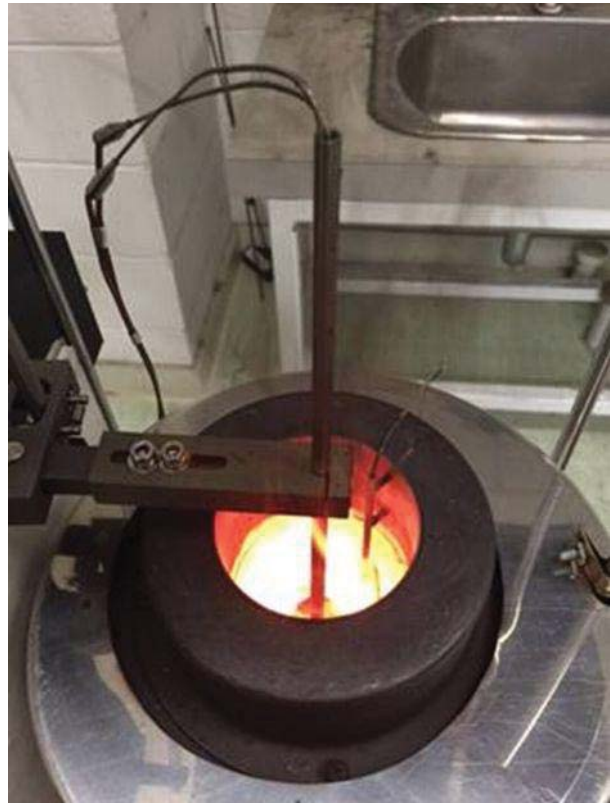
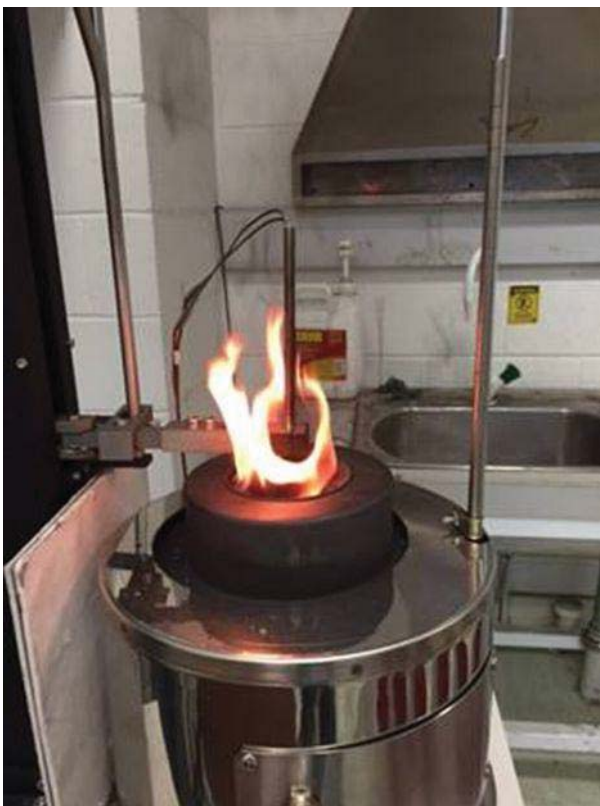
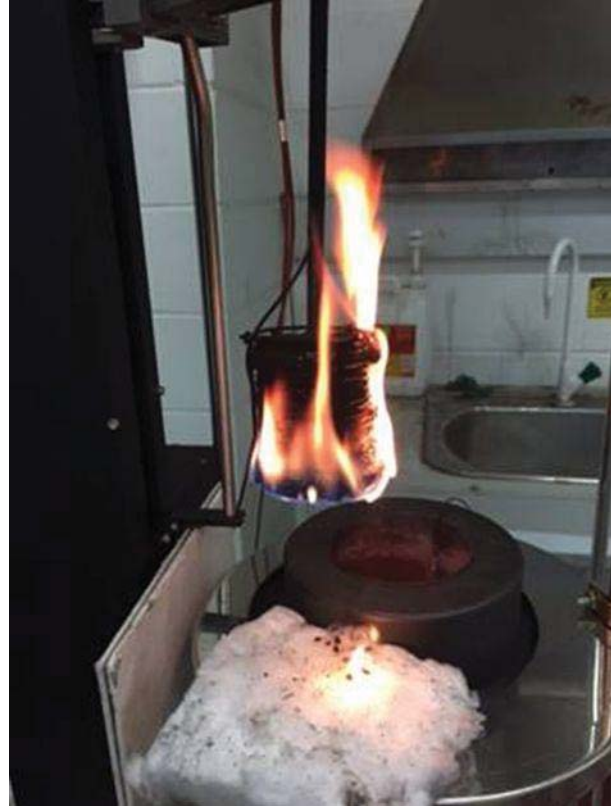
Specimen photos before, during and after the test.

***Observations:*** Sustained flaming was observed on the specimen at 55 seconds into the test. The test was terminated at 93 seconds due to excessive flaming and smoking.

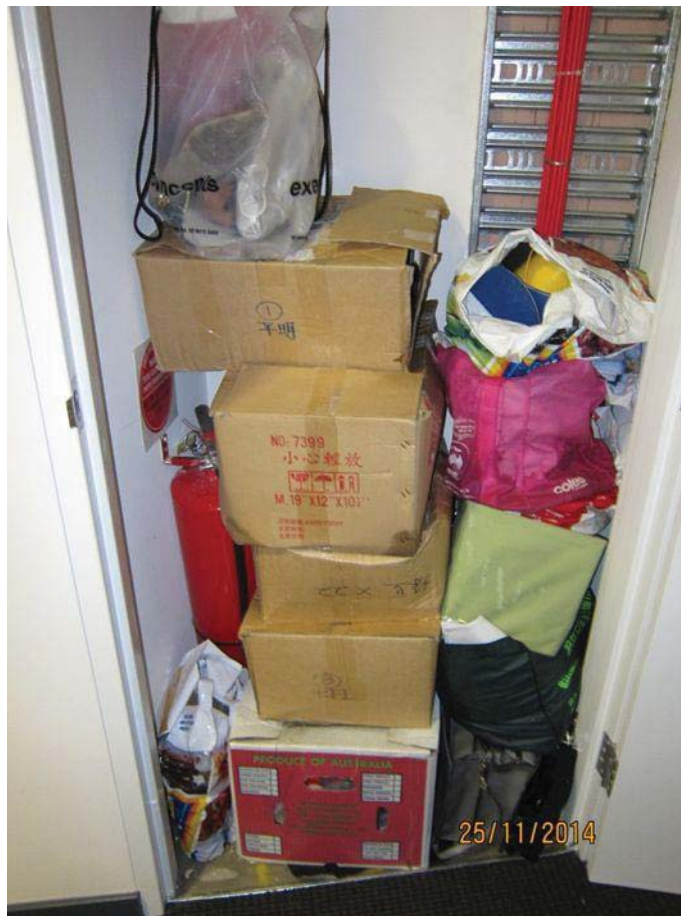
In this instance, a number of the purposely designed extinguisher enclosure housing Extinguishers 1 and 2 shown in [Figure 12 \(refer previous page\)](#), were being used by occupants as storage areas thus blocking access to the extinguishers.

**Figure 13 - Fire extinguisher cupboard on Level 6.**

The storage of goods and materials in enclosures used to accommodate fire safety equipment, delays access for occupants or fire-fighters who require the equipment in an emergency. These storage items are generally of a combustible nature and present an additional hazard.

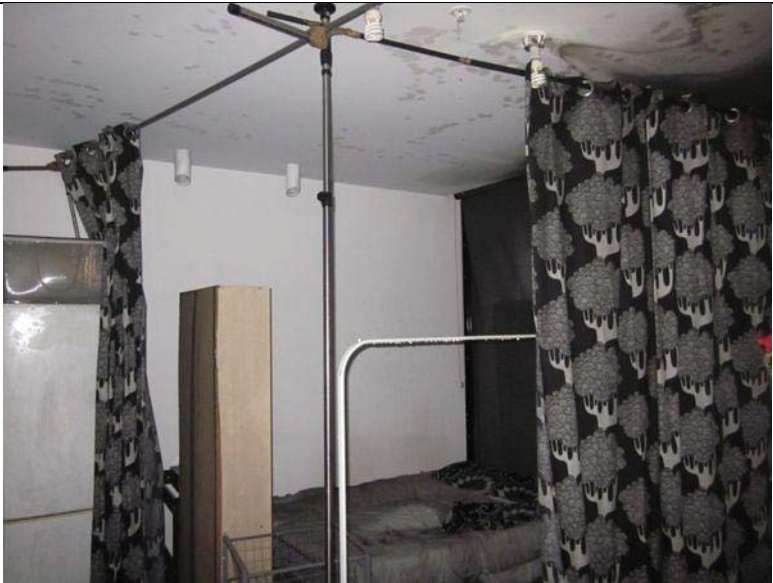
| Living room cordoned off to create additional bedroom | |

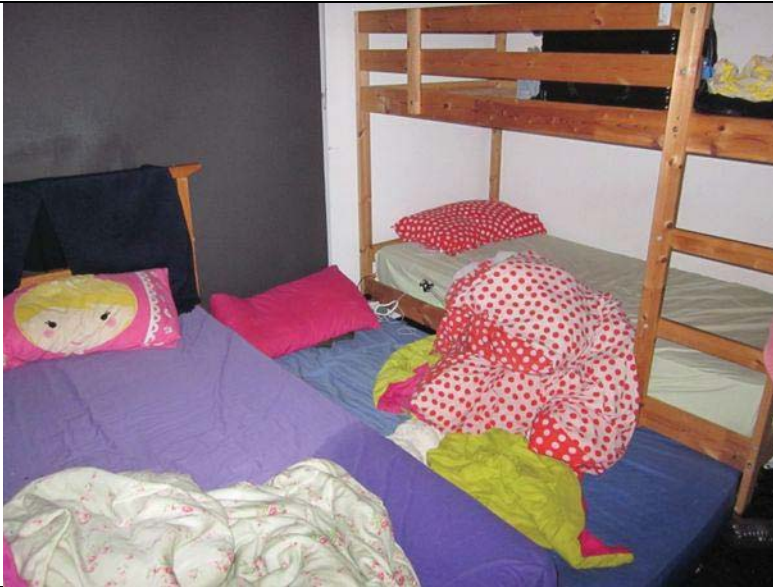
| Multiple Beds in two bedroom apartment. | |

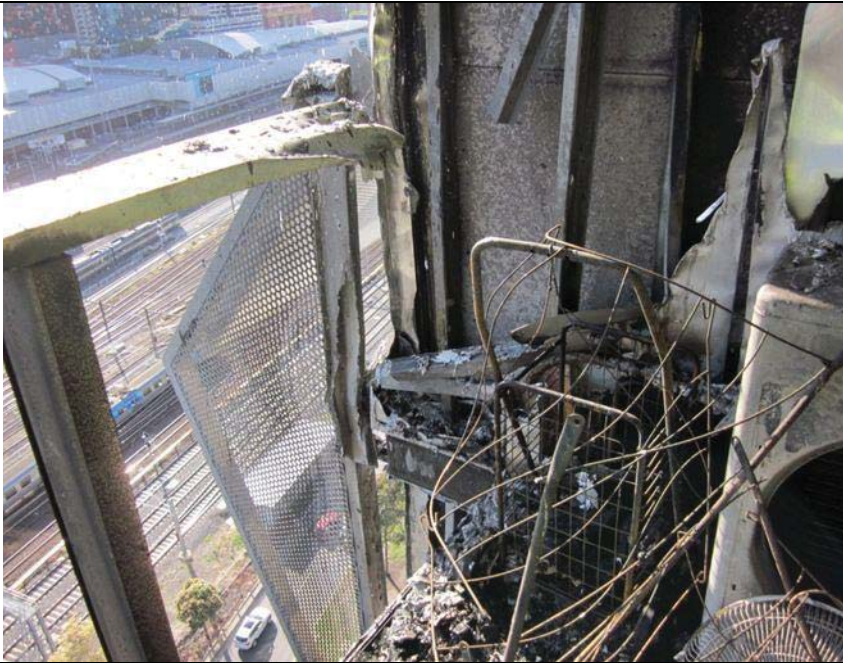
Wall between bedroom and balcony. Construction lightweight wall with steel studs, aluminium type external cladding plasterboard to internal. Material stored on balcony.

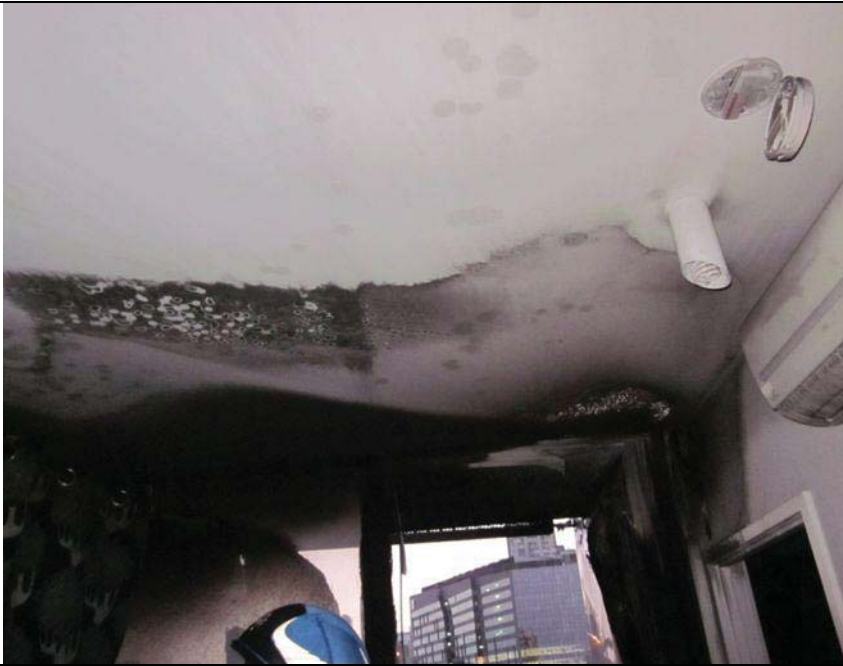
View of damaged wall and smoke detectors made inoperable. Others were covered over.

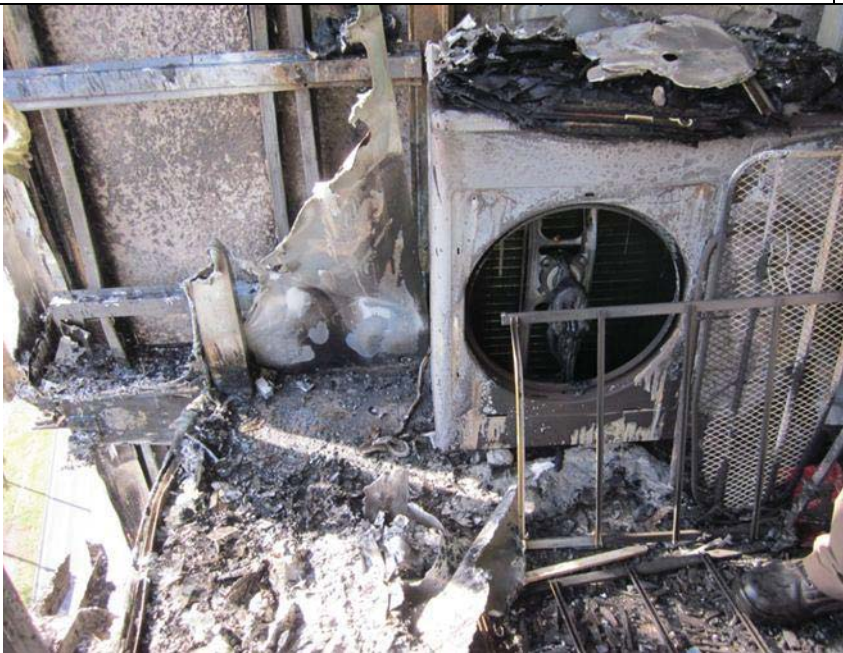
Photo of base of wall and penetrations plus overhang past balcony edge

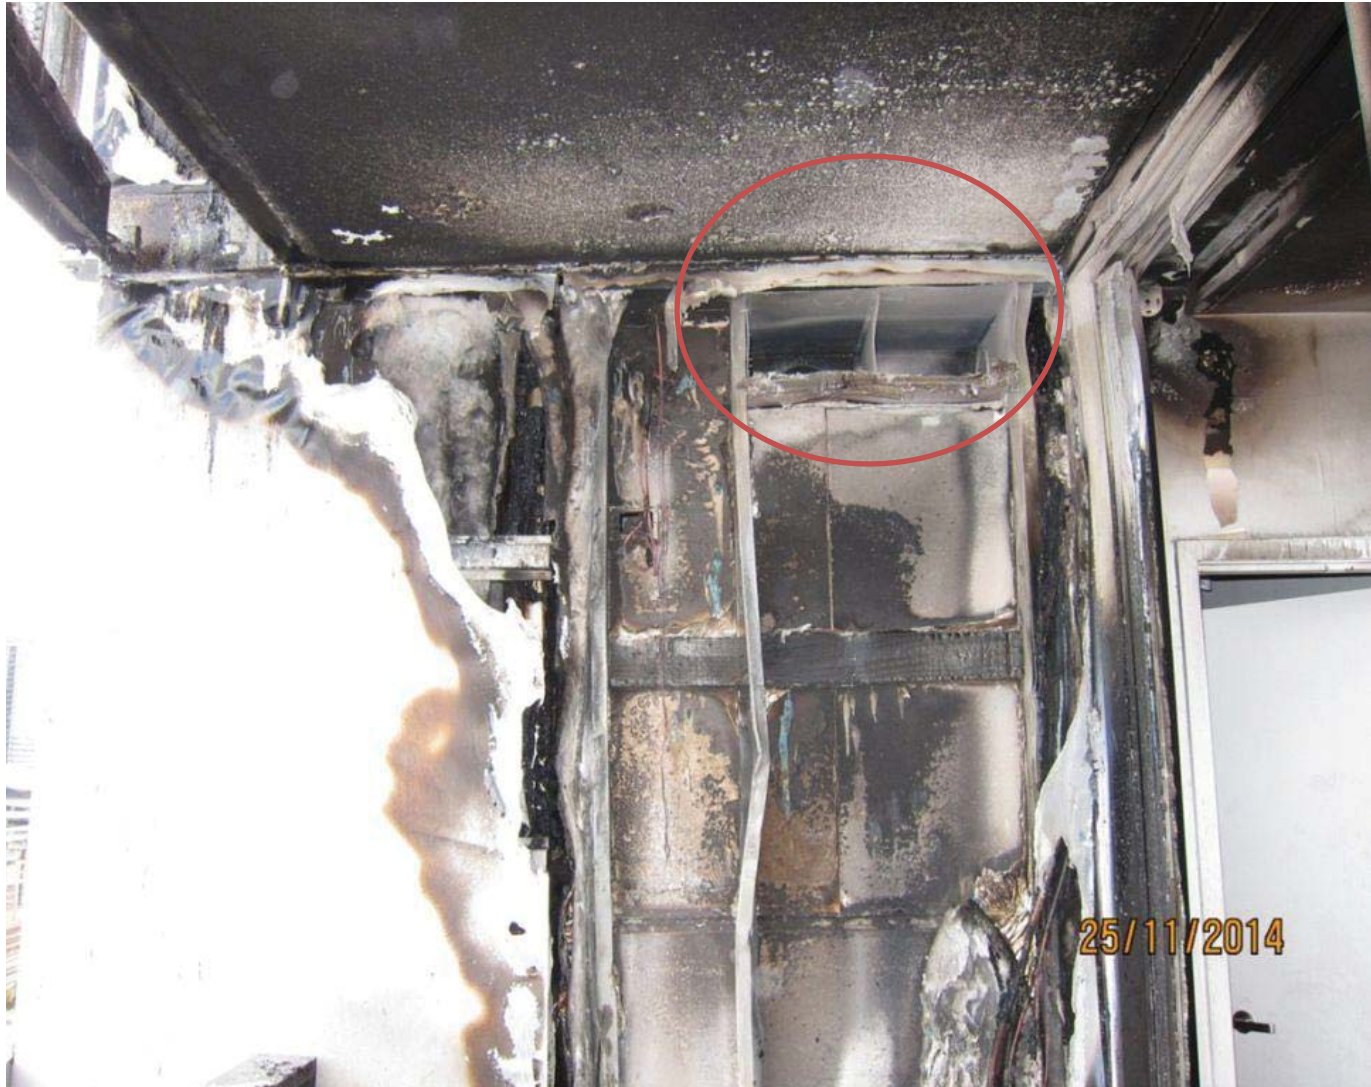
Figure 19 - Apartment Exhaust Duct

Image depicts apartment exhaust duct, the image also shows how close the door of Bedroom 2 is to the exhaust. The EWIS speaker is located roughly 400mm inside this door.
