Post Incident Analysis Report

**Lacrosse Docklands
673-675 La Trobe Street, Docklands
25 November 2014**

Point of Interest: Rapid external fire spread in a high-rise apartment building resulting in a mass evacuation

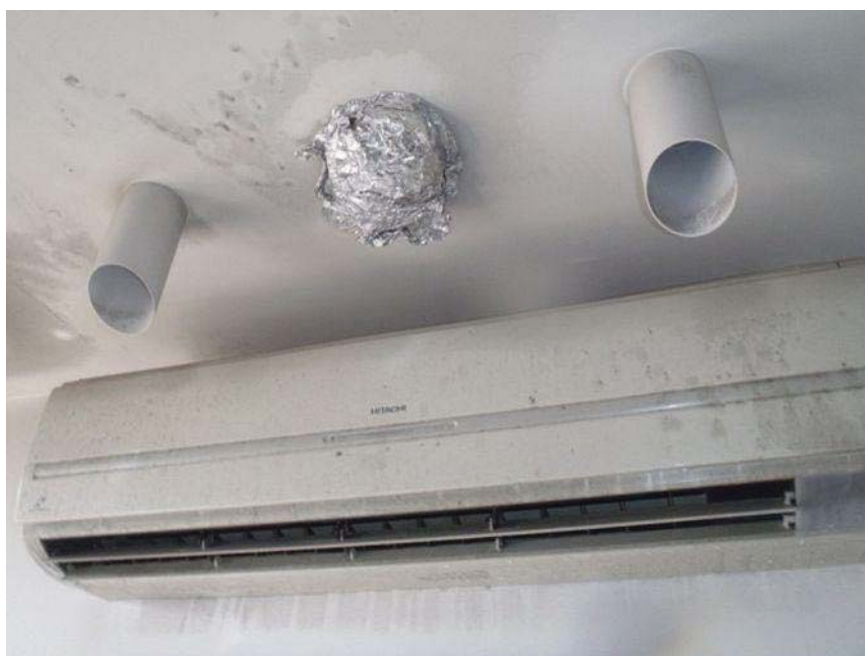
It was observed that within a number of apartments the battery had been removed from the smoke alarm. In addition some smoke alarms had been covered (Refer to Figure 14 below).

Figure 14 - An example of an obstructed Smoke Alarm – Apartment 805

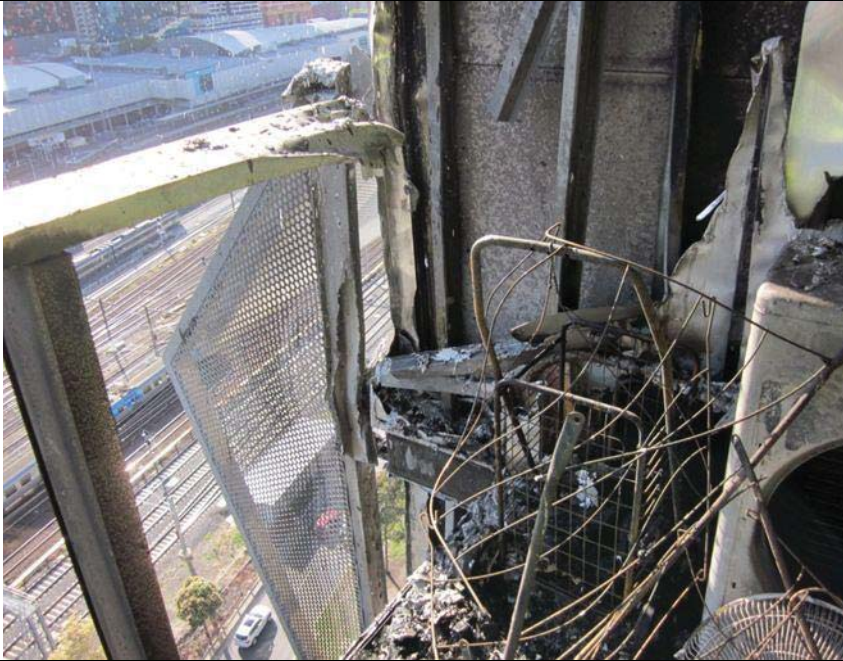
Wall between bedroom and balcony. Construction lightweight wall with steel studs, aluminium type external cladding plasterboard to internal. Material stored on balcony.

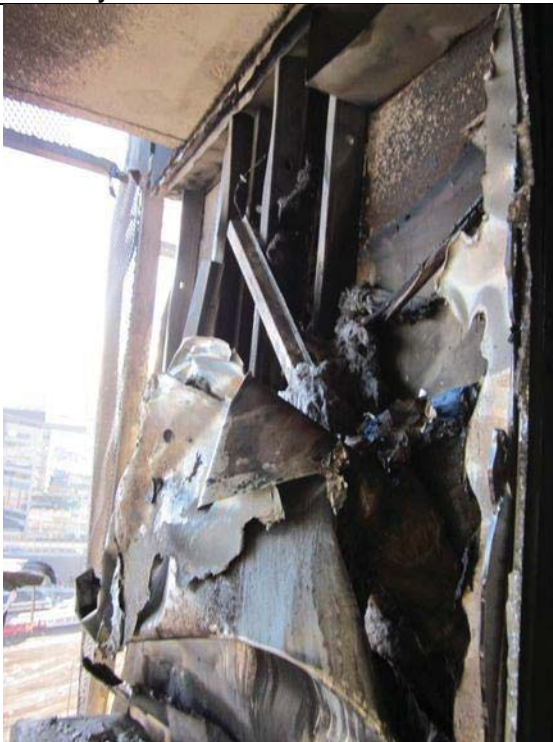
External wall at upper height

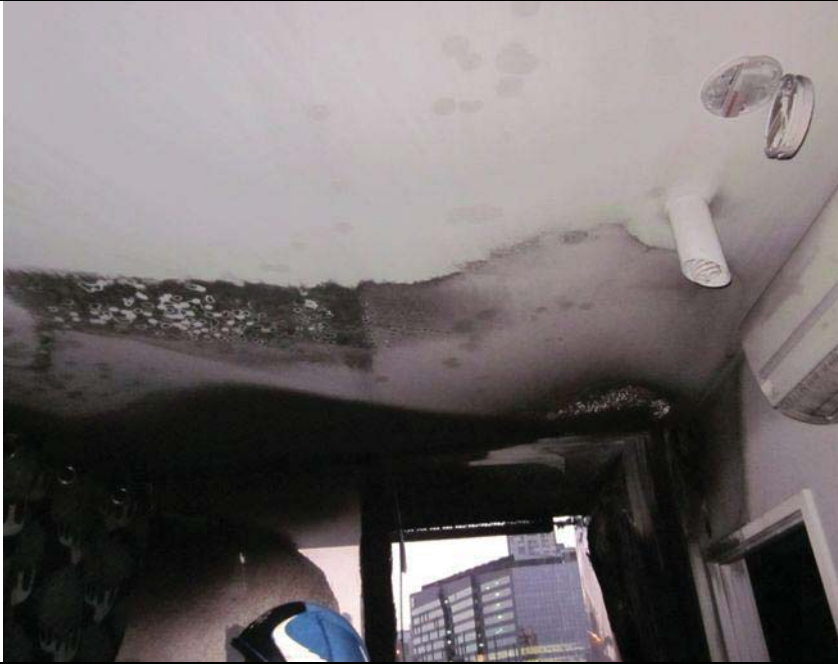
View of damaged wall and smoke detectors made inoperable. Others were covered over.

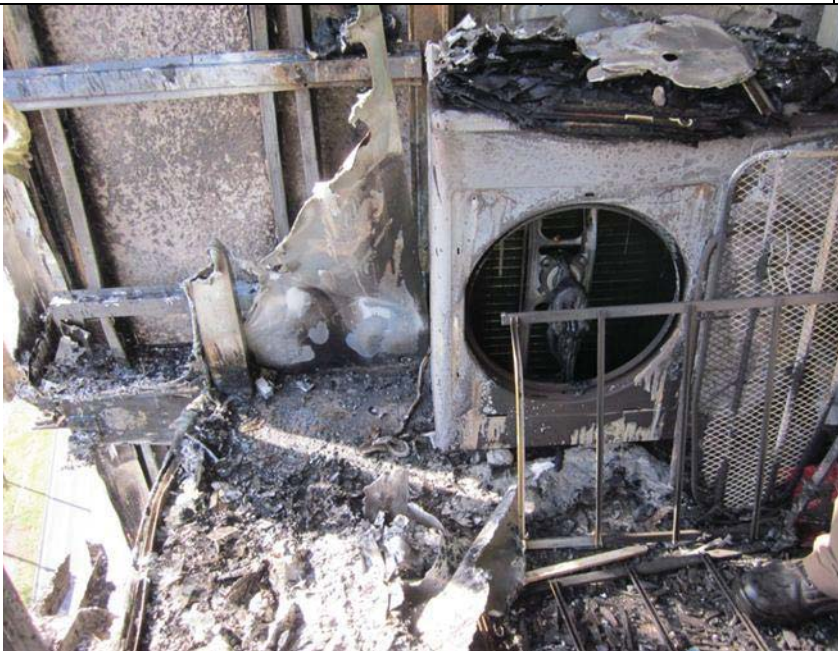
Photo of base of wall and penetrations plus overhang past balcony edge
