AS3996 – 2006 ACCESS COVERS & GRATES

COMPLIANCE – ROAD PROJECTS vs. BUILDING PROJECTS

Current Case Studies

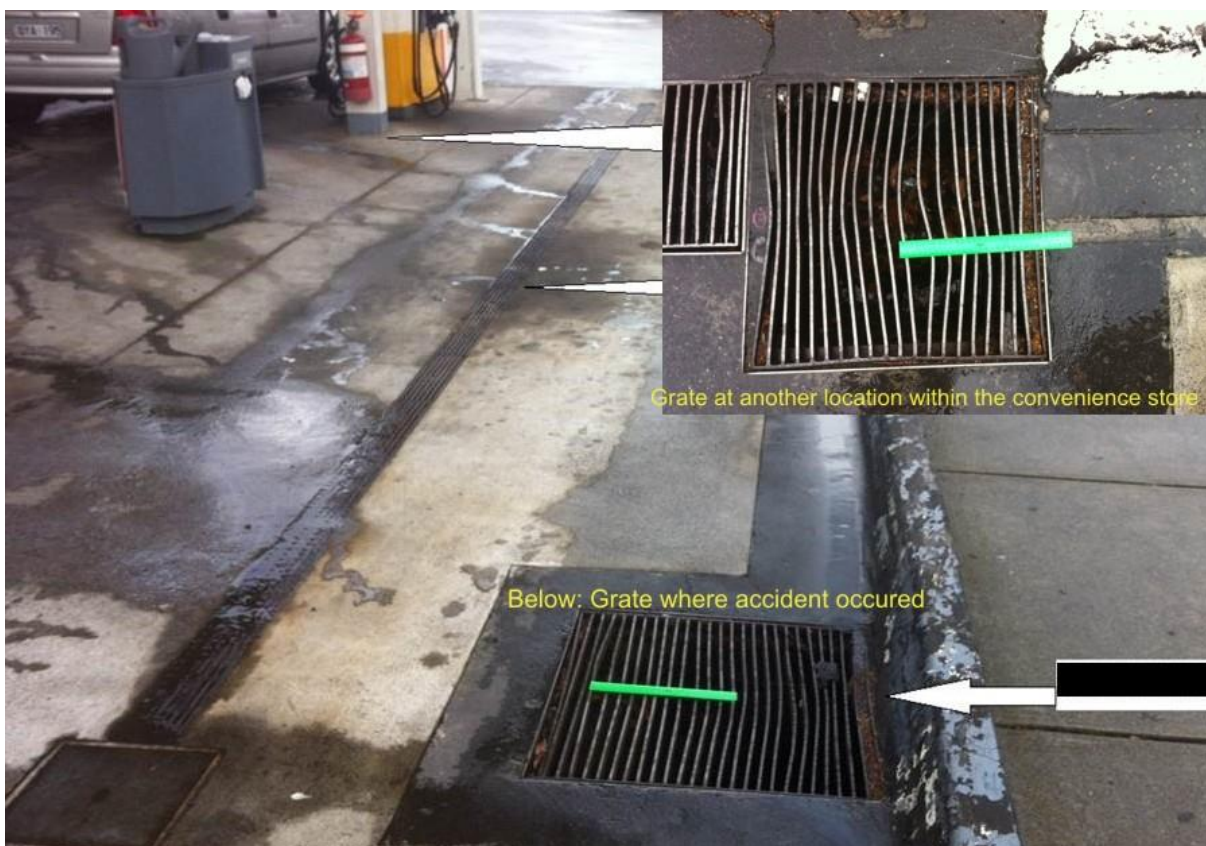
Case Study – Injured Cyclist

On-going case involving a cyclist who has received serious facial injuries as a result of a bicycle tire becoming jammed in a grate whilst traversing through a convenience store. The convenience store had undergone renovations in 2007 and additional stormwater grates were installed again after that time.

The grate shown below is in a serious state of failure and doesn't comply with AS3996-2006 in either Load Capacity, Pedestrian tolerances or Bicycle Safety. The failing grate should have been replaced once identified as failing. No action at this time has been undertaken by the site owner and the grates are still in service.

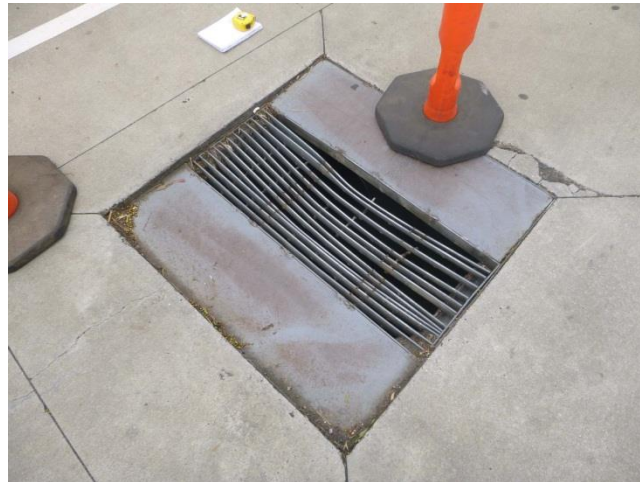
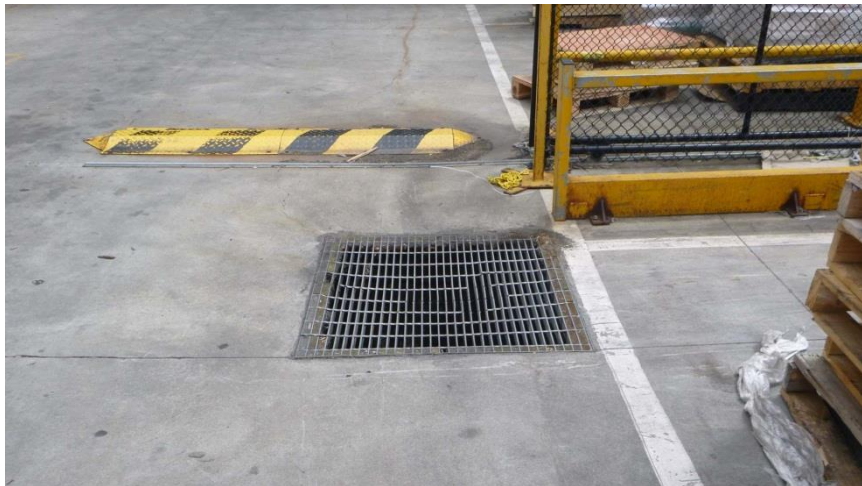
Case Study 1 - Distribution Warehouse subject to transverse impact load from low speed heavy transport

On this particular site the hardstand had 10 stormwater pit grates which were all in various stages of failure. 900mm x 900mm clear opening pits were covered with grates of an unknown load capacity. The owner, in one case, had attempted a repair, which quite obviously, had been inadequate. Had grates manufactured to AS3996-2006 Load Class D been used this would have been avoided. Replacement cost for all grates on the site could be in excess of \$10,000.00

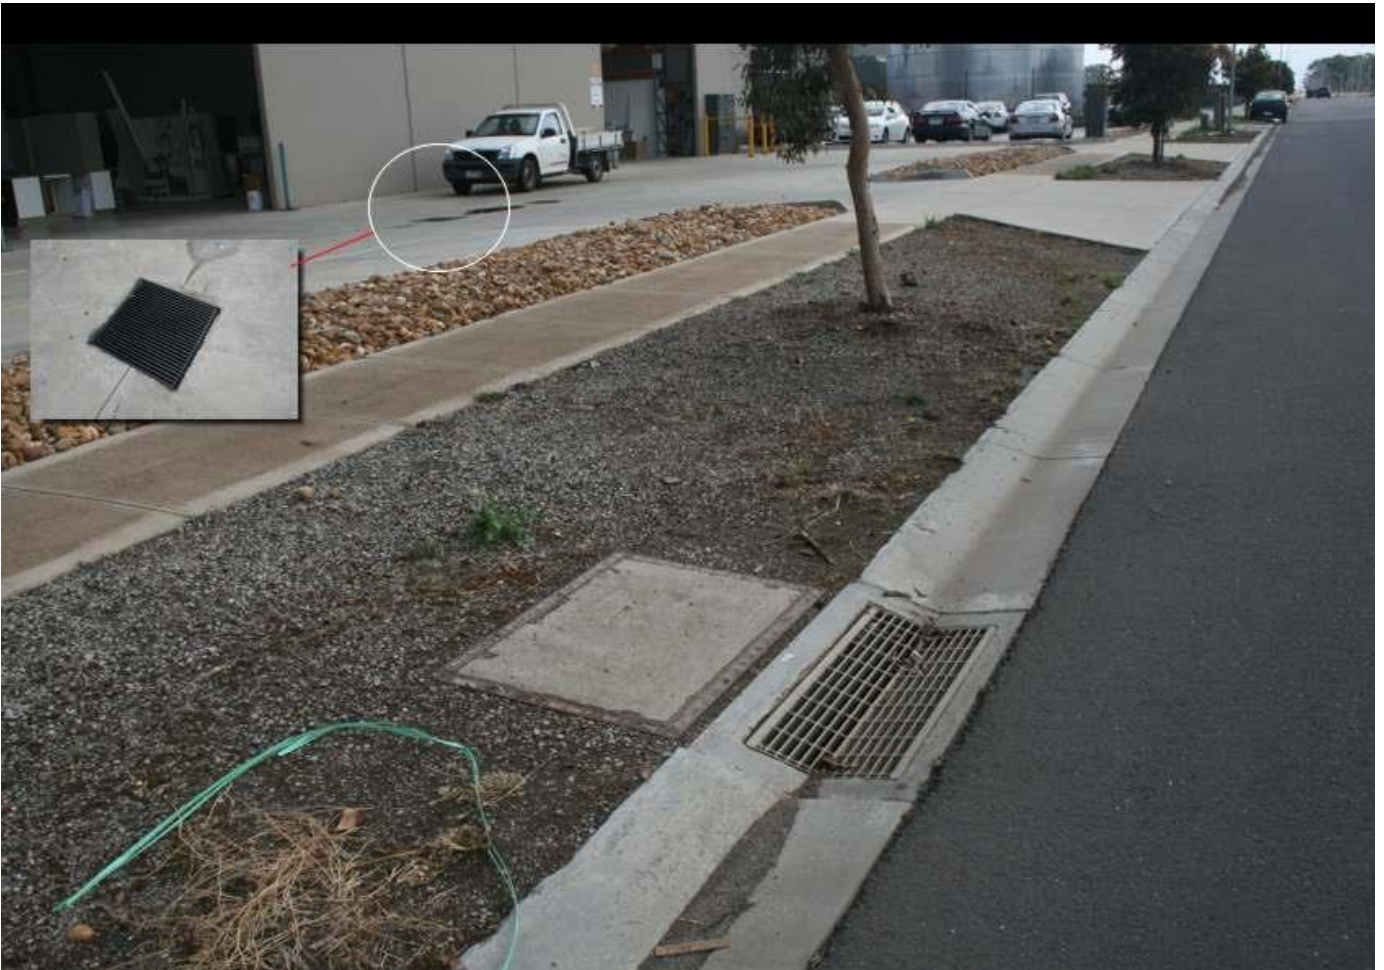
Case Study 2 – Small Manufacturing Facility

In this location, in the foreground we can see a Council Gully Grate installed as per their specification, product compliant with AS3996- 2006. In the background (and inset) we see a small painted grate, according to the owner of the factory the grates in the parking areas have been replaced 3 times due to either theft and/or failure under load. The likelihood of further replacement of these grates is high. Had the builder used grates complaint with AS3996-2006 with a Class C load capacity, lockable, they would almost certainly still be in service.

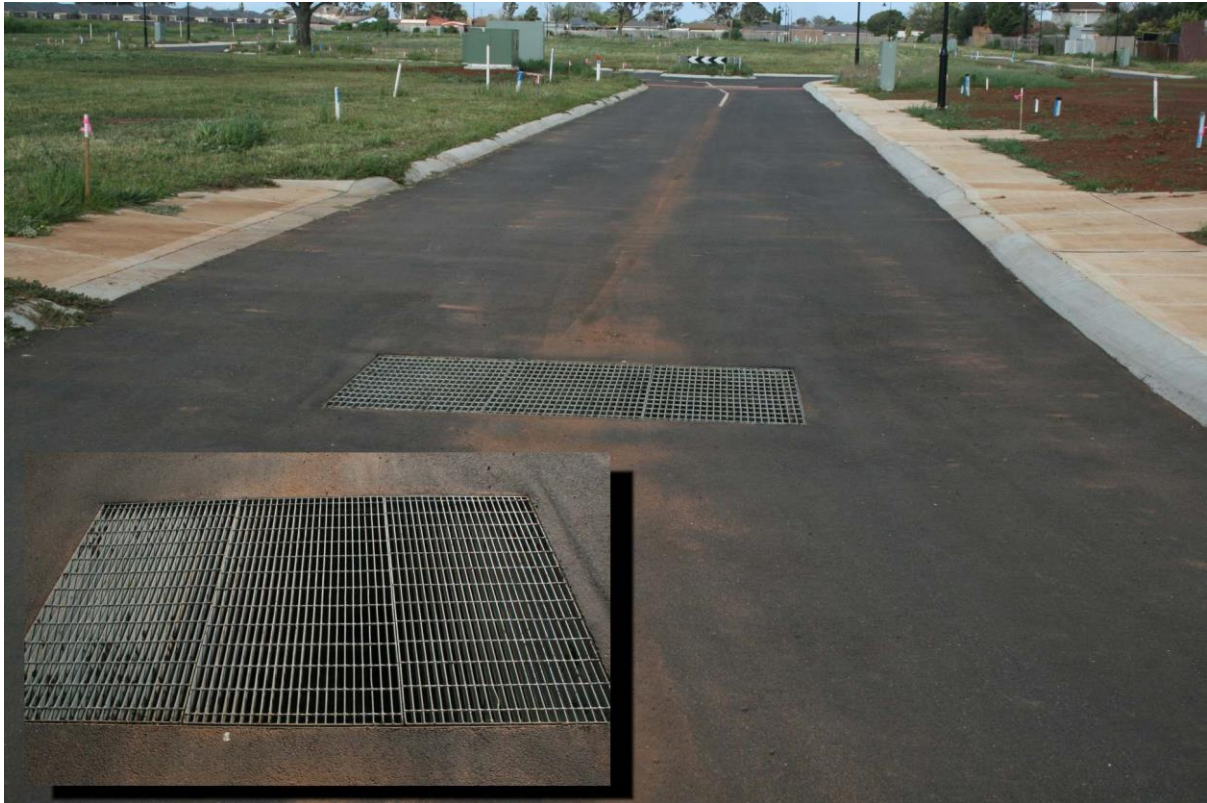
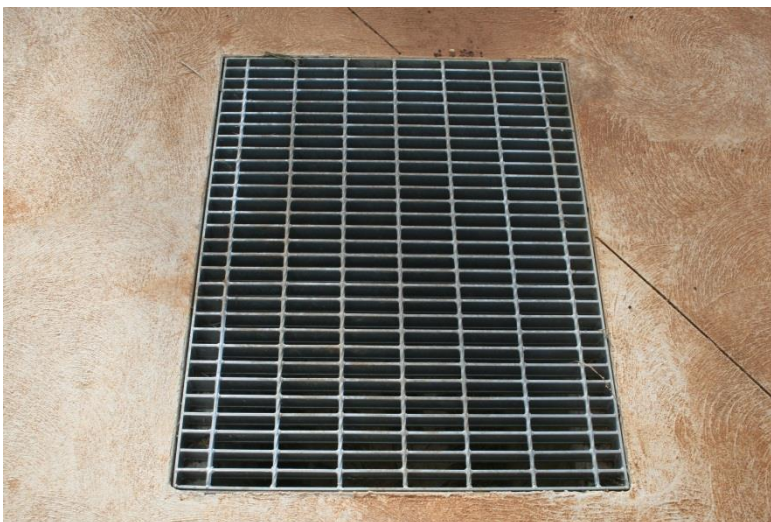
Case Study 3 – Private Body Corporate Housing Development

Clearly, in the construction of this development, the builder has not used any grates that are compliant with AS3996-2006. All grates observed at this location were non-identifiable by manufacturer. All were of insufficient structure to carry the required Class D loading. In the case of the main picture the wide span of this particular pit and the inadequacy of the grate will lead to inevitable failure under load.

None of the Stormwater grates at this location were compliant with the requirements of AS3996. All were of insufficient structural capacity and were not identifiable by manufacturer.

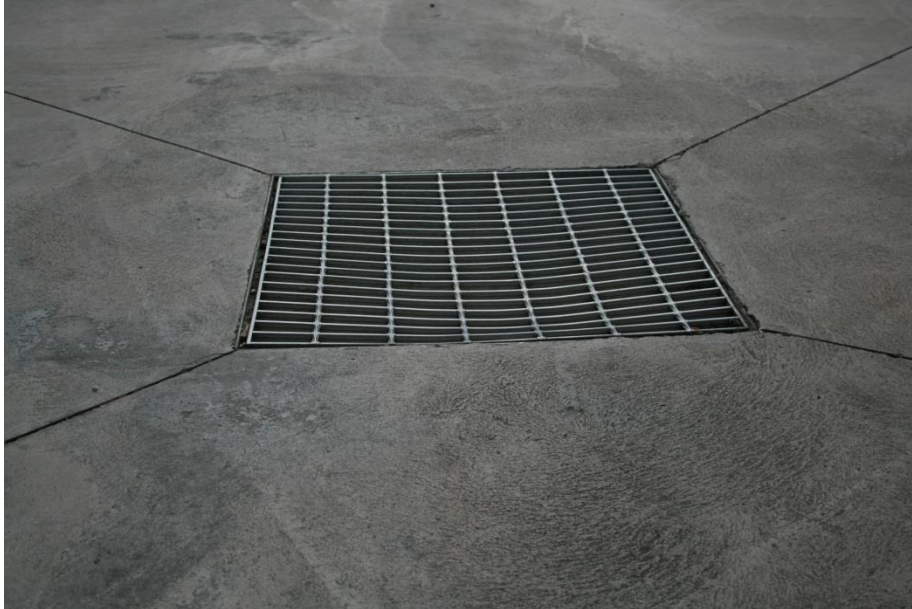
Case study--4-Commercial Car park-Sunshine- Vic

This newly constructed car park, at a commercial premises-contractor has used cheap non-compliant stormwater grates. These failed within 6 months and will require replacement. AS3996-Class C was required, but these product load capacities cannot be determined

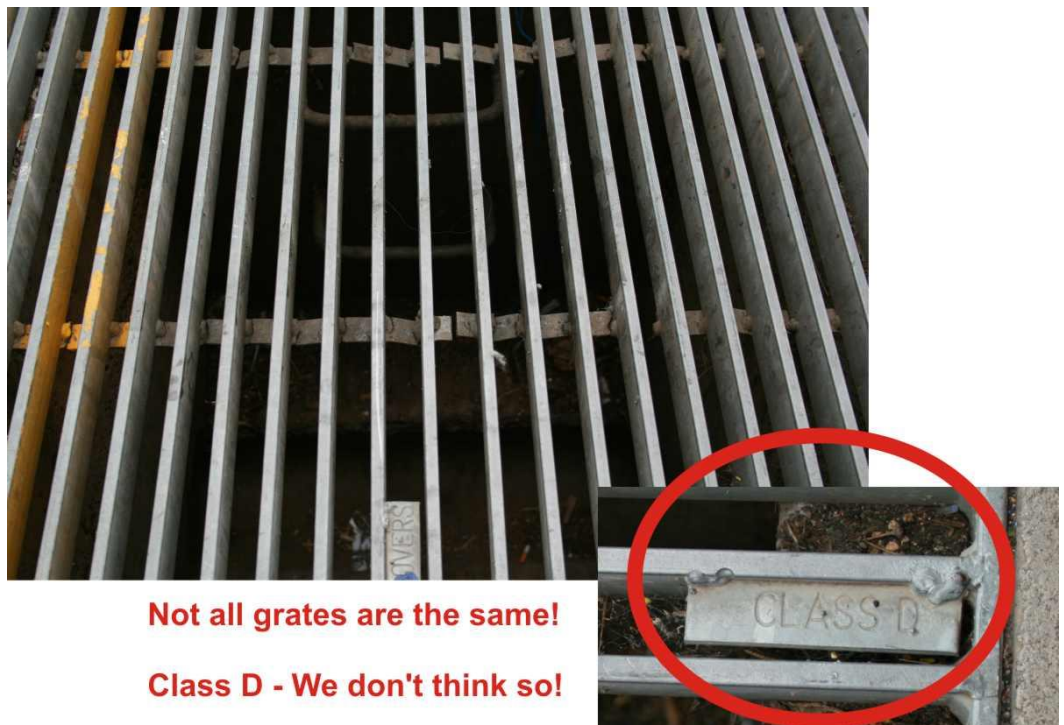
Case Study 5 - Commercial Car park, at Derrimut Victoria

Manufacturer demonstrates clear disregard for the Australian Standard. In this case the grate has been tagged with a label indicating Class D when it is clearly not, having failed in the car park of a commercial premises. The manufacturer in this case indicated to the contractor that the Class D tag was only his "internal code" and if he wanted AS3996 compliant " he should have asked for it"

Class D - We don't think so!

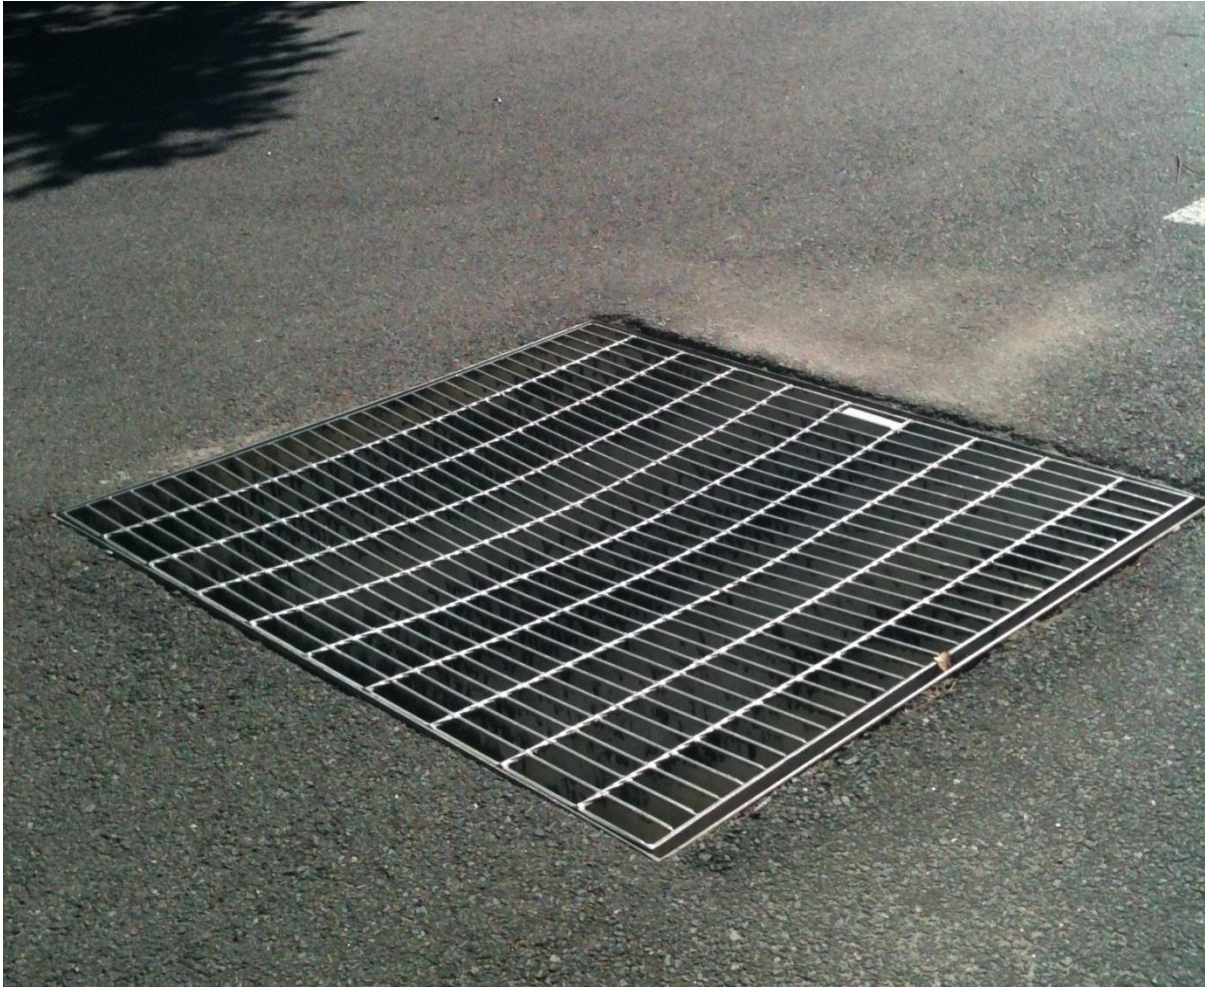
Case Study 6 – Commercial Car Park – Brisbane

As per AS3996-2006 the grate used in this application should have been Load class C, but here we have a Load Class B grate being used. However given the location and limited access to heavy vehicular traffic a Class B load grate should not sustain this type of failure leading to questions on the integrity of the manufacturers load capacity claim.

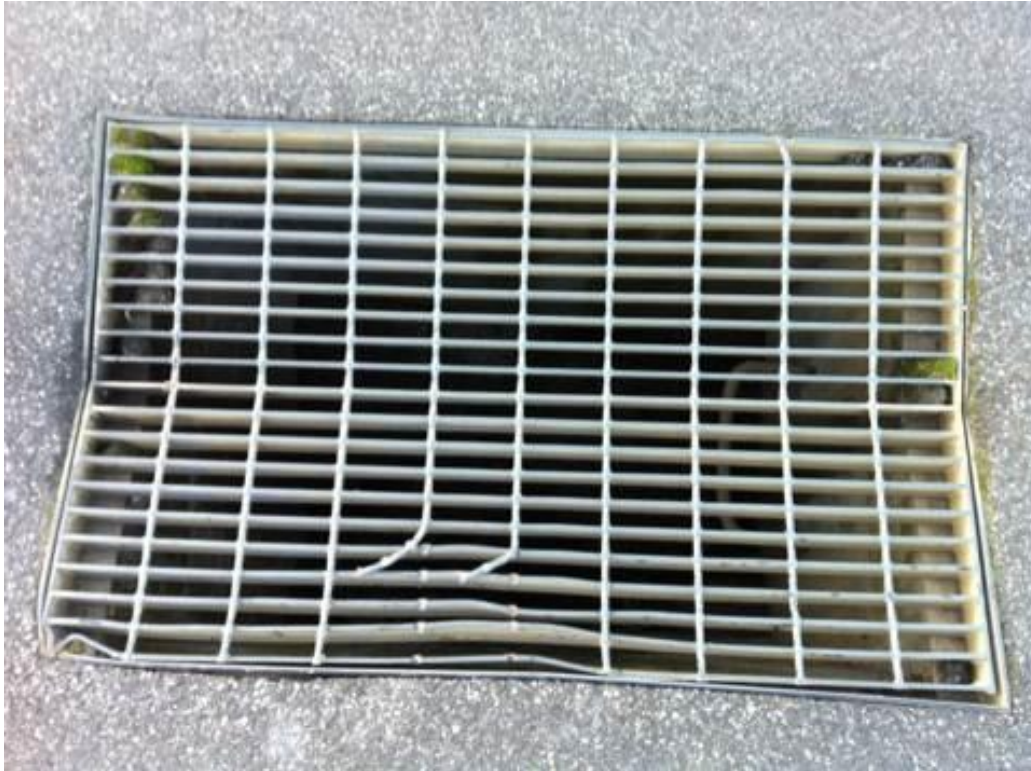
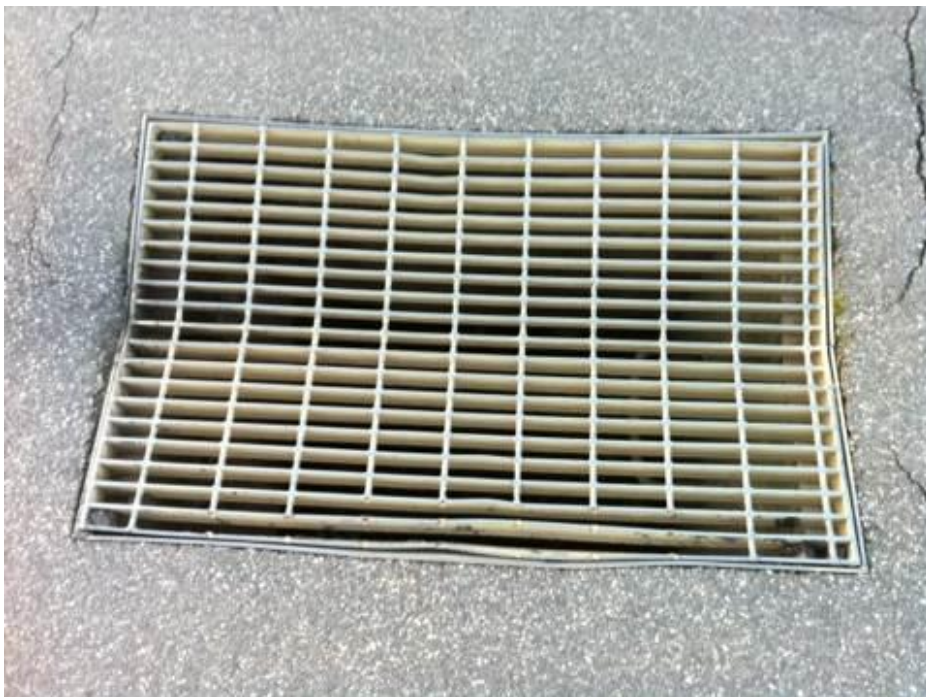
Case Study 7 - Non identifiable imports

Very large numbers of cheap, non-compliant, non-identifiable imports are being sold around Australia. This should be a cause for concern. The construction of the grating material can be quite inferior (as seen in this image) and in case of failure the supplier cannot be identified. *Whether the product is locally made or imported is not the issue but compliance to Australian Standard AS3996 2006 certainly is.*

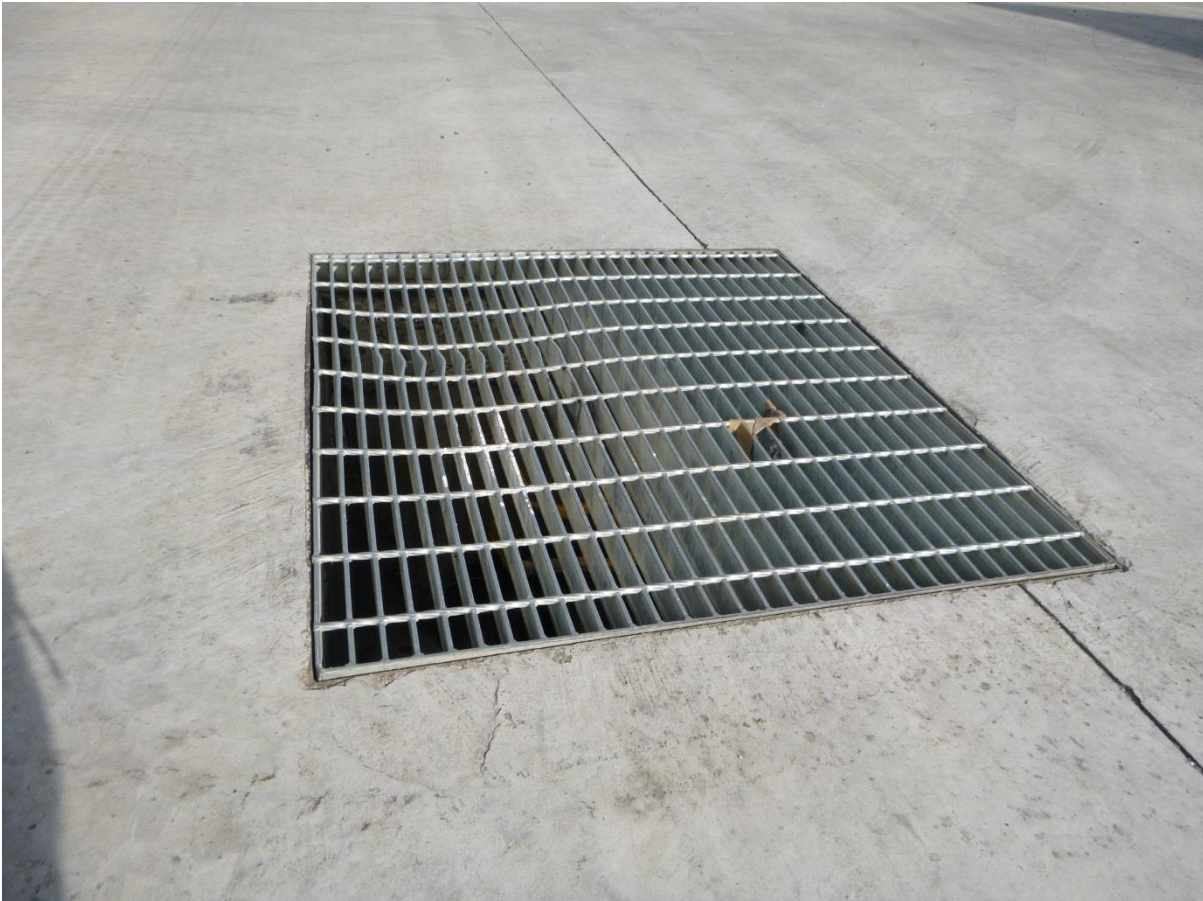
Case Study 9–Multi-Unit Commercial Development–Thomastown

This development contained grates installed from 3 separate manufactures, of which only one brand of grate was AS3996-2006 compliant. The example below of obvious insufficient load capacity, was in a state of failure and unidentifiable by manufacturer.

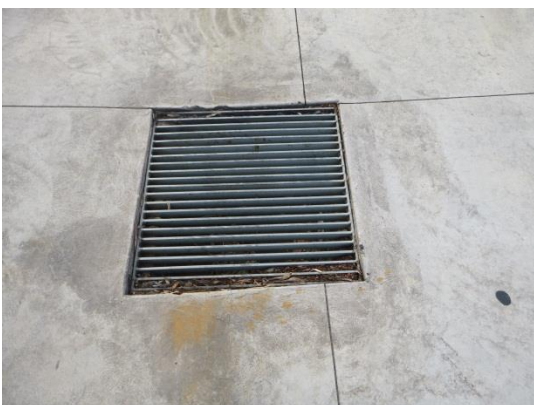
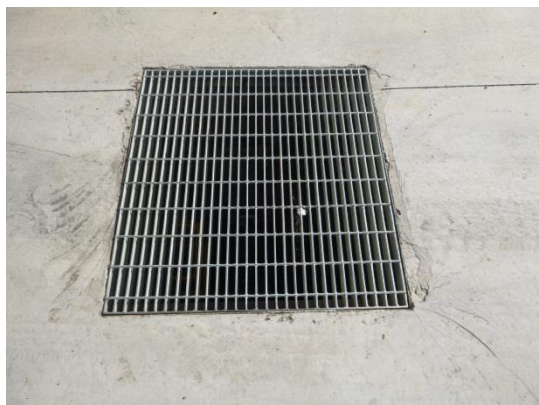
Both grates below were non-compliant and unidentifiable.

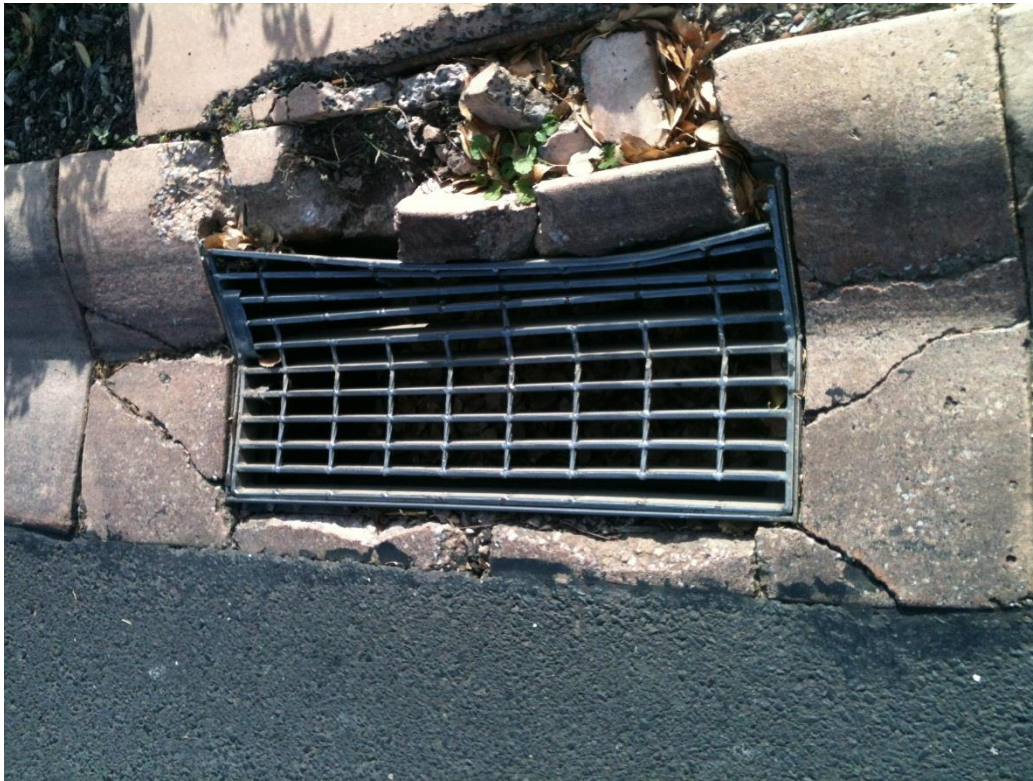
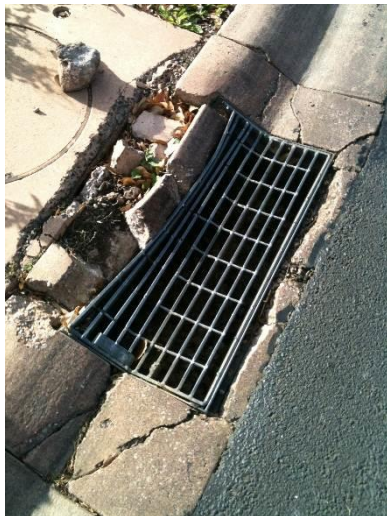
Case Study 10 – Kerb Profile Gully Grate. Sanctuary Lakes Vic

Products of inadequate load capacity will fatigue and deflect under load. In this case we see a bad imitation of an approved product that has deformed dramatically and damaged the surrounding concrete. The original specification was for a Class C grate, It is clear in this image that grate was incapable of being used in any trafficable installation. The cost of reinstatement will be 2-3 times the original cost of installation.

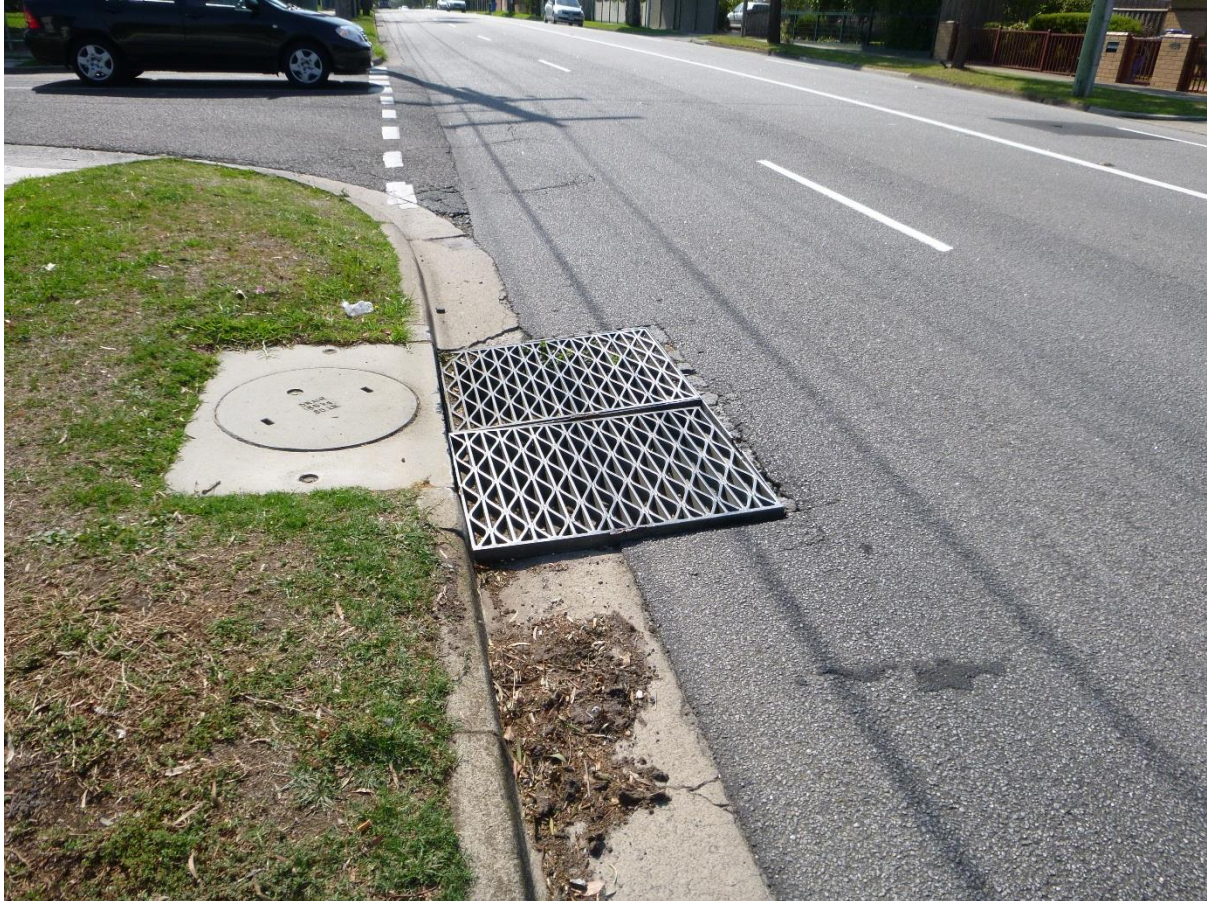
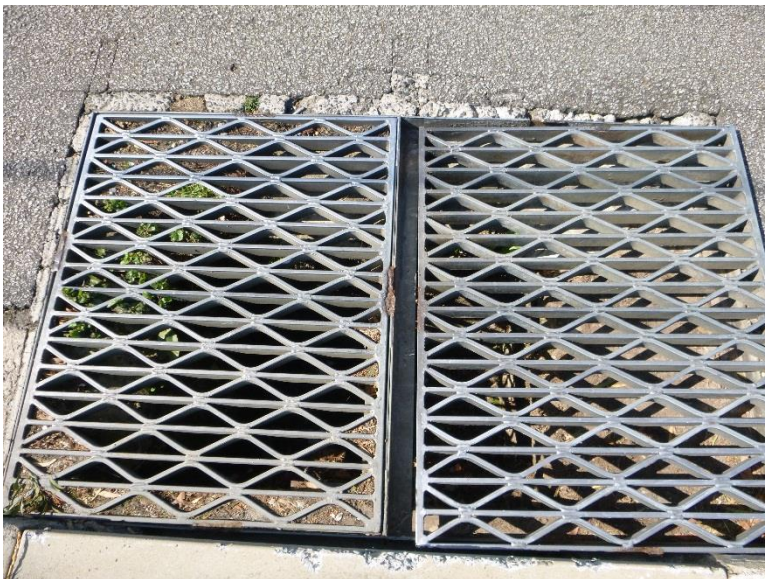
Case Study 11-Gully Grate-Vic

The installation below is a retro fit situation that has been poorly designed. The grate frames have experienced fatigue at the centre support and the grates dislodged from the frame.

The effect, had it not immediately been reported to council, would have been of, a car or truck completely dislodging the first grate and driving into the pit. These grates were not marked with any manufacturer's name and it would be unclear if they comply to AS3996 - 2006

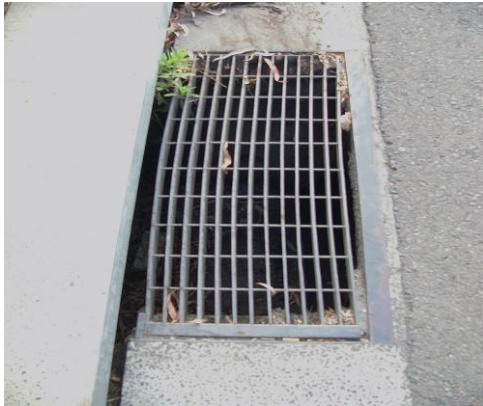
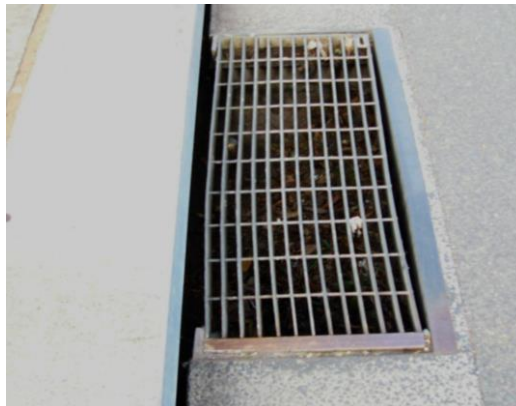
Case Study 12 – Liverpool CC – NSW

The grates below are imitations of a compliant product, but clearly do not have the load capacity of an AS3996 Class D product or this dramatic deformation would not have occurred in service. The products have no tagging, so the supplier/manufacturer cannot be traced.

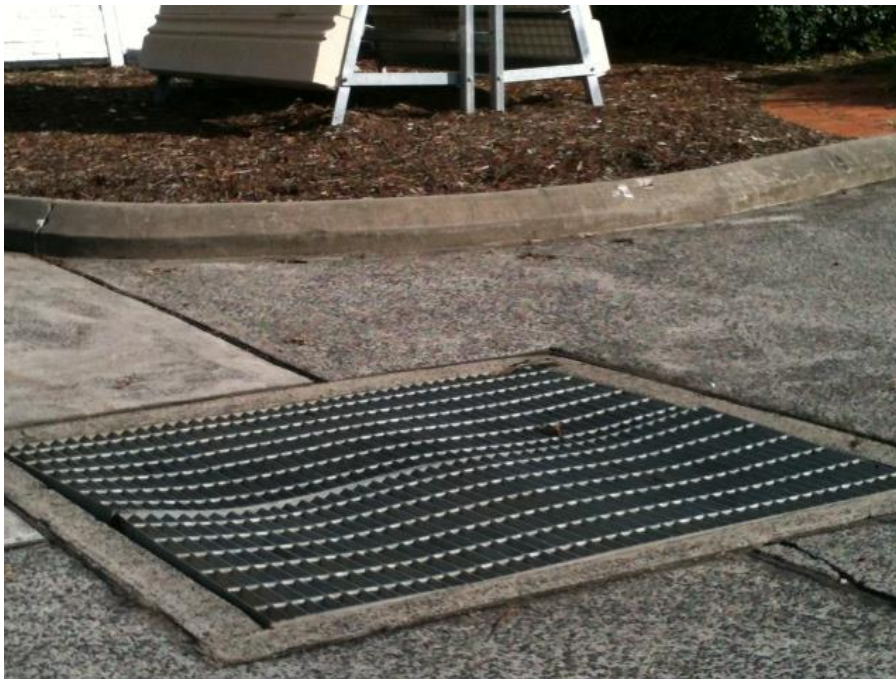
Case Study 13 – Commercial Car park – Tuggerah . NSW

The grate below again demonstrates lack of load carrying capacity for the given span. The grate has deformed dramatically and the expectation will be the failure of the welded cross bars leading to ultimate product failure.
