# *Deepwater Horizon* Accident Investigation Report

September 8, 2010

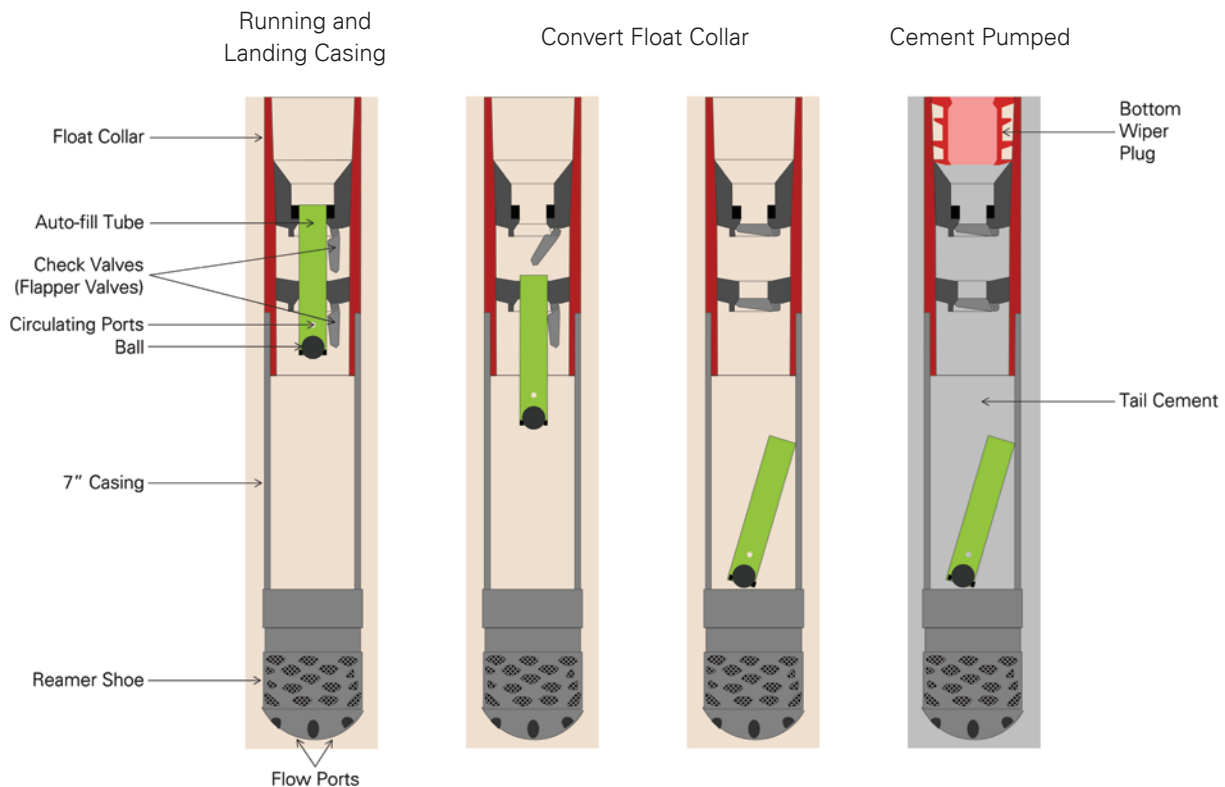
**Figure 5.** Float Collar Conversion.

The BP Macondo well team interpreted the float collar testing after cement placement as successful. This was further documented in the Halliburton post-job report, which indicated that the float collar was holding backpressure. (Backpressure is the difference between hydrostatic pressure in the annulus and hydrostatic pressure inside the casing, which results from different fluid densities and heights.) However, the investigation team concluded that, with the 38 psi backpressure predicted in the Halliburton April 18, 2010, OptiCem™ program, the backpressure test that was conducted was not a reliable indicator that the float collar sealed.

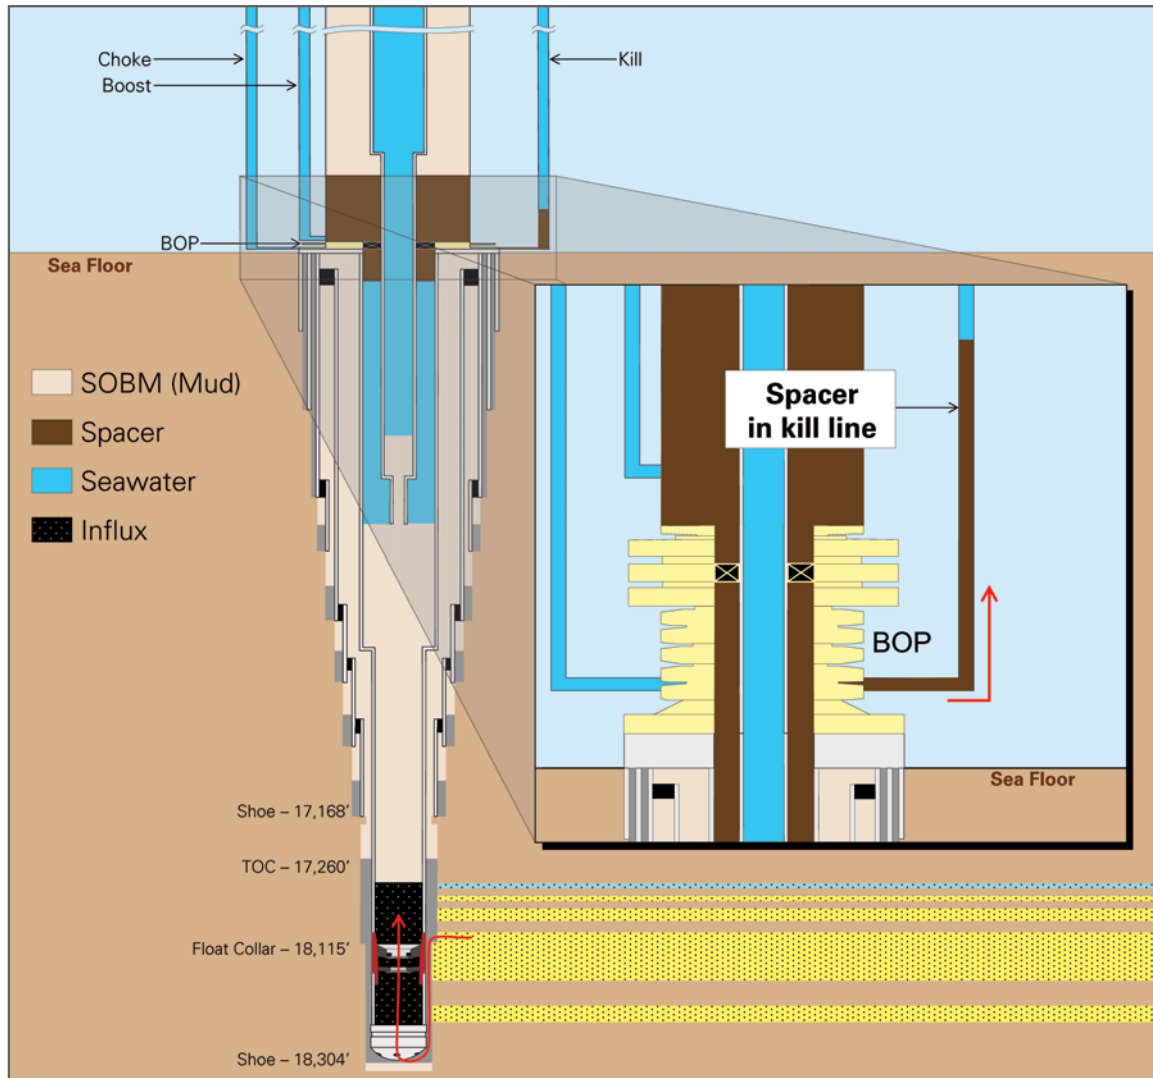
**Figure 3.** Possible Movement of Spacer into Kill Line.

As previously discussed in *2.2 Displaced Mud to Seawater* of this analysis, spacer material was unintentionally placed across the kill line at the BOP. At least 3 bbls of highly viscous fluid (occupying approximately 150 ft. in the kill line) could have been drawn into the kill line during this part of the test. (Refer to Figure 3.)

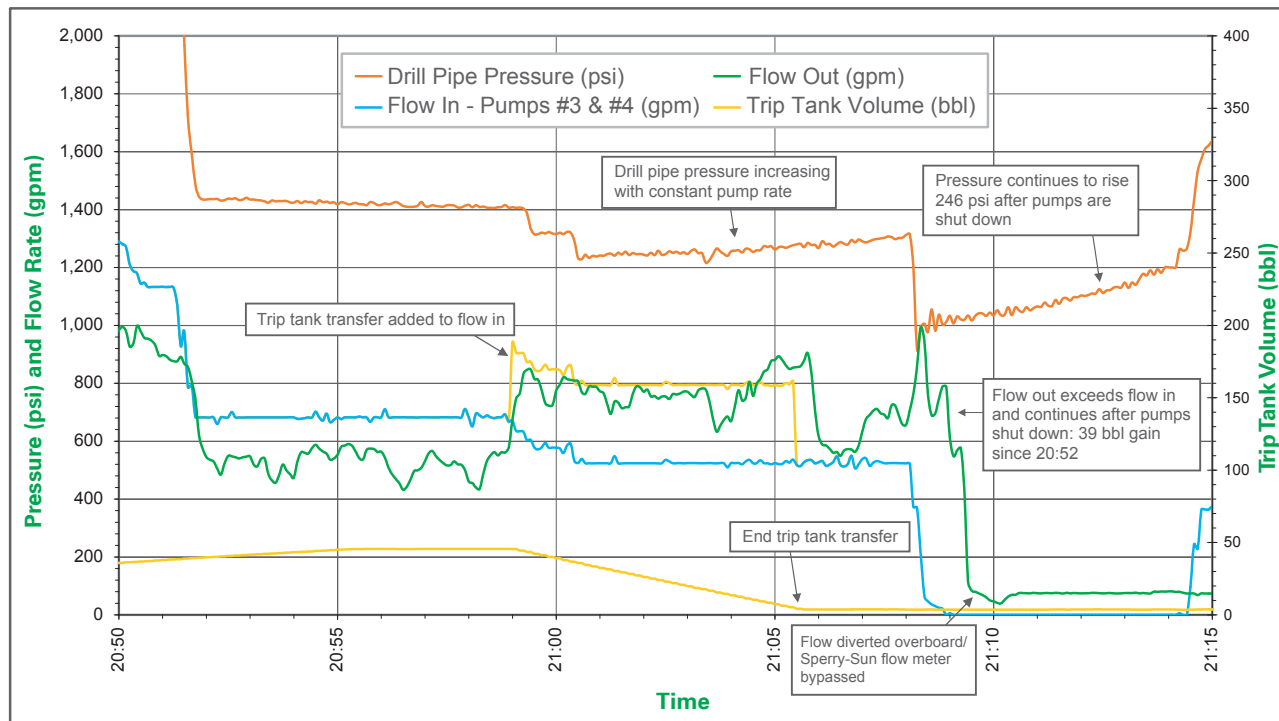
**Figure 8.** Flow Indication Graph Showing Anomalies (Real-time Data).

The first indication of flow likely would have been at 20:58 hours, but emptying of the trip tank could have masked this flow indication in the real-time data. The pressure abnormality starting at 21:01 hours would have been the first clear indication of flow visible to the rig crew and mudloggers.

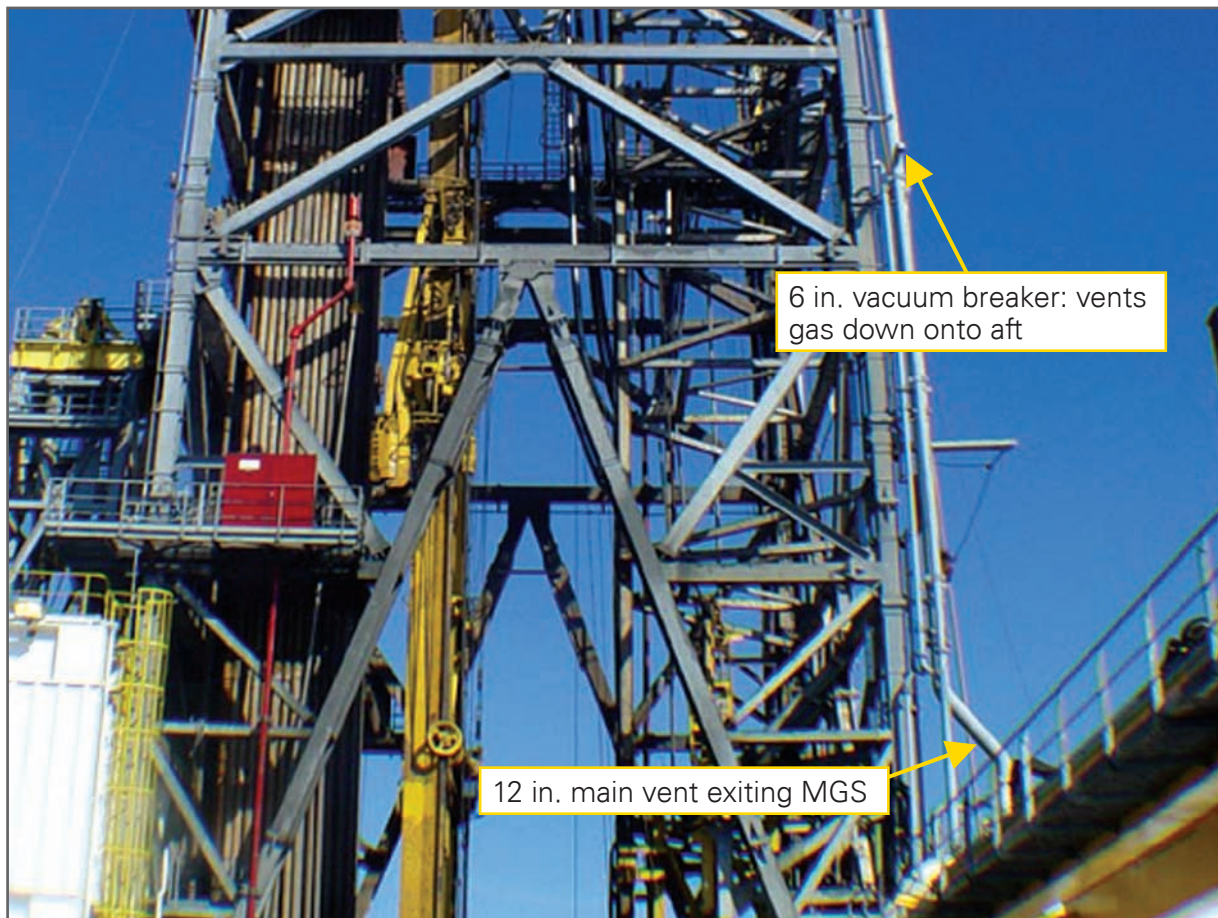
**Figure 5.** Photograph of 6 in. Vacuum Breaker Line Gooseneck Vent.

**6 Diversion to the mud gas separator resulted in gas venting onto the rig.** Once diverted to the MGS, hydrocarbons were vented directly onto the rig through the 12 in. goosenecked vent exiting the MGS, and other flow-lines also directed gas onto the rig. This increased the potential for the gas to reach an ignition source. *The design of the MGS system allowed diversion of the riser contents to the MGS vessel although the well was in a high flow condition. This overwhelmed the MGS system.*
