INTERIM REPORT

Perth Children's Hospital asbestos

An interim report on the discovery of asbestos
within imported atrium roof panel products
used in the construction of the new
Perth Children's Hospital

13 September 2016

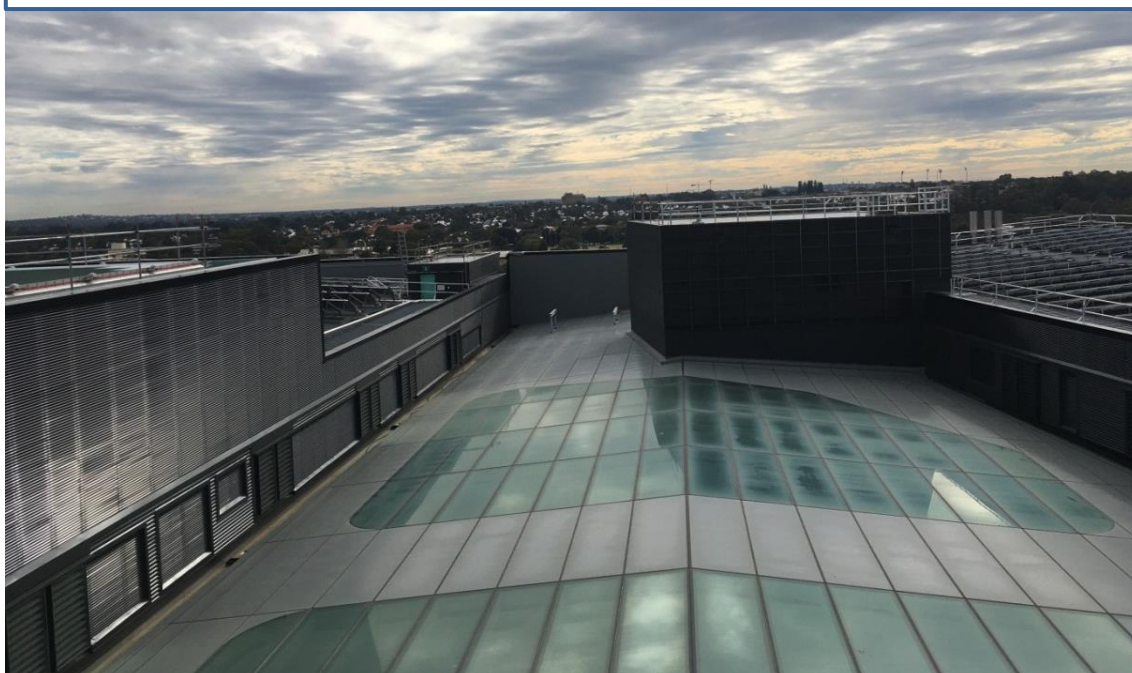
Photograph 1

On Monday 11 July 2016, work was undertaken at the PCH to fit an additional mechanical smoke exhaust fan system into and through the atrium roof section which is constructed with URPs. The URPs were designed as a type of sandwich panel, consisting of a core of SMF insulating batts with two layers of fibre cement sheeting located underneath the batts (see Figure 1). This sheeting was the element that was found to be an ACM. The atrium roof is made up of 174 URPs, restricted to a single area of the hospital roof, located outside of the level seven and level eight link bridges on the north balcony (see Photograph 1).

Unitised roof panels installed at Perth Children's Hospital

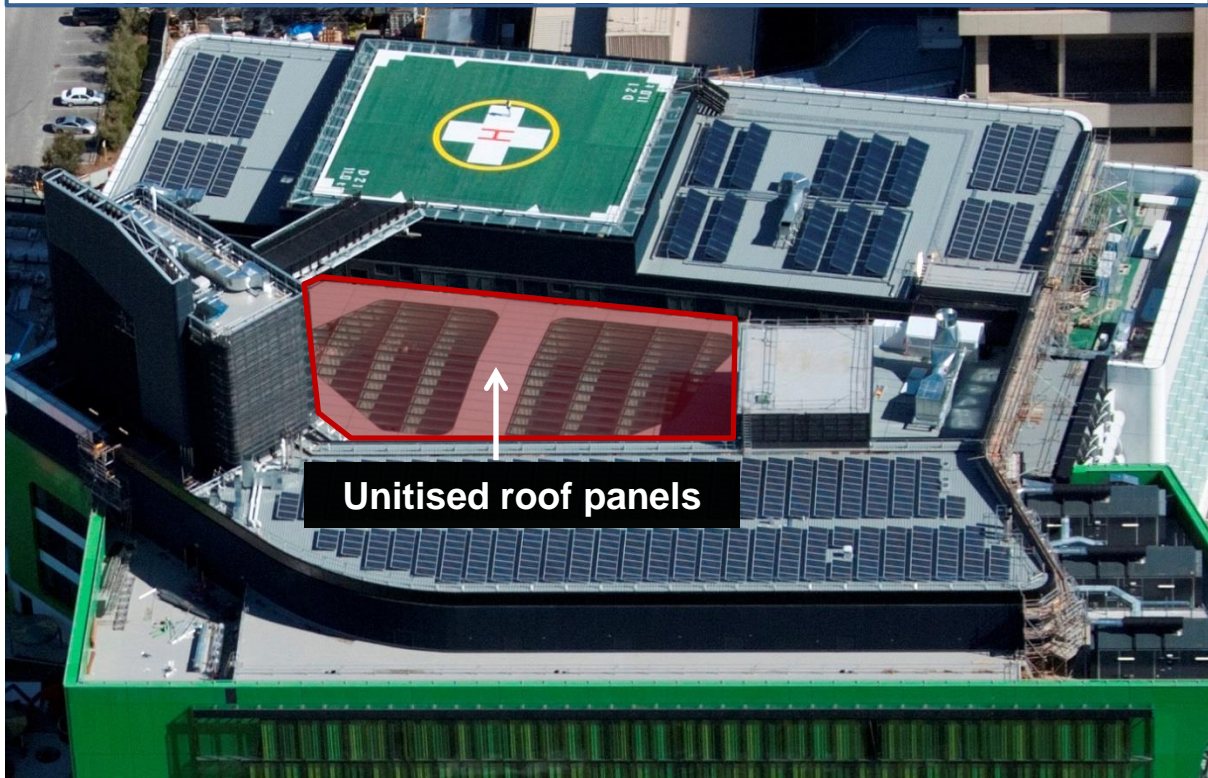
Photograph 2

The URPs are a bespoke design situated immediately adjacent to the roof-top helicopter landing pad, and over the atrium section, and as such, were required to meet a stringent acoustic performance requirement (see Photograph 2).

Helipad at Perth Children's Hospital
