QUALITY SYSTEM COMPLIANCE VENDOR / SUPPLIER AUDIT REPORT

Qantas Airways Limited

**Contracted Maintenance – SIAEC Singapore "D" Check on
Qantas Aircraft VH-OJO V/C: T7105**

AQD Audit ID: 06/SPT/10

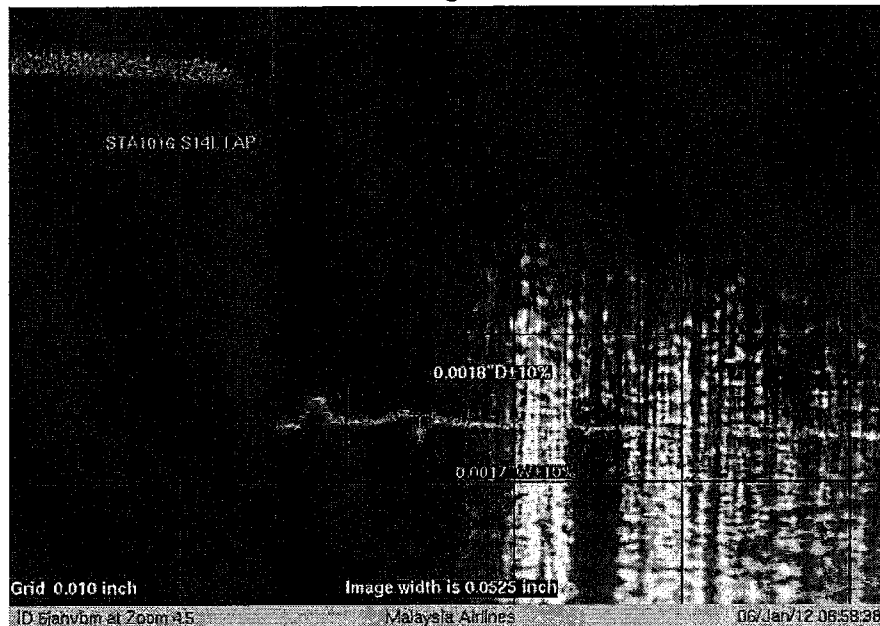
Image 1

2a) The Image shown below (from ID 6thjanvbm) was captured and measured with a software zoom setting of 4.5. This is the requirement of all Boeing documentation for the 1 thou scribe line limit (0.001"). The image CLEARLY showed that the lens WAS NOT set to match the Software setting of 4.5.

The Step in the Lap Joint is approximately 25 thou, (from the grid on the Image). See Drawing 1 below for what this should be.

The above shows the structure of the bonded doubler on a 737 Lap Joint, on the 737-700 each sheet is close to 40 thou in thickness, the step should therefore be in the order of 80 thou, NOT 25 thou as per **Image 1**.

It is my considered opinion that this error should have been rapidly noted by the personal conducting the Inspection. Also QC at MAS should have detected the error.

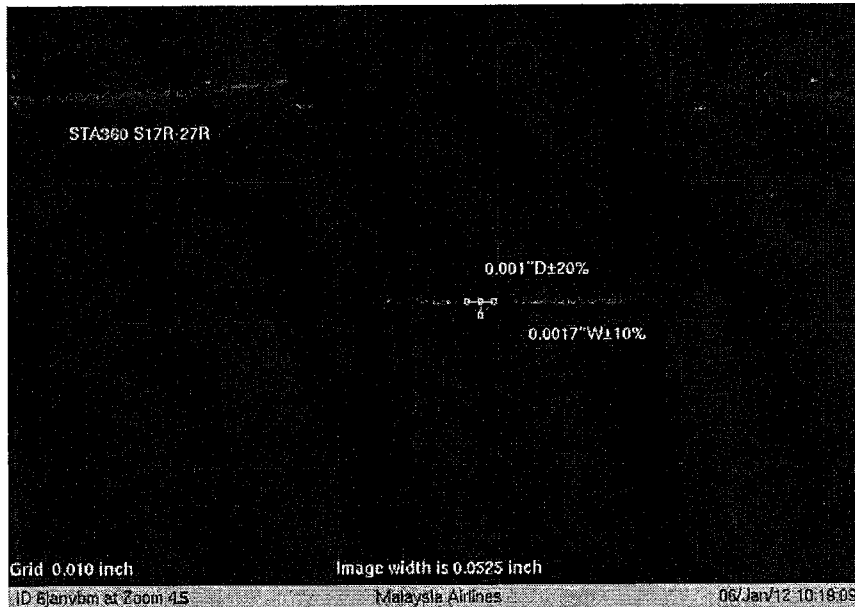
Image 2

2b) A second fundamental error can be established via the image below.

To clearly see the problem requires the detail of the measurements to be enlarged.

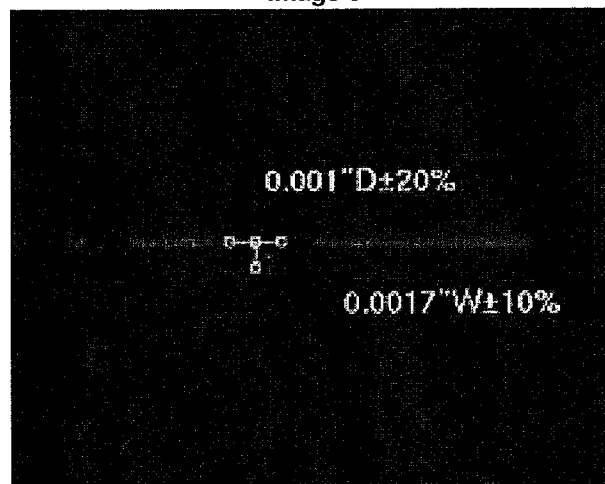
The errors in the above Image 3 are:-

The use of "D" is NOT recommended. (The "D" command was used in Image 3; the small square at the junction shows that clearly!)

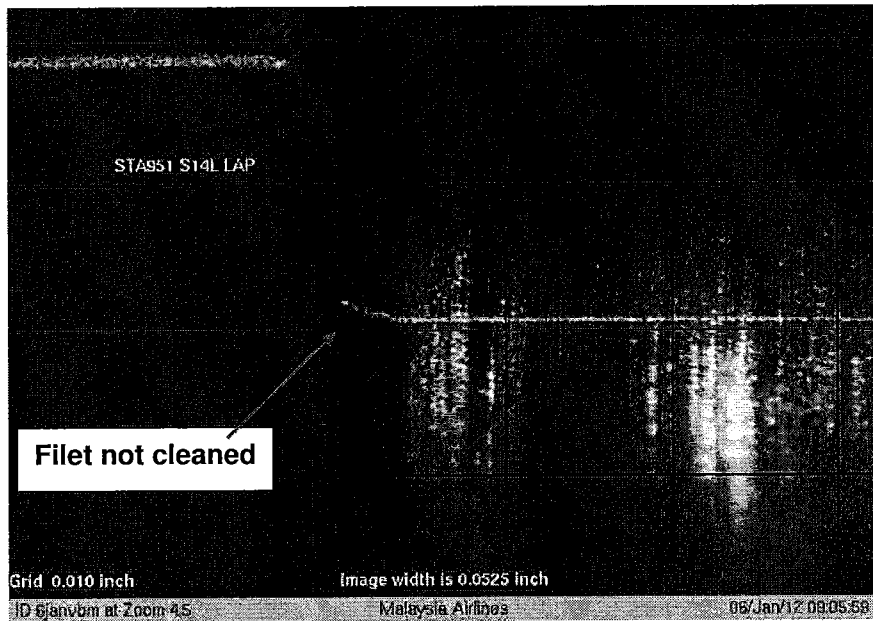
Image 4

The first and most important step in Scribe Line Inspection is Surface Preparation. This was clearly not carried out correctly at MAS for the Jan 6th Inspection. The area that **MUST** be observed very closely, is right up to the edge of the Lap Joint! The Sealing Filet must be removed. The Image below shows that was not the case. The image clearly shows a substantial amount of the filet still in place. This Image also shows, once again; incorrect setting of the Hardware Zoom. The image magnification should be about 4.3 times larger. This would give a filet of at least 18 thou width. Plenty of room to hide a Scribe Line! On all the areas Inspected on Thurs 1st Mar I carefully checked for this problem. All were clean. The question remains, how was the rest of the Aircraft? This is a concern!

Areas of the Butt points clearly showed a high level of surface working. I believe that NONE of the surfaces that I saw on the 1st Mar were the same surfaces as per the Jan 6th Inspection. Very substantial "Cleaning" had occurred since 6th Jan.

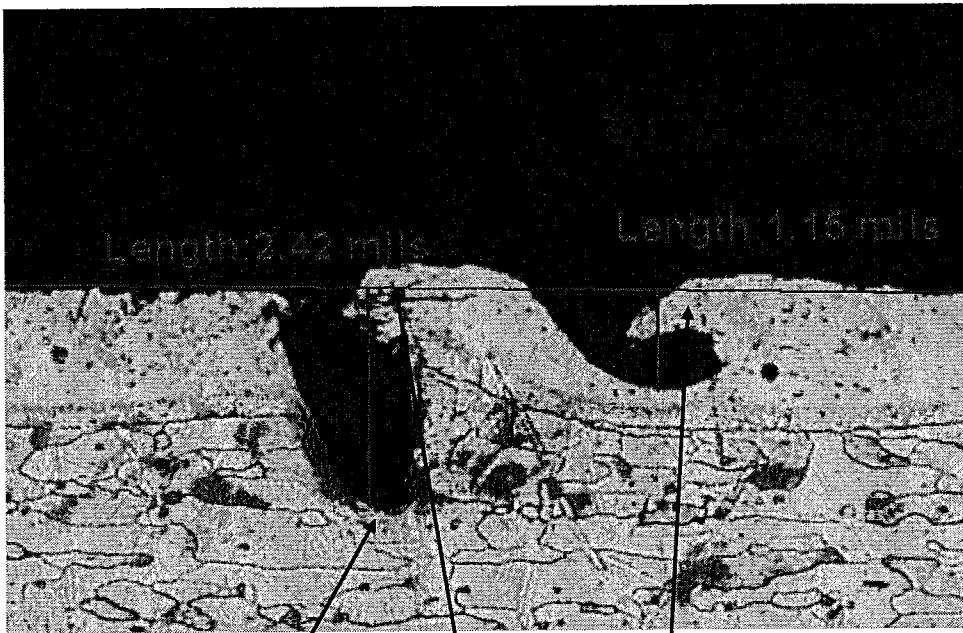
Image 6

**Contamination of Scribe
Impossible to Clean**

Folded Lands

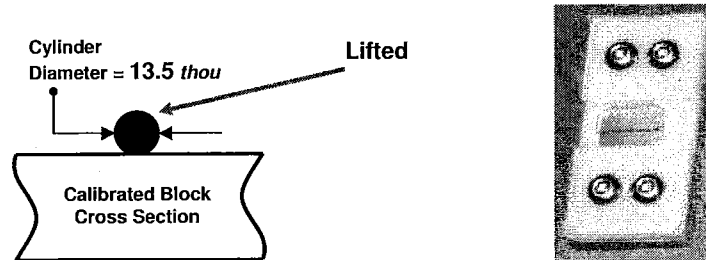
a)
On first testing the Calibration Block S/N 197 was found to be faulty! It should have been 13.5 thou (WORST CASE +/- 3%) It was measured to be 14.1 thou! This is an error of over +4%. The block showed no sign of physical damage, but on close inspection it was found that the 13.5 thou steel wire had a "bow" in it, lifting it about 0.6 thou of the surface. The block cannot be easily repaired and was therefore destroyed! (As per the internal QC requirements of both STTR and Hextronics).

A new Calibration Block was manufactured, S/N 421.

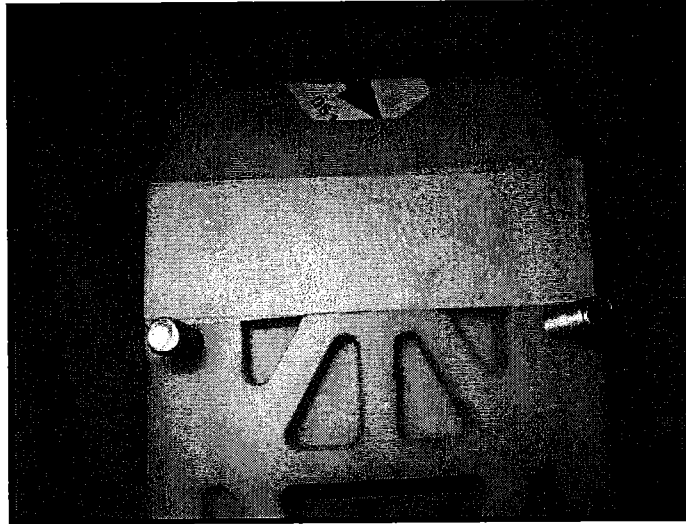
Tape on the Dings Plate!

b)
When we tried to make a Calibration measurement we found that the "Dings" Plate set
had a broken Slider. See below!

I have sought feedback from ST Aerospace as to whether there are any reports the
system was dropped! No reply!
The Slider was replaced!

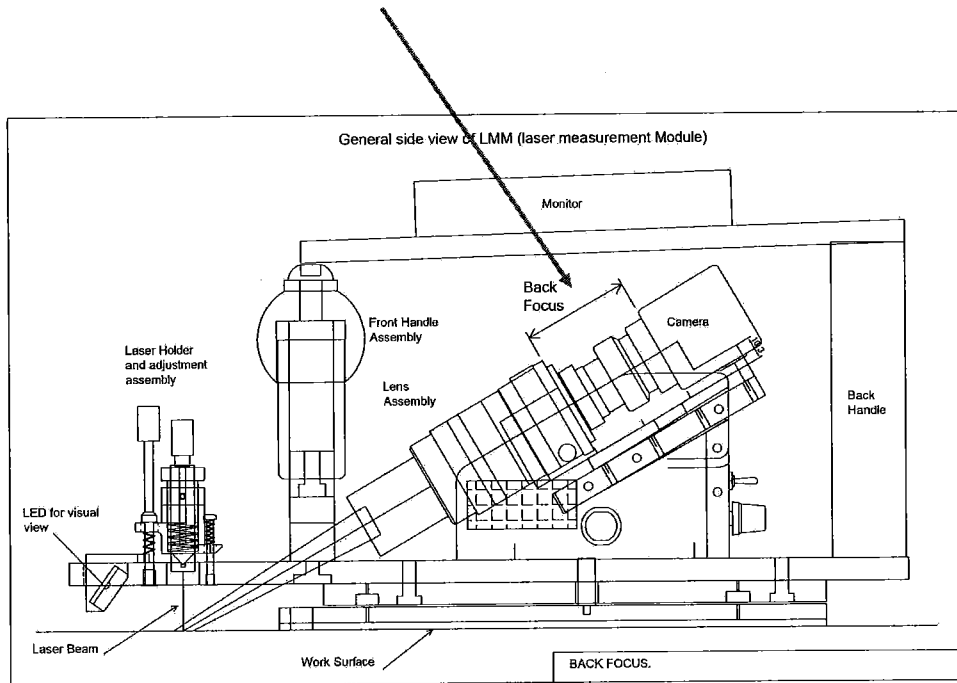
From our internal notes this should have been 50.4mm, I measured 50.9mm on the system as returned. Unfortunately it is not simple to just change this back to 50.4mm. Although we measured 50.4mm during production of this system, the actual dimension is much more critical. It required the lens/camera assembly to be put into our alignment jig! We decided to wait for the new Calibration Block before doing this.

On close inspection it was the Camera that had moved backwards by about 0.5mm. But I found the lock screw to be tight! This suggests a drop or VERY hard knock!

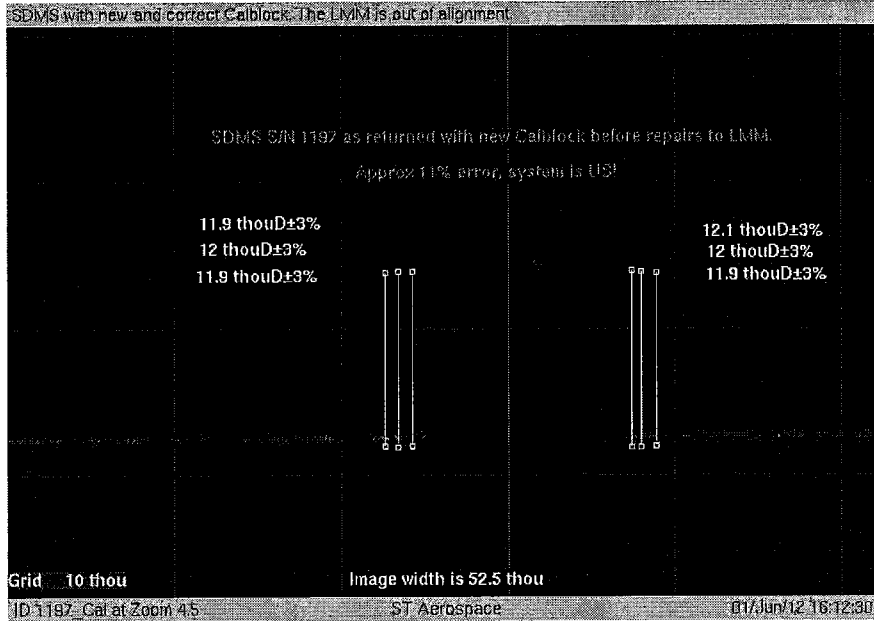
First result with new calblock 421. This is SDMS system AS RETURNED!
 The Calblock 421 was known to be 13.5 thou! Taking 12 thou as the average for the 6
 measurements below we have a measurement error of approximately of 11%.

In this condition the system is Un-Serviceable! And should not be used for an Inspection!

The Lens/Camera was removed, placed in a jig and realigned!
