QUALITY SYSTEM COMPLIANCE VENDOR / SUPPLIER AUDIT REPORT

Qantas Airways Limited

**Contracted Maintenance – SIAEC Singapore "D" Check on
Qantas Aircraft VH-OJO V/C: T7105**

AQD Audit ID: 06/SPT/10

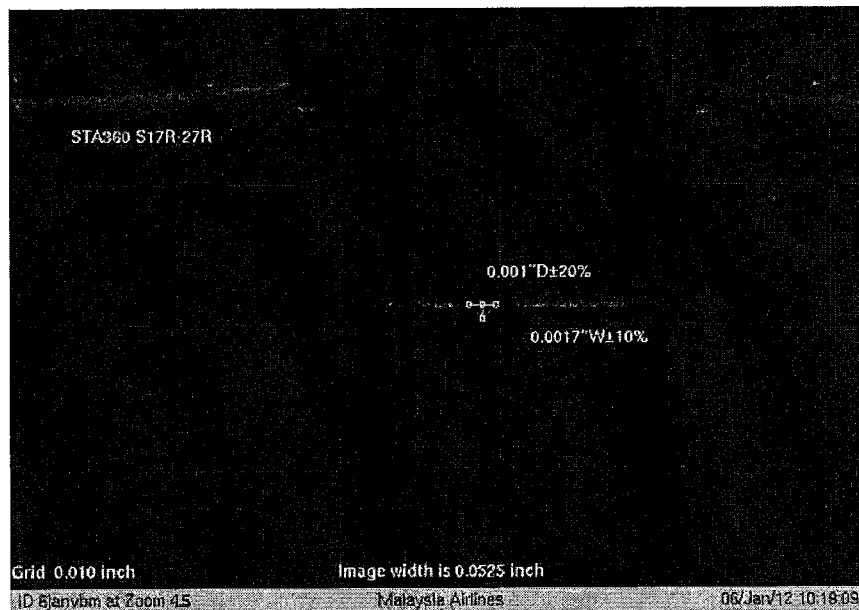
2b) A second fundamental error can be established via the image below.
Image 2

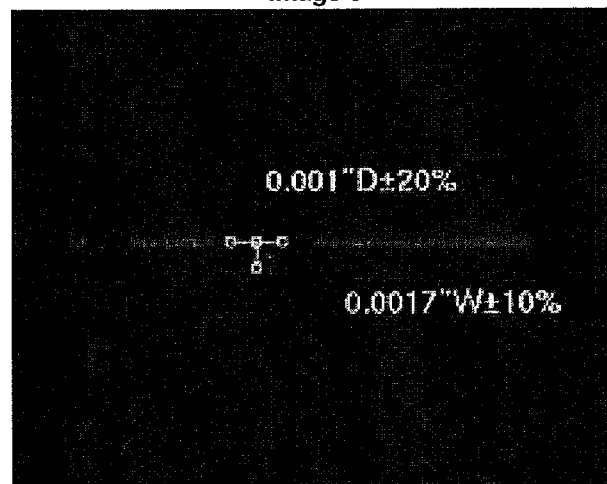
The errors in the above Image 3 are:-

The use of "D" is NOT recommended. (The "D" command was used in Image 3; the small square at the junction shows that clearly!)

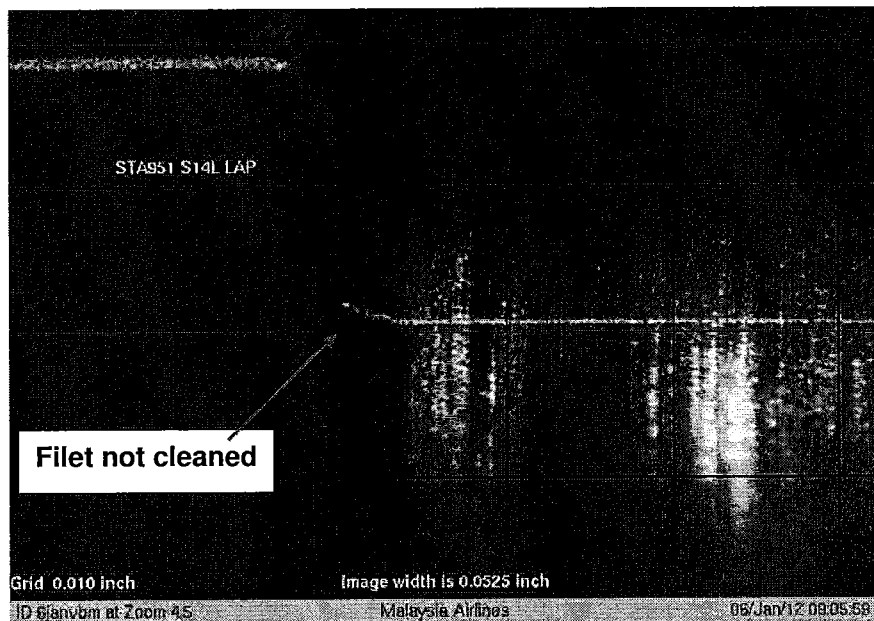
Image 4

The first and most important step in Scribe Line Inspection is Surface Preparation. This was clearly not carried out correctly at MAS for the Jan 6th Inspection. The area that **MUST** be observed very closely, is right up to the edge of the Lap Joint! The Sealing Filet must be removed. The Image below shows that was not the case. The image clearly shows a substantial amount of the filet still in place. This Image also shows, once again; incorrect setting of the Hardware Zoom. The image magnification should be about 4.3 times larger. This would give a filet of at least 18 thou width. Plenty of room to hide a Scribe Line! On all the areas Inspected on Thurs 1st Mar I carefully checked for this problem. All were clean. The question remains, how was the rest of the Aircraft? This is a concern!

Areas of the Butt points clearly showed a high level of surface working. I believe that NONE of the surfaces that I saw on the 1st Mar were the same surfaces as per the Jan 6th Inspection. Very substantial "Cleaning" had occurred since 6th Jan.

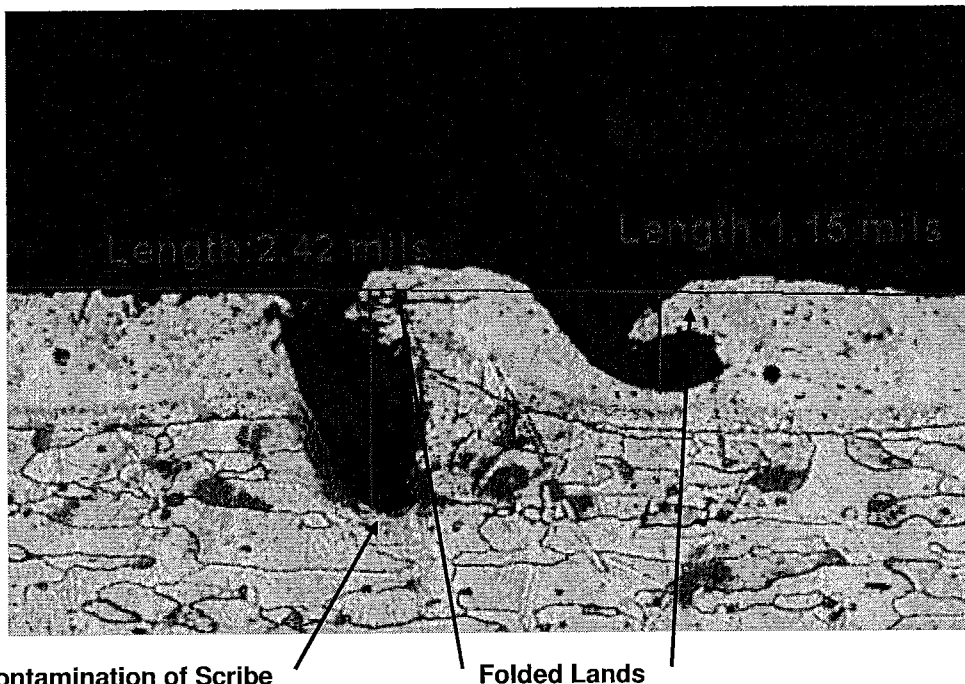
Image 6

**Contamination of Scribe
Impossible to Clean**

Folded Lands

The above image shows why Scotch Brite etc are such a problem. They cause the lands to collapse and fold over. This can trap contaminants in the scribe line as well as moisture. Also the folded lands can prevent the Laser seeing the true bottom. Therefore the depth reading will always be too low! No Scotch Brite is ALWAYS covered in detail during training on the SDMS.

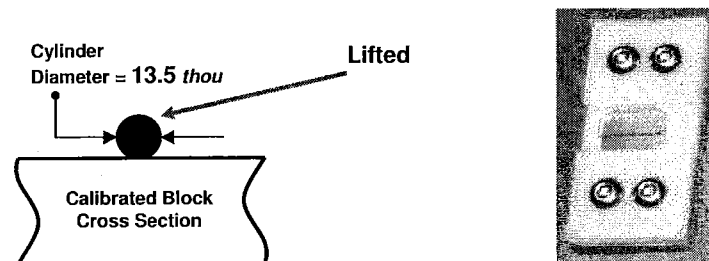
- a)
On first testing the Calibration Block S/N 197 was found to be faulty! It should have been 13.5 thou (WORST CASE +/- 3%) It was measured to be 14.1 thou! This is an error of over +4%. The block showed no sign of physical damage, but on close inspection it was found that the 13.5 thou steel wire had a "bow" in it, lifting it about 0.6 thou of the surface. The block cannot be easily repaired and was therefore destroyed! (As per the internal QC requirements of both STTR and Hextronics).

A new Calibration Block was manufactured, S/N 421.

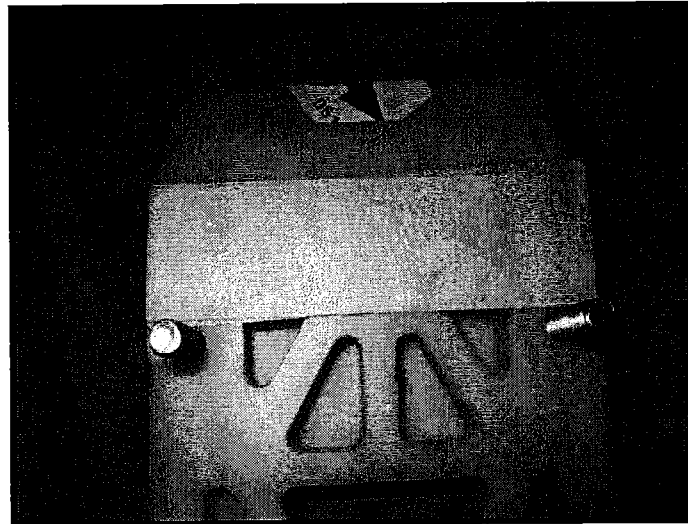
Tape on the Dings Plate!

b)
When we tried to make a Calibration measurement we found that the "Dings" Plate set
had a broken Slider. See below!

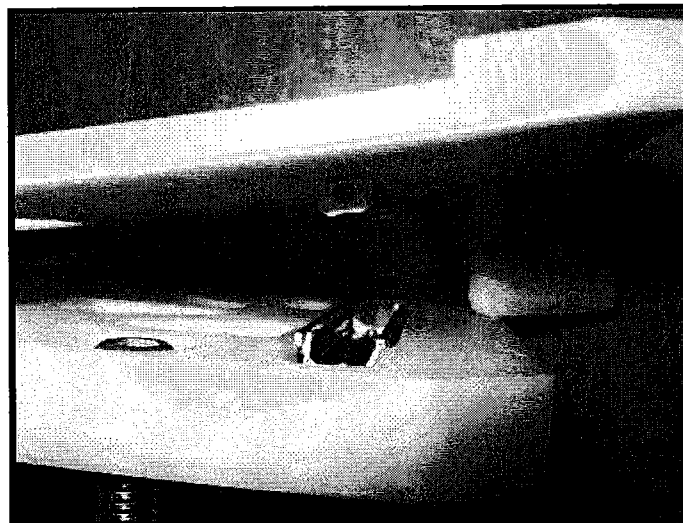
The Broken Slider!

I have sought feedback from ST Aerospace as to whether there are any reports the
system was dropped! No reply!
The Slider was replaced!

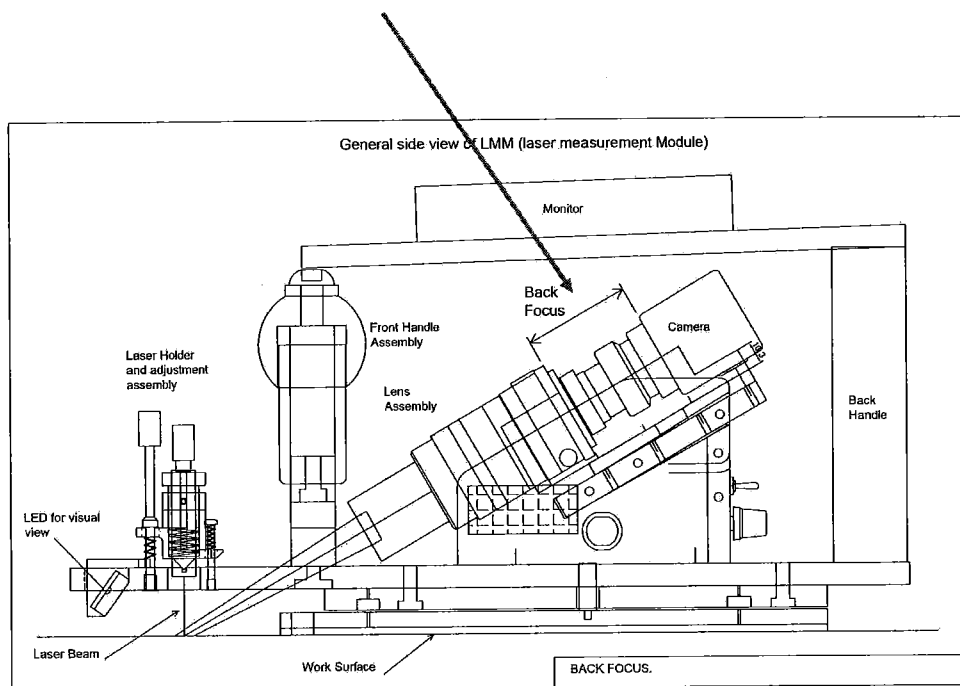
From our internal notes this should have been 50.4mm, I measured 50.9mm on the system as returned. Unfortunately it is not simple to just change this back to 50.4mm. Although we measured 50.4mm during production of this system, the actual dimension is much more critical. It required the lens/camera assembly to be put into our alignment jig! We decided to wait for the new Calibration Block before doing this.

On close inspection it was the Camera that had moved backwards by about 0.5mm. But I found the lock screw to be tight! This suggests a drop or VERY hard knock!

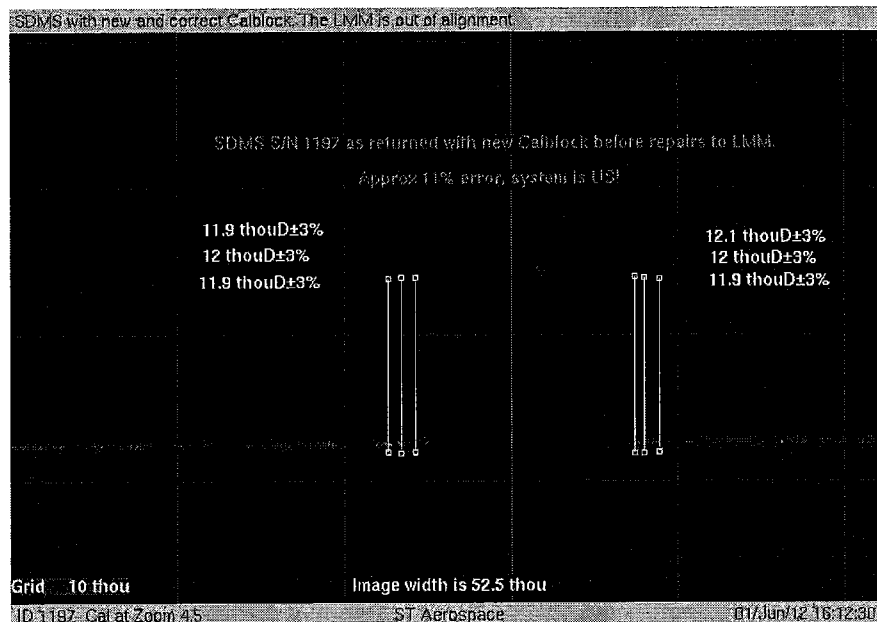
First result with new calblock 421. This is SDMS system AS RETURNED!
The Calblock 421 was known to be 13.5 thou! Taking 12 thou as the average for the 6 measurements below we have a measurement error of approximately of 11%.

In this condition the system is Un-Serviceable! And should not be used for an Inspection!

The Lens/Camera was removed, placed in a jig and realigned!
