HOUSE
232

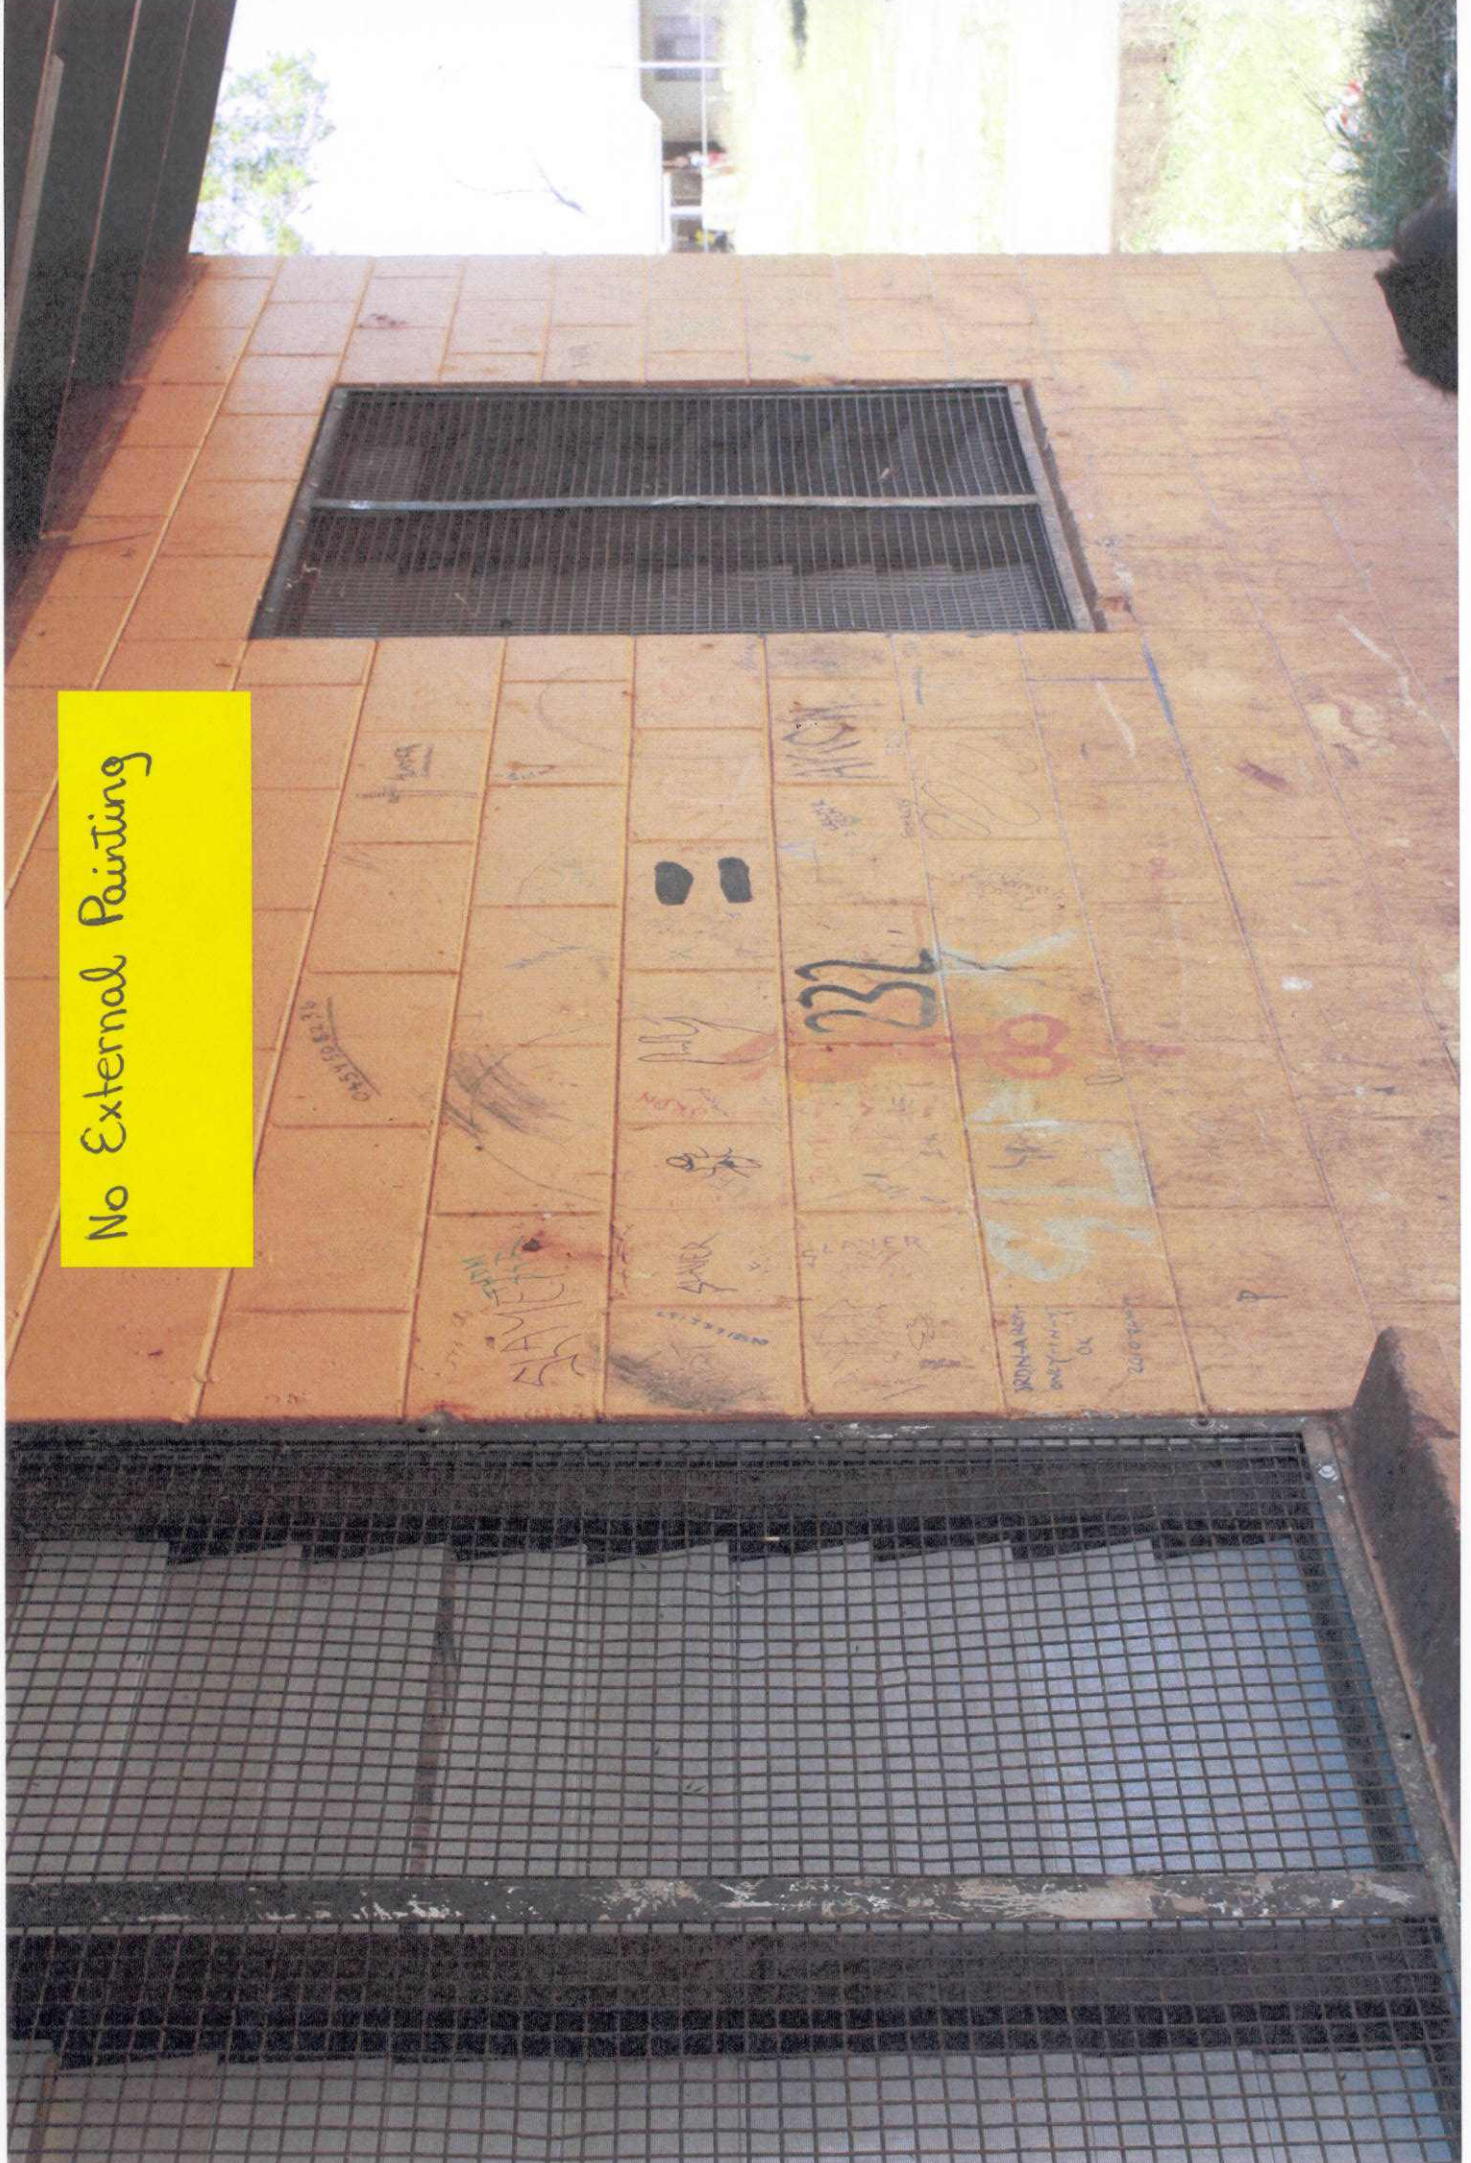
No External Painting

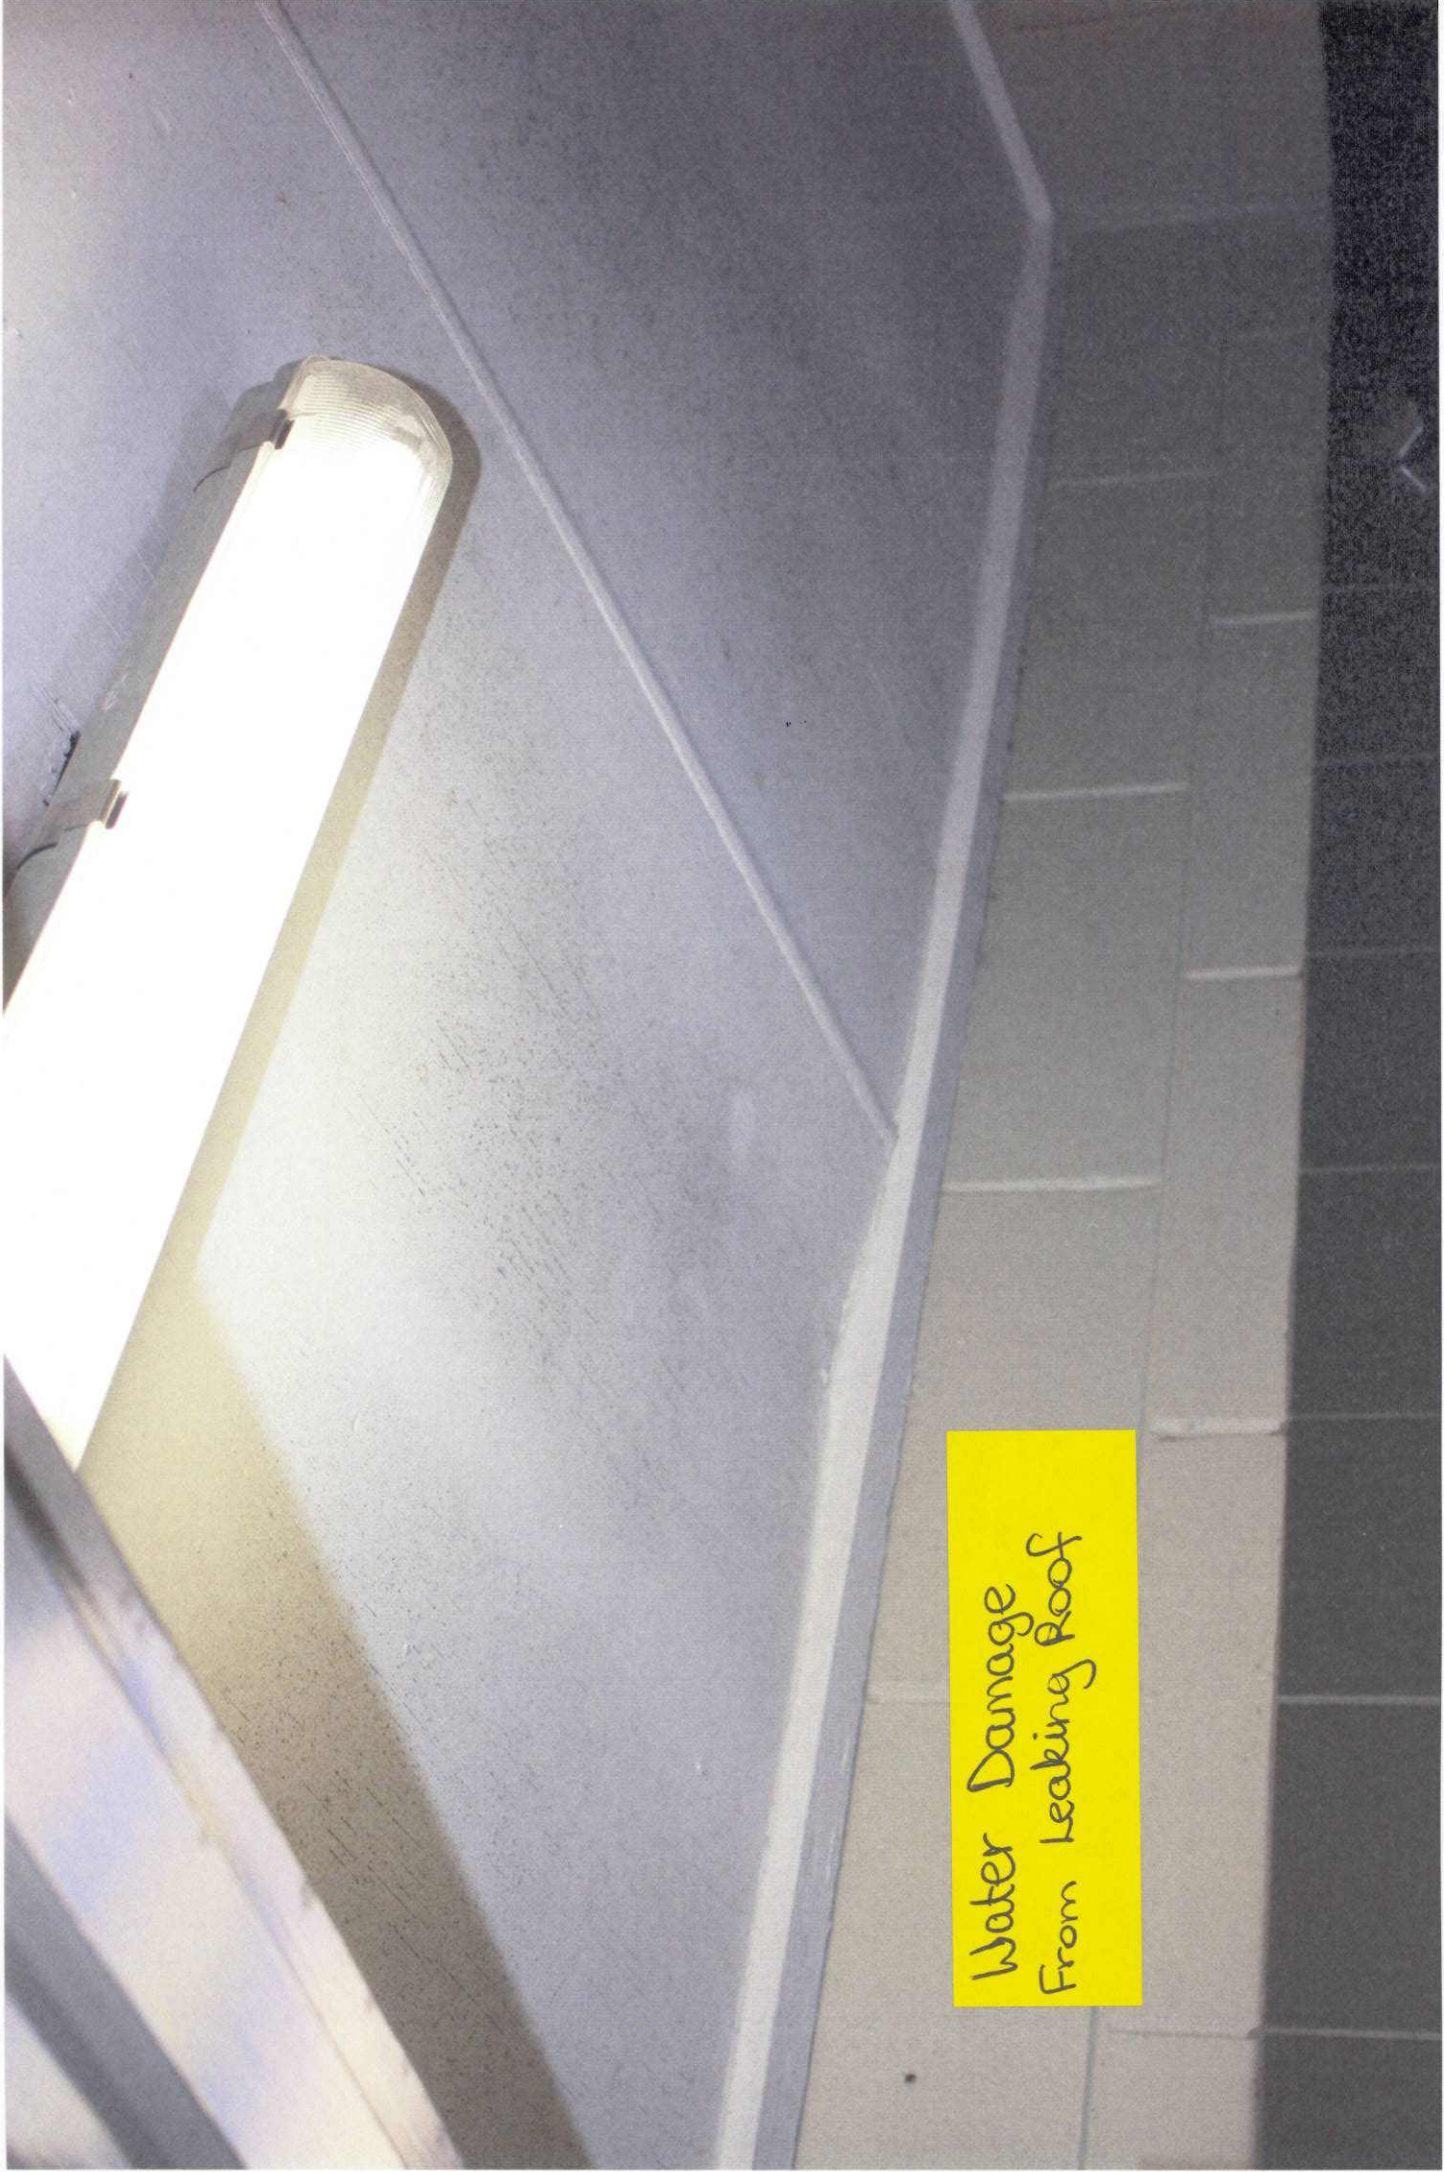
Water Damage
From Leaking Roof

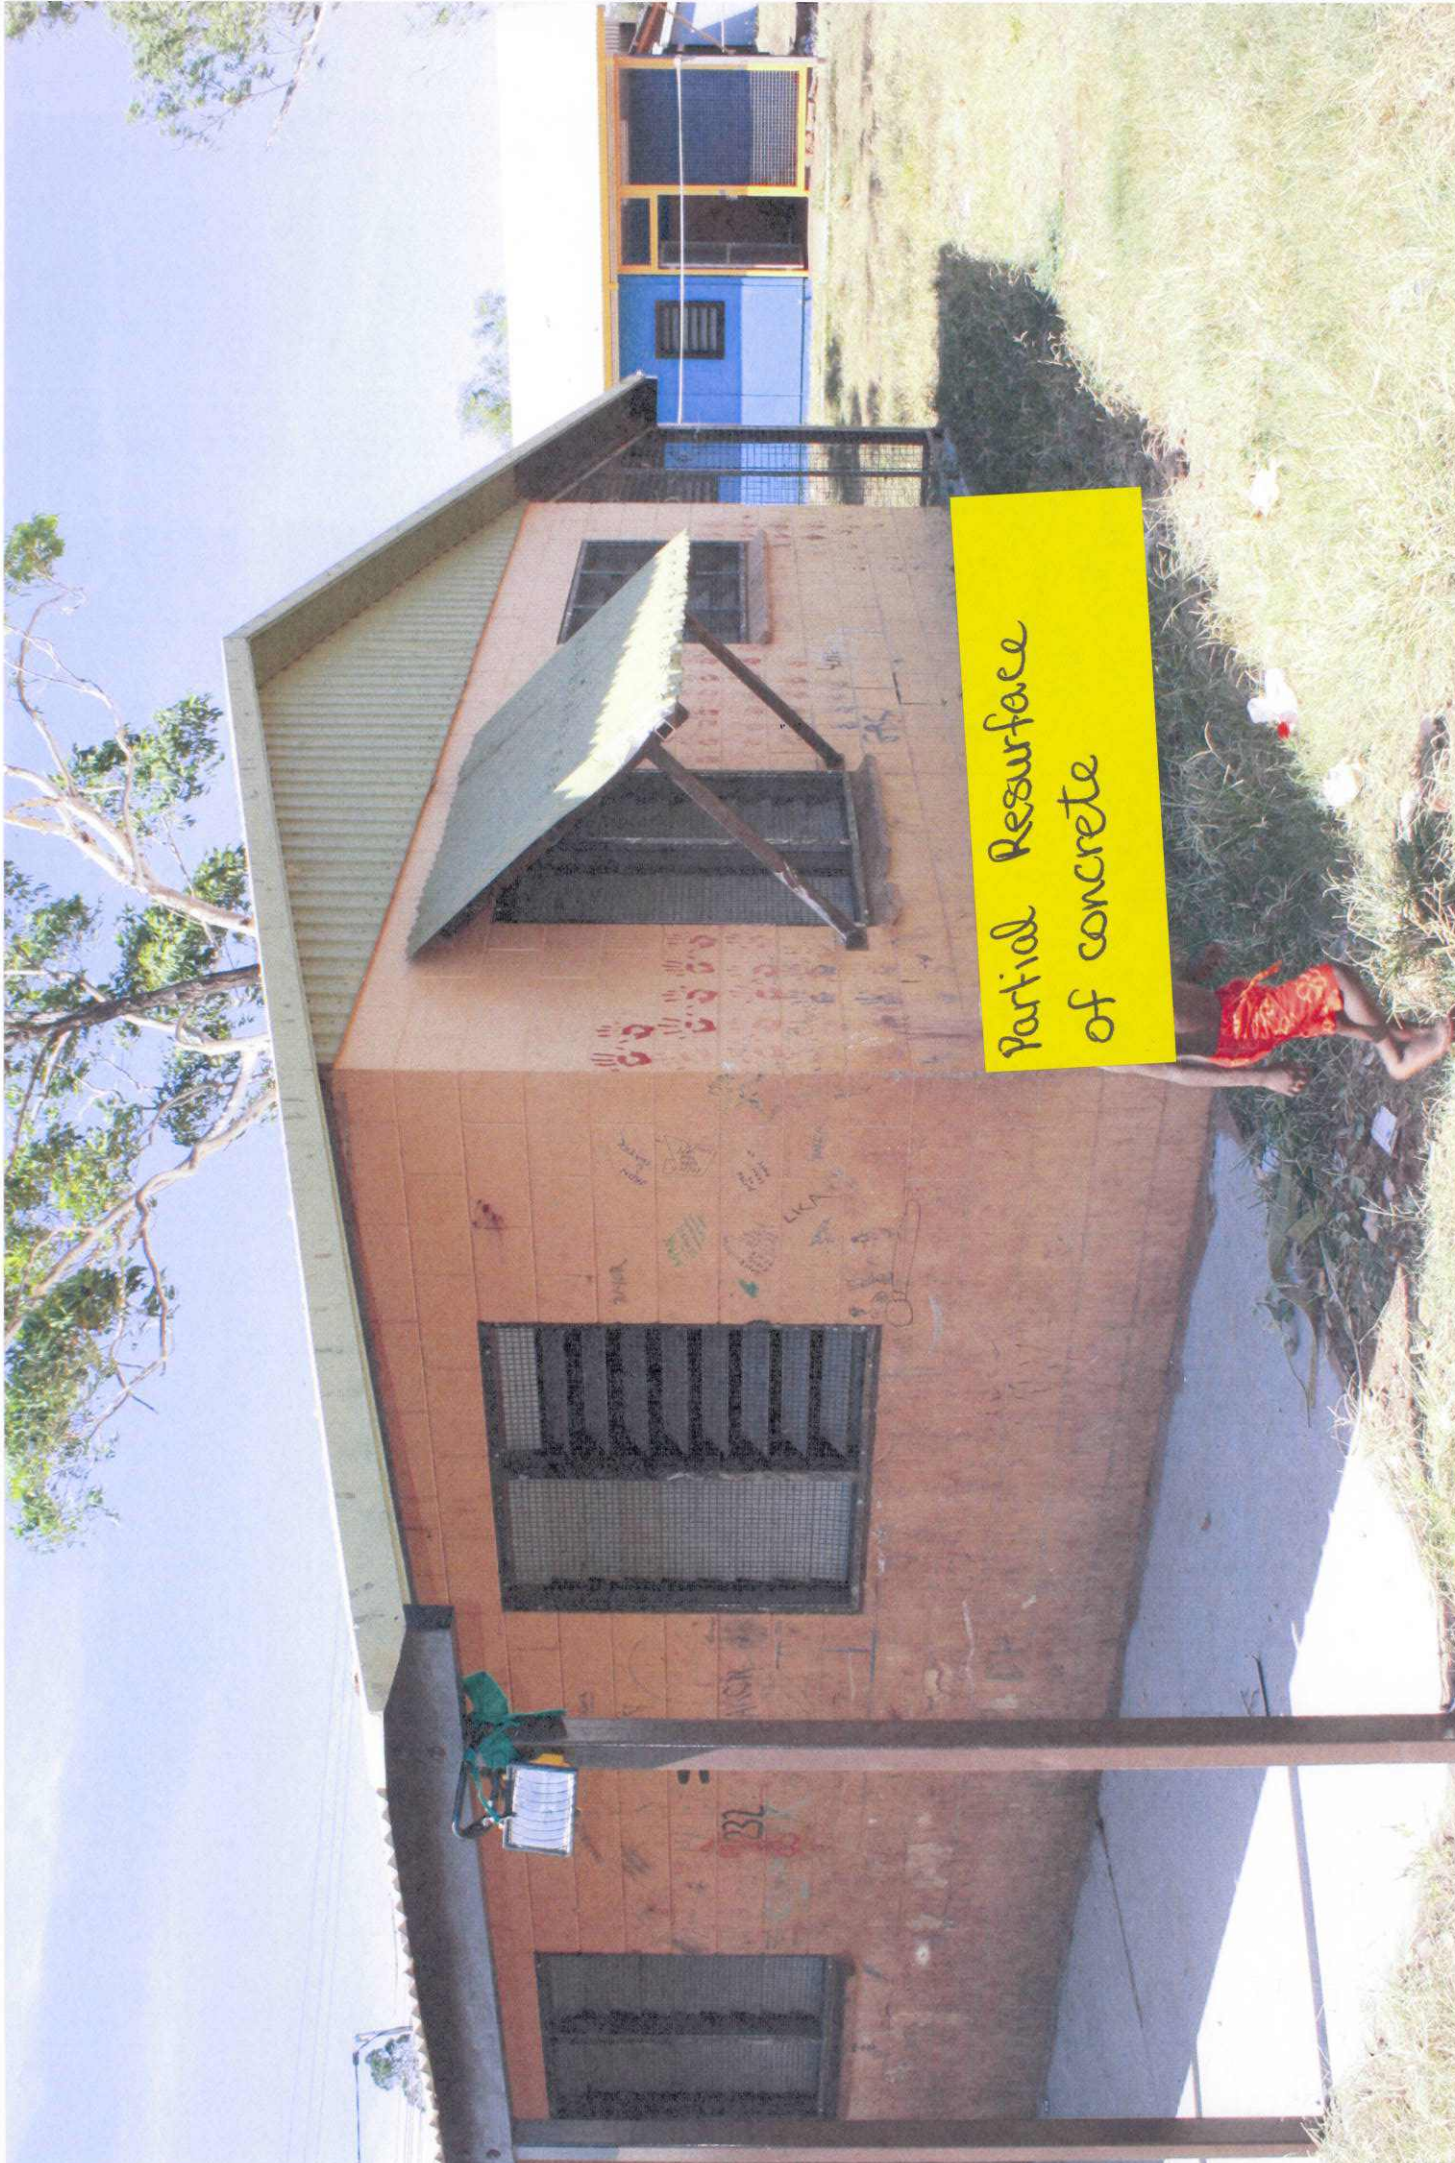
Partial Resurface
of concrete

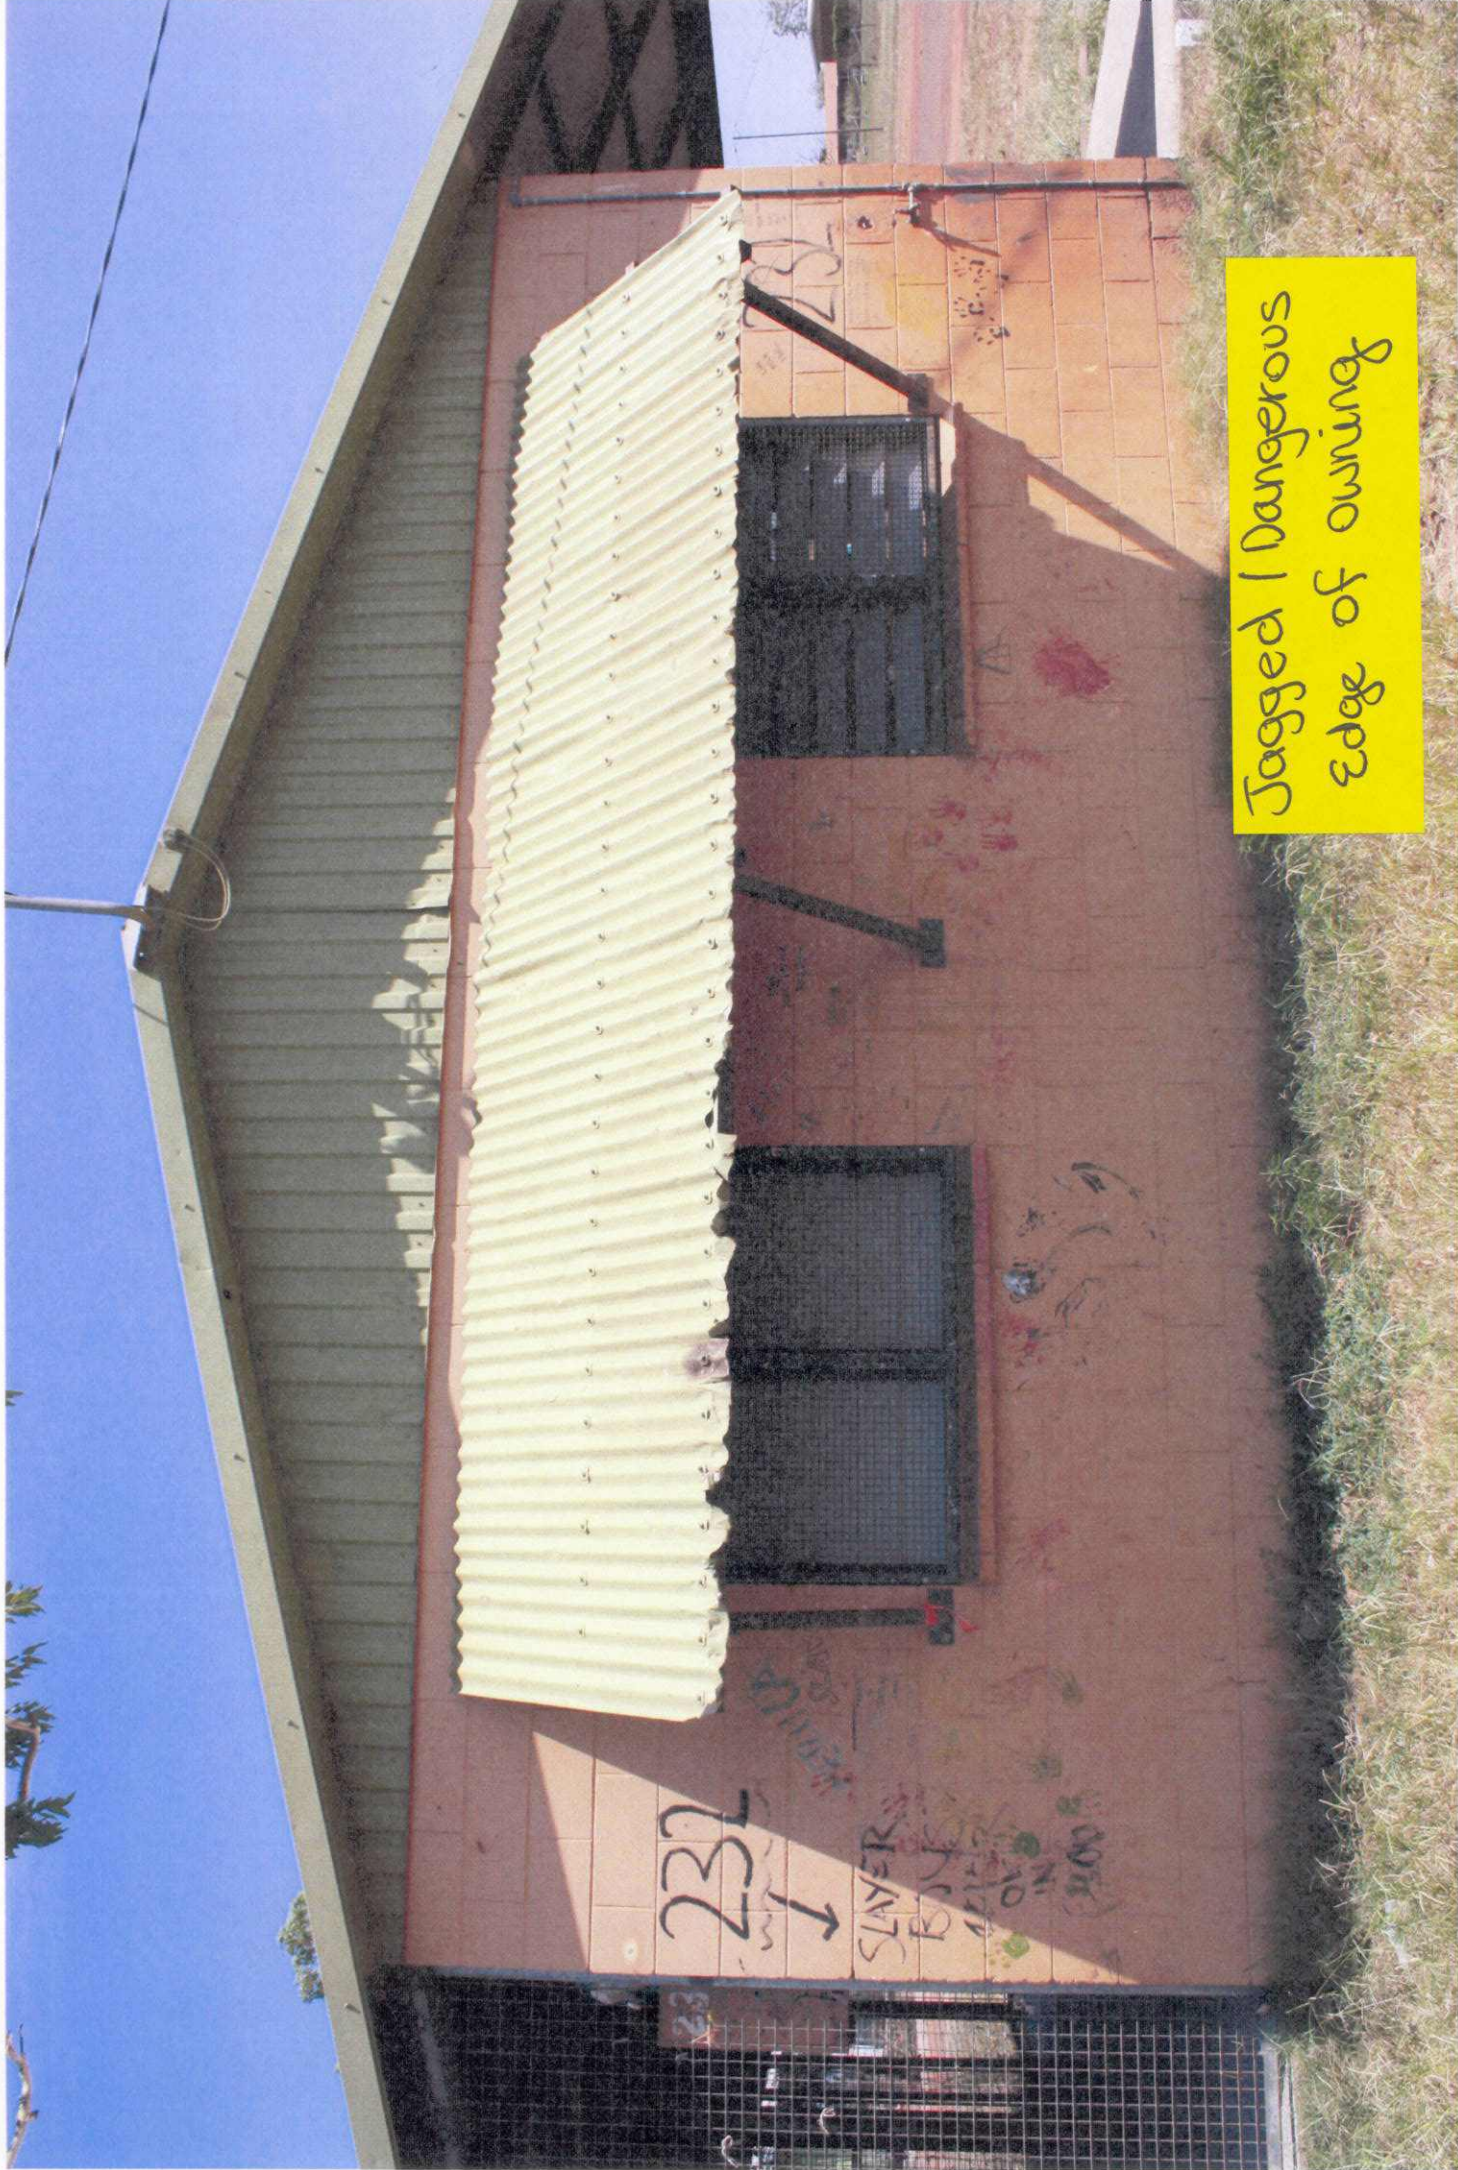
Jagged / Dangerous
Edge of awning

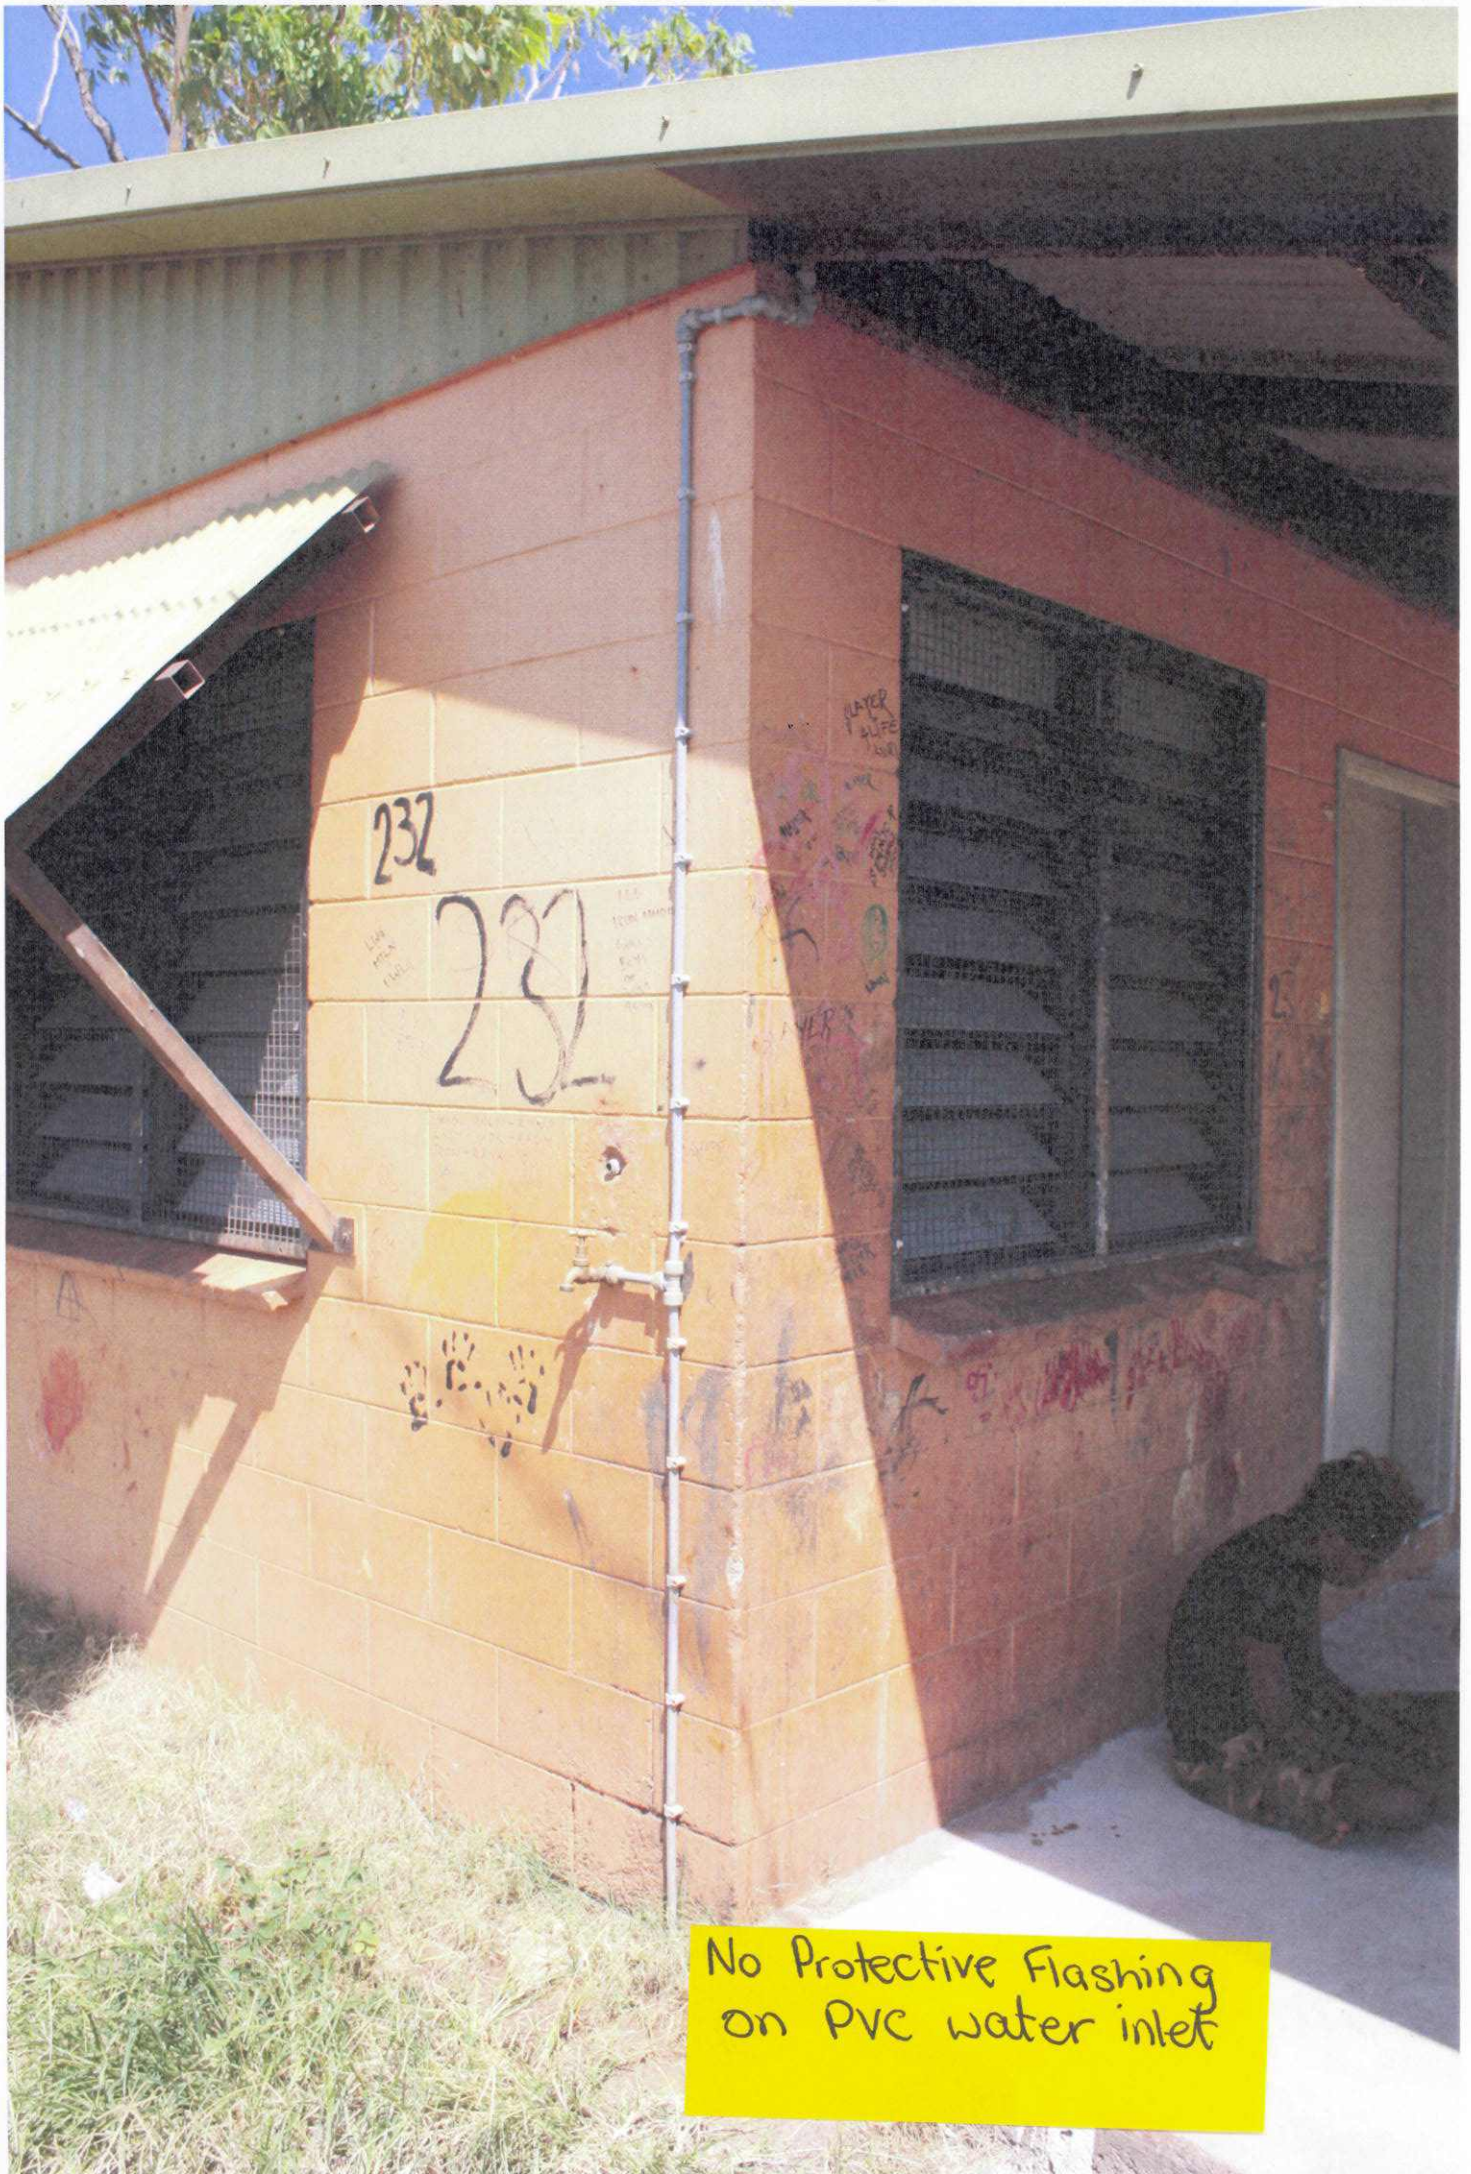
No Protective Flashing
on PVC water inlet

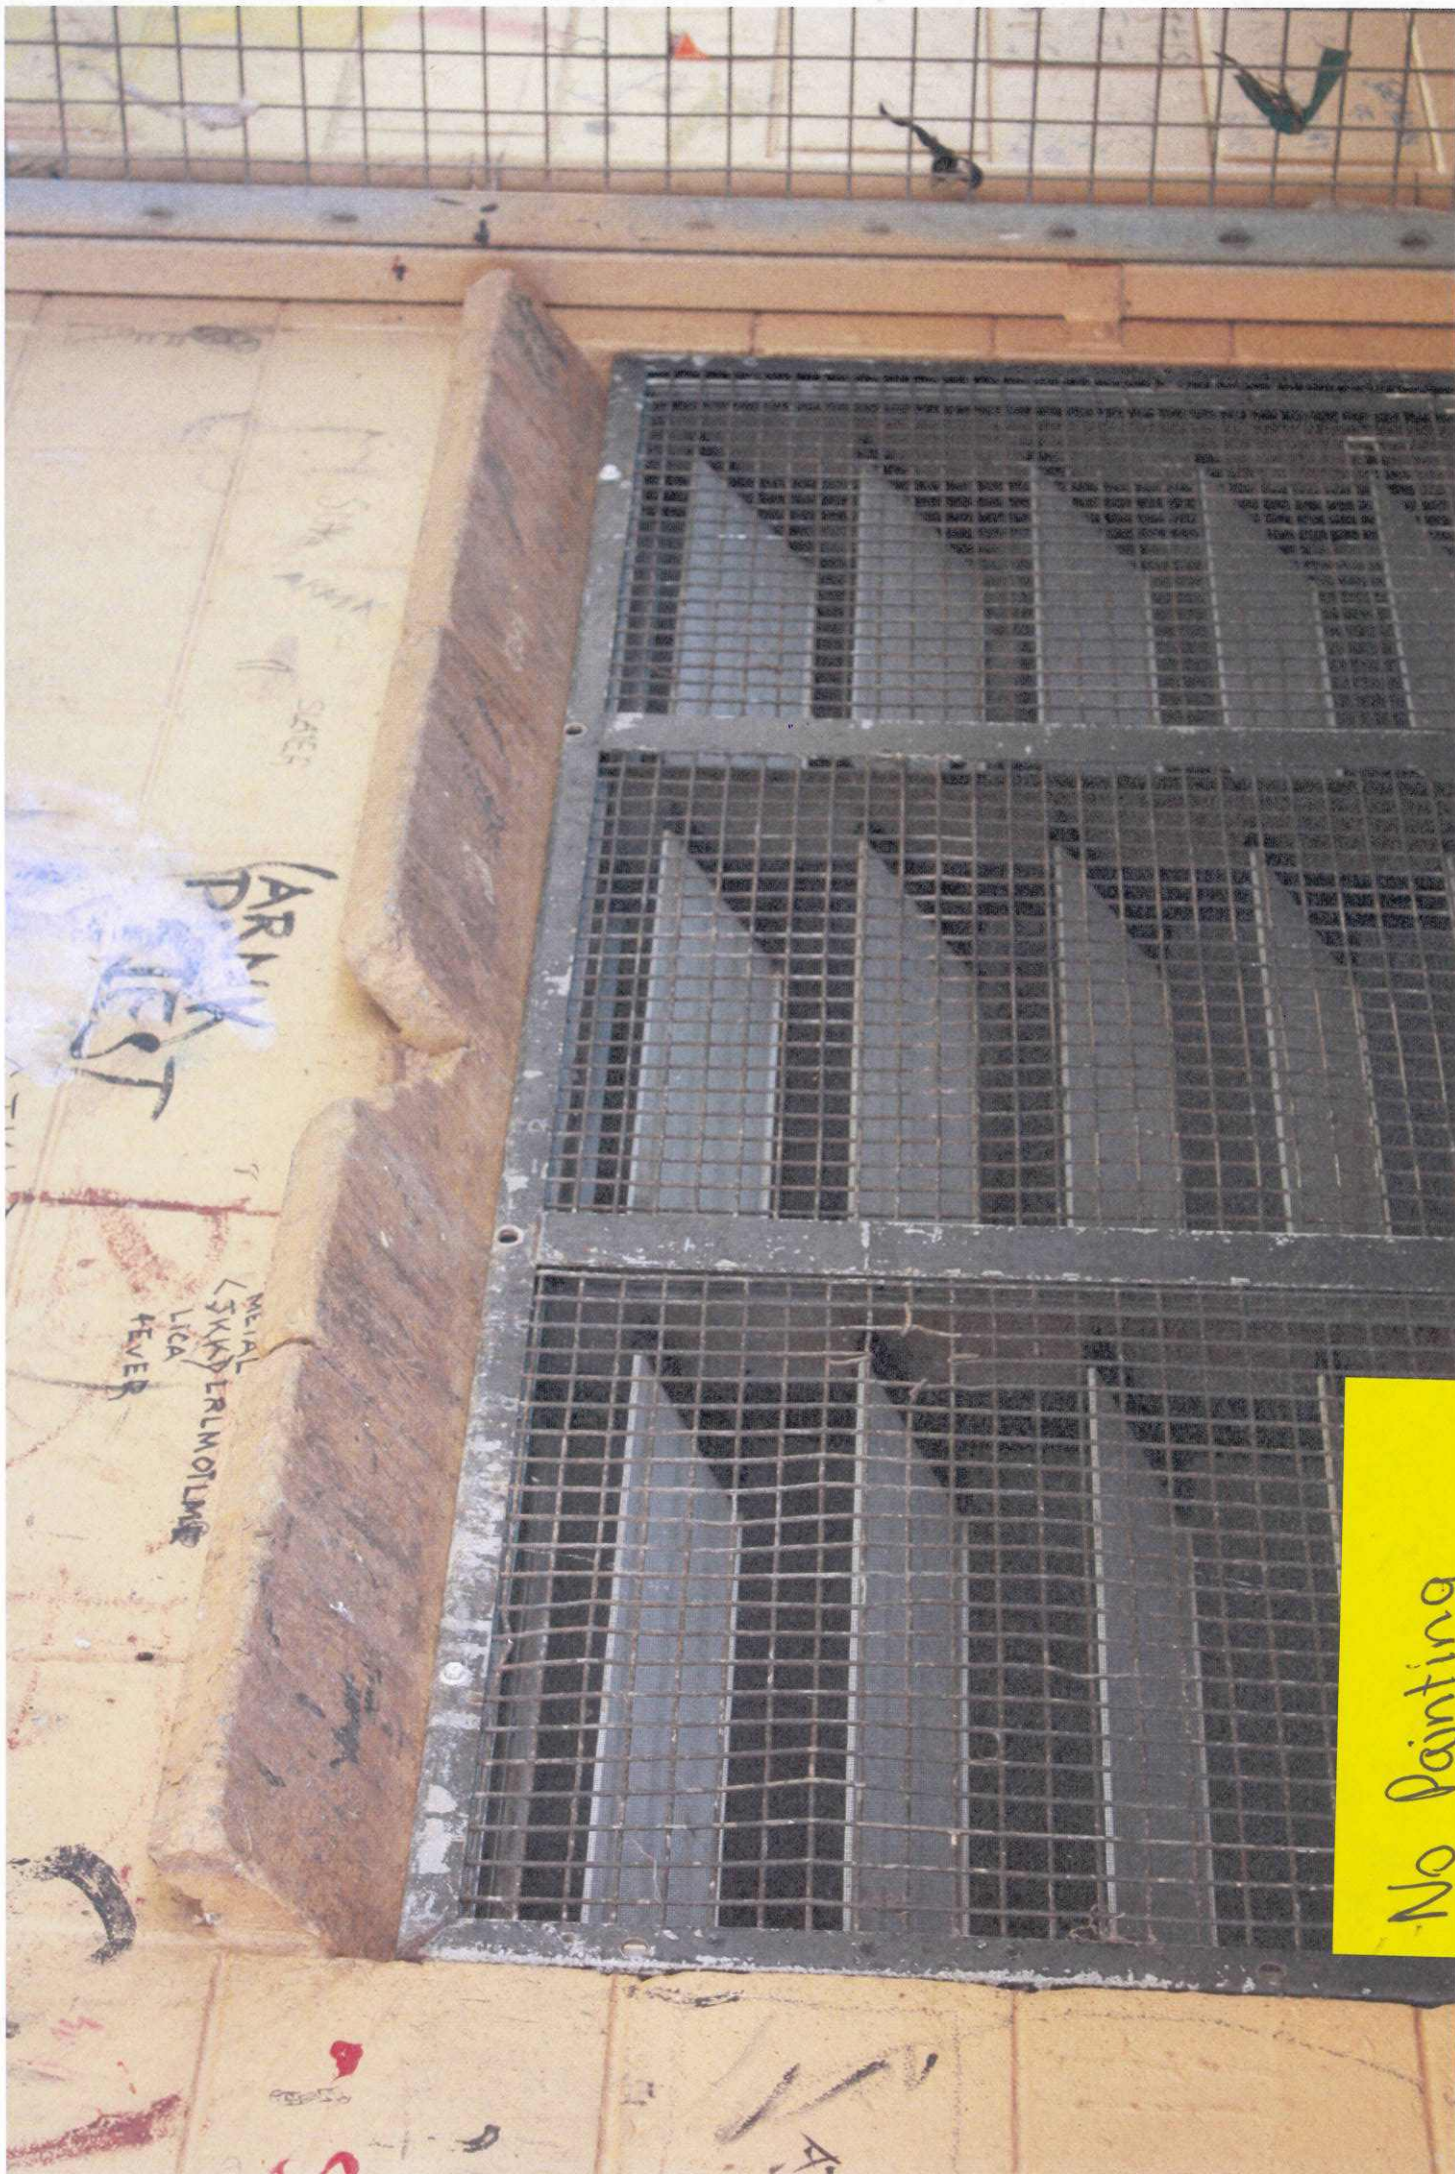
No Painting

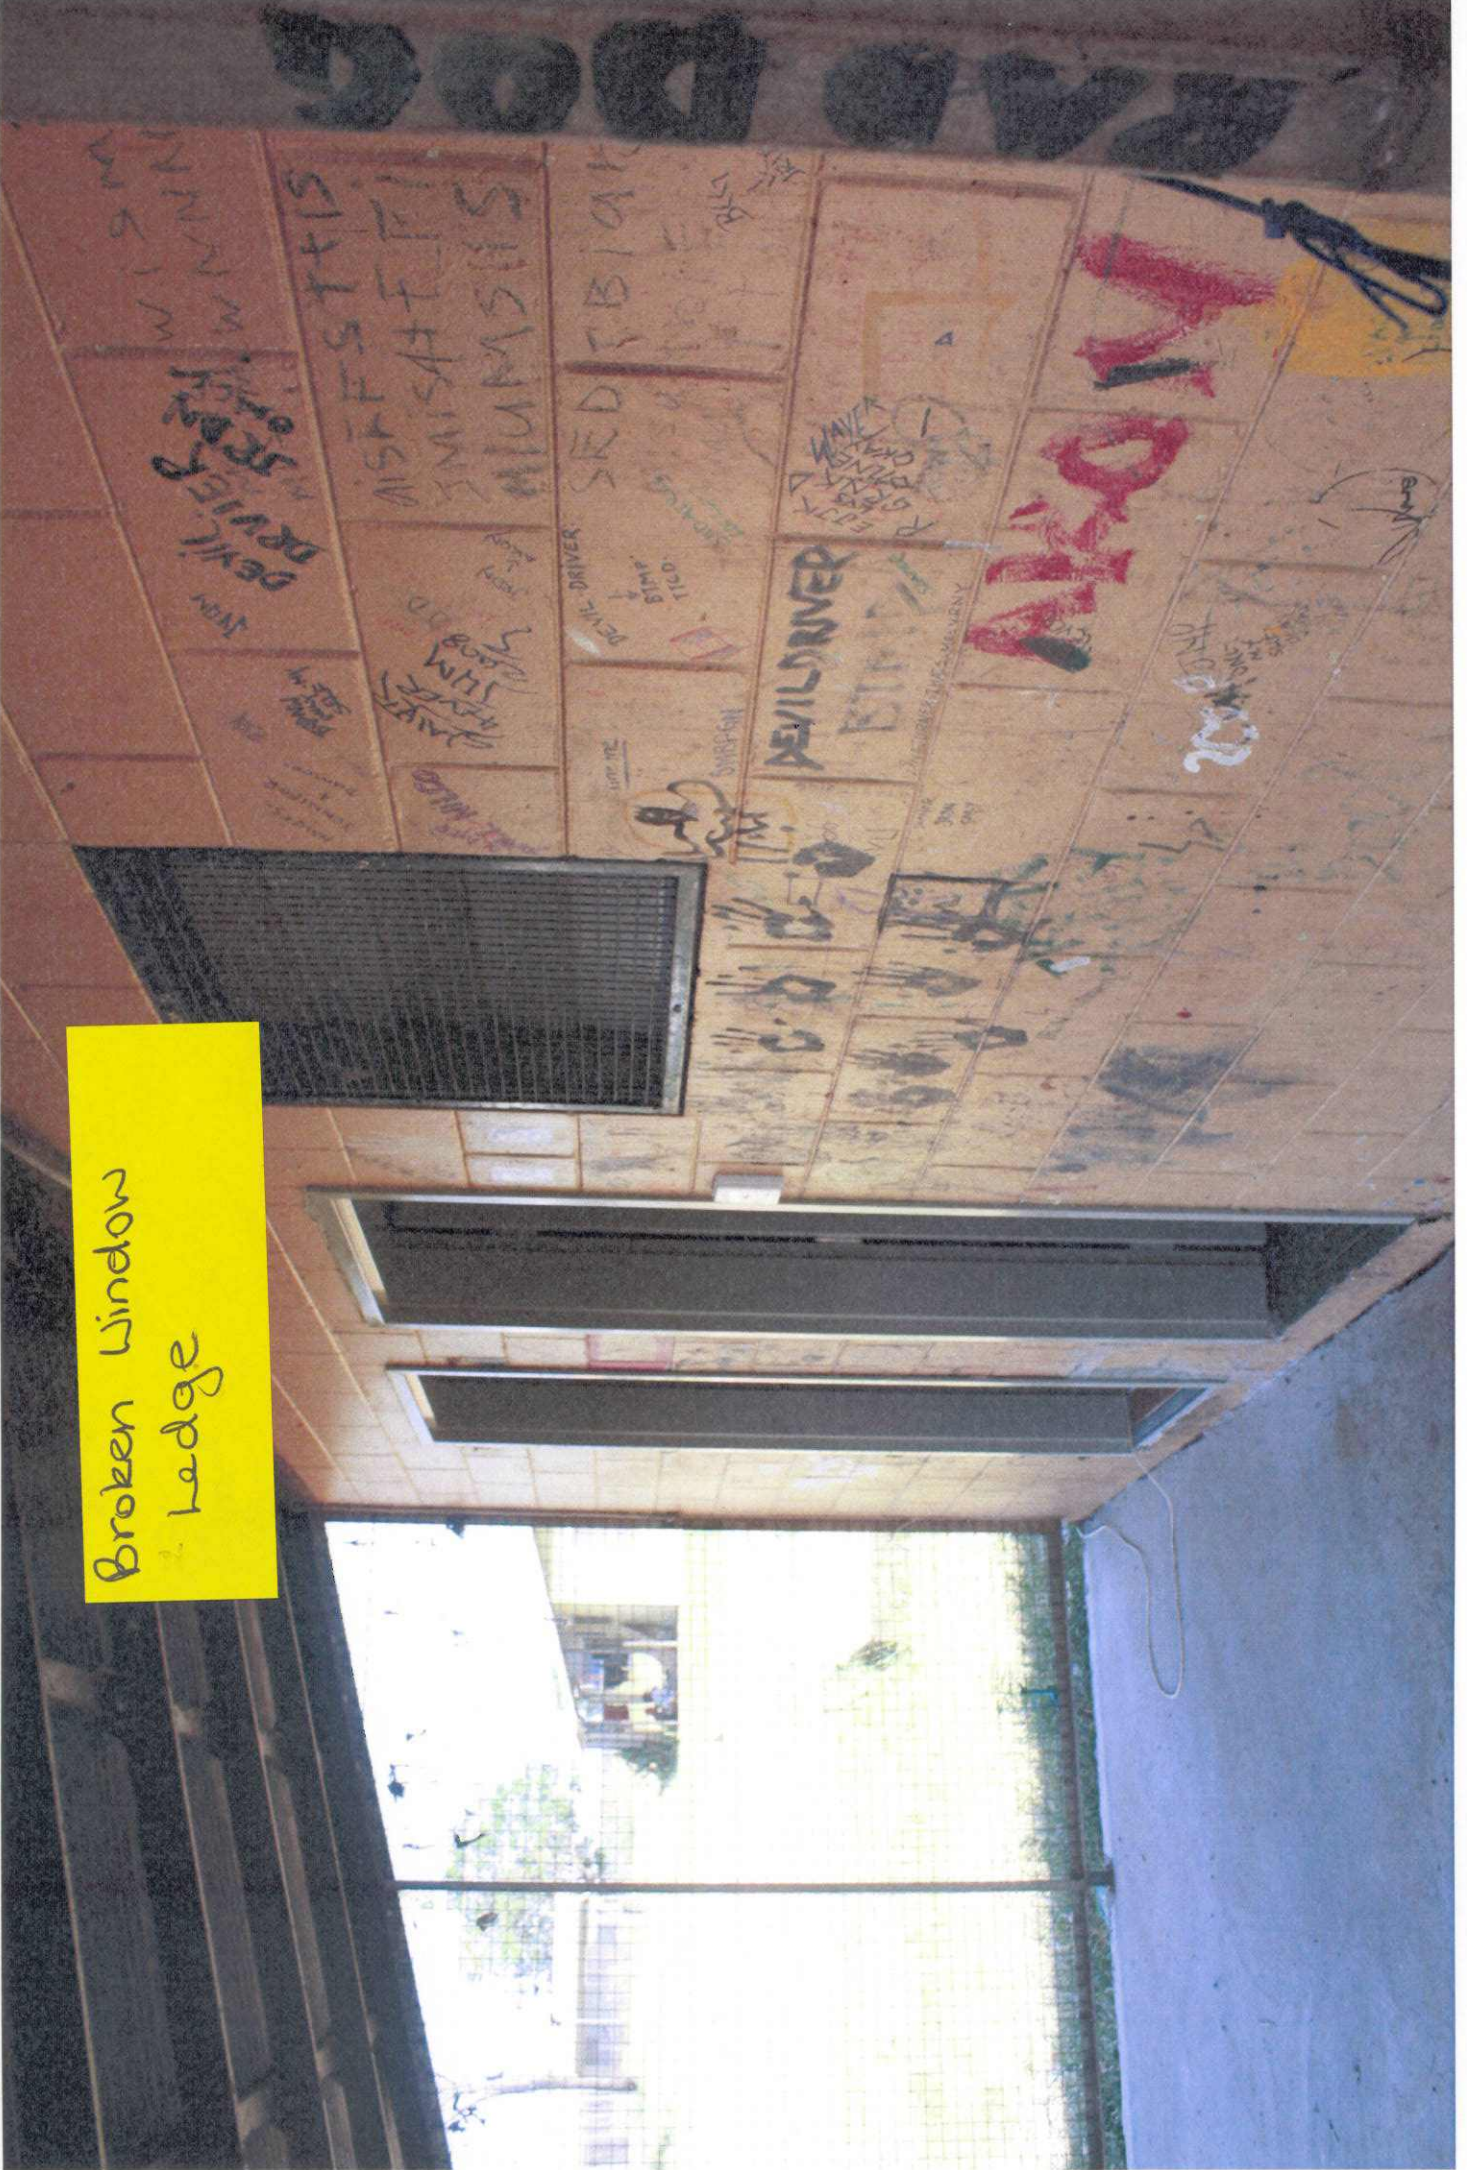
Broken Window
Ledge
