HOUSE
232

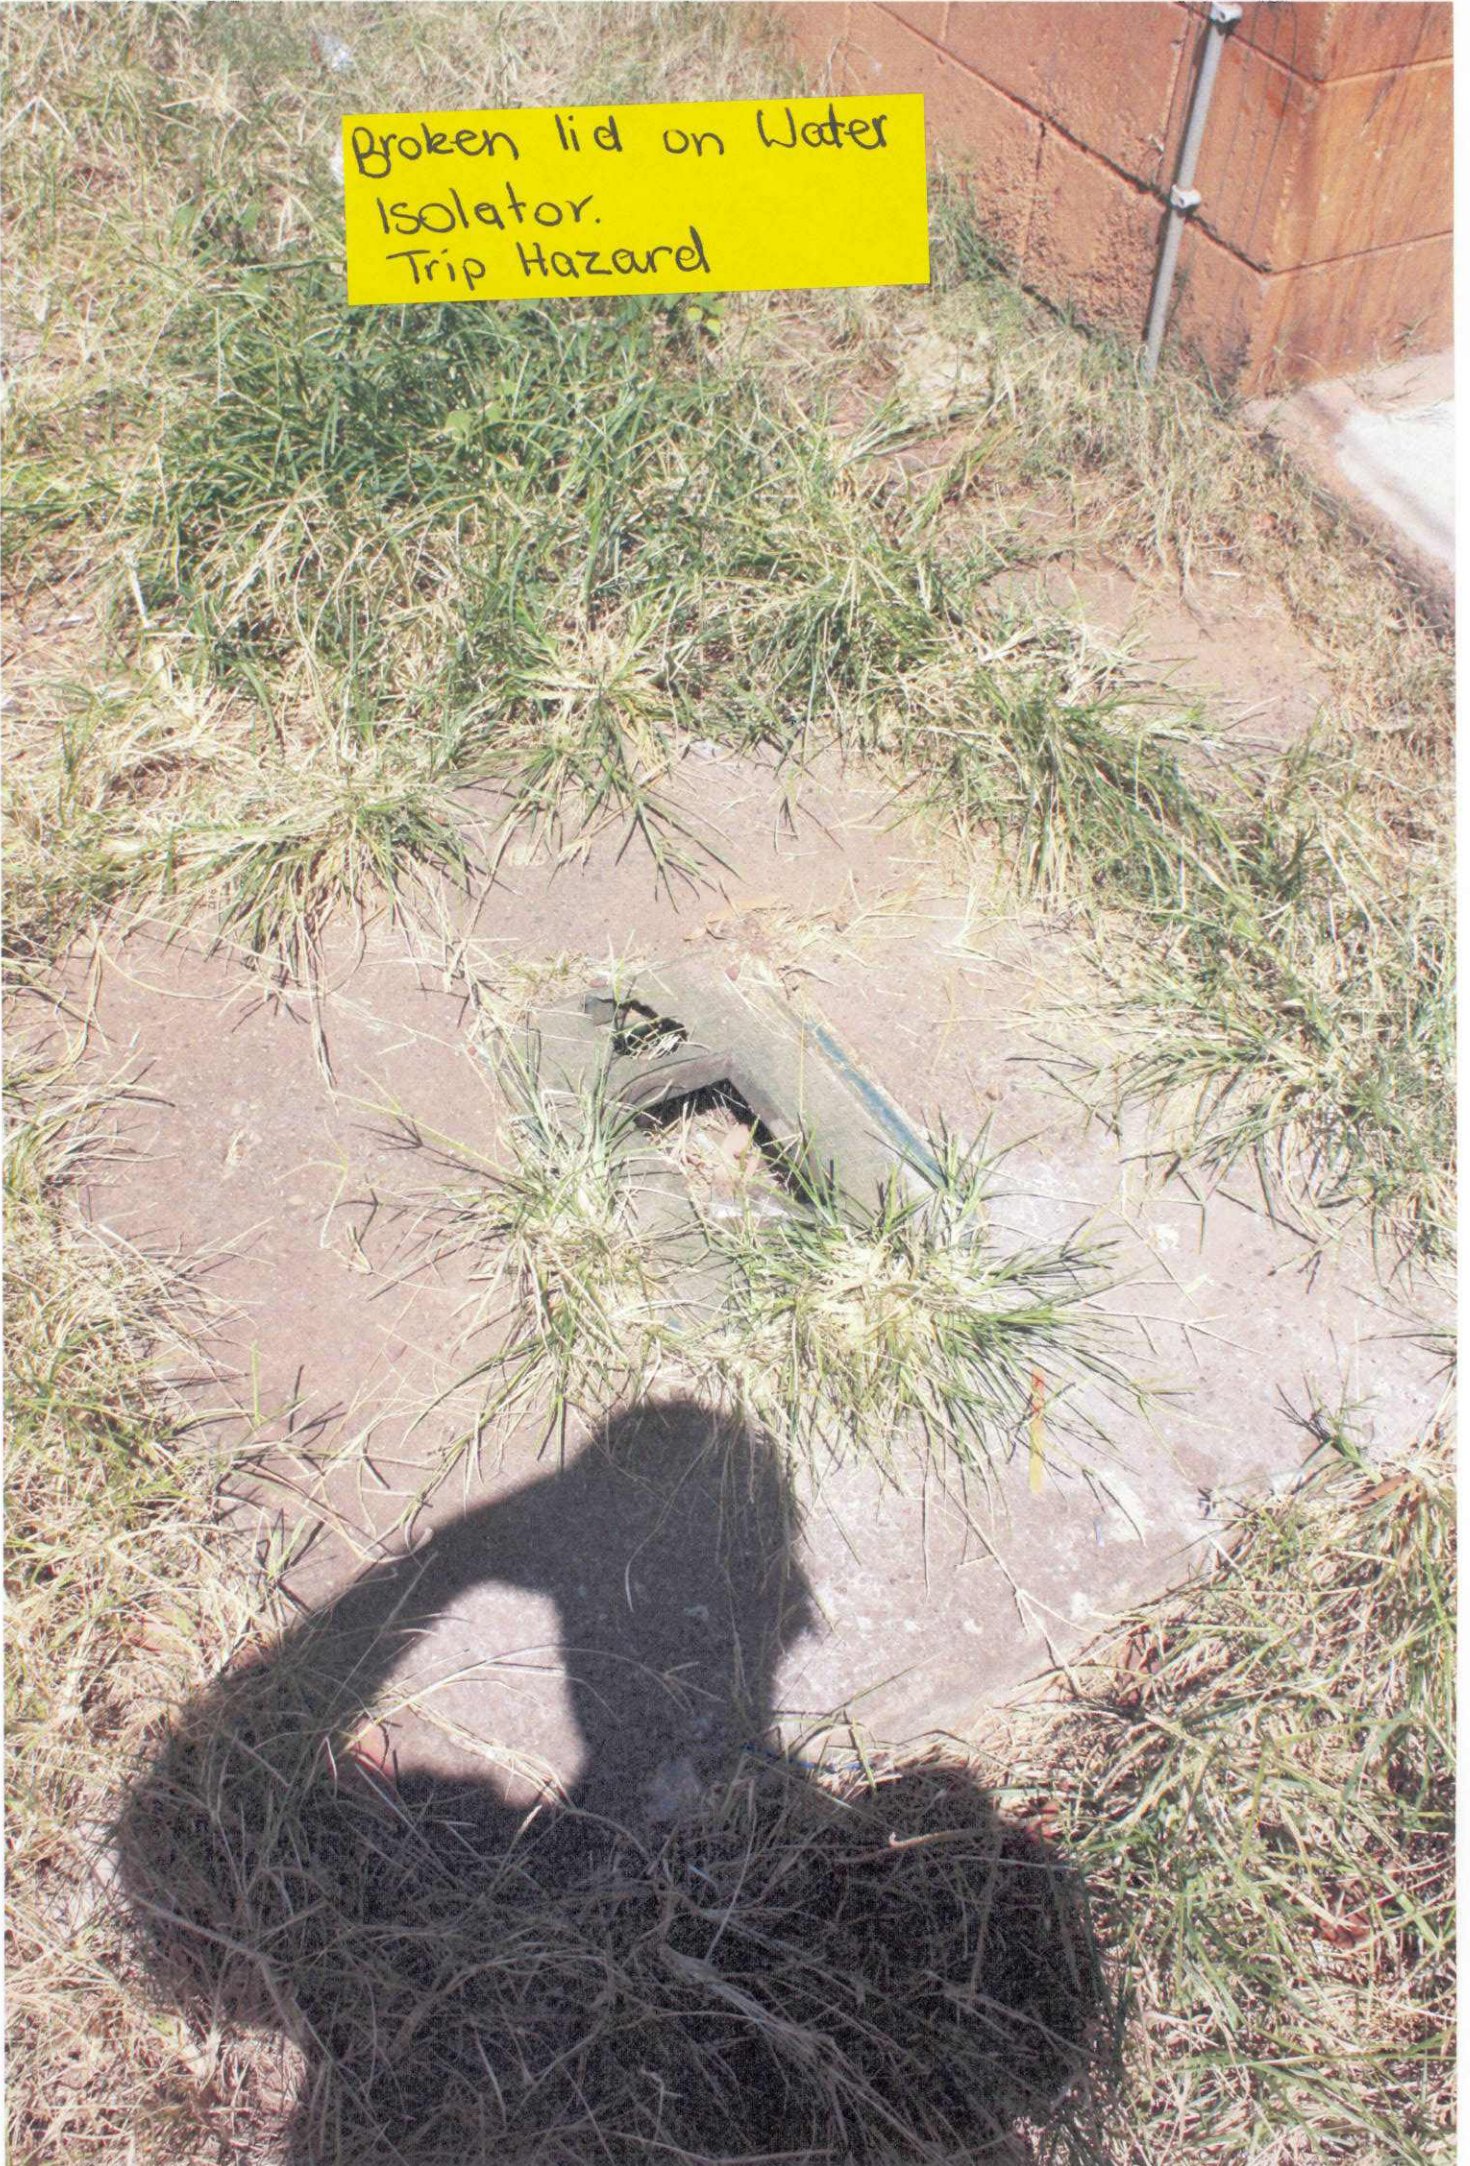
Broken lid on Water Isolator.
Trip Hazard

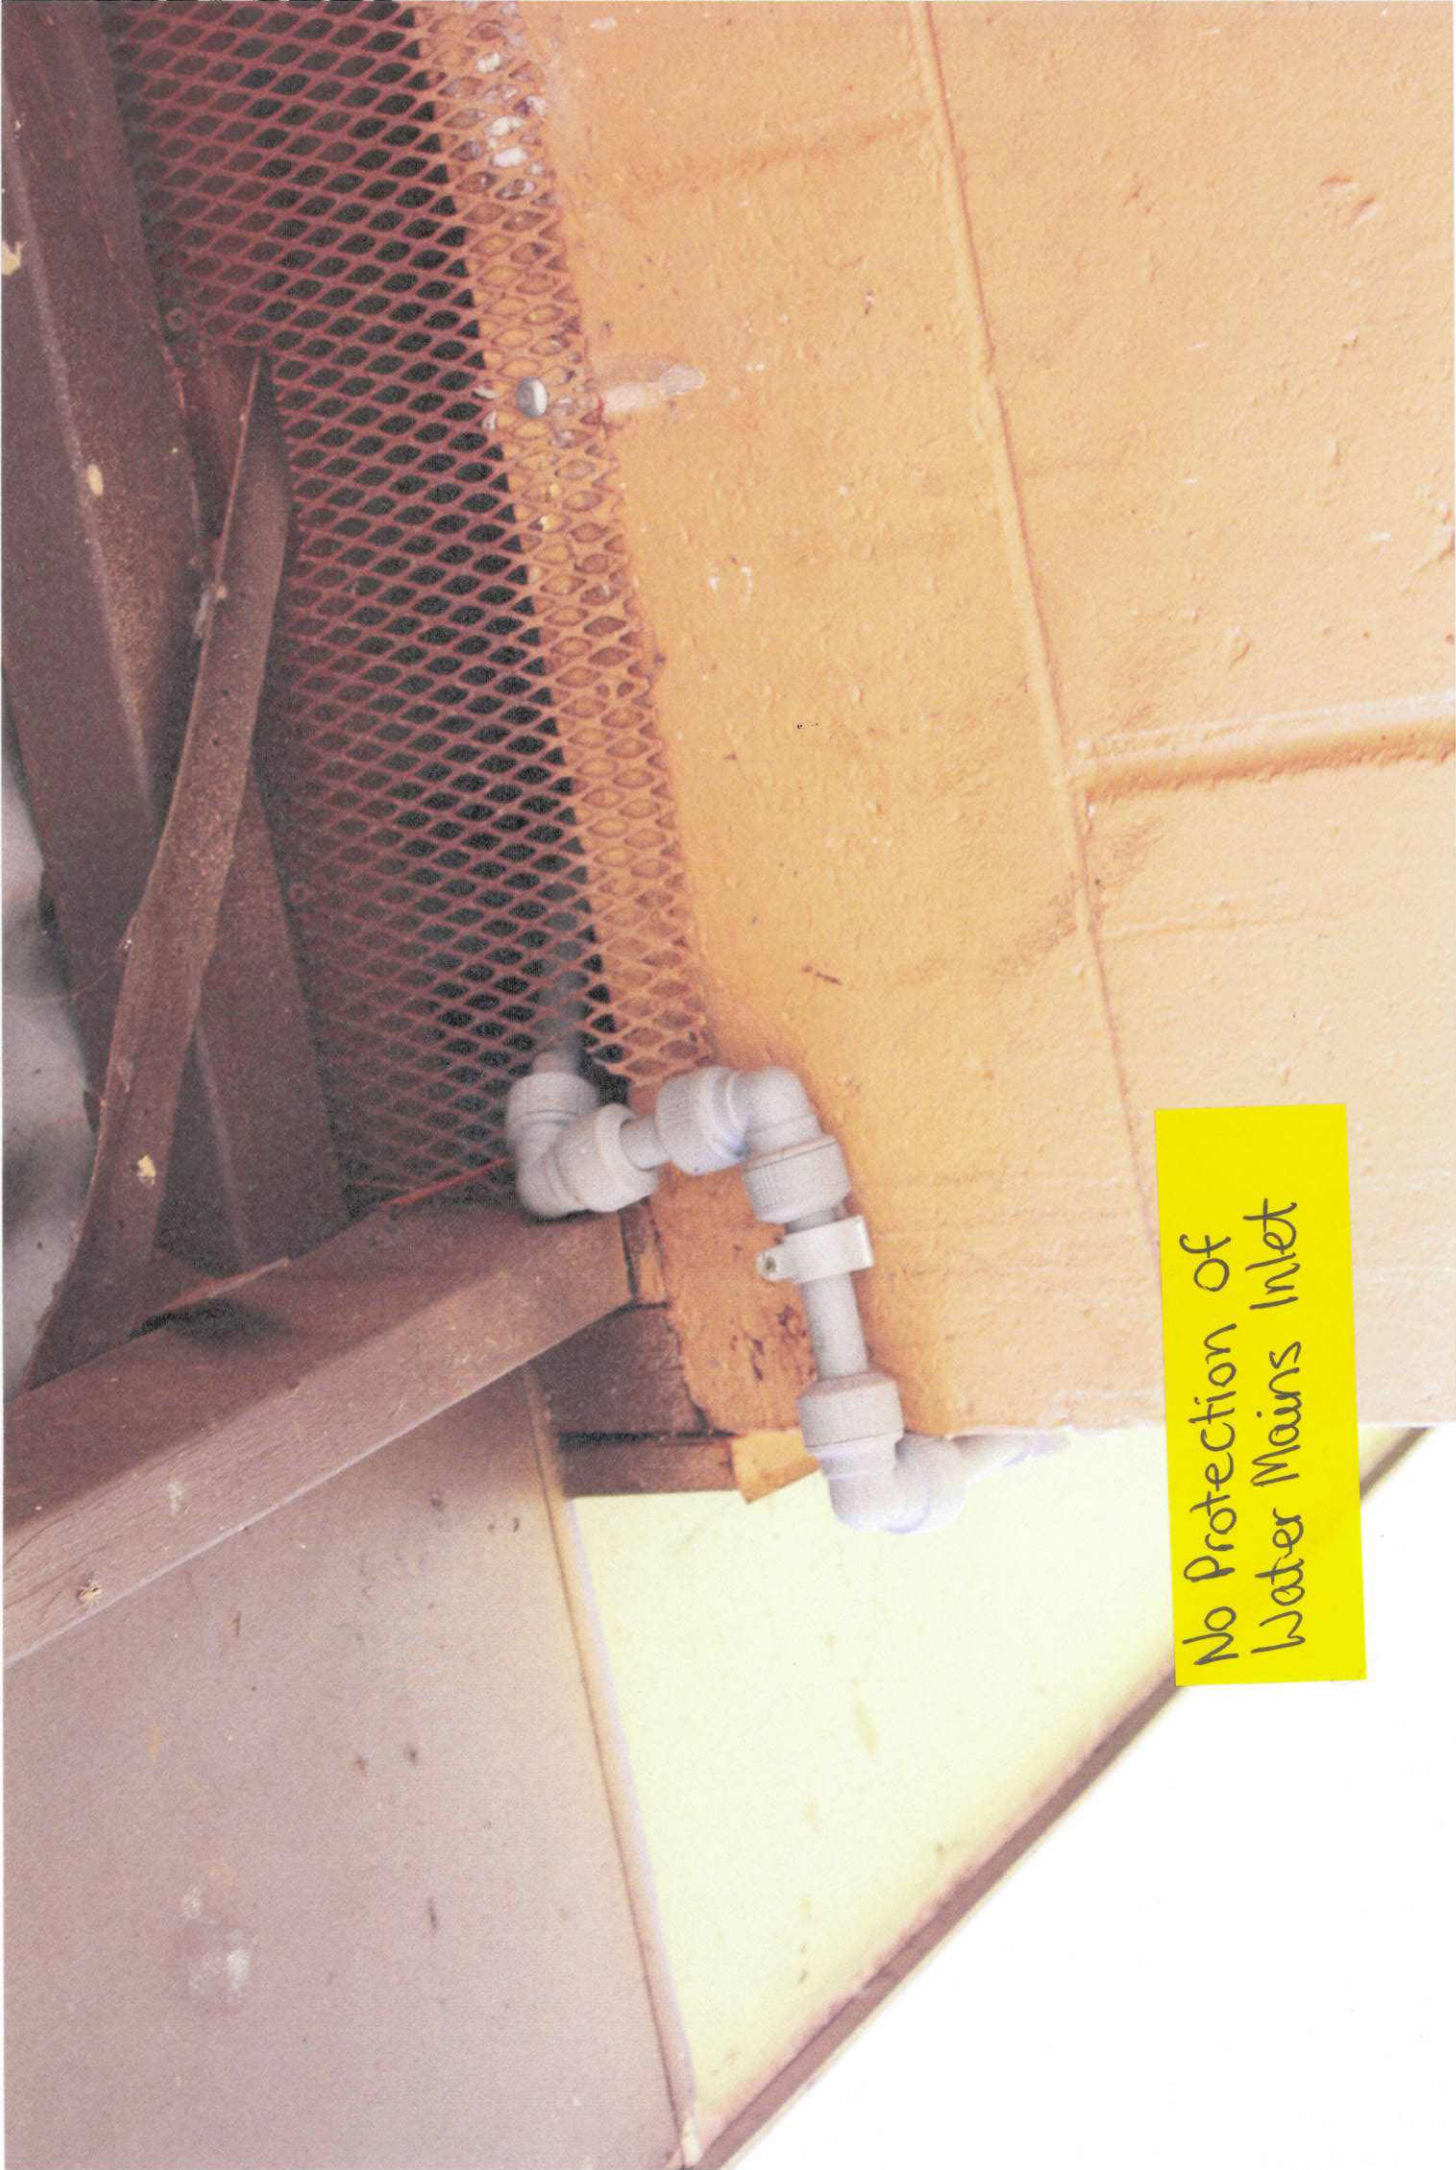
No Protection Of
Water Mains Inlet

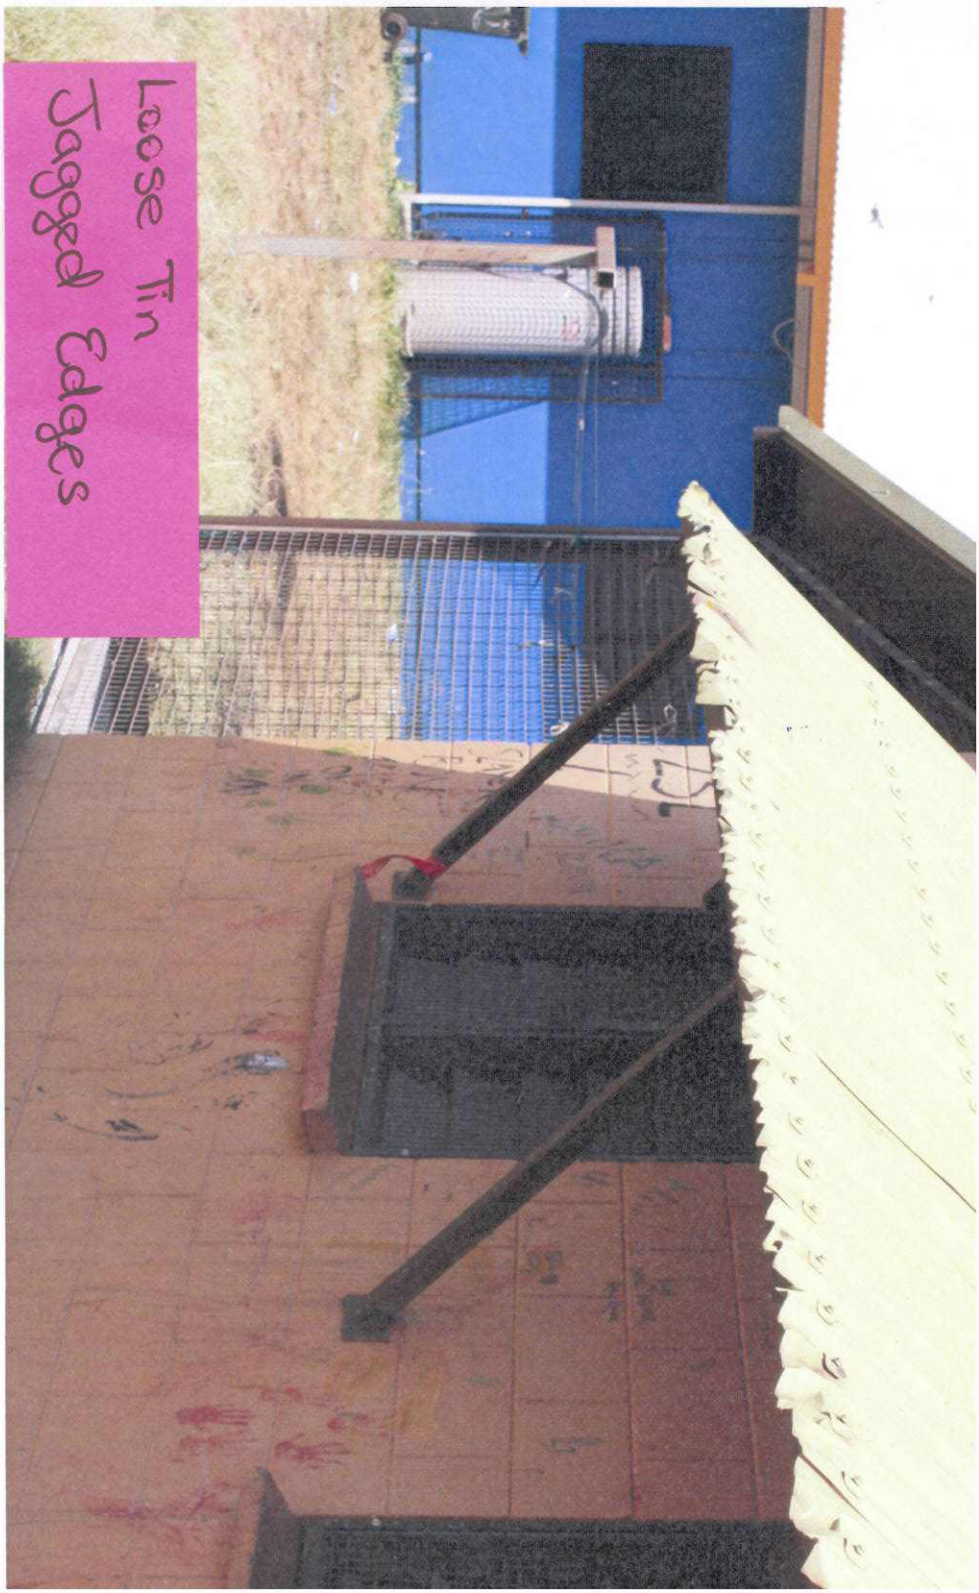
Loose Tin
Jagged Edges

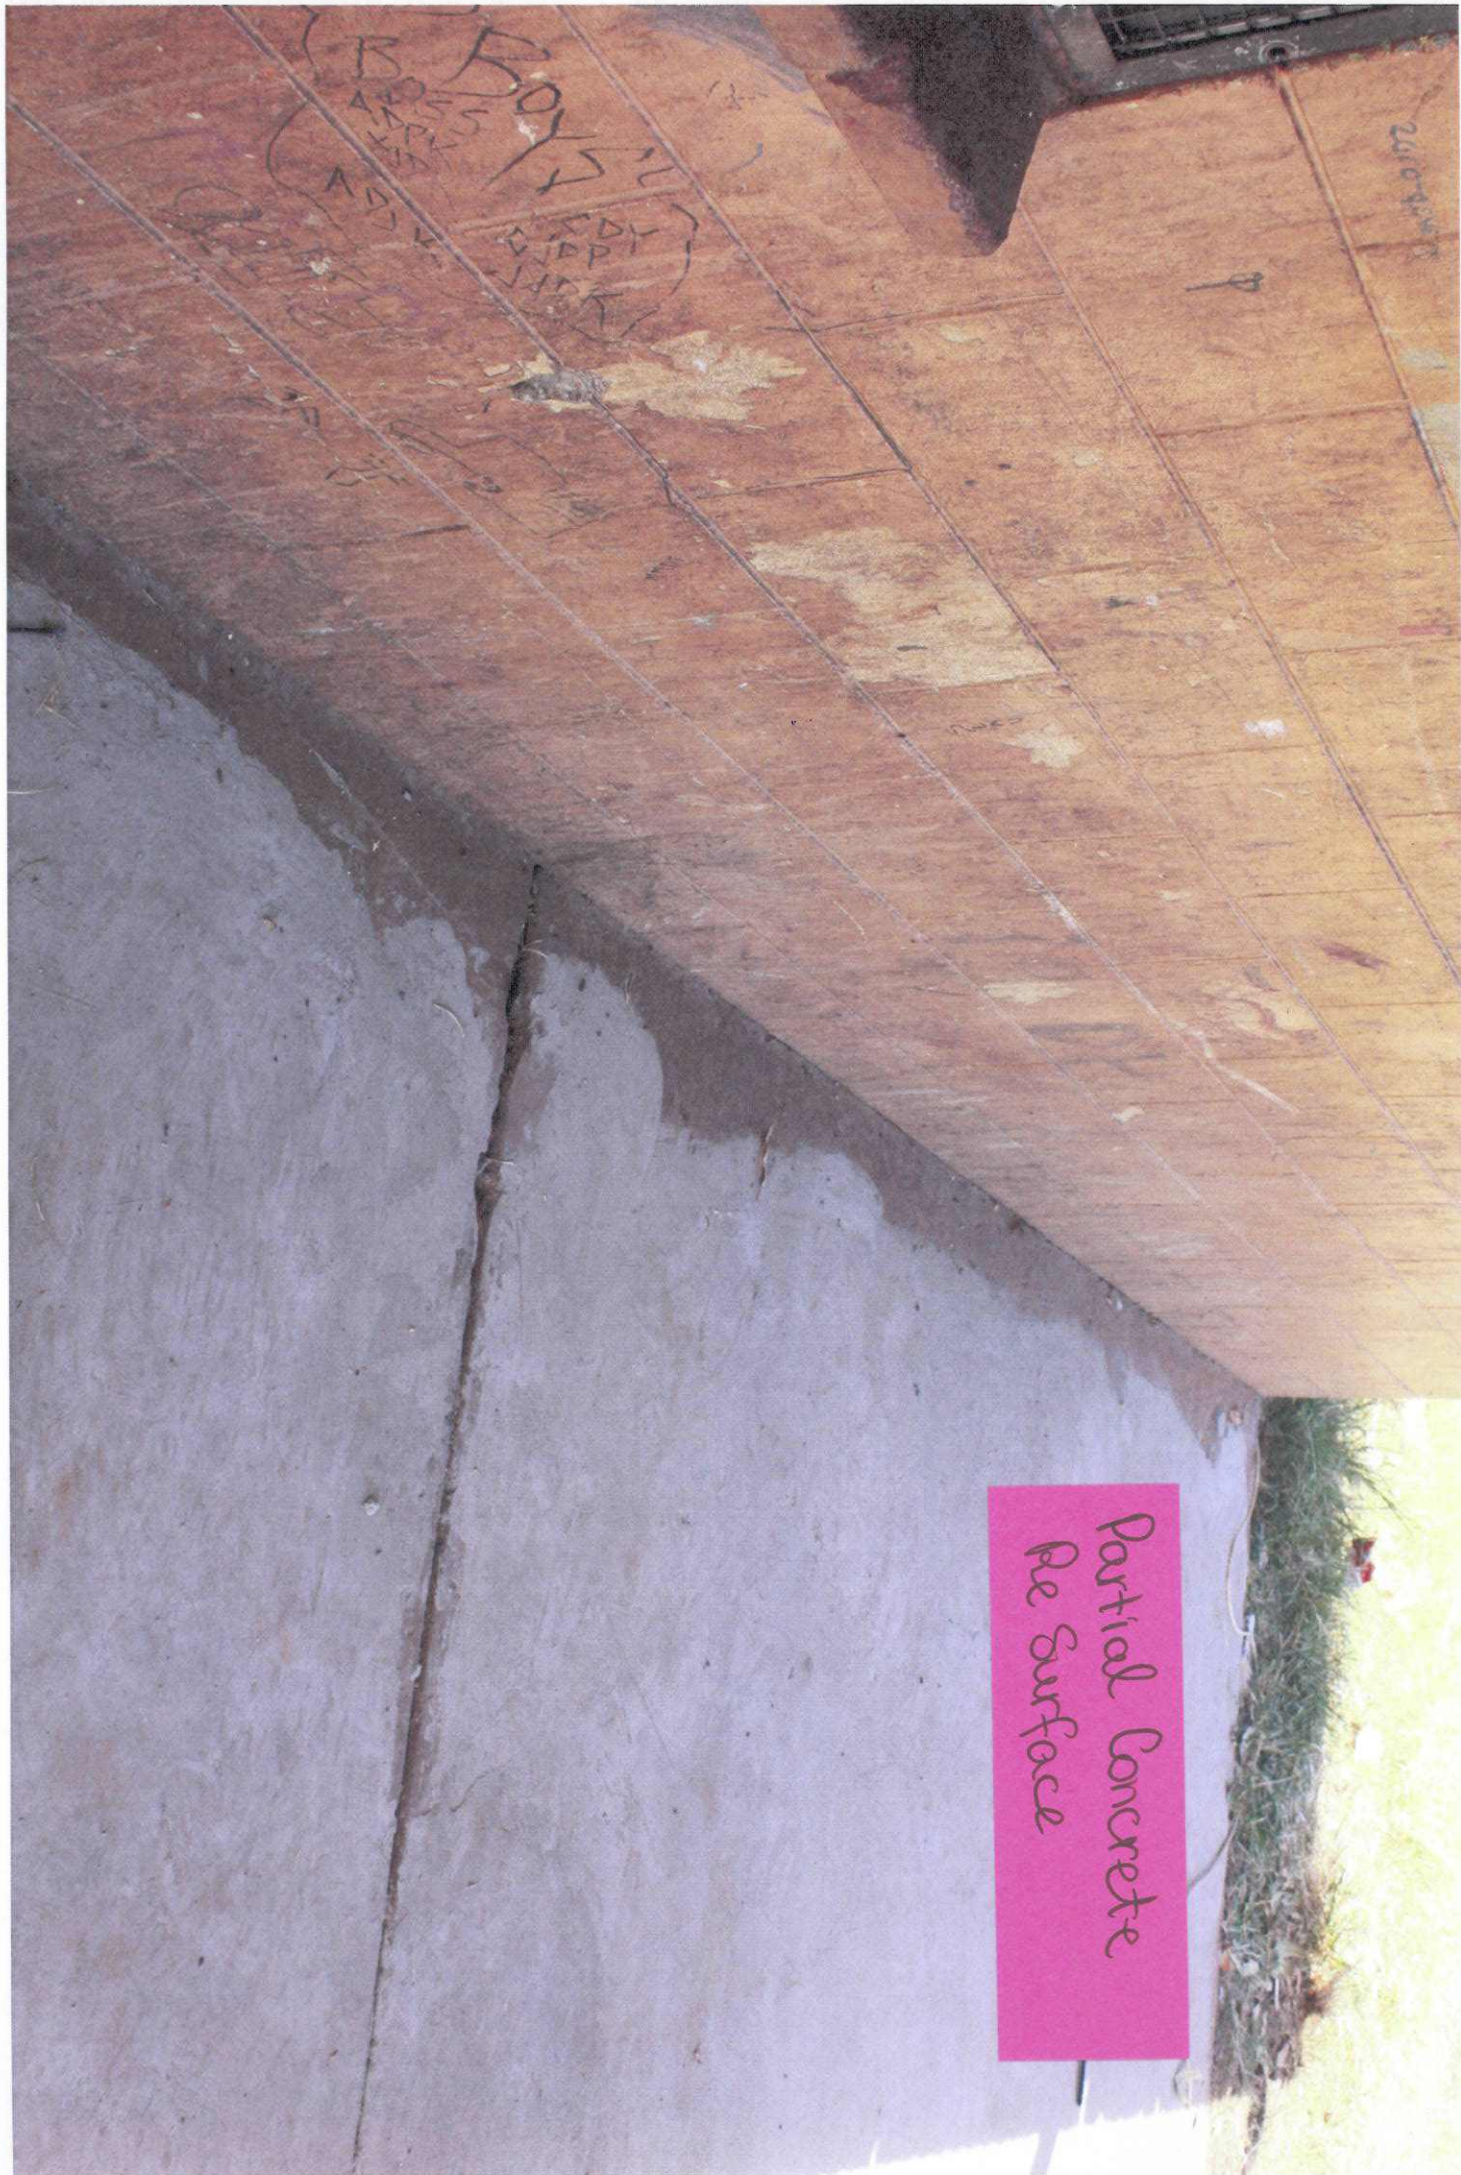
Partial Concrete
Re Surface

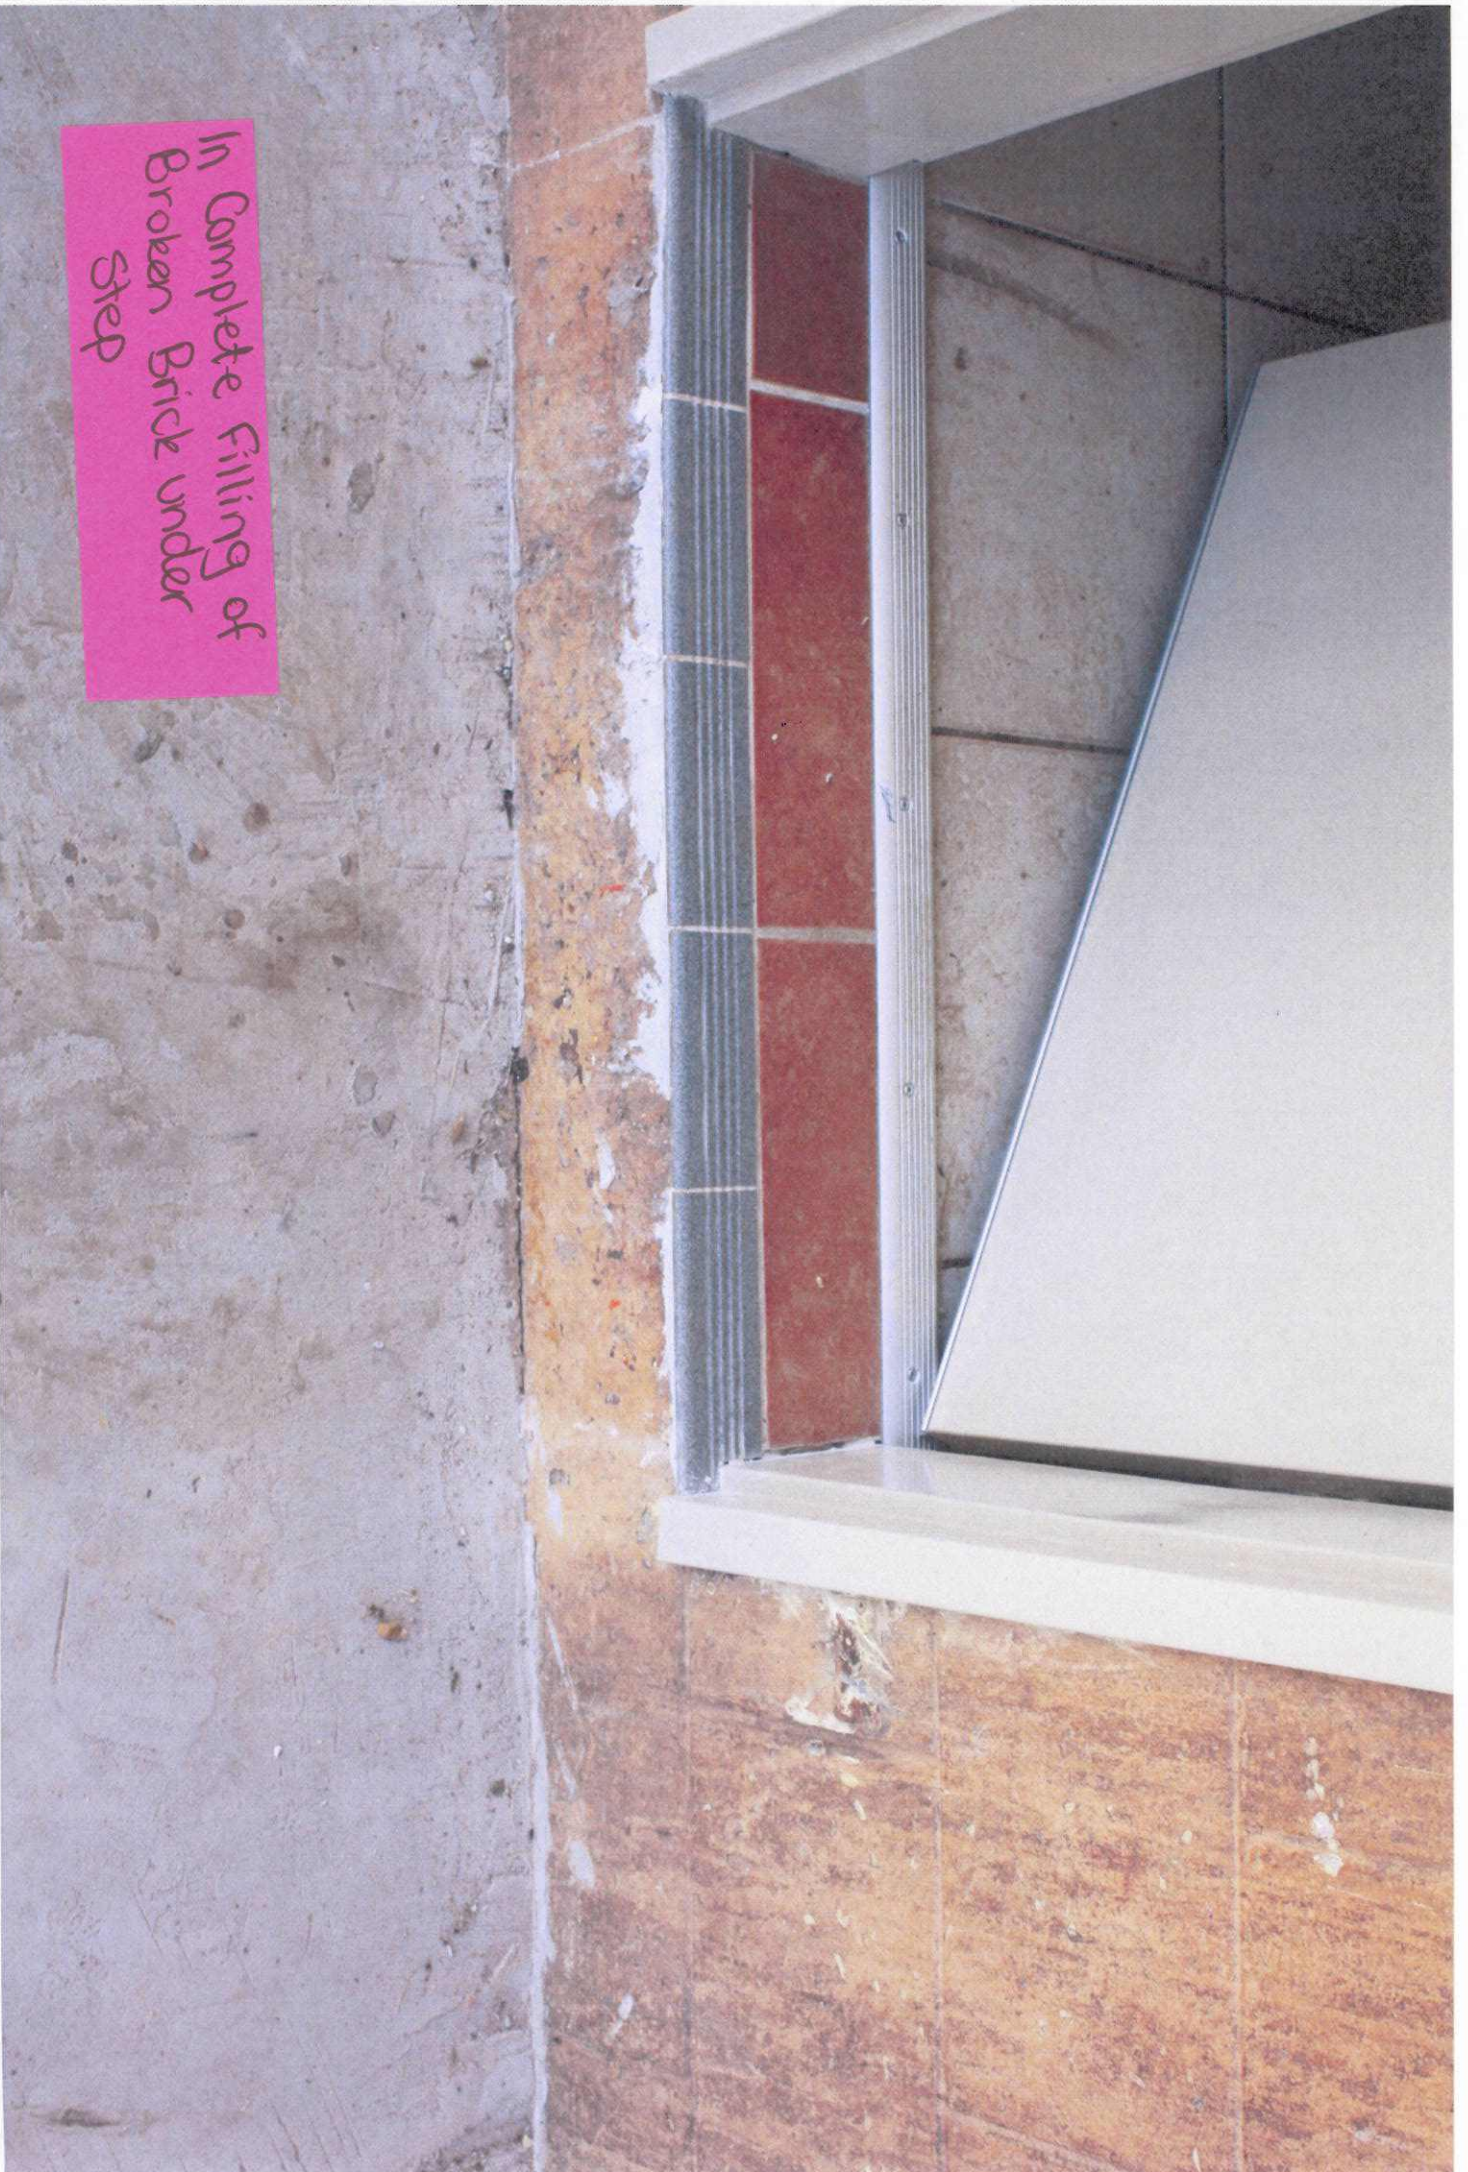
In Complete Filling of
Broken Bricks under
Step

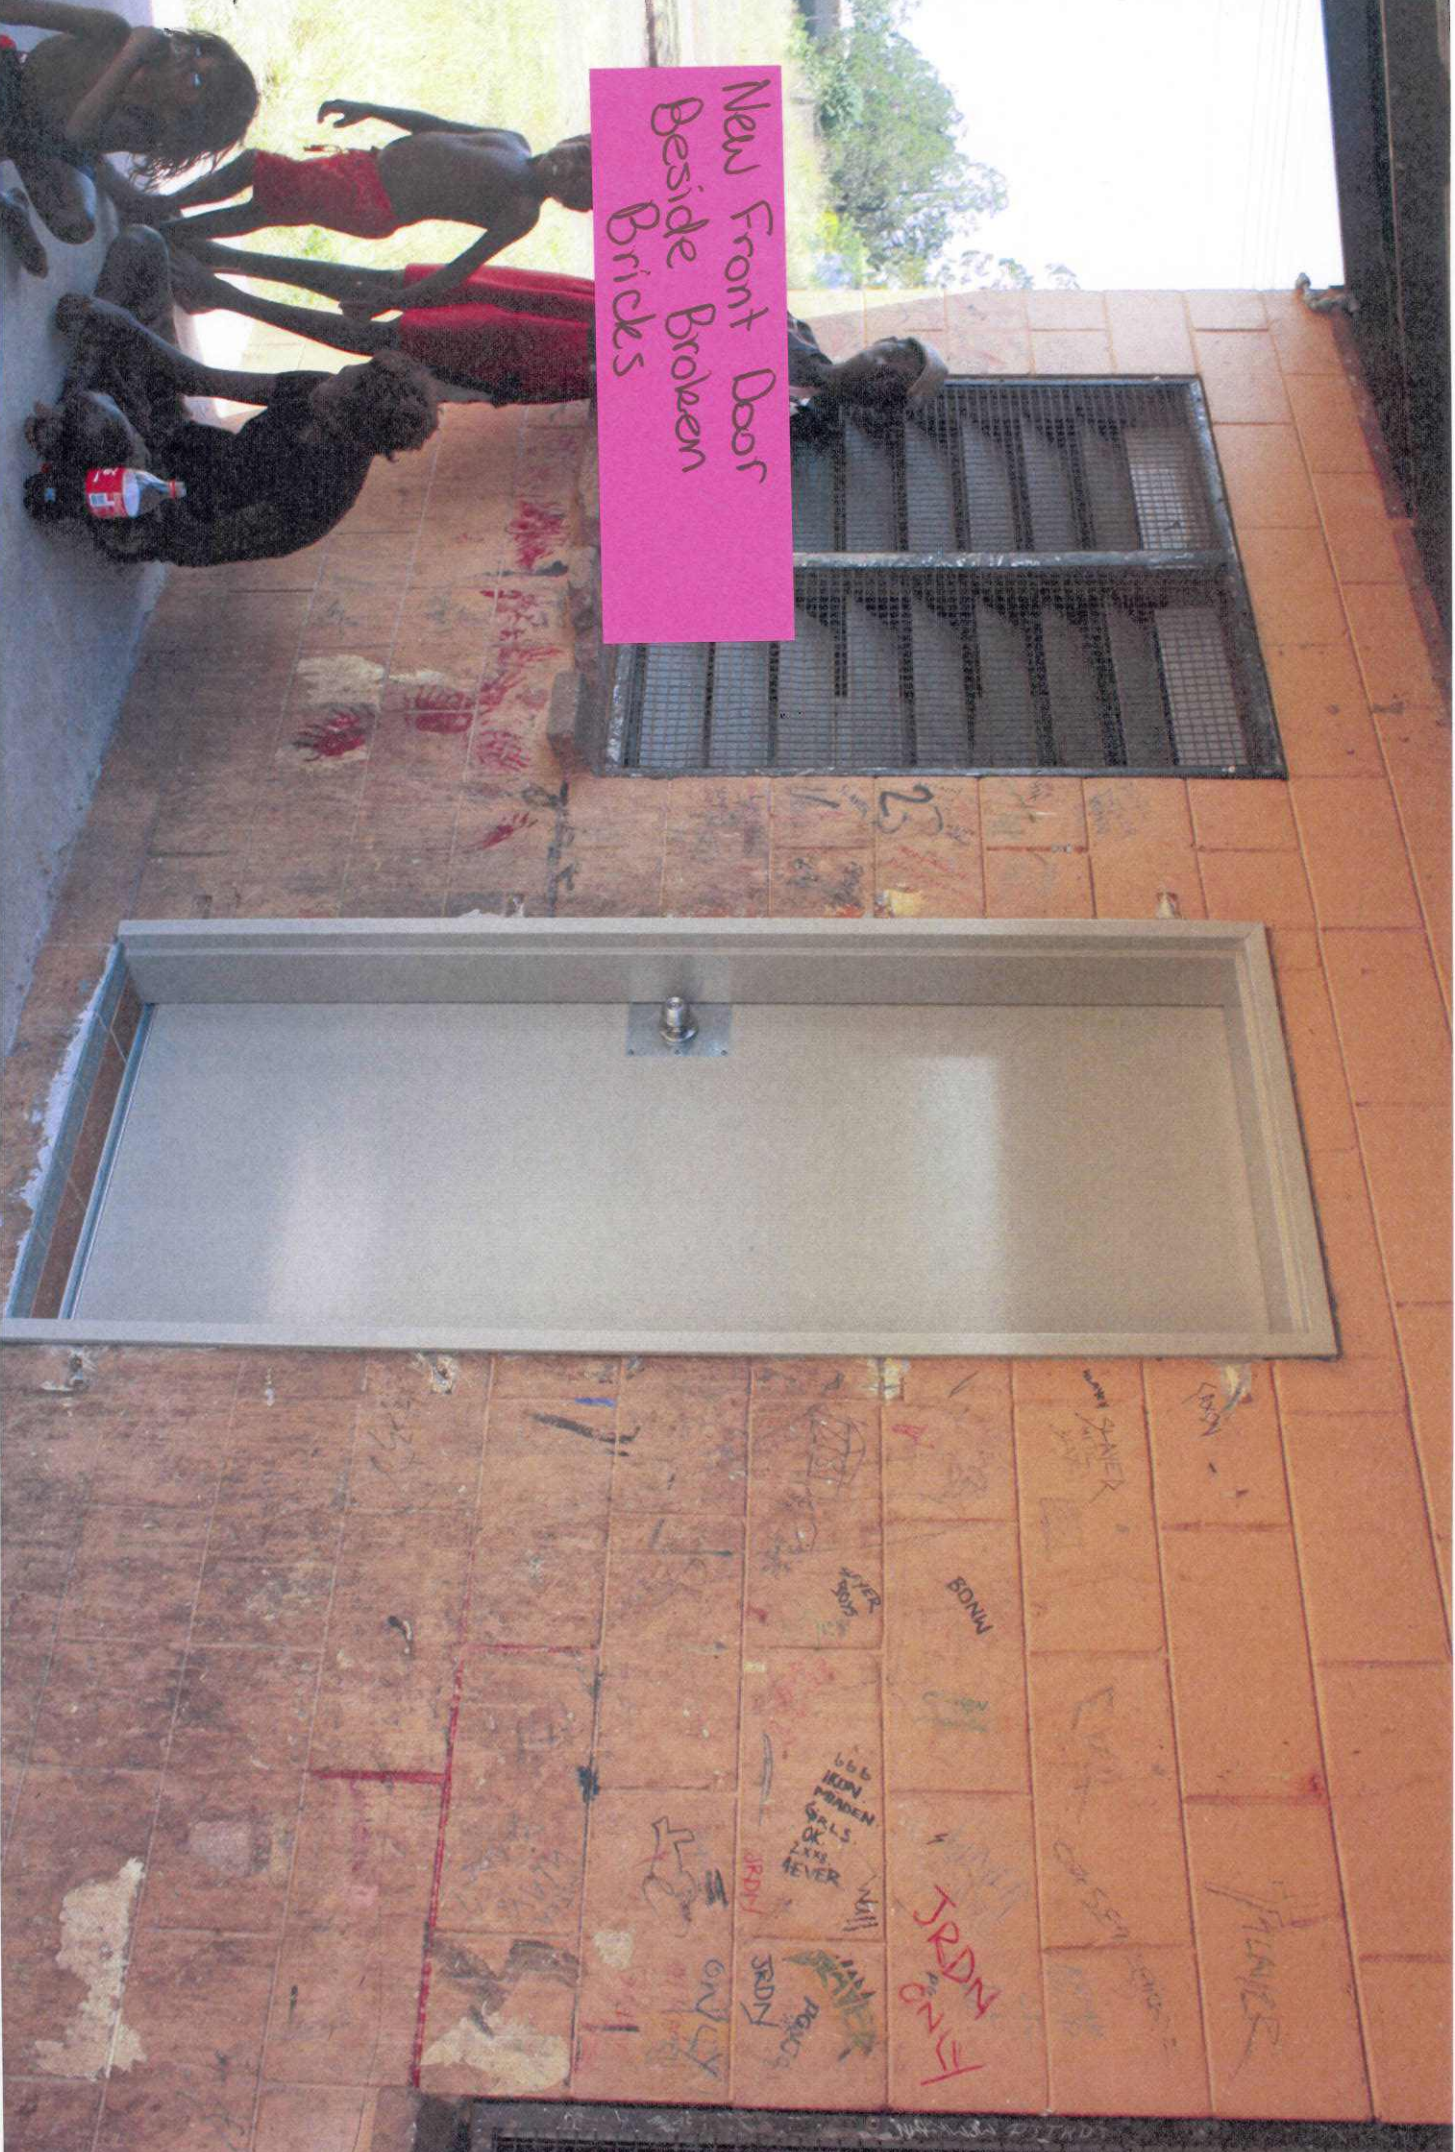
New Front Door
Beside Broken
Bricks

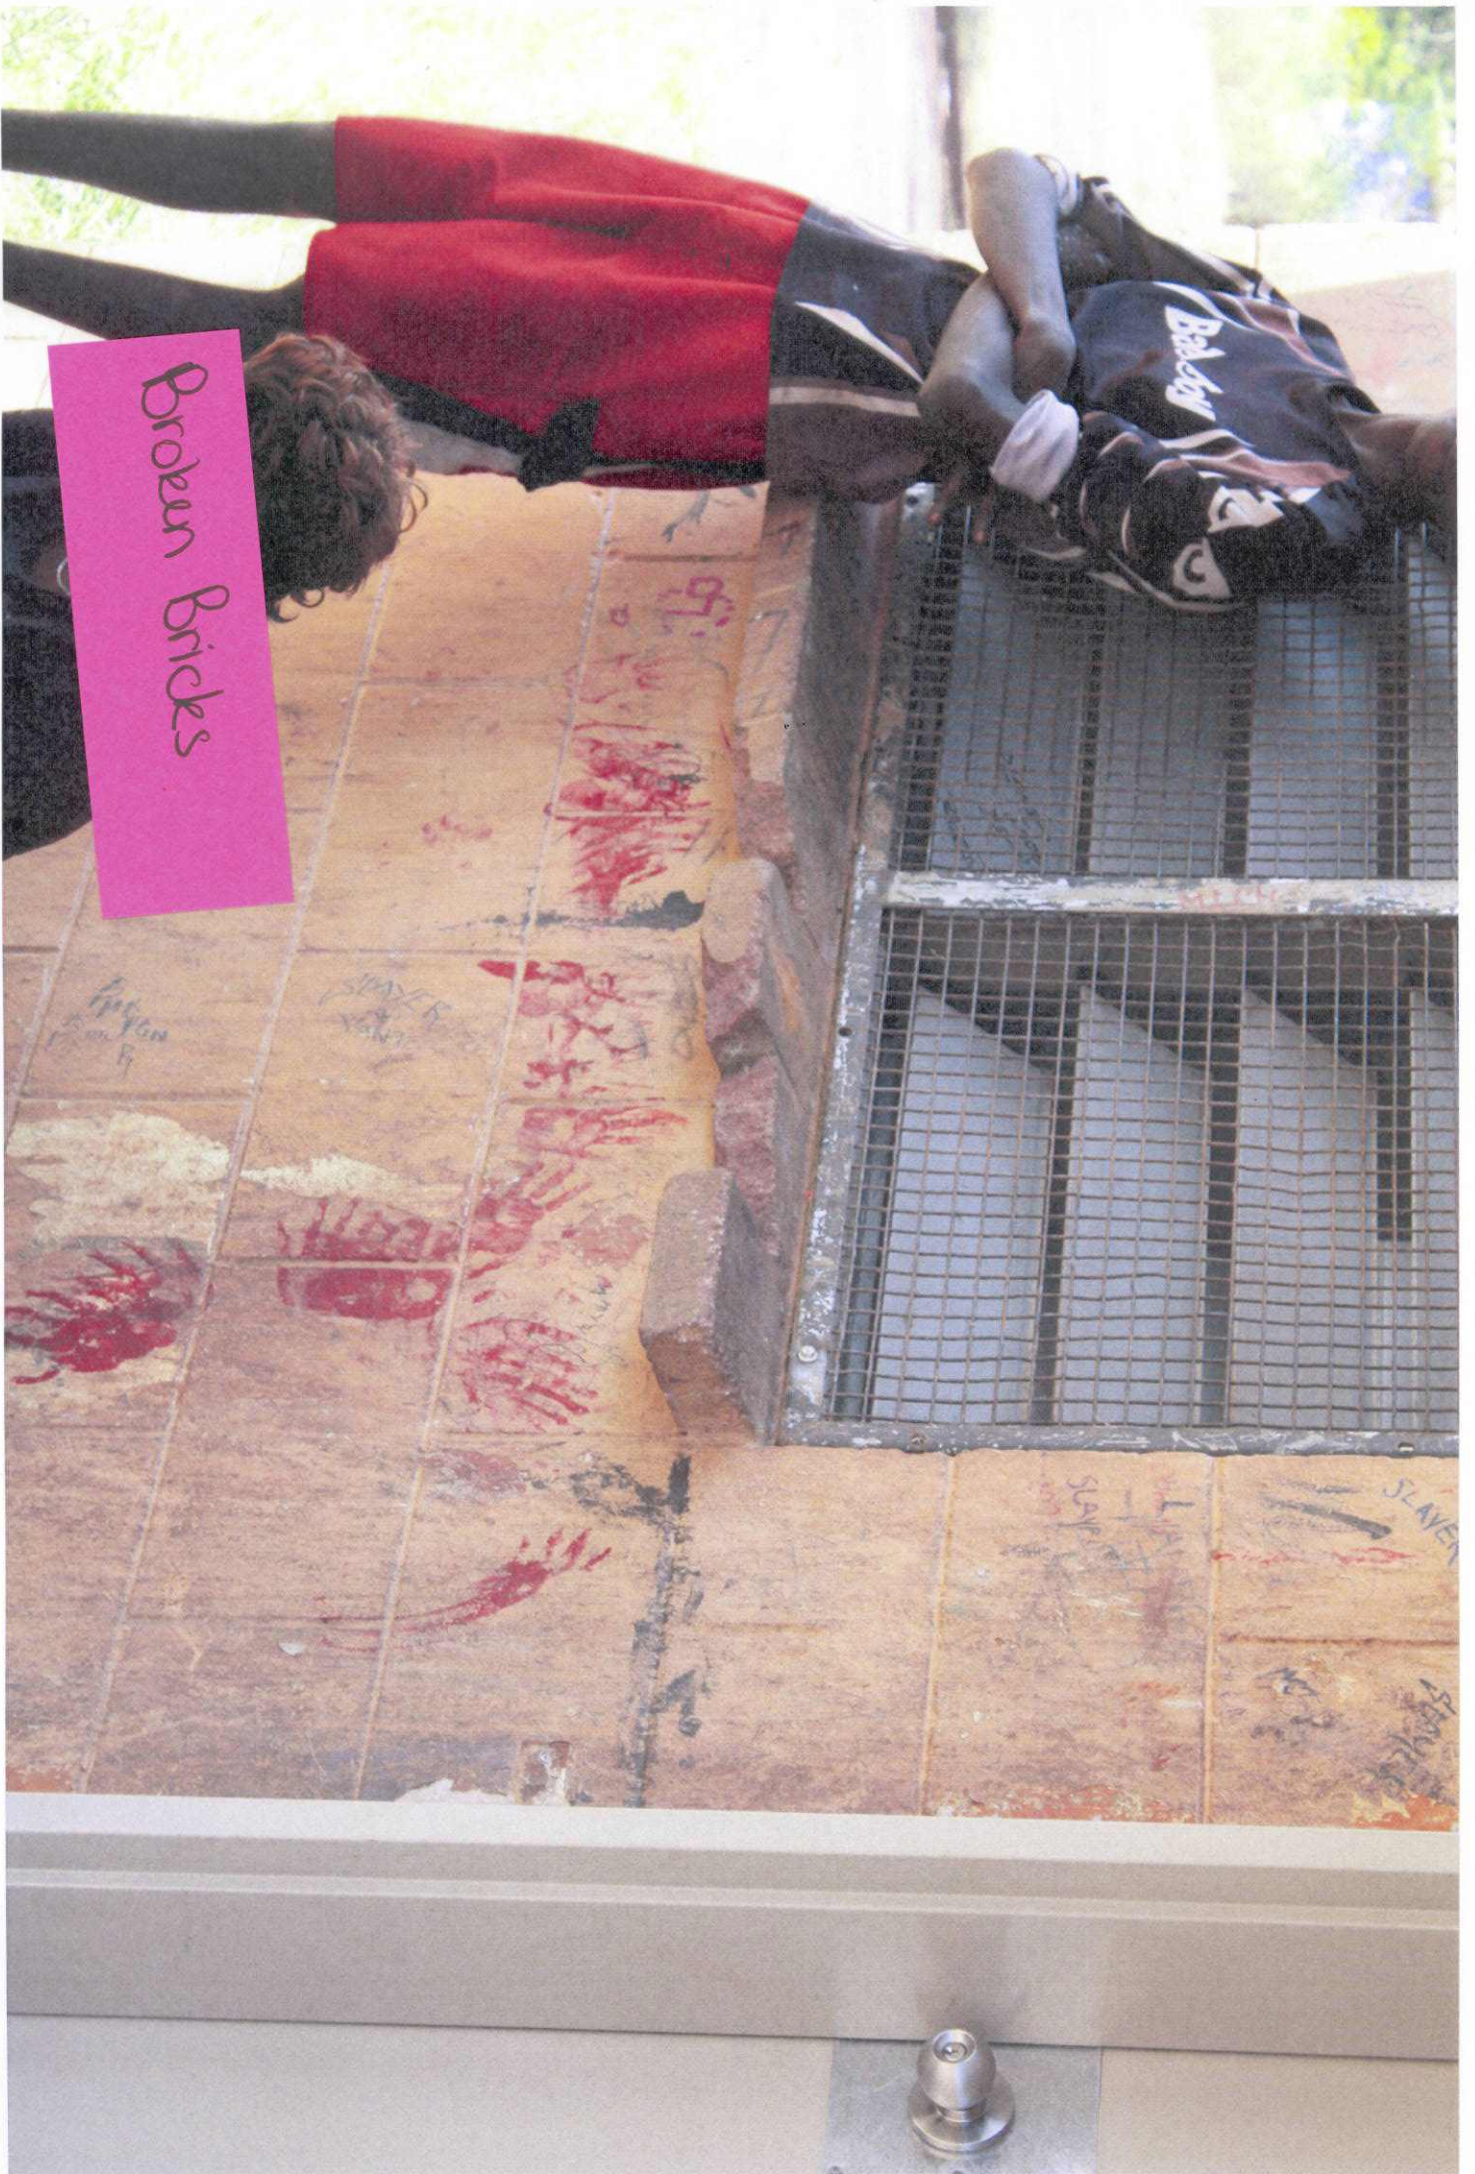
Broken Bricks
