HOUSE
232

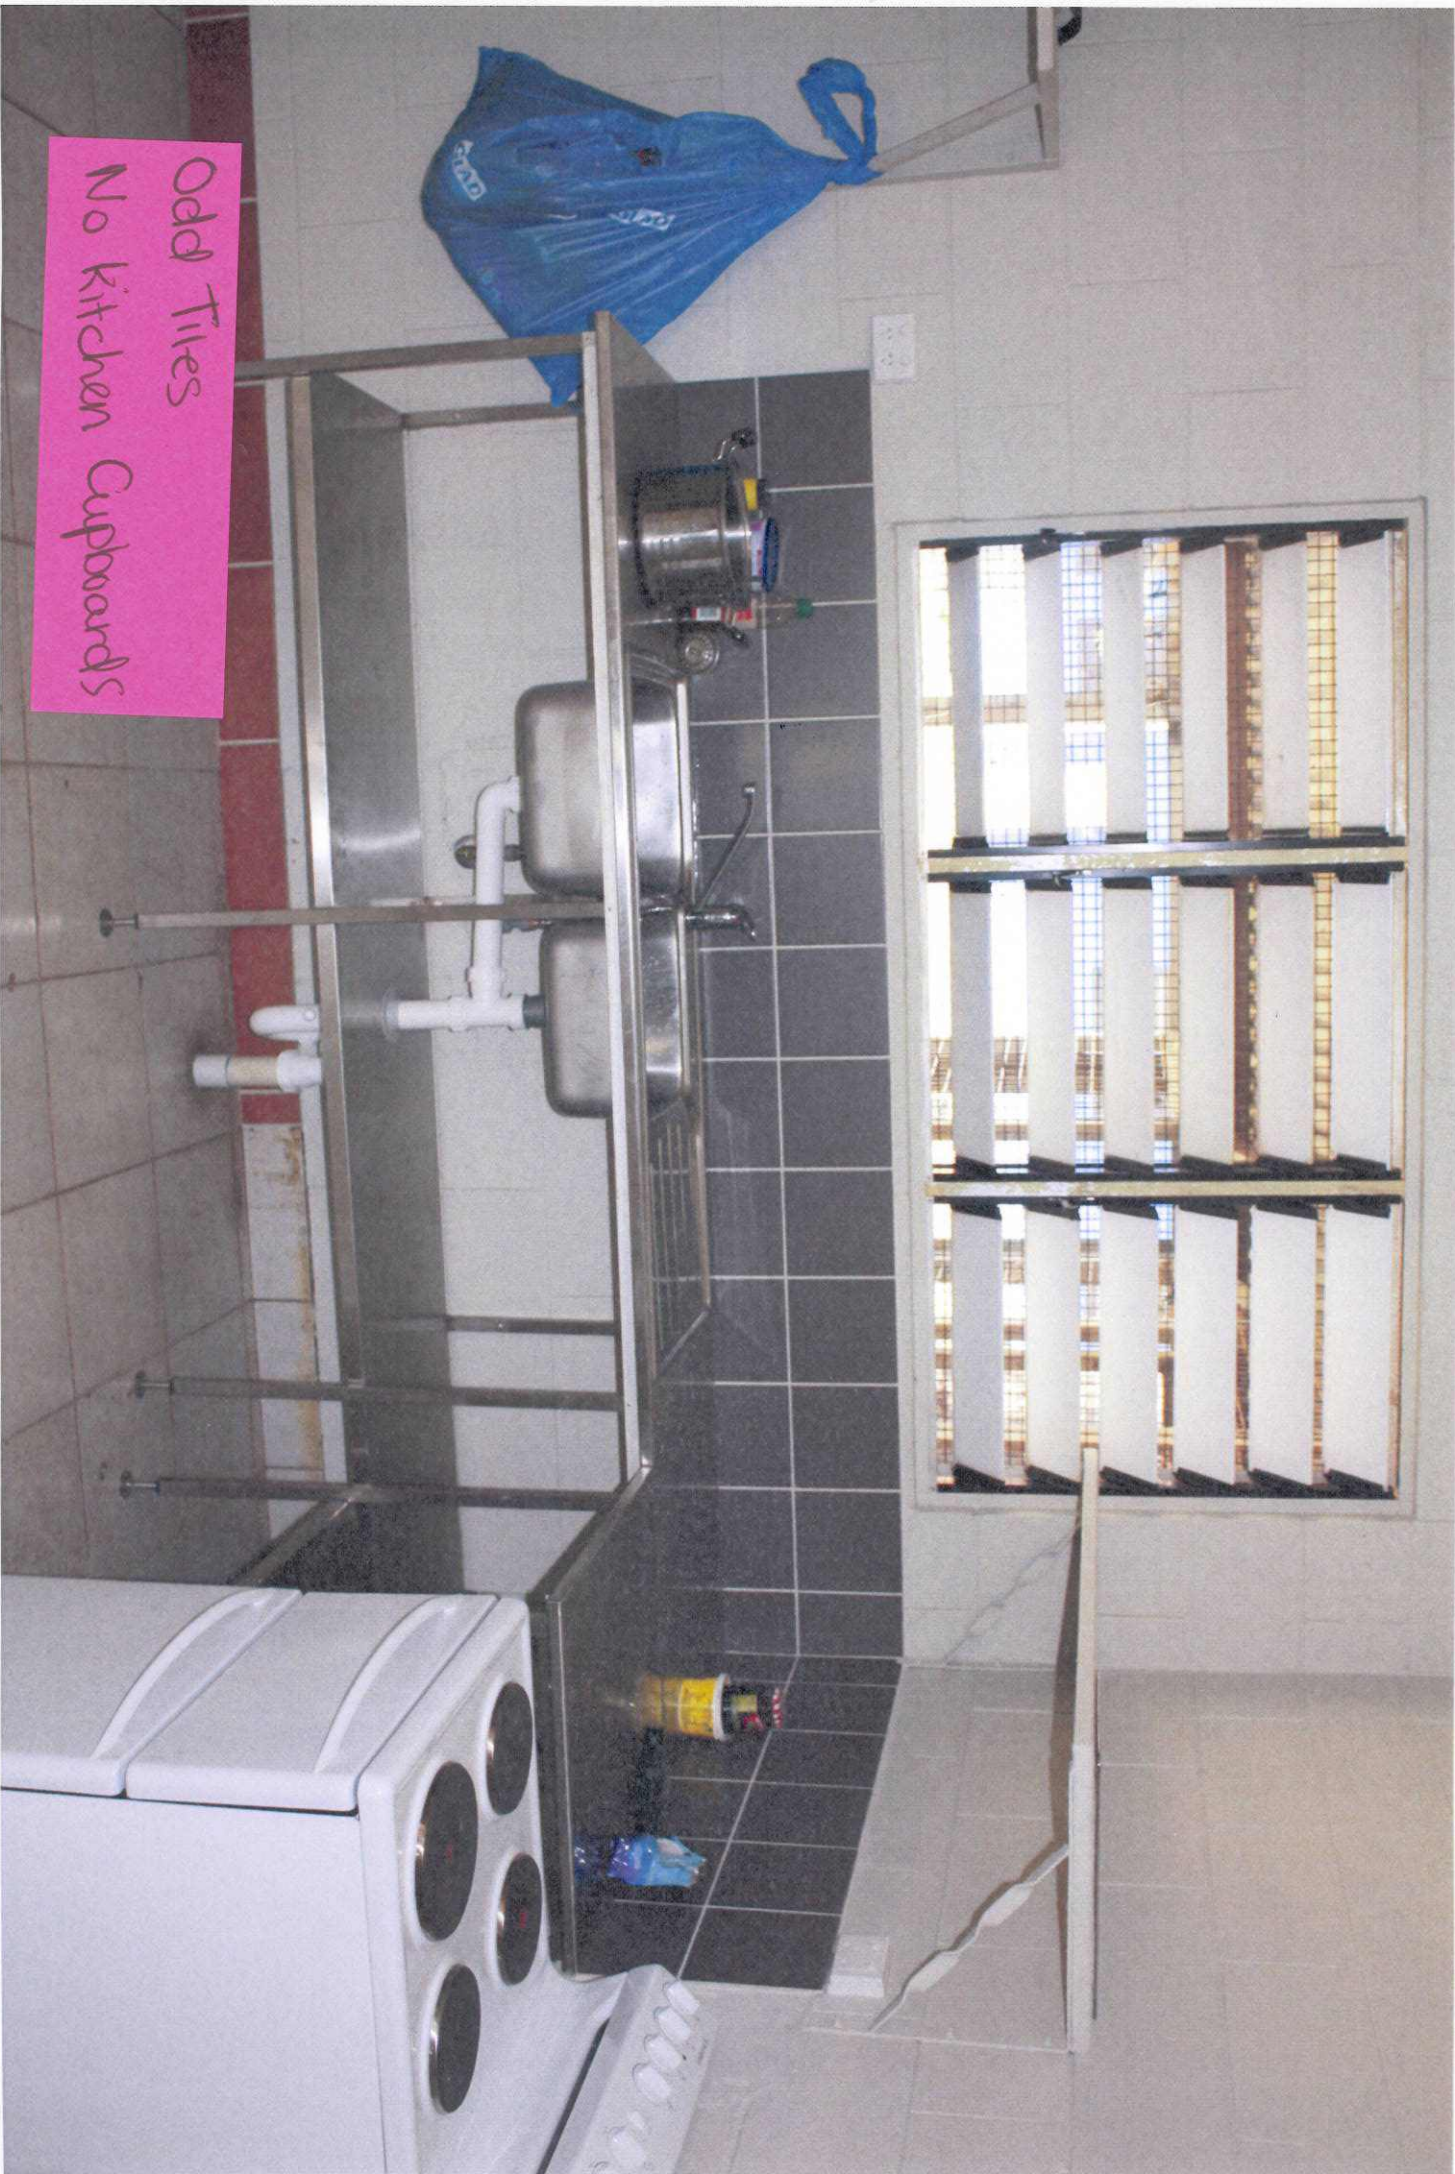
Odd Tiles
No Kitchen Cupboards
