# ENVIRONMENTAL INCIDENT NOTIFICATION REPORT

## WESTERN BASIN DREDGING AND DISPOSAL PROJECT

### Incident No. 014 36.3144-E-13.3.1-014 Oil Spillage Forklift Workshop 20111106

### Incident No. 011 Fuel Spillage Tug Pedro

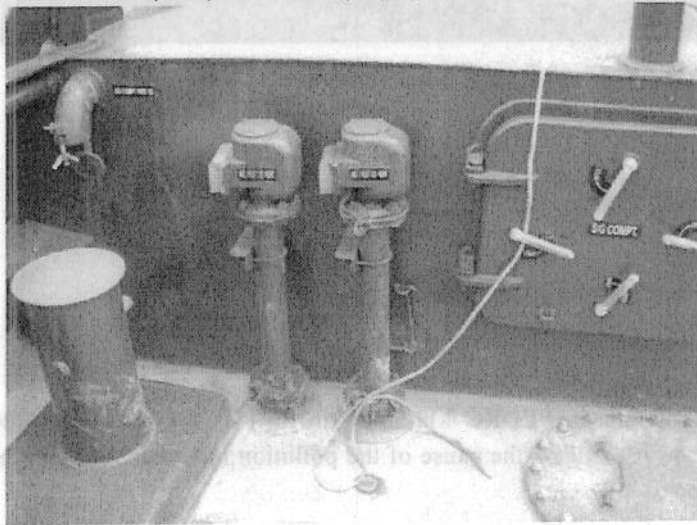
**Photo 1: PEDRO 1 Starboard (Left) & Centre (Right) Fuel Tank Vent**

Fuel spill from fuel tank through breather pipe onto deck, caused by thermal expansion of air. Unawareness of crew caused fuel to leak from deck into the water.

1. There are 3 fuel storage tanks located at the stern of the vessel (Port, Centre & Starboard)
2. The starboard and centre fuel tank vents are located on the starboard aft quarter (Refer Photo 1)
3. The tanks were filled to the normal capacity a few days prior to the incident
4. The crew maintain a slight list to starboard so that water can drain from the shower
5. As a result of the list and the fact the starboard fuel tank was at 88%, some fuel gathered in the horizontal section of the vent pipe causing a U bent effect
6. The air inside the fuel tank would certainly have expanded due to the ambient weather conditions and could not naturally vent due to the U bend effect created by the fuel
7. It would appear that the build up in pressure was sufficient to cause some of the fuel to be pushed out of the vent and onto the aft deck

I am of the opinion that the starboard fuel tank vent design cannot be changed without significant modifications. However, it would be relatively easy to fabricate a small tray that is connected onto the flange between the vent pipe and the vent unit similar to the examples in Photo 2 & 3. To fabricate and install this style of drip tray would not require hot work and could be done by shore-side technicians and installed by crew.

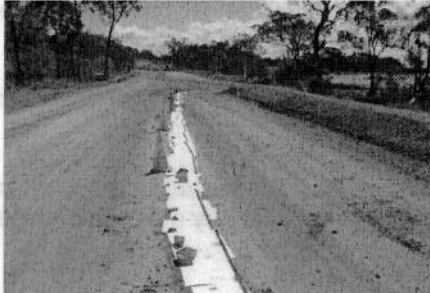
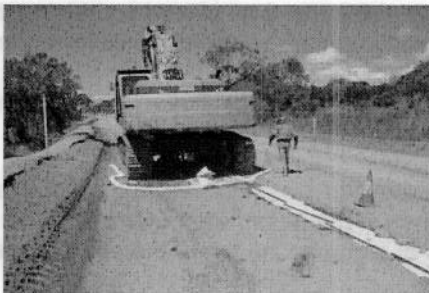
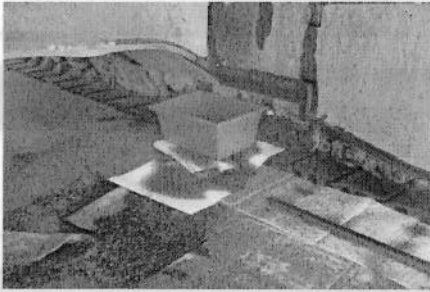
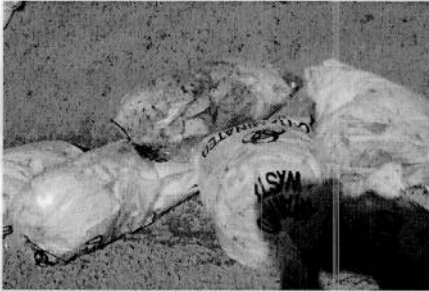
When moving the excavator the operator Trevor Puhi was notified by ABI personnel that the excavator was losing oil. After stopping the excavator the defect causing the oil leakage from the right hand track driving mechanism became apparent. The leakage had caused an oil trail of approximately 50 meters between the corners of the temporary shore access and the Northern temporary haul road.

Damaged/broken hydraulic hose right hand track driving mechanism

Between 10 and 15 litres of hydraulic oil was spilled on the road from the excavator driving mechanism. Oil spilled was contained and recovered by means of absorbing boom, patches and absorbent pellets. After the clean-up operation no remainders of oil were visible on the soil surface.

Proposed Actions to Prevent a Recurrence of the Release/Event			
No	Action/s Taken	Responsible Person	Due Date / Status
1.	Additional visual check of hydraulic system of driving mechanism prior operating	Operator	Ongoing
2.			
3.
