g Radiation survey of exposed tailings in the area around Rockhole mine

Internal Report 332

FEBRUARY 2000

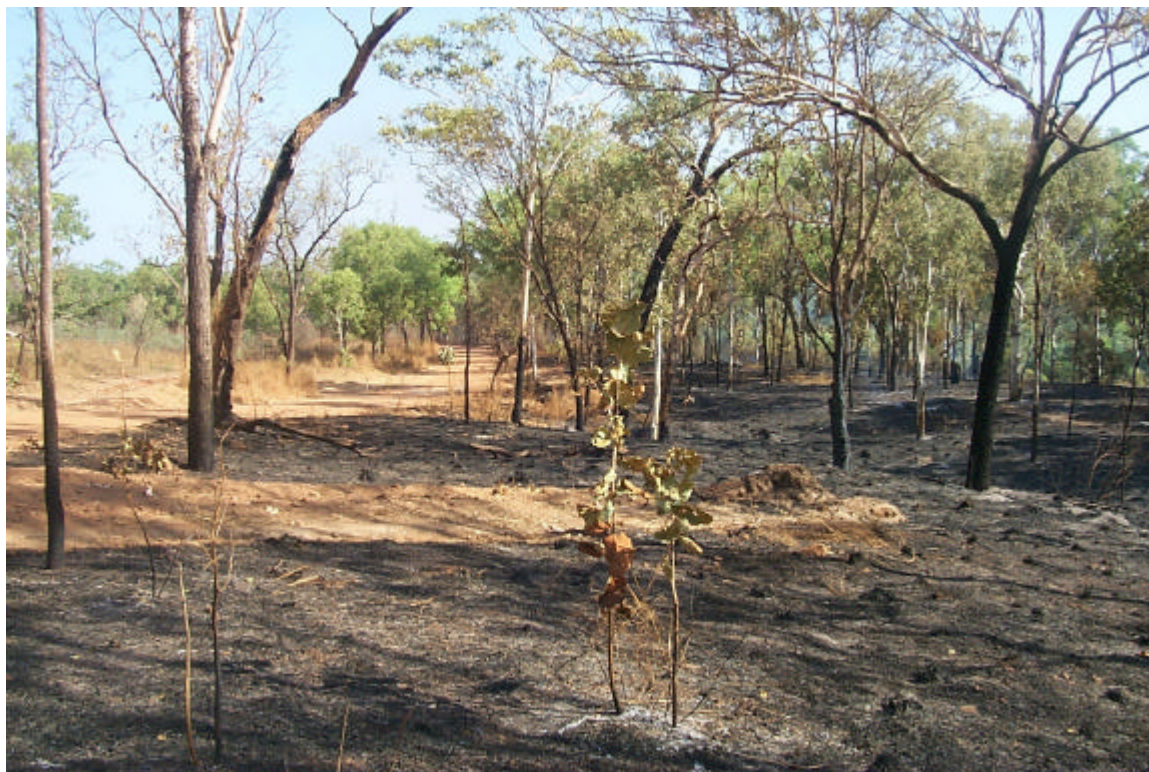
satisfactory under the hazard reduction program, had revealed significant amounts of exposed tailings material at the soil surface. Sample readings indicated that gamma radiation levels were sufficiently high to warrant further investigation. In addition there was evidence which suggested that recent road maintenance activities had spread the tailings into the windrows and adjacent areas of the road for a considerable distance westward of the site. The team was unable to perform a complete survey at the time and a more detailed survey was recommended in order to implement an appropriate intervention program. The photograph presented in figure 1, which was taken just after the site had been burnt off to facilitate access, shows the general topography of the area.

Figure 1. The erosion gully area near the Rockhole mine. The tailings dam area is in the clearing on the left-hand side of the photograph. The gully can be seen on the right. The photograph was taken from a position close to site S4 of Table 2, looking almost due south.

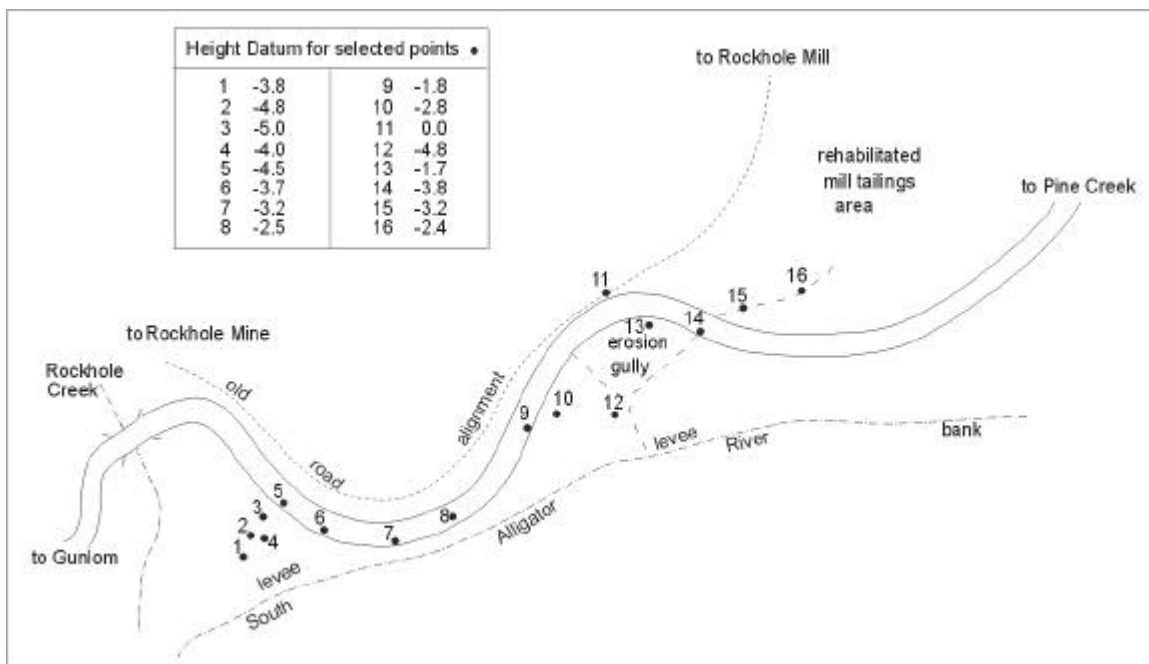
Following the hazard reduction works at Rockhole an extensive radiological survey of the mill site and surrounding area was conducted by *eriss* scientists and staff of the OSS in October 1991. The former tailings dam area was considered to be particularly important to survey because its leveled nature and proximity to the road and river made it a potentially attractive camping site. It was noted that the erosion gully was the main run-off for the road and the water catchments of the extended mill tailings dam area. Accordingly a survey of the gully area was also included in the 1991 program. As part of this survey, natural datum heights at selected points between the mill tailings area and RMC, and bounded by the road and the SAR, were measured. The results are presented in Figure 2; point 14 corresponds to the location where tailings material crossed the road.

Figure 2. South Alligator mill area map from the 1991 survey with selected datum heights.

The dose rate values presented in Figure 2 generally agree with those found during the analogue survey of the erosion gully area. However the shape of the category 4 zone has changed slightly over the intervening period. This change is most likely associated with topographic changes to the region, as a result of road maintenance activities and/or erosion, and also with the dispersal of both covering and tailings material via wet season surface waters. Accordingly, the apparent agreement between the dose rate value obtained at site S4 in the present survey ($\sim 3.0 \mu\text{Gy}\cdot\text{h}^{-1}$) and the mean of the dose rate values given in Figure 2 ($\sim 2.6 \mu\text{Gy}\cdot\text{h}^{-1}$) should not be over emphasized, and is perhaps a little surprising. However, the average dose rate within the category 4 zone is probably $\sim 2\text{-}3 \mu\text{Gy}\cdot\text{h}^{-1}$. The approximate upper limit on the direct gamma component of the whole body effective dose rate is therefore $\sim 18\text{-}26 \text{mSv}\cdot\text{y}^{-1}$ (Tims and Ryan (1998)), and hence to remain below the public dose limit of $1 \text{mSv}\cdot\text{y}^{-1}$ the total time spent within the category 4 zone should remain below 2 weeks per year. Given the small physical size of the zone it is considered unlikely that total occupation periods would exceed this limit.

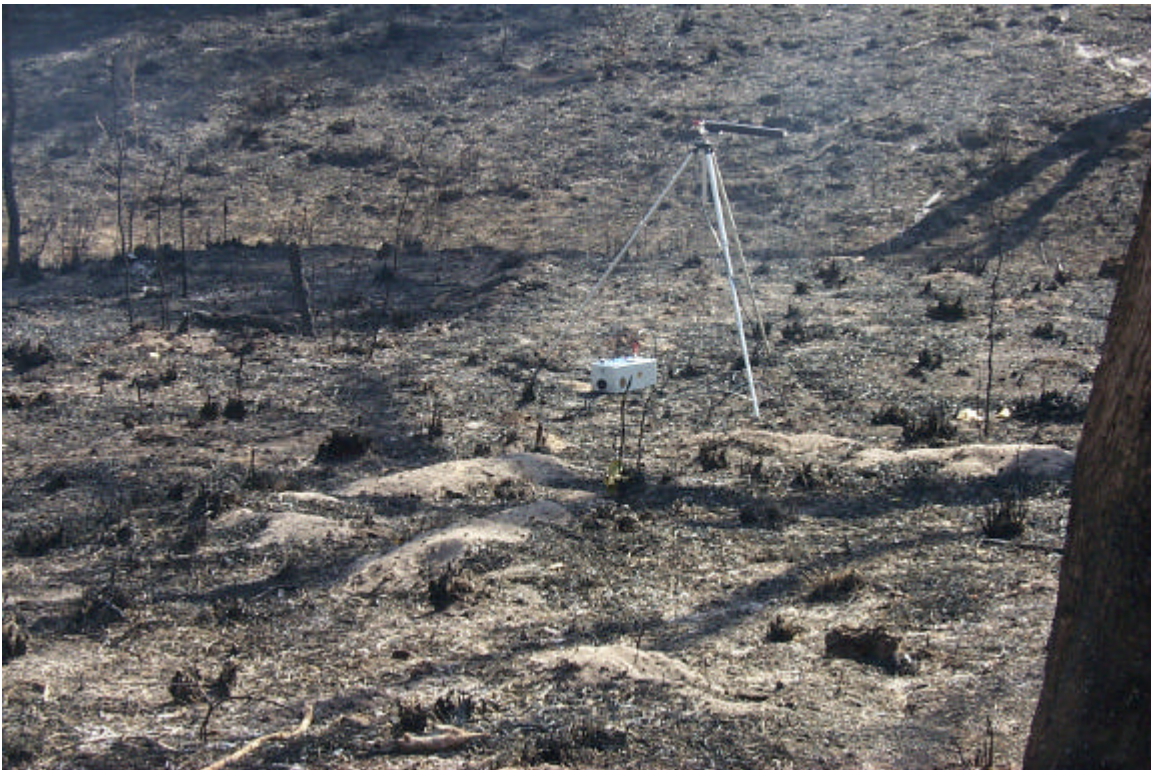
the analogue survey are presented in Figures 4 and 5. As can be seen in the photograph presented in Figure 6, which is of the location where the maximum dose rate was recorded, exposed tailings are clearly visible in the immediate area.

Figure 6. Exposed tailings at the erosion gully site to the west of the South Alligator mill tailings dam. This area is immediately adjacent to the road to Gunlom falls. Numerous small gray mounds, such as those visible in the center foreground below, are present between the bottom of the gully and the road and appear to be tailings.

1. The site be cleared of residual tailings to the greatest extent practicable at the earliest opportunity. A draft outline program of works is attached at Appendix B.
2. A special survey should be undertaken to establish if the roadway itself needs to be removed. Consideration should be given to sealing/surfacing the roadway as an alternative to total removal and re-building.
3. A consulting engineer should be engaged by PAN to establish if the integrity of the road's foundations will be threatened by the removal of the tailings deposits. If so the engineer will need to develop a strategy and design for the remedial works to restore the road to a safe and stable condition.

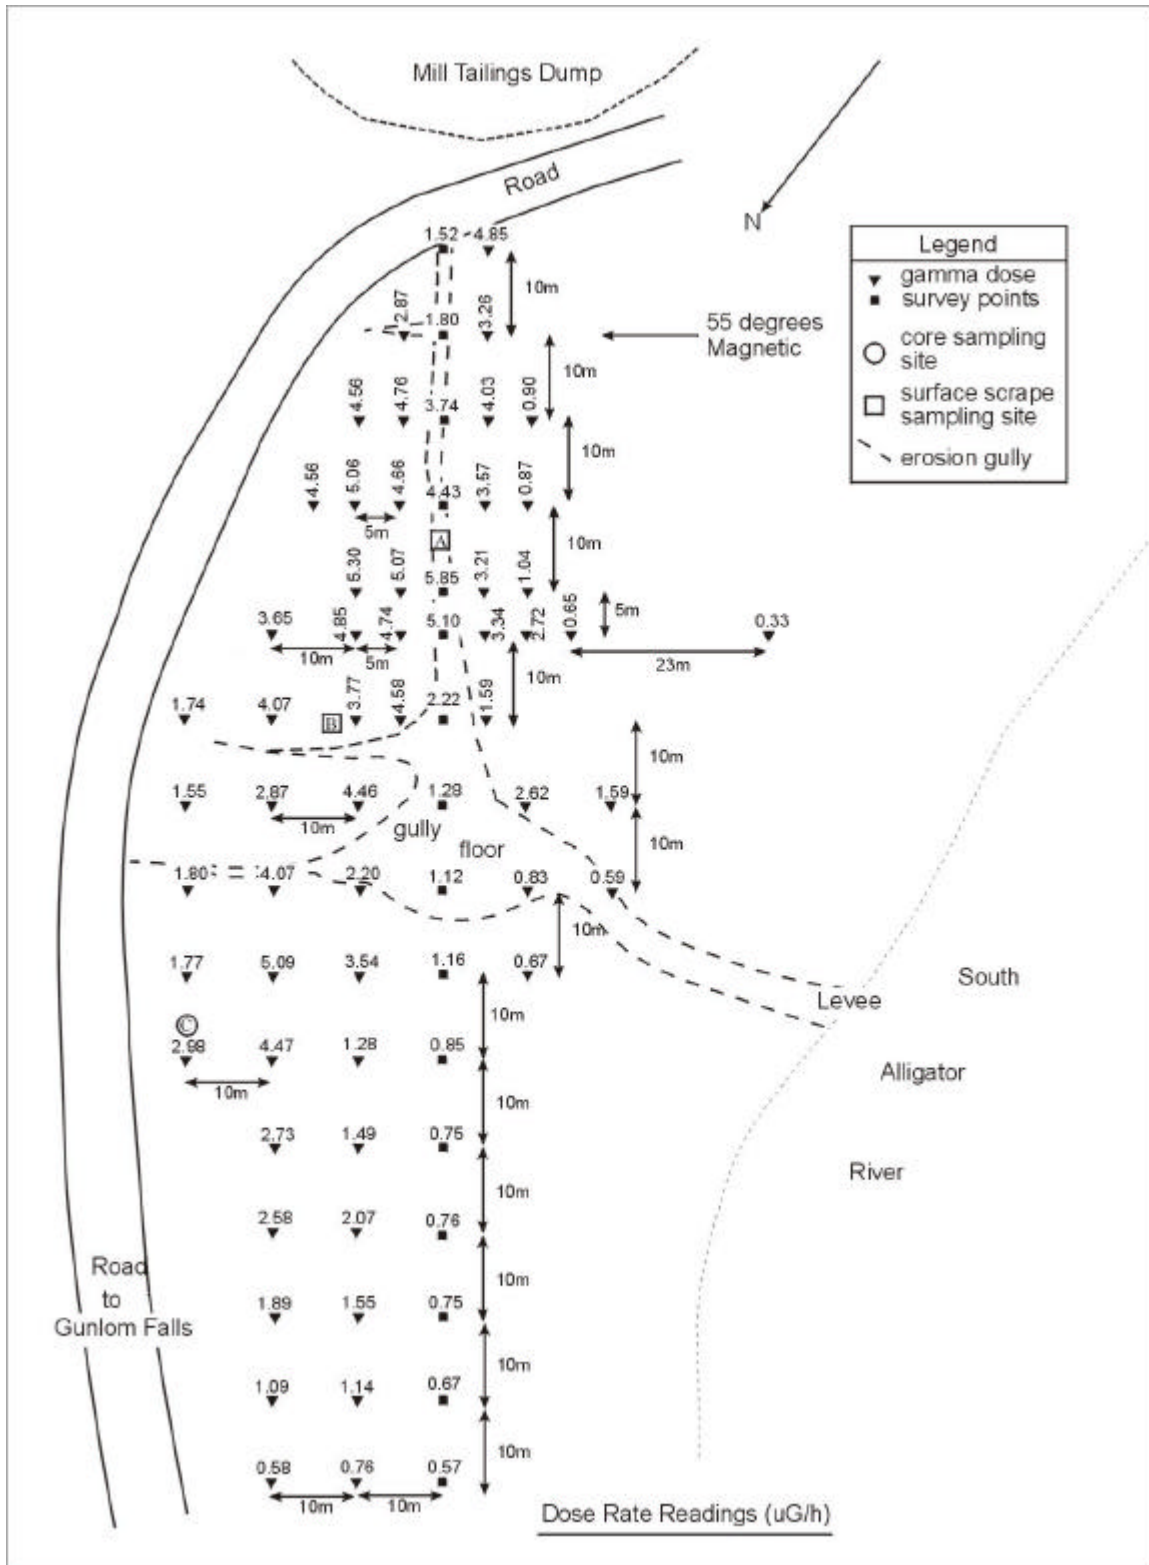
It was noted that gamma dose rates in the erosion gully were frequently $5\text{-}6 \mu\text{Gy}\cdot\text{h}^{-1}$, which was more than double the highest levels recorded over the (hazard reduced) tailings dam area at this time, the average for which was $\sim 0.9 \mu\text{Gy}\cdot\text{h}^{-1}$. Furthermore, at a distance of 150 m along the road in the downstream direction from the site, readings were still $0.5\text{-}1.0 \mu\text{Gy}\cdot\text{h}^{-1}$. The data from this survey are presented in Figure 3. Taken together, the datum height and gamma dose rate surveys are consistent with the proposition that tailings from the mill area were deposited along and across the road, following the natural datum heights, and were to a degree diluted with soils of the environment.

The location of 3 sites within the gully where soil samples were collected for high-resolution gamma spectroscopy analysis are also indicated in Figure 3. The results, which are presented in Table 1, show a strong disequilibrium between uranium and the other members of the decay series. Whereas the ^{230}Th , ^{226}Ra and ^{210}Pb activity concentrations within each sample are similar, the ^{238}U activity concentrations are much lower. This is as expected for uranium mill tailings; the milling process removes uranium (which is the desired product for sale) while the other radionuclides remain predominantly in the tailings.

Figure 3. Gamma dose rate readings from the 1991 survey of the erosion gully area at Rockhole mine.

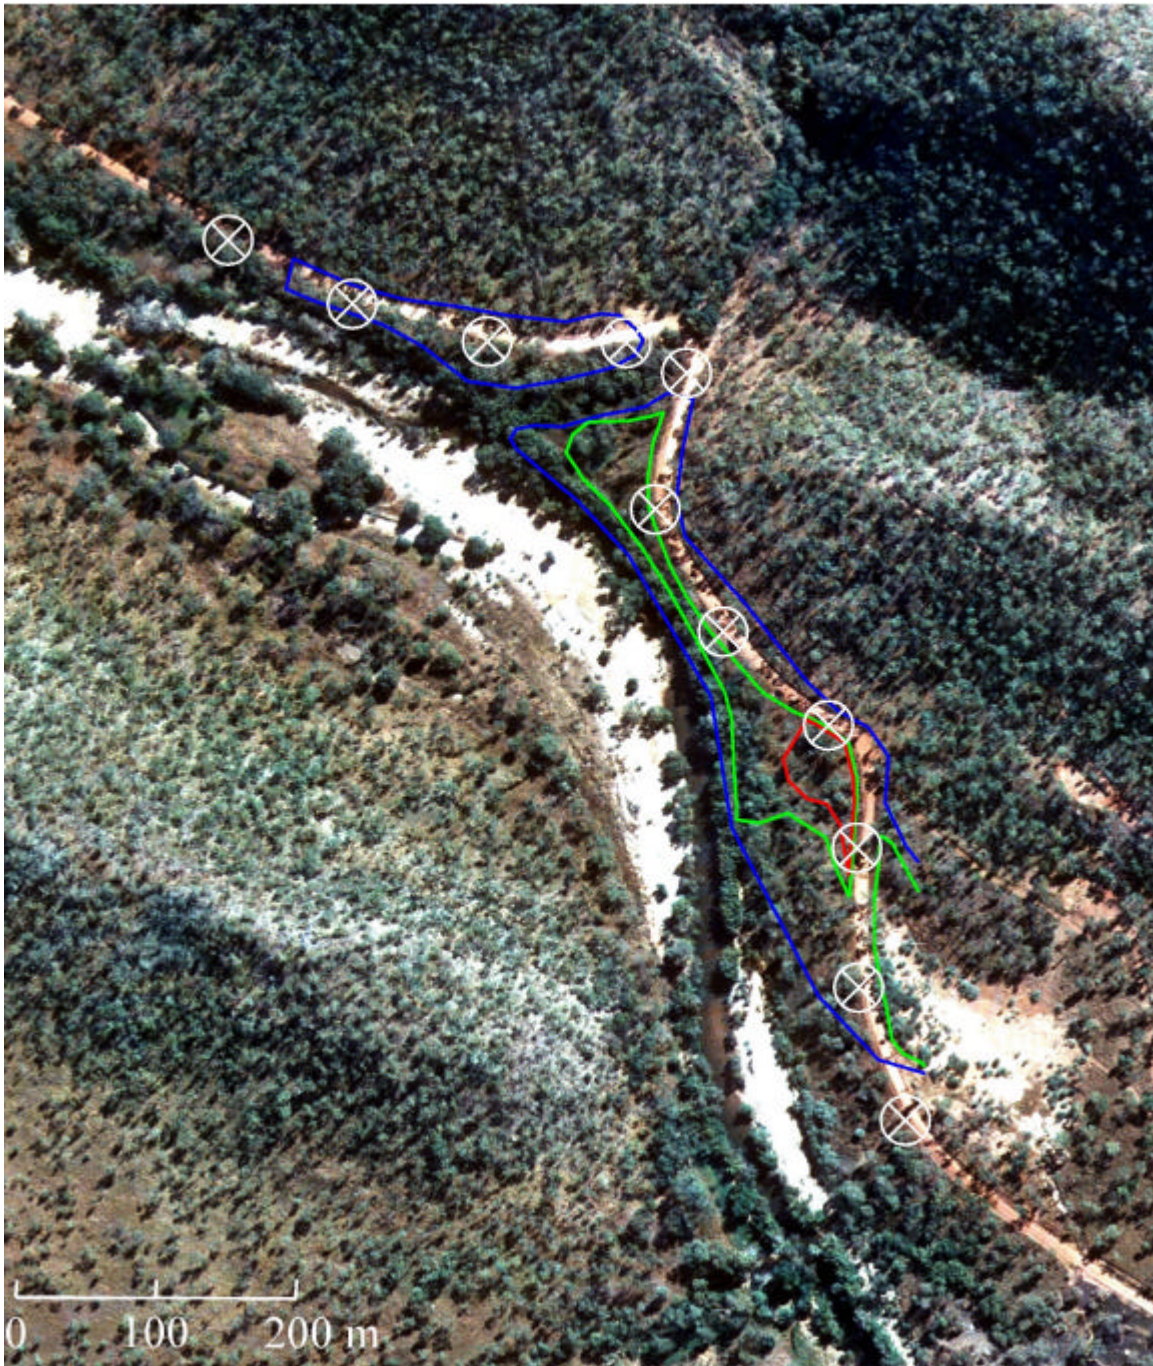
Measurements were made at 11 sites located sequentially at 100 m intervals along the road, in roughly an east to west direction. The location of each site is indicated in Figure 4. At each site a recording was made above the windrow on the southern edge of the road, and also on both sides of the road at 25 m distance from the windrow[†], measured at right angles to the road. Count periods of 300 s duration were used for each recording. The statistical error on each measurement was never more than 3.5 %, and was typically 2.1 %. The results for the terrestrial gamma dose rate are presented in Table 2. The first letter of each site label presented in Table 2 indicates where the recording was made: R refers to those measurements made close to the road (above the windrow), S to those made to the south of the road (towards the SAR) and N to those made to the north of the road. A contribution of $0.07 \mu\text{Gy}\cdot\text{h}^{-1}$, corresponding to the estimated cosmic ray background for the area, has been subtracted from the dose rate values recorded in the present survey. This estimate was taken from the work of Marten (1992).

A survey was made using the analogue meters to determine the extent of the affected area. The dose rate across the surveyed region was found to vary considerably, even over distances $\sim 2\text{-}3$ m. Accordingly, in order to facilitate the interpretation of the data, areas of similar activity have been classed together so that they fall into one of four categories. The terrestrial component of the gamma dose rate within a category 1 zone is largely in the range $0\text{-}0.14 \mu\text{Gy}\cdot\text{h}^{-1}$ and is probably typical of the local background for the SAR valley. In categories 2, 3 and 4 the dose rates fall into the general ranges $0.14\text{-}0.40 \mu\text{Gy}\cdot\text{h}^{-1}$, $0.40\text{-}1.0 \mu\text{Gy}\cdot\text{h}^{-1}$ and $1.0\text{-}6.0 \mu\text{Gy}\cdot\text{h}^{-1}$, respectively. The maximum dose rate recorded over the course of these recordings was $6 \mu\text{Gy}\cdot\text{h}^{-1}$. The results from

Figure 4. Aerial photograph of the Rockhole mine site area. The sites of the 11 measurements from the 1999 gamma dose-rate survey are indicated. The red, green and blue lines respectively correspond to the approximate extents of the category 4, 3 and 2 areas discussed in the text.

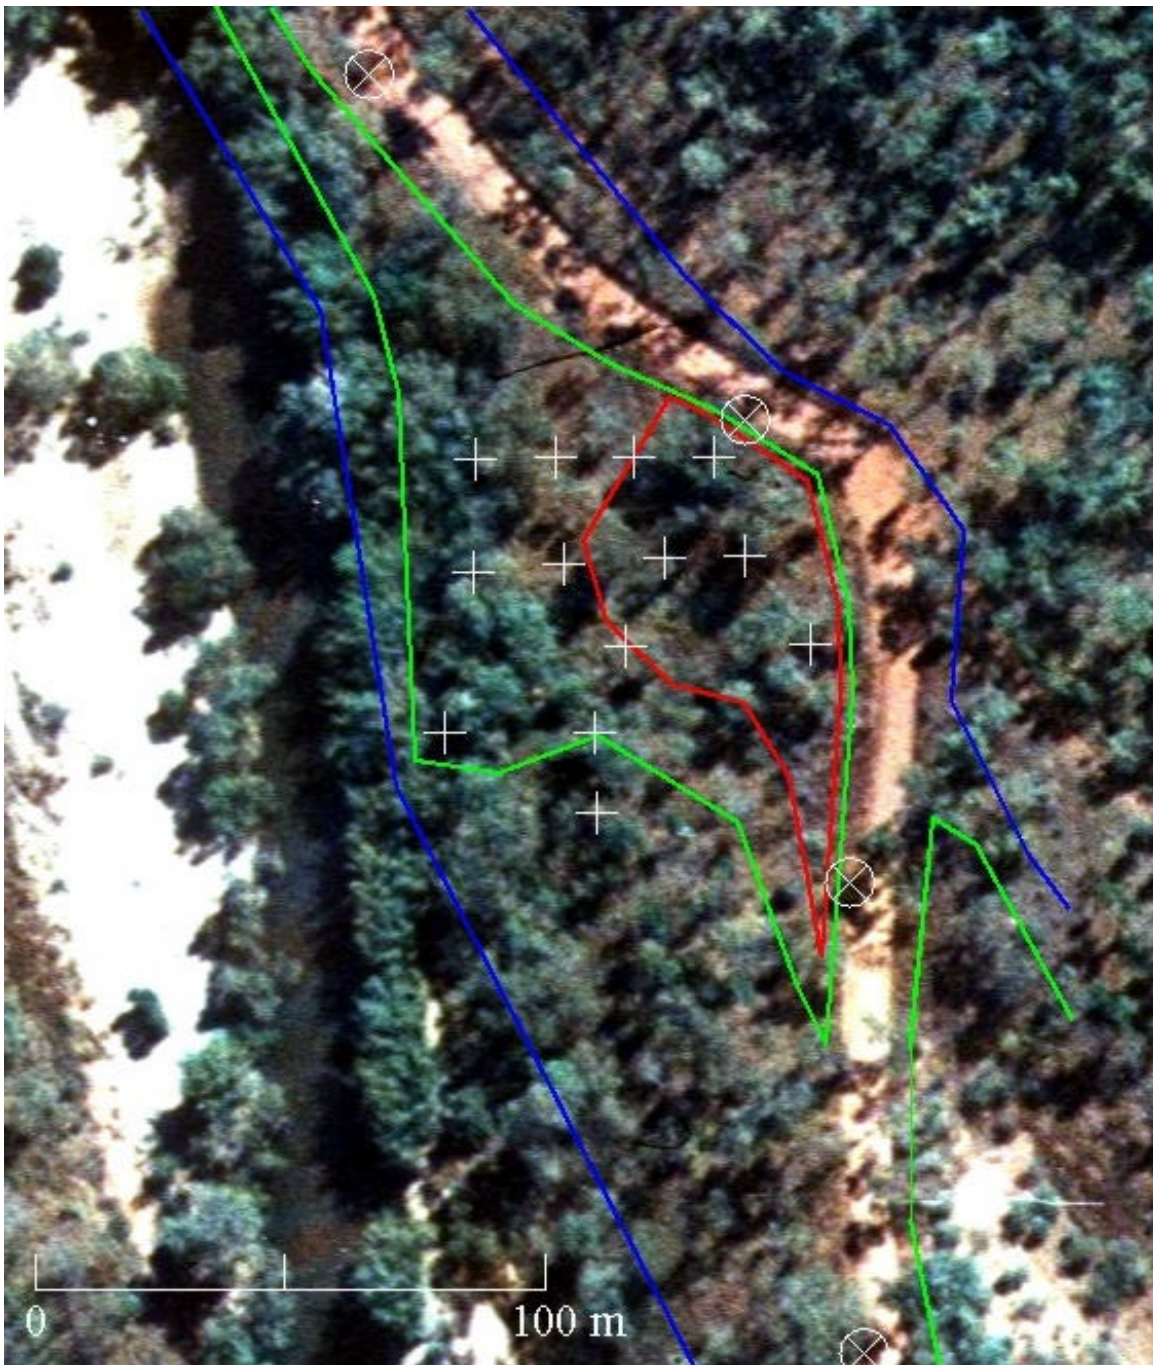
The auger samples suggested that most of the area surveyed was covered with a relatively thin layer of radioactive material. At most of the sites the samples showed that a considerable amount of tailings had become incorporated in the near surface layer with little evidence of undiluted tailings at depths below 150 mm. However, as can be seen in Figure 8, substantial tailings deposits of up to 1.5 meters thick, which was the maximum depth augered, were found within the category 4 region. Tailings extracted from the auger hole shown in Figure 8 has been laid out in two sections which correspond to the top ~25 cm and the lower ~25 – 150 cm of material. As can be seen in the photograph the extracted material is essentially undiluted tailings down to a depth ~120 cm, below which it progressively darkens in colour as it becomes mixed with local material.

Figure 5. Enlargement of the erosion gully area from the photograph presented in figure 3. Auger sites from the 1999 survey are indicated by + signs.

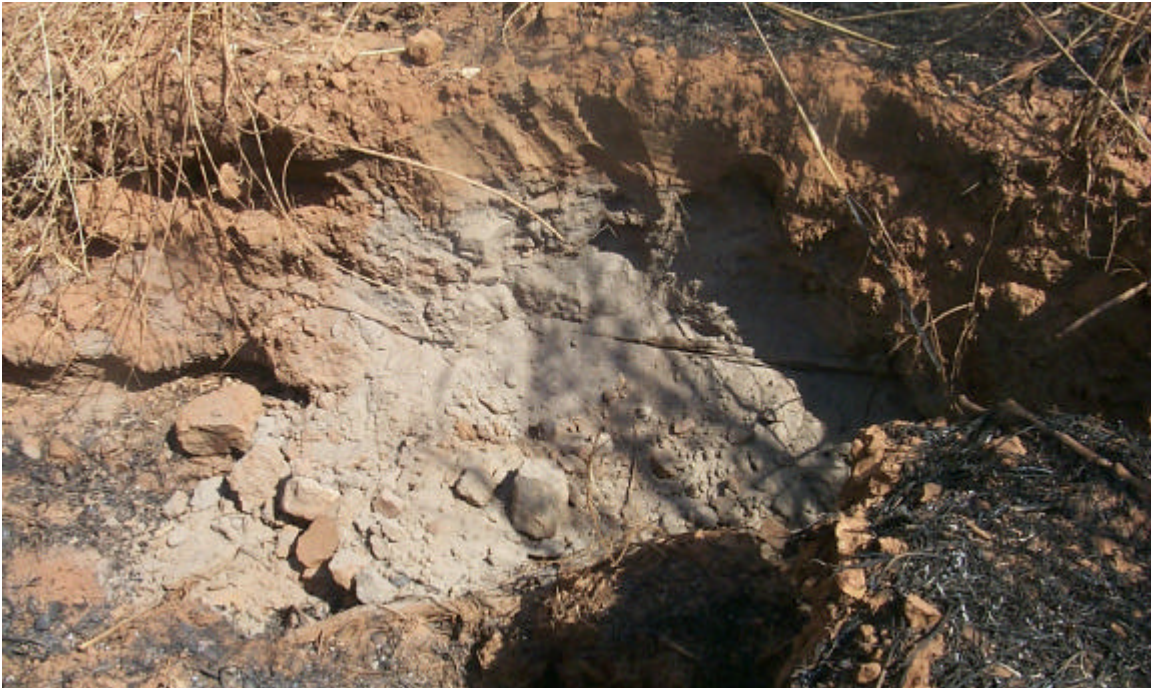
It is evident from a visual inspection of the area that more than one mechanism is responsible for the dispersal of tailings material. At least two locations close to the mill tailings dam area have been disturbed by road maintenance activities and tailings material has clearly been exposed. Furthermore, there are strong indications that the work has led to the dispersal of this material along the road for a considerable distance, and that this has happened on more than one occasion[‡]. Most of this dispersed material appears to be confined to the windrow on the southern side of the road, but elevated gamma radiation levels were also noted over some sections of the road surface, and over parts of the windrow to the north of the road. However, the exact distance over which dispersal can clearly be attributed to the road maintenance activities is somewhat unclear. The northern boundary of the above background regions that lie to the north of the Gunlom road appear to coincide with what could reasonably be expected to be the typical maximum flood height of the SAR. The reappearance of above background areas to the west of the RMC- SAR confluence also indicates that at least some of the material has been dispersed via wet season surface waters[§]. It is almost certain that some of the dispersed material will have been deposited along the road. In addition the elevated gamma dose rate results at sites N1, N2 and N3 support the original observations that tailings material was also transported directly from the mill area, via the breach in the southwestern corner of the tailings dam and across the road, into the southeastern tip of the erosion gully area.

Figure 7. Tailings material covered with local soil as a result of road maintenance activities. This photograph was taken on the northern edge of the category 4 zone.

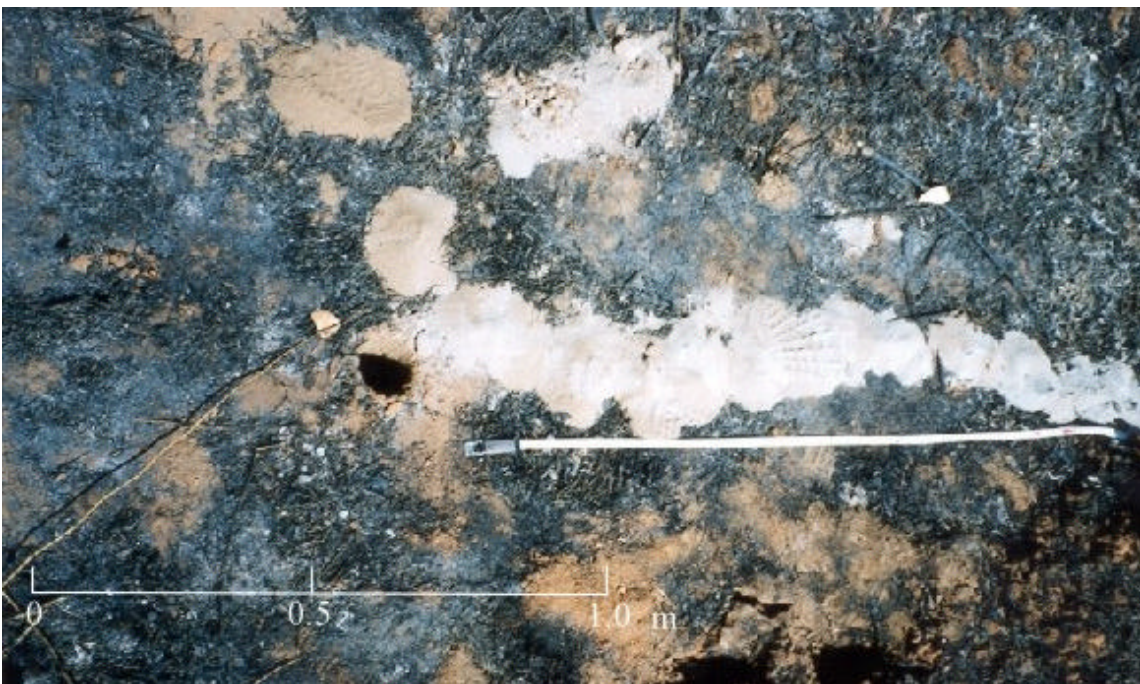
However, the depth of the tailings material in the auger samples from the category 4 area, and their essentially undiluted appearance, implies that the bulk of the radioactive material in the erosion gully has not been deposited as part of the natural dispersal of tailings from the mill area. Indeed, the datum heights from Figure 1 show that the northeastern side of the category 4 area was higher than the point where material from the tailings dam crossed the road, and that sites B and C could well have been up to 2 m above this point. Similarly, as can be seen in Figures 4 and 5, in the vicinity of the erosion gully the northern boundary of the above background region is very close to the road. Hence surface water transport of material from the mill area to the northern

Figure 8. Tailings material removed from an auger hole in the category 4 zone. The surrounding brown/yellow soil can be seen as patches in the black/gray background (which is largely ash from the recent burn off). The undiluted tailings are light gray in colour and comprise all of the material removed from the 1.5 m hole.
