**Australian Government**  
**Department of Immigration**  
**and Citizenship**

**Submission**

**Subject** **Infrastructure Report on Nauru**

1. This version updates the original CB2012-00071 now that updated costings are available (Attachment A).
2. Departmental officers travelled to Nauru to inspect the two previous processing centres on Nauru on 3-4 January 2012. The sites are known as Topside and State House. A map of Nauru is at Attachment B. Photos of the sites as originally provided are available if required..

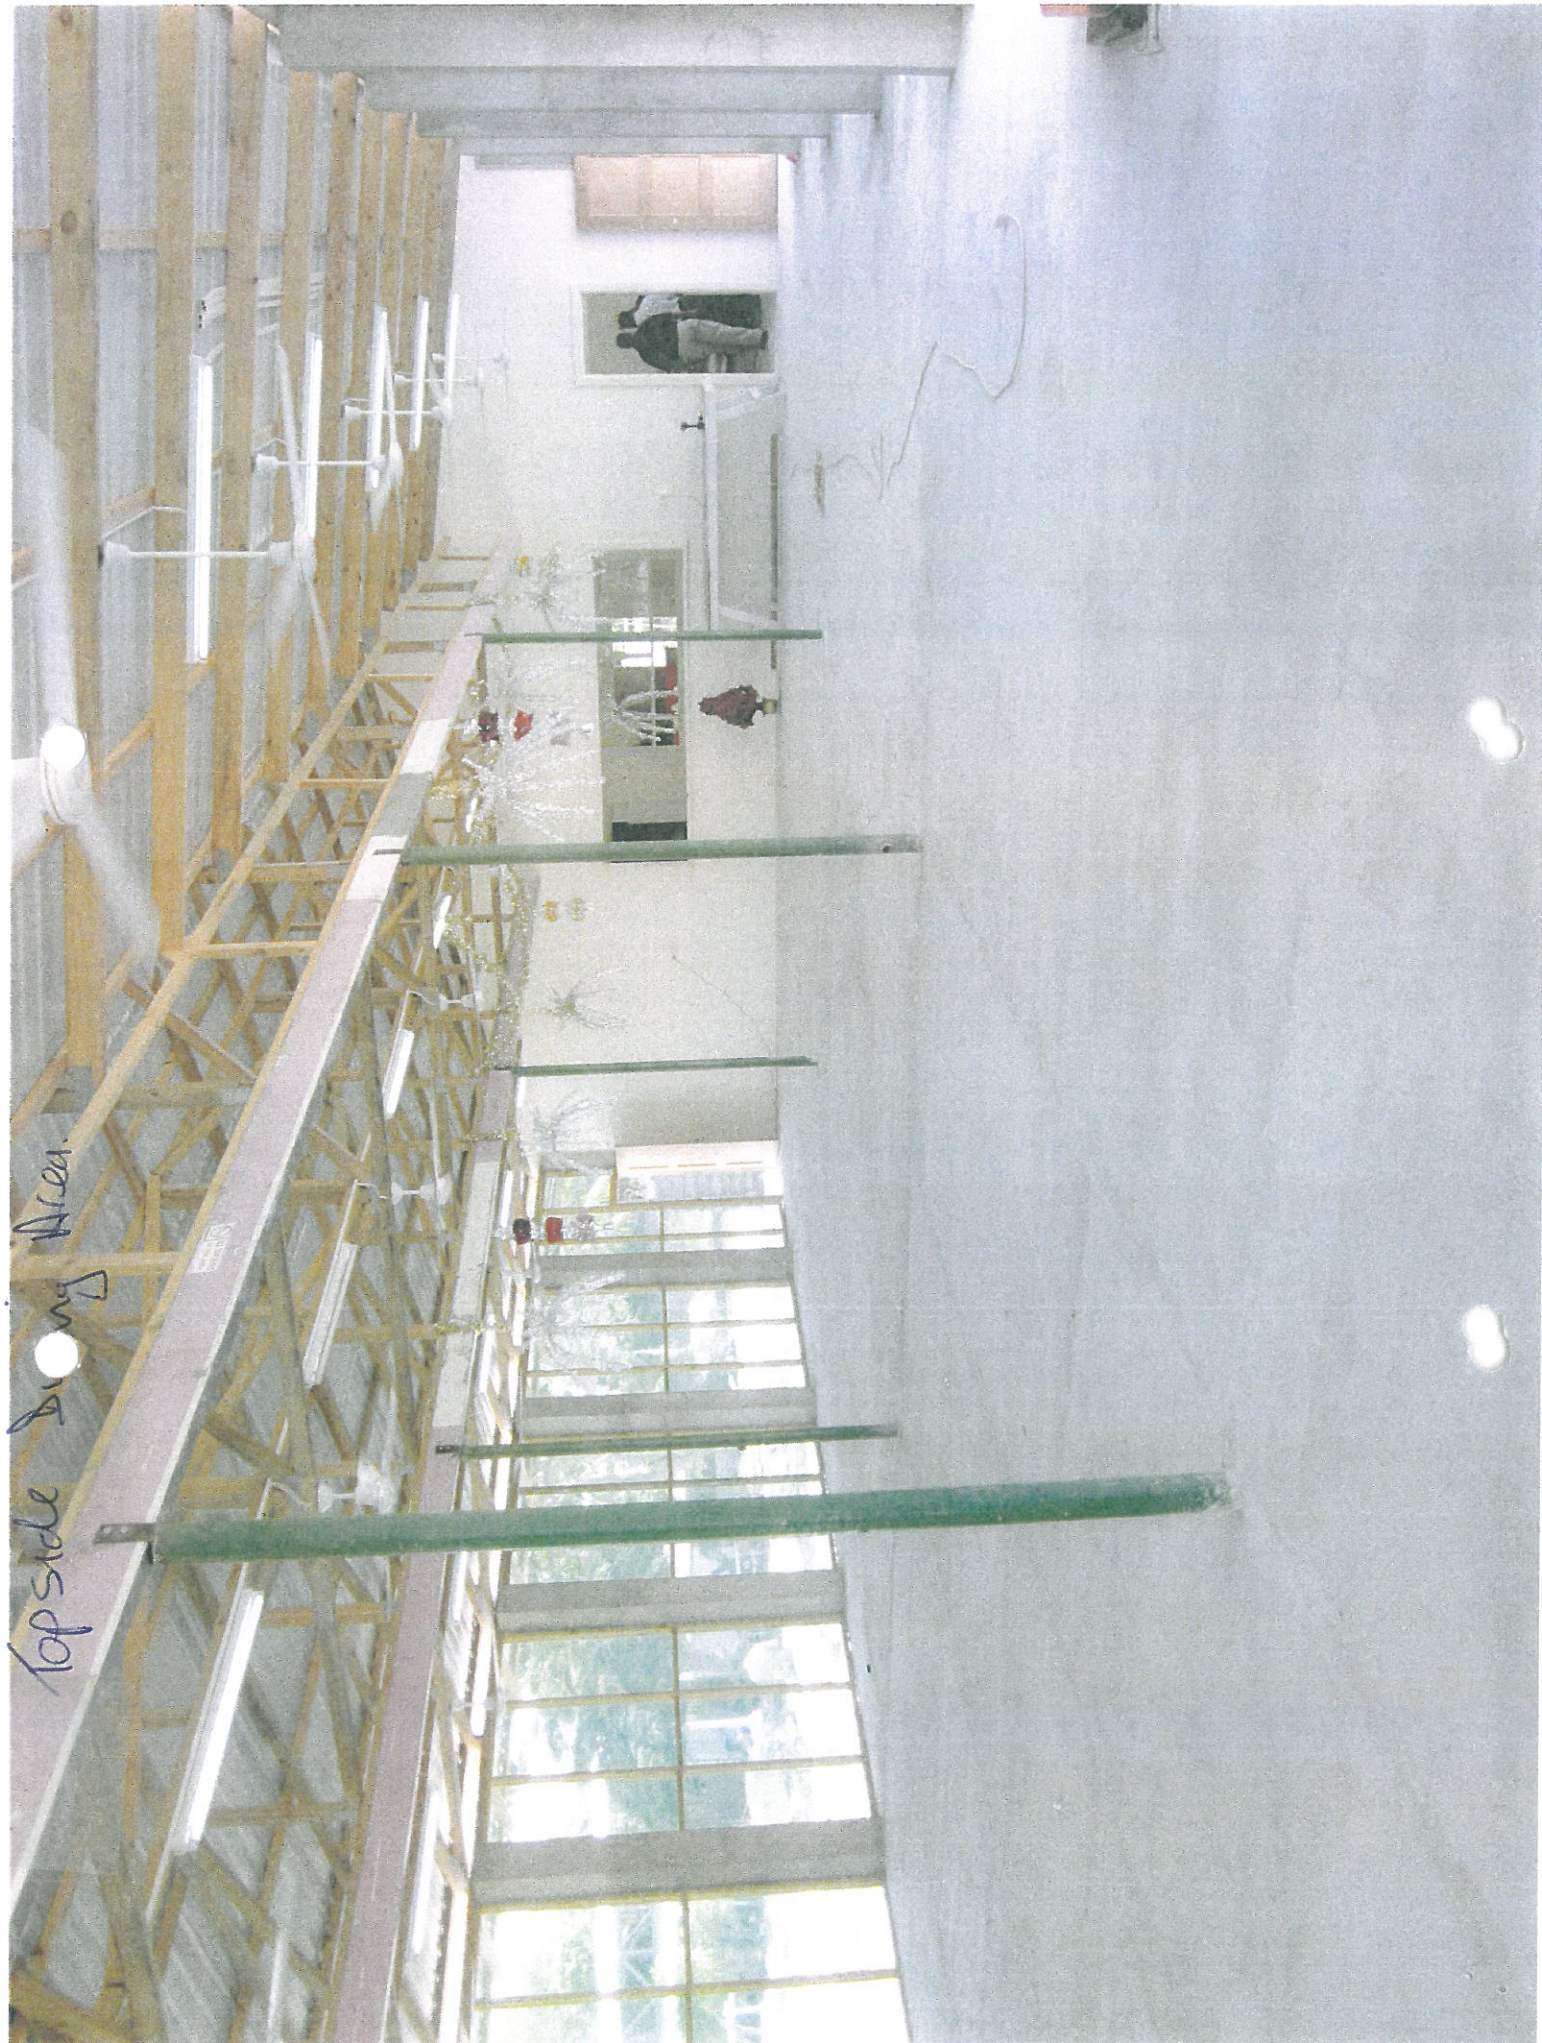
Top side Dining Area.

22. The site has reasonable kitchen and dining facilities. Additional cooking equipment would be required if the site became operational.

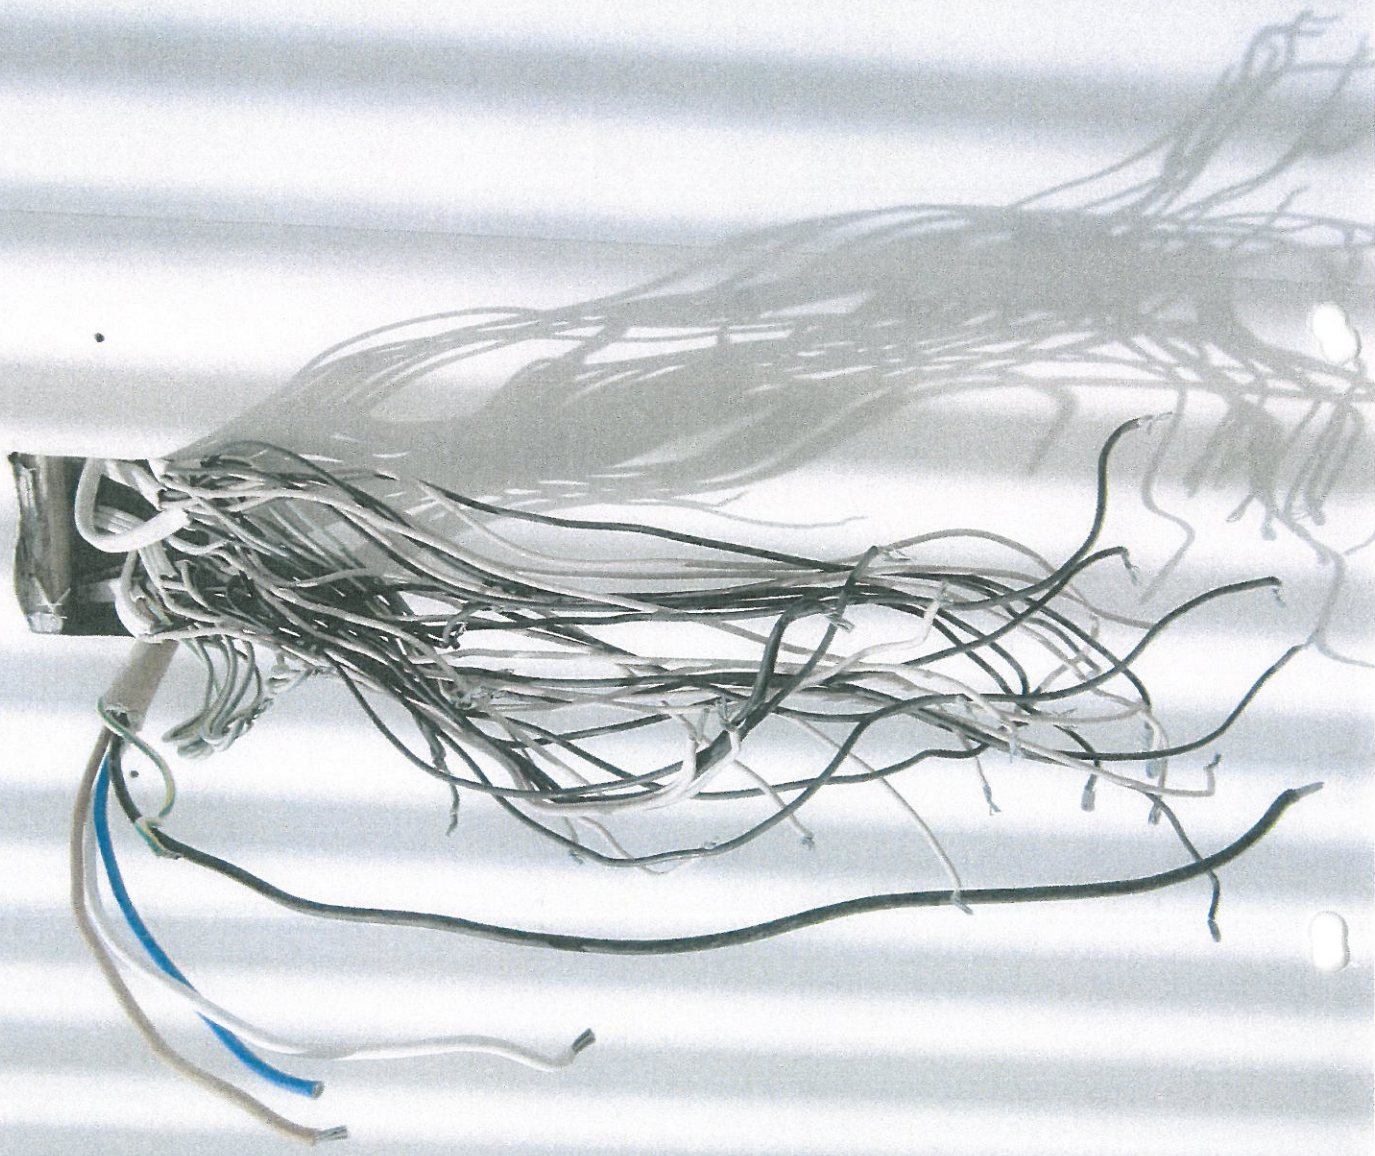
Switch boards from red.  
Top side

17. The accommodation buildings that have not been removed from the site have all been uplifted and sat at the back of the site. They are not installed or connected to services. All buildings need refurbishment, ranging from replacement of broken windows, repair of water leaks, installation of air conditioners, and replacement of floors and ceilings. A number of buildings have had walls removed and in some cases floors removed. Most have all electrical fittings removed.

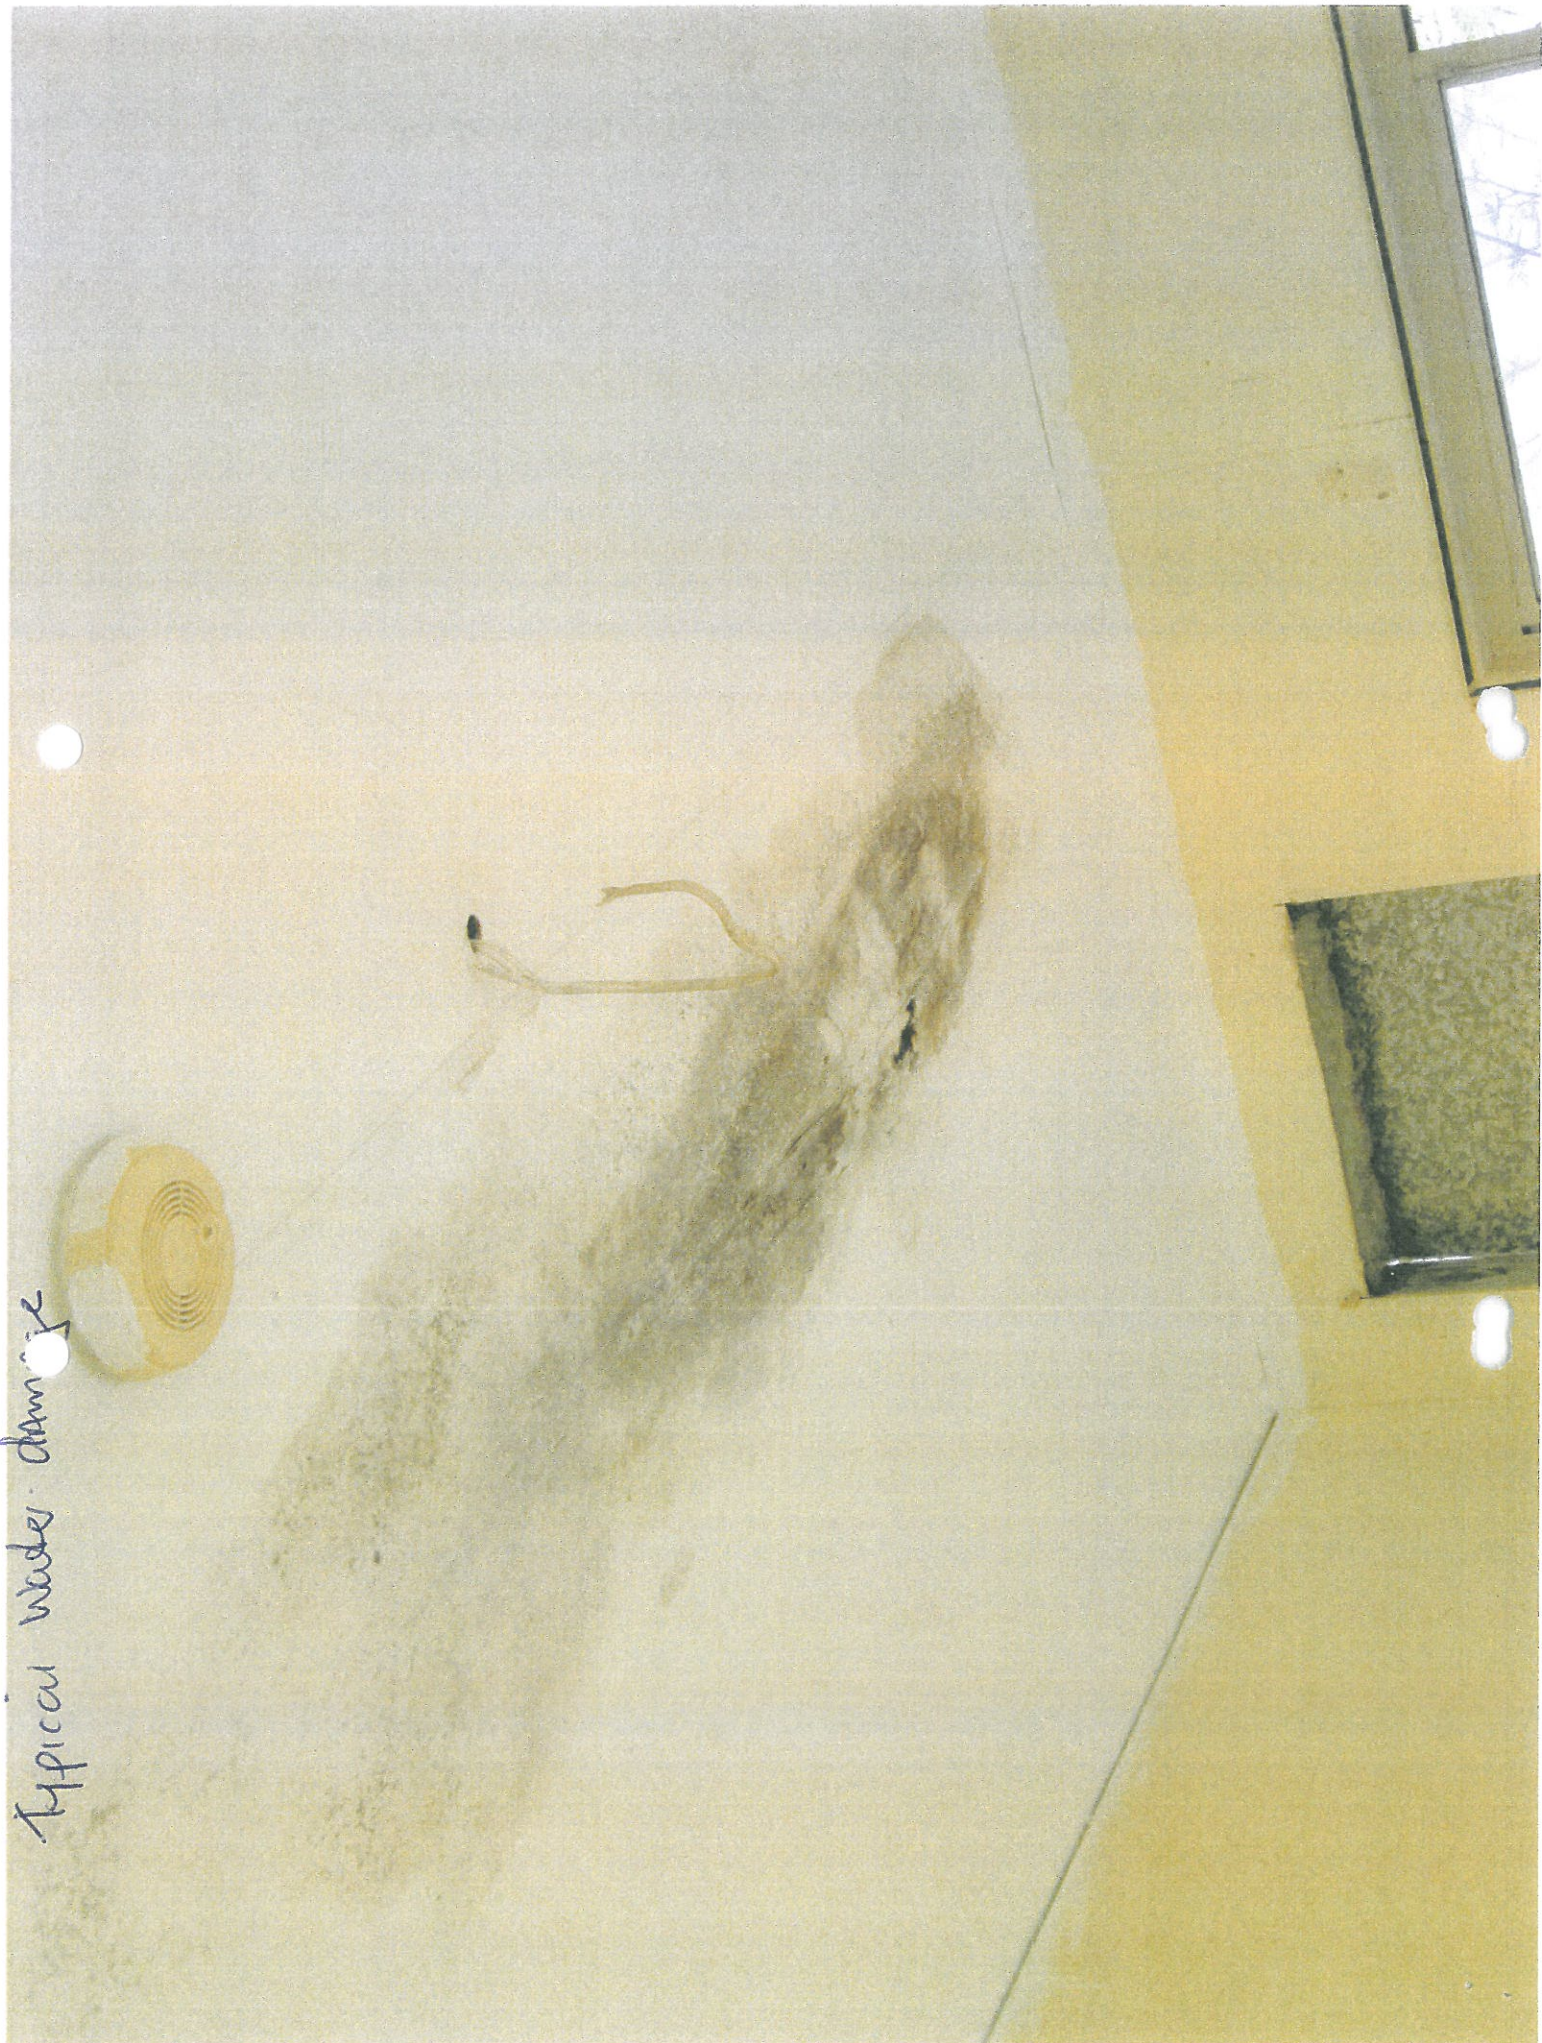
Typical water damage

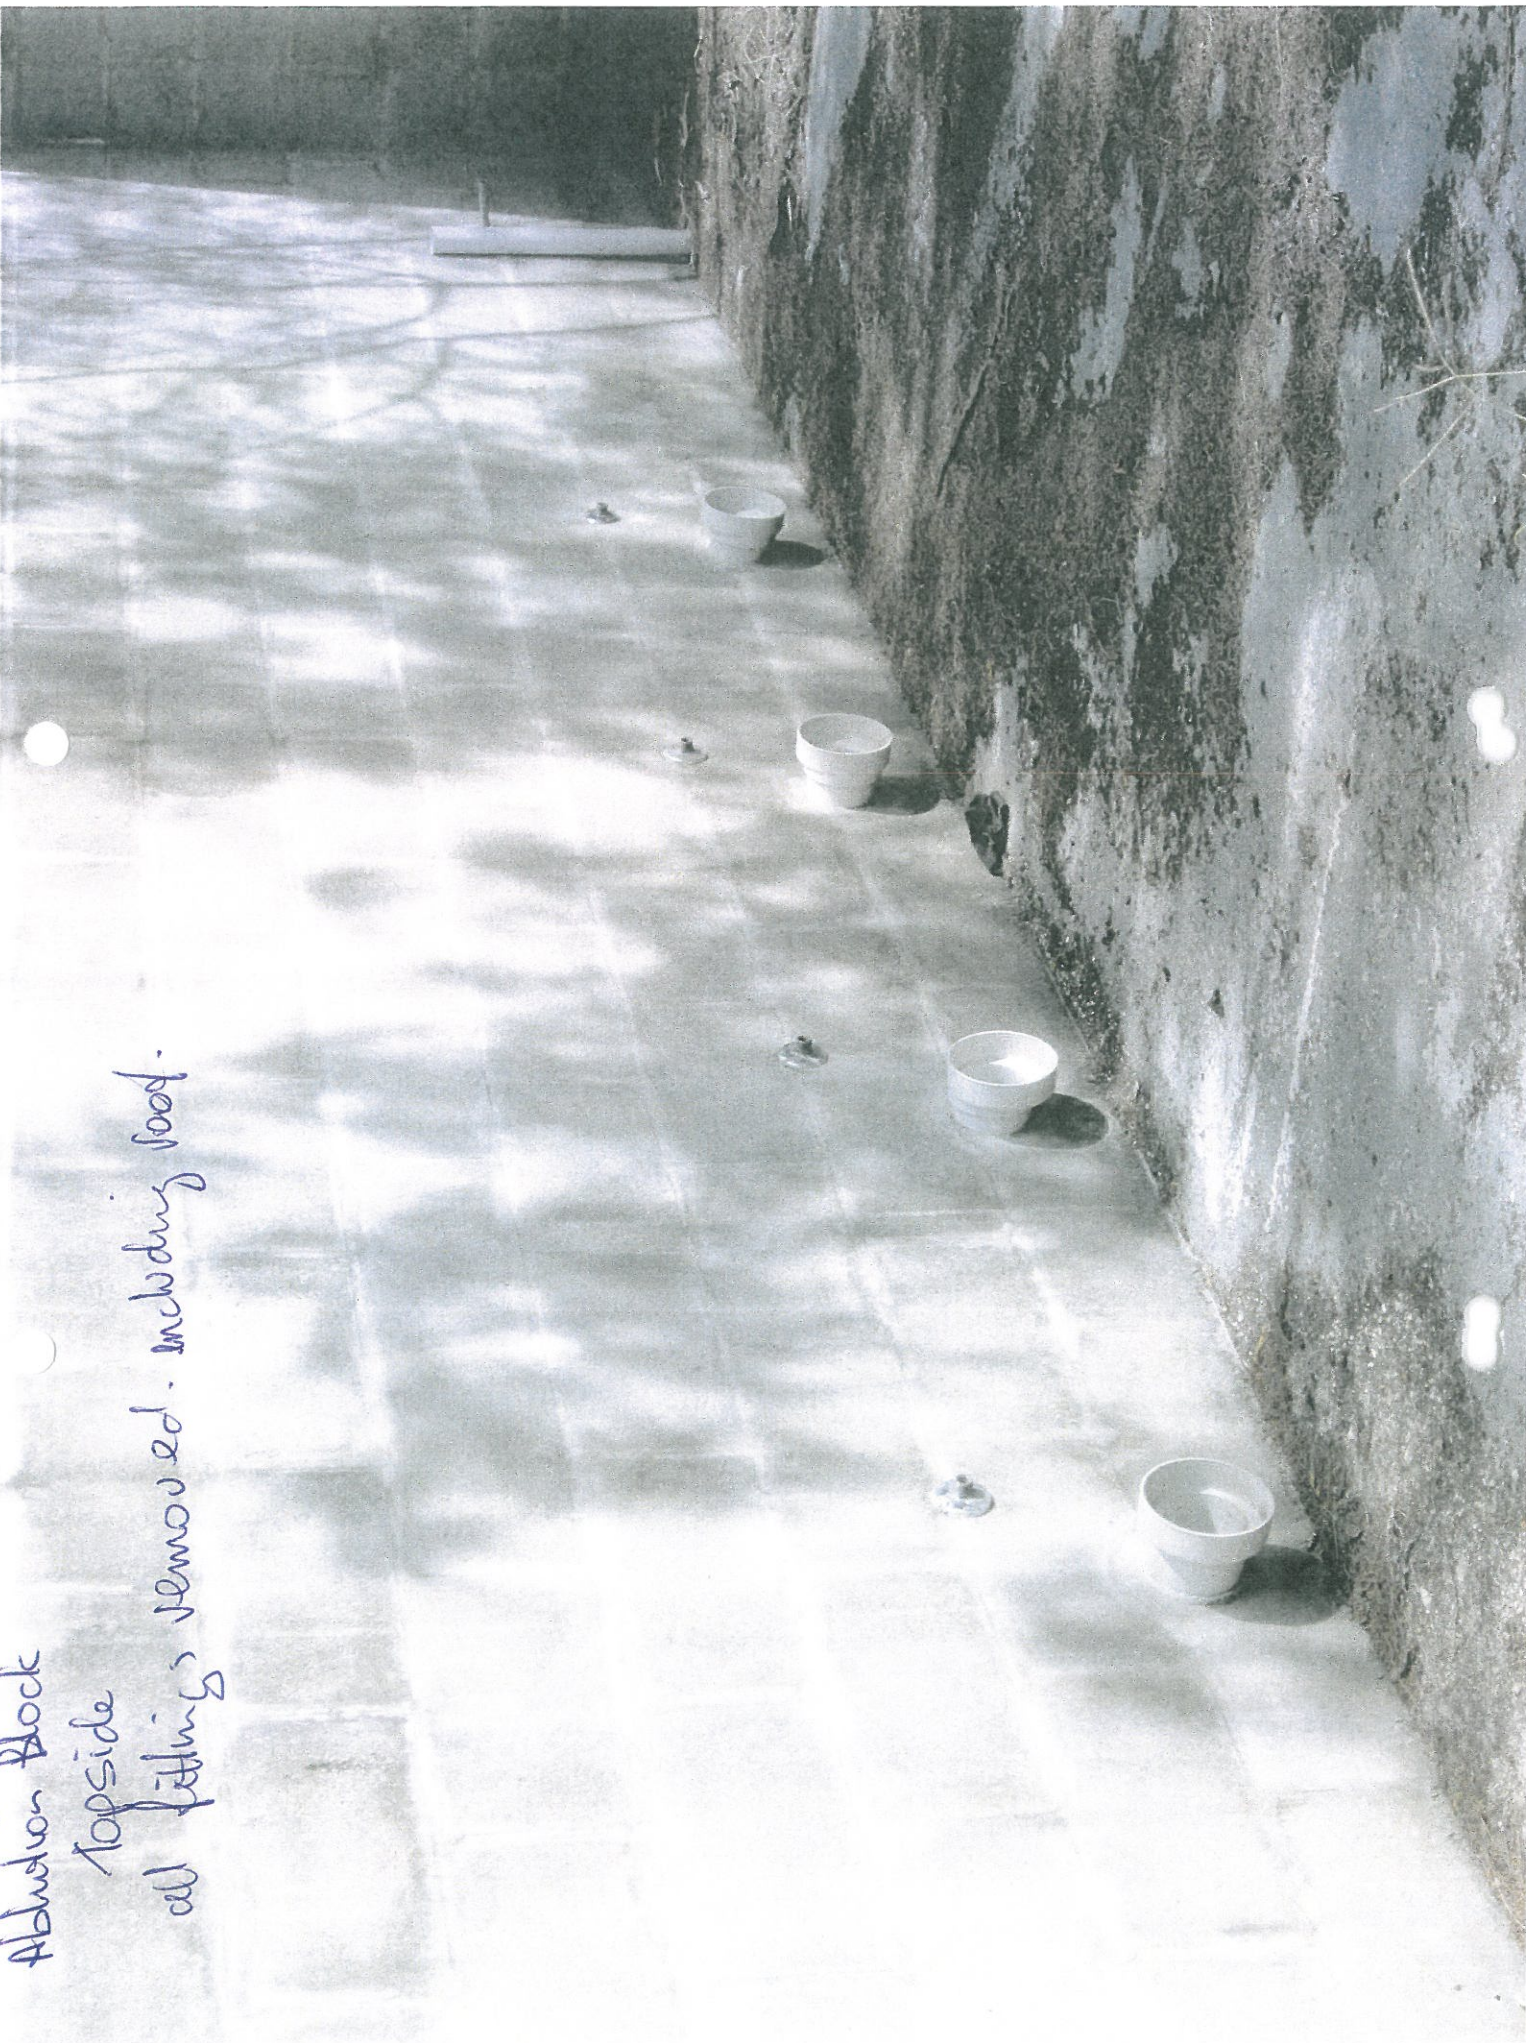
Abductor Block  
Topside

16. Major issues at this site include no ablution blocks, no permanent water supply, no shade, no recreational facilities and no operating waste water treatment plant.

all fittings removed - including roof.

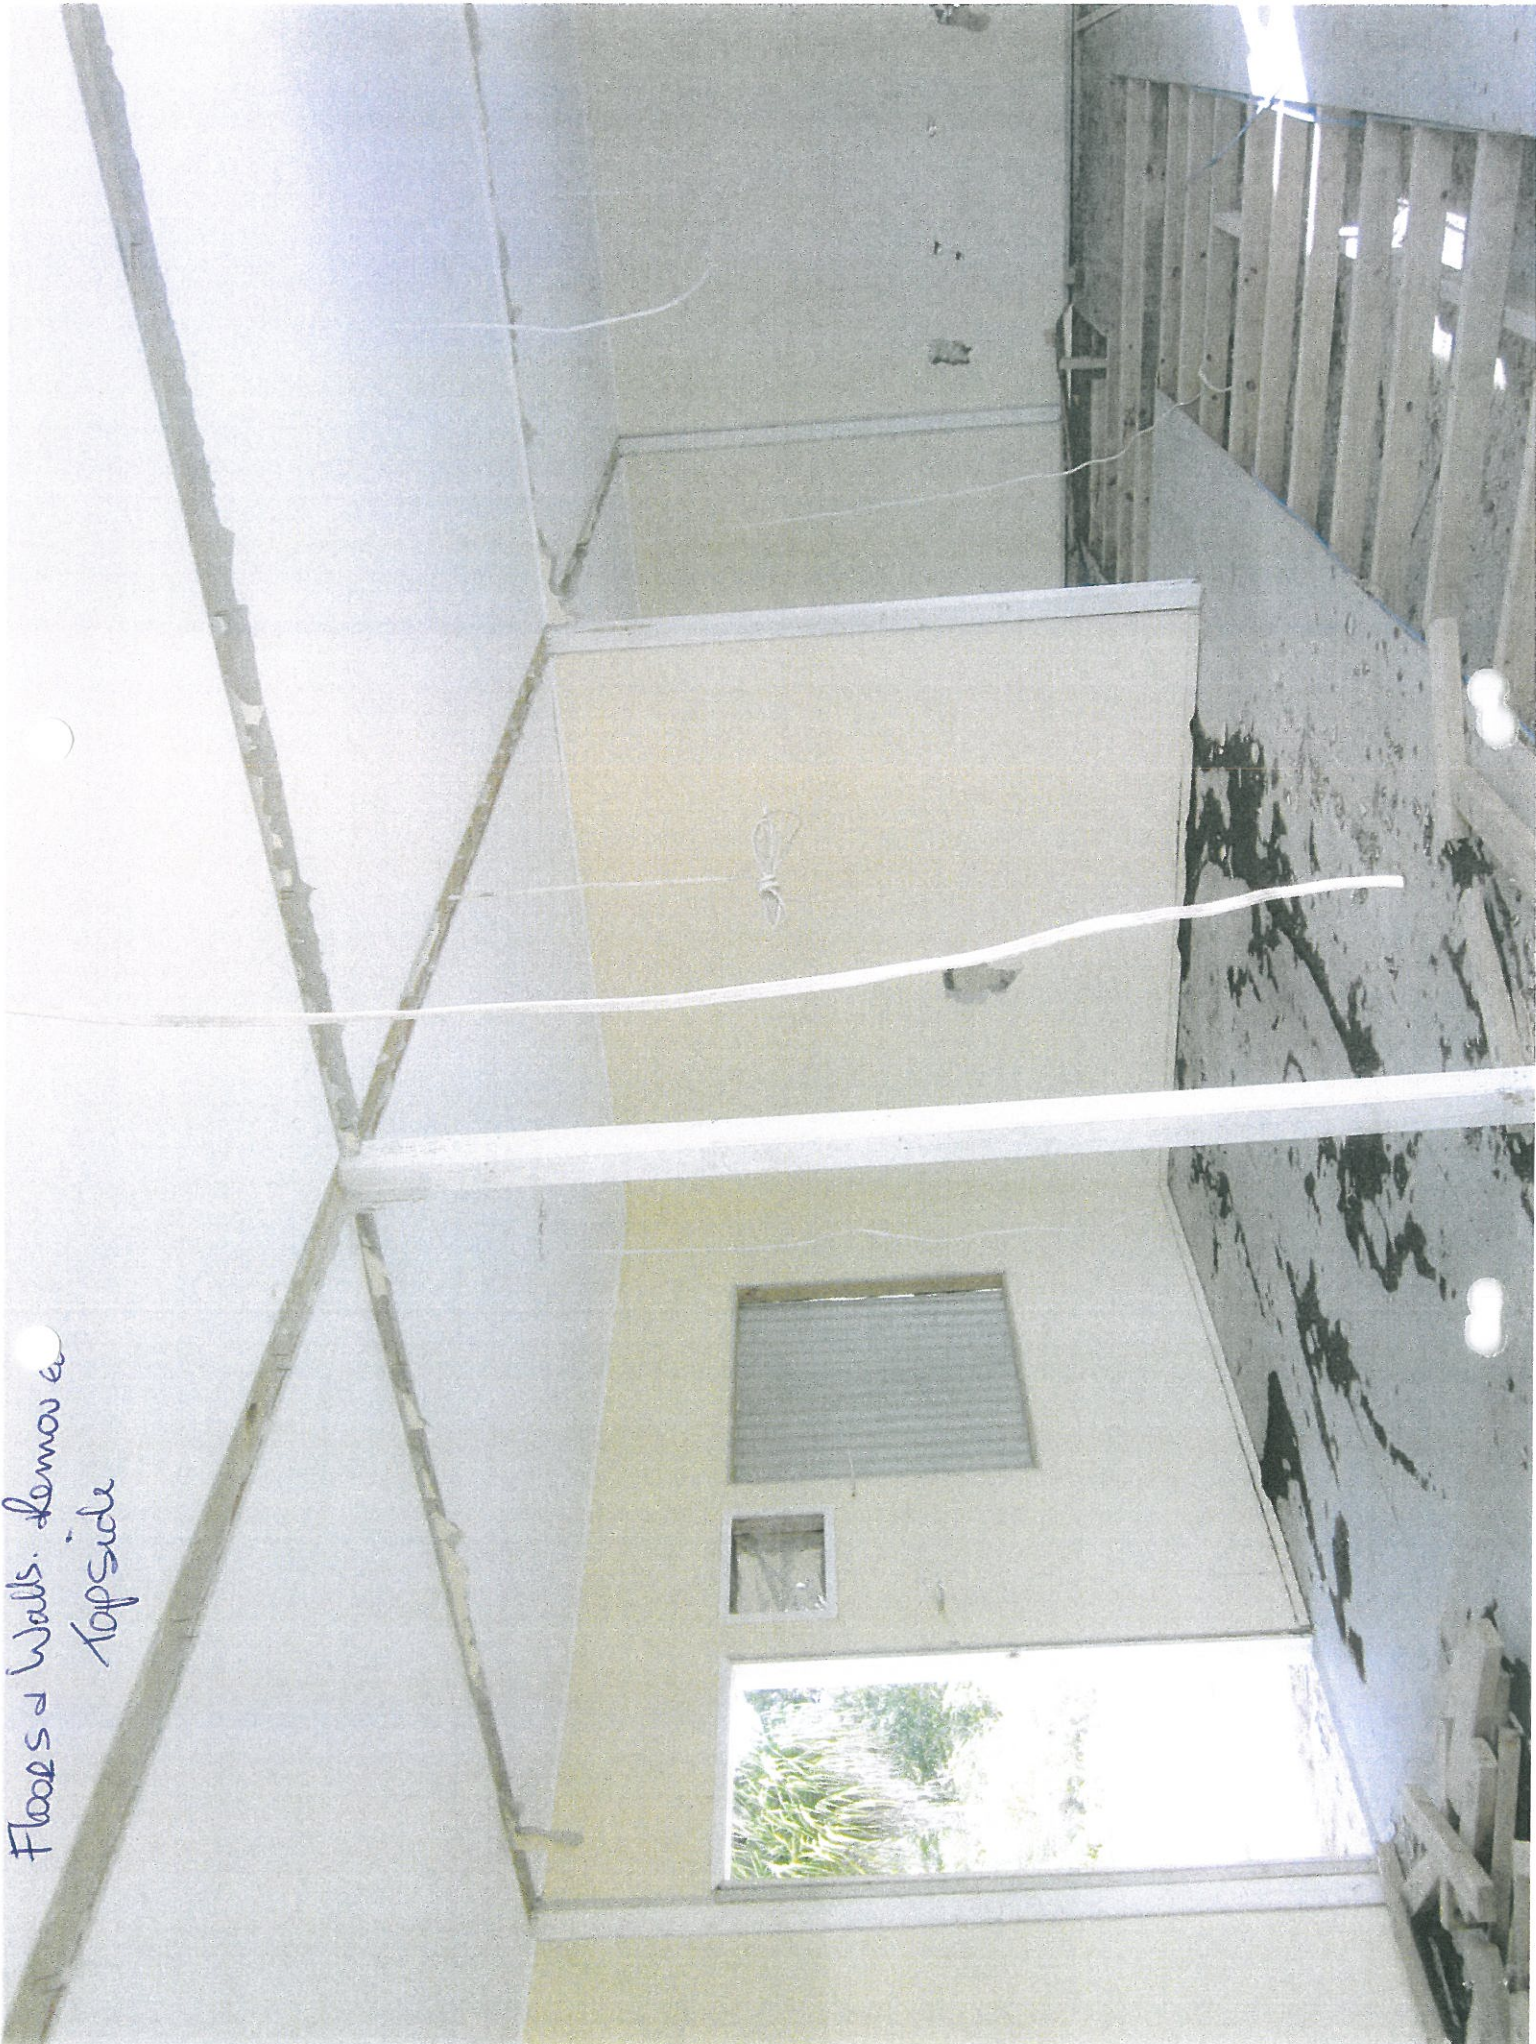
Floors & Walls. Remove  
Topside

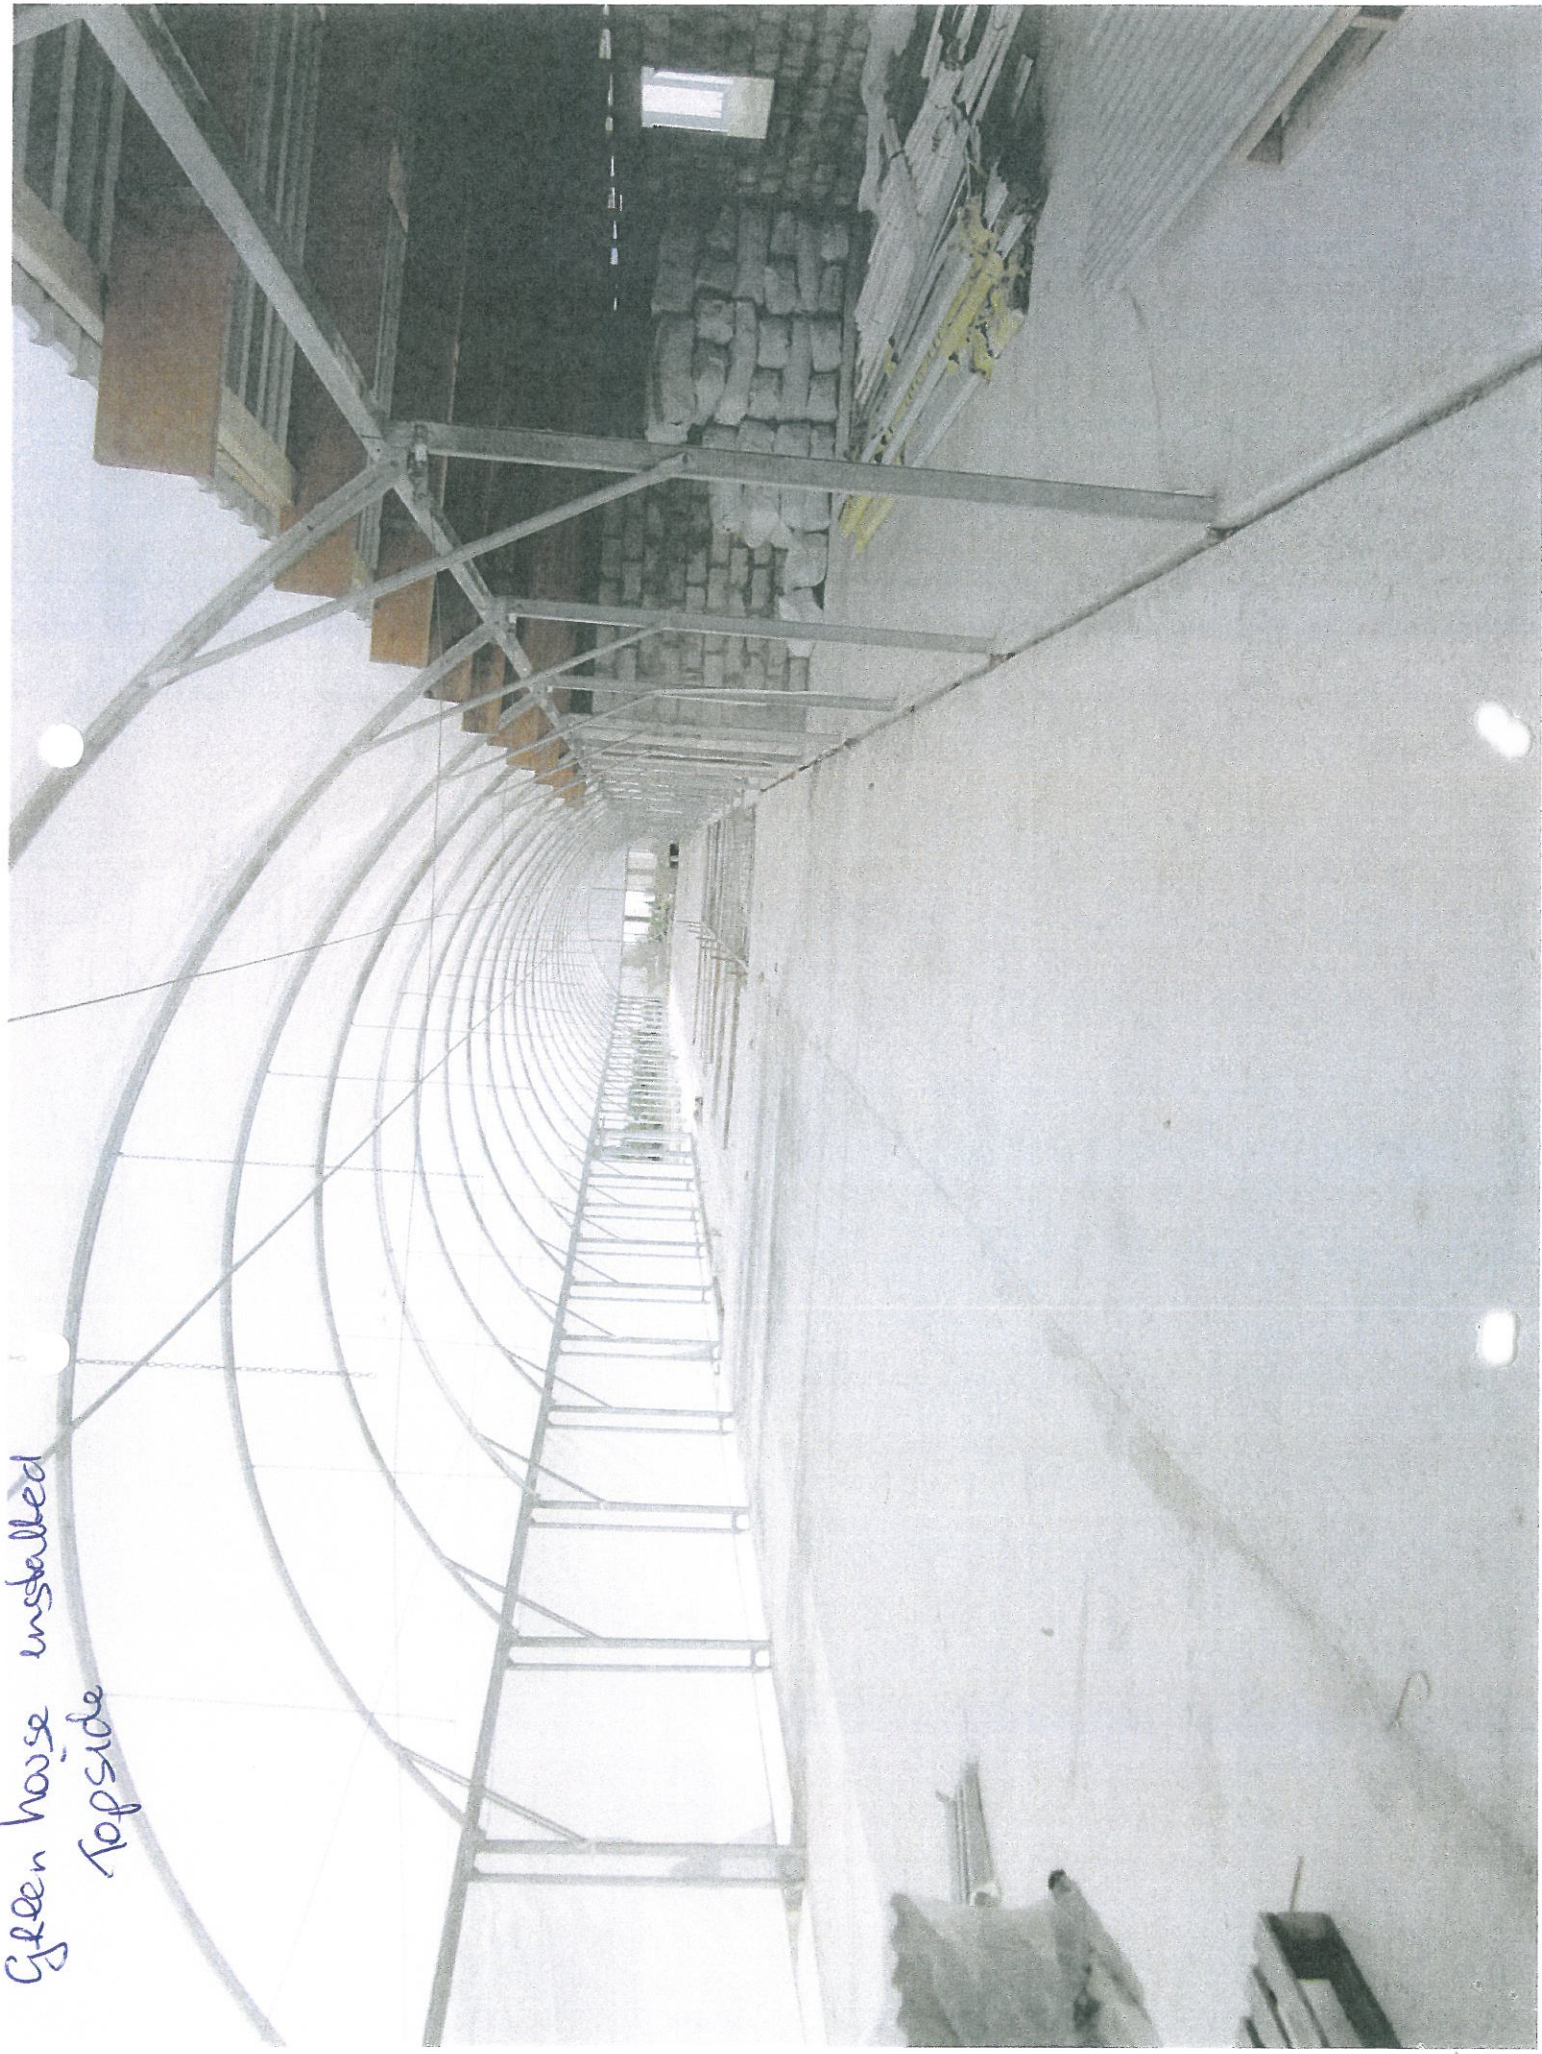
15. The NRC employs 270 workers in the rehabilitation of phosphate fields around the island. They have set up Topside with a large greenhouse in the middle of the complex for the propagation of plants.

Green house installed  
topside

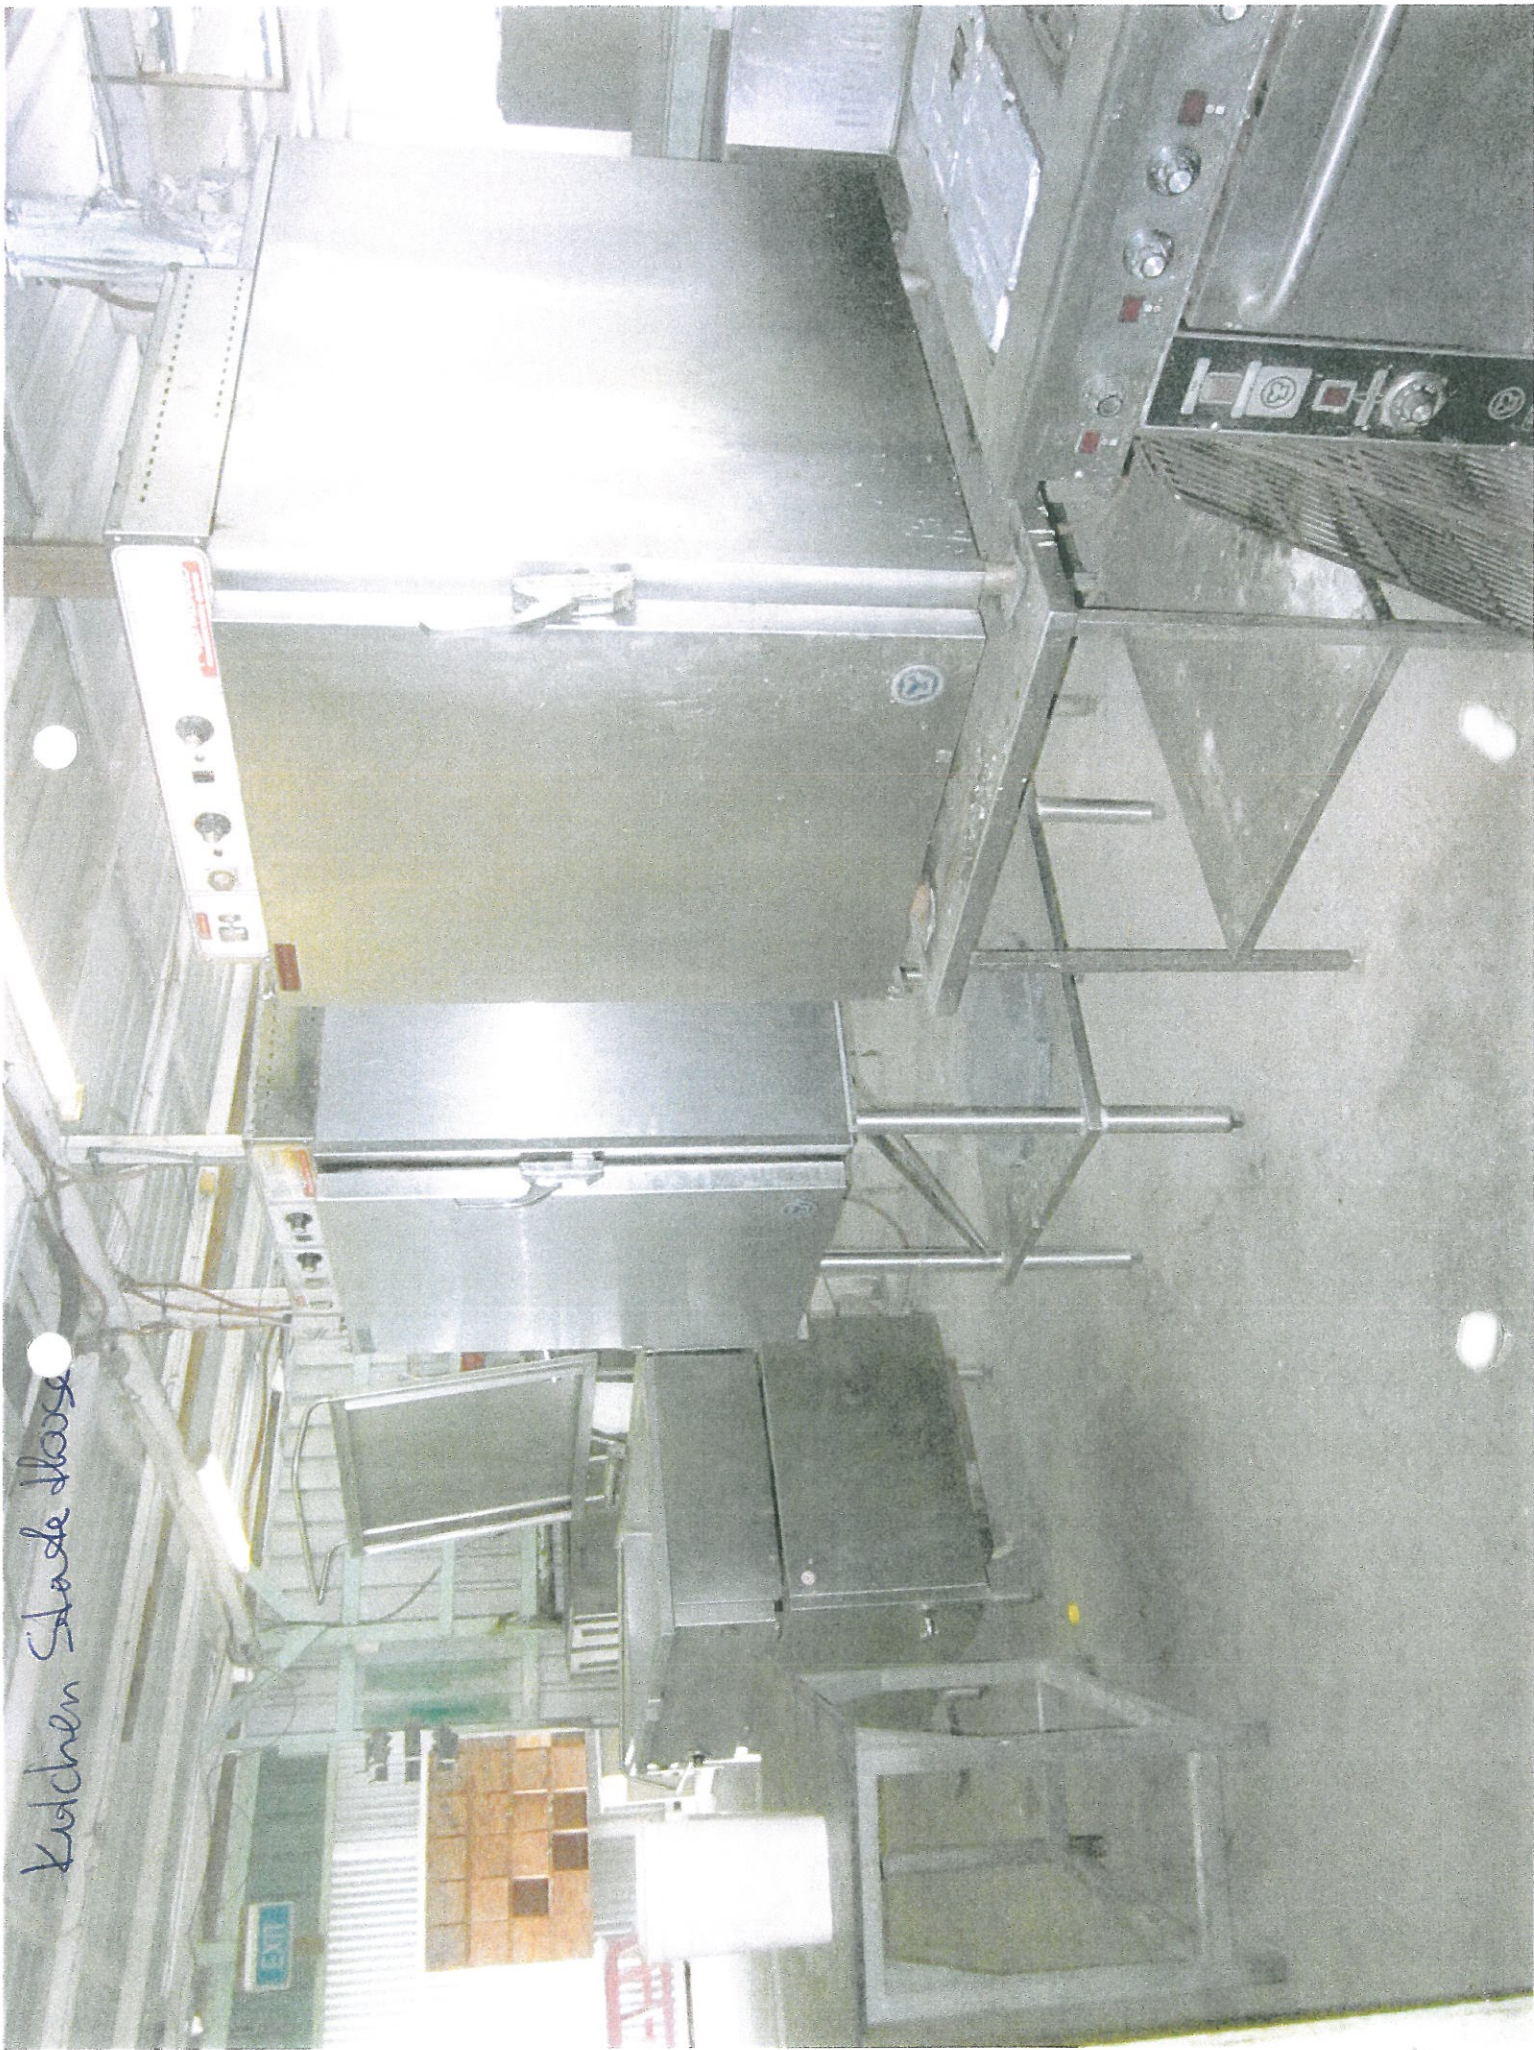
Kitchen Stove Hood

30. The current kitchen arrangements at State House would not meet any food handling certification without major works. The current cooking area is under an un-vented iron roof with no walls and very basic floor. This issue could be resolved by installing a temporary kitchen. The kitchen is currently cooking meals for the hospital, so other arrangements would need to be negotiated with the Nauru Government.
