**Australian Government**  
**Department of Immigration**  
**and Citizenship**

**Submission**

**Subject** **Infrastructure Report on Nauru**

1. This version updates the original CB2012-00071 now that updated costings are available (Attachment A).
2. Departmental officers travelled to Nauru to inspect the two previous processing centres on Nauru on 3-4 January 2012. The sites are known as Topside and State House. A map of Nauru is at Attachment B. Photos of the sites as originally provided are available if required..

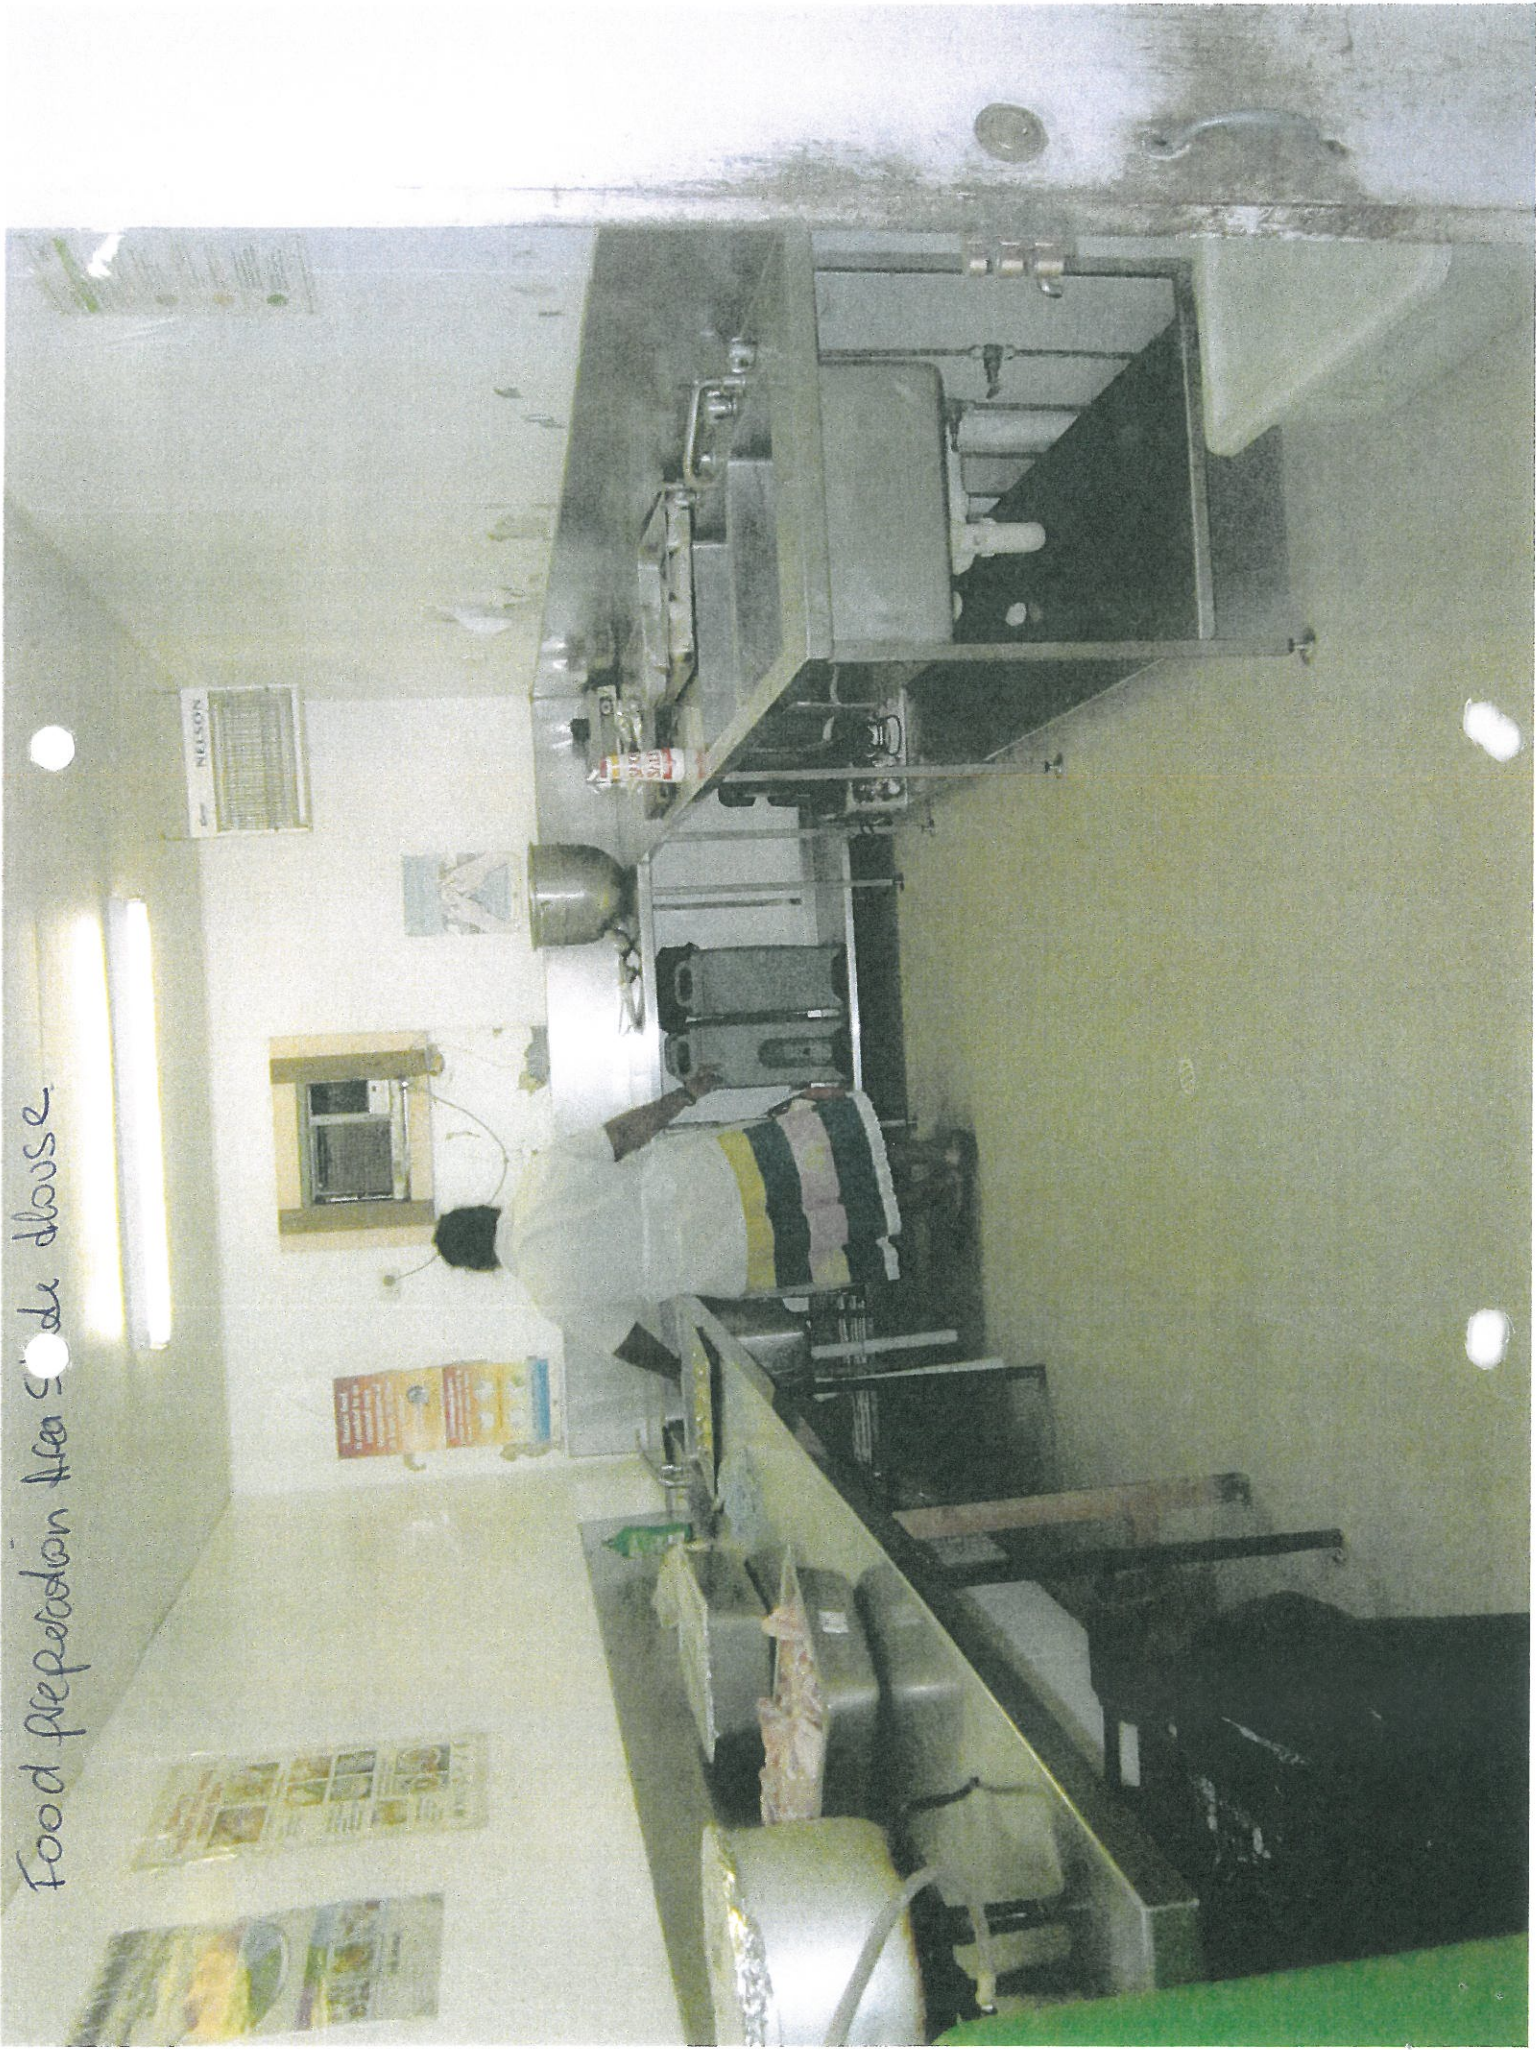
Food preparation Area Side douse.

30. The current kitchen arrangements at State House would not meet any food handling certification without major works. The current cooking area is under an un-vented iron roof with no walls and very basic floor. This issue could be resolved by installing a temporary kitchen. The kitchen is currently cooking meals for the hospital, so other arrangements would need to be negotiated with the Nauru Government.

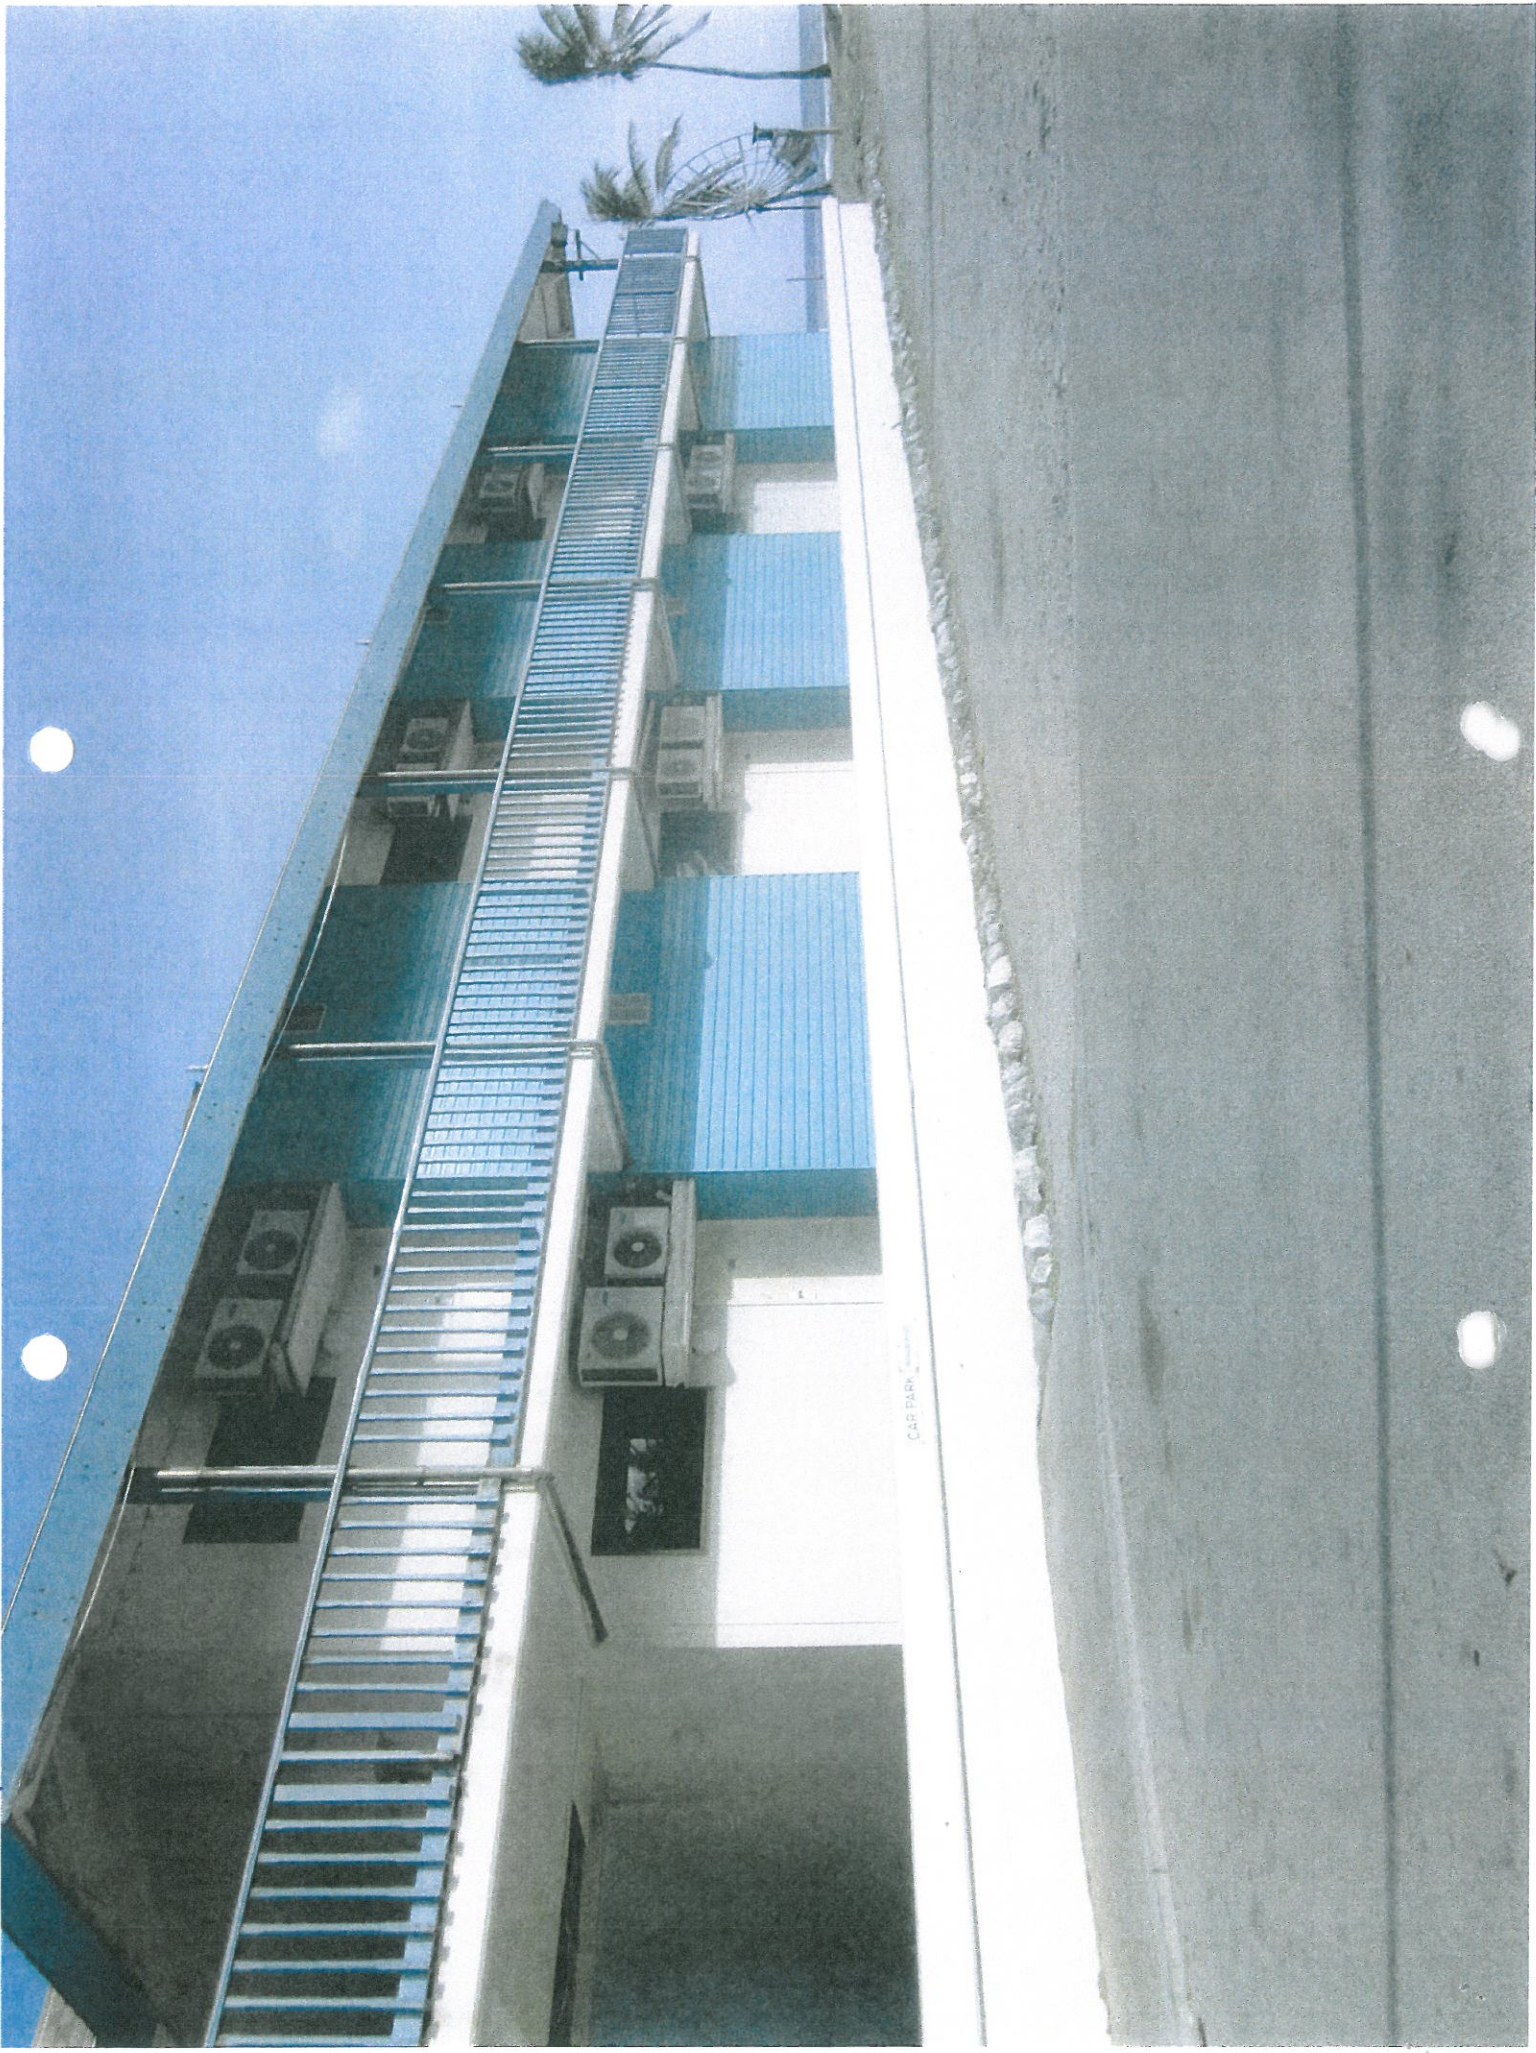
WENNER HOTEL

41. Staff accommodation will pose an issue. There is limited accommodation on Nauru. The Menen Hotel is suffering from lack of ongoing maintenance. From a visual observation, it appears most of the handrails are in a dangerous condition, having rotted or rusted out as a legacy of the tropical climate. Unsafe electrical wiring was observed around the hotel.

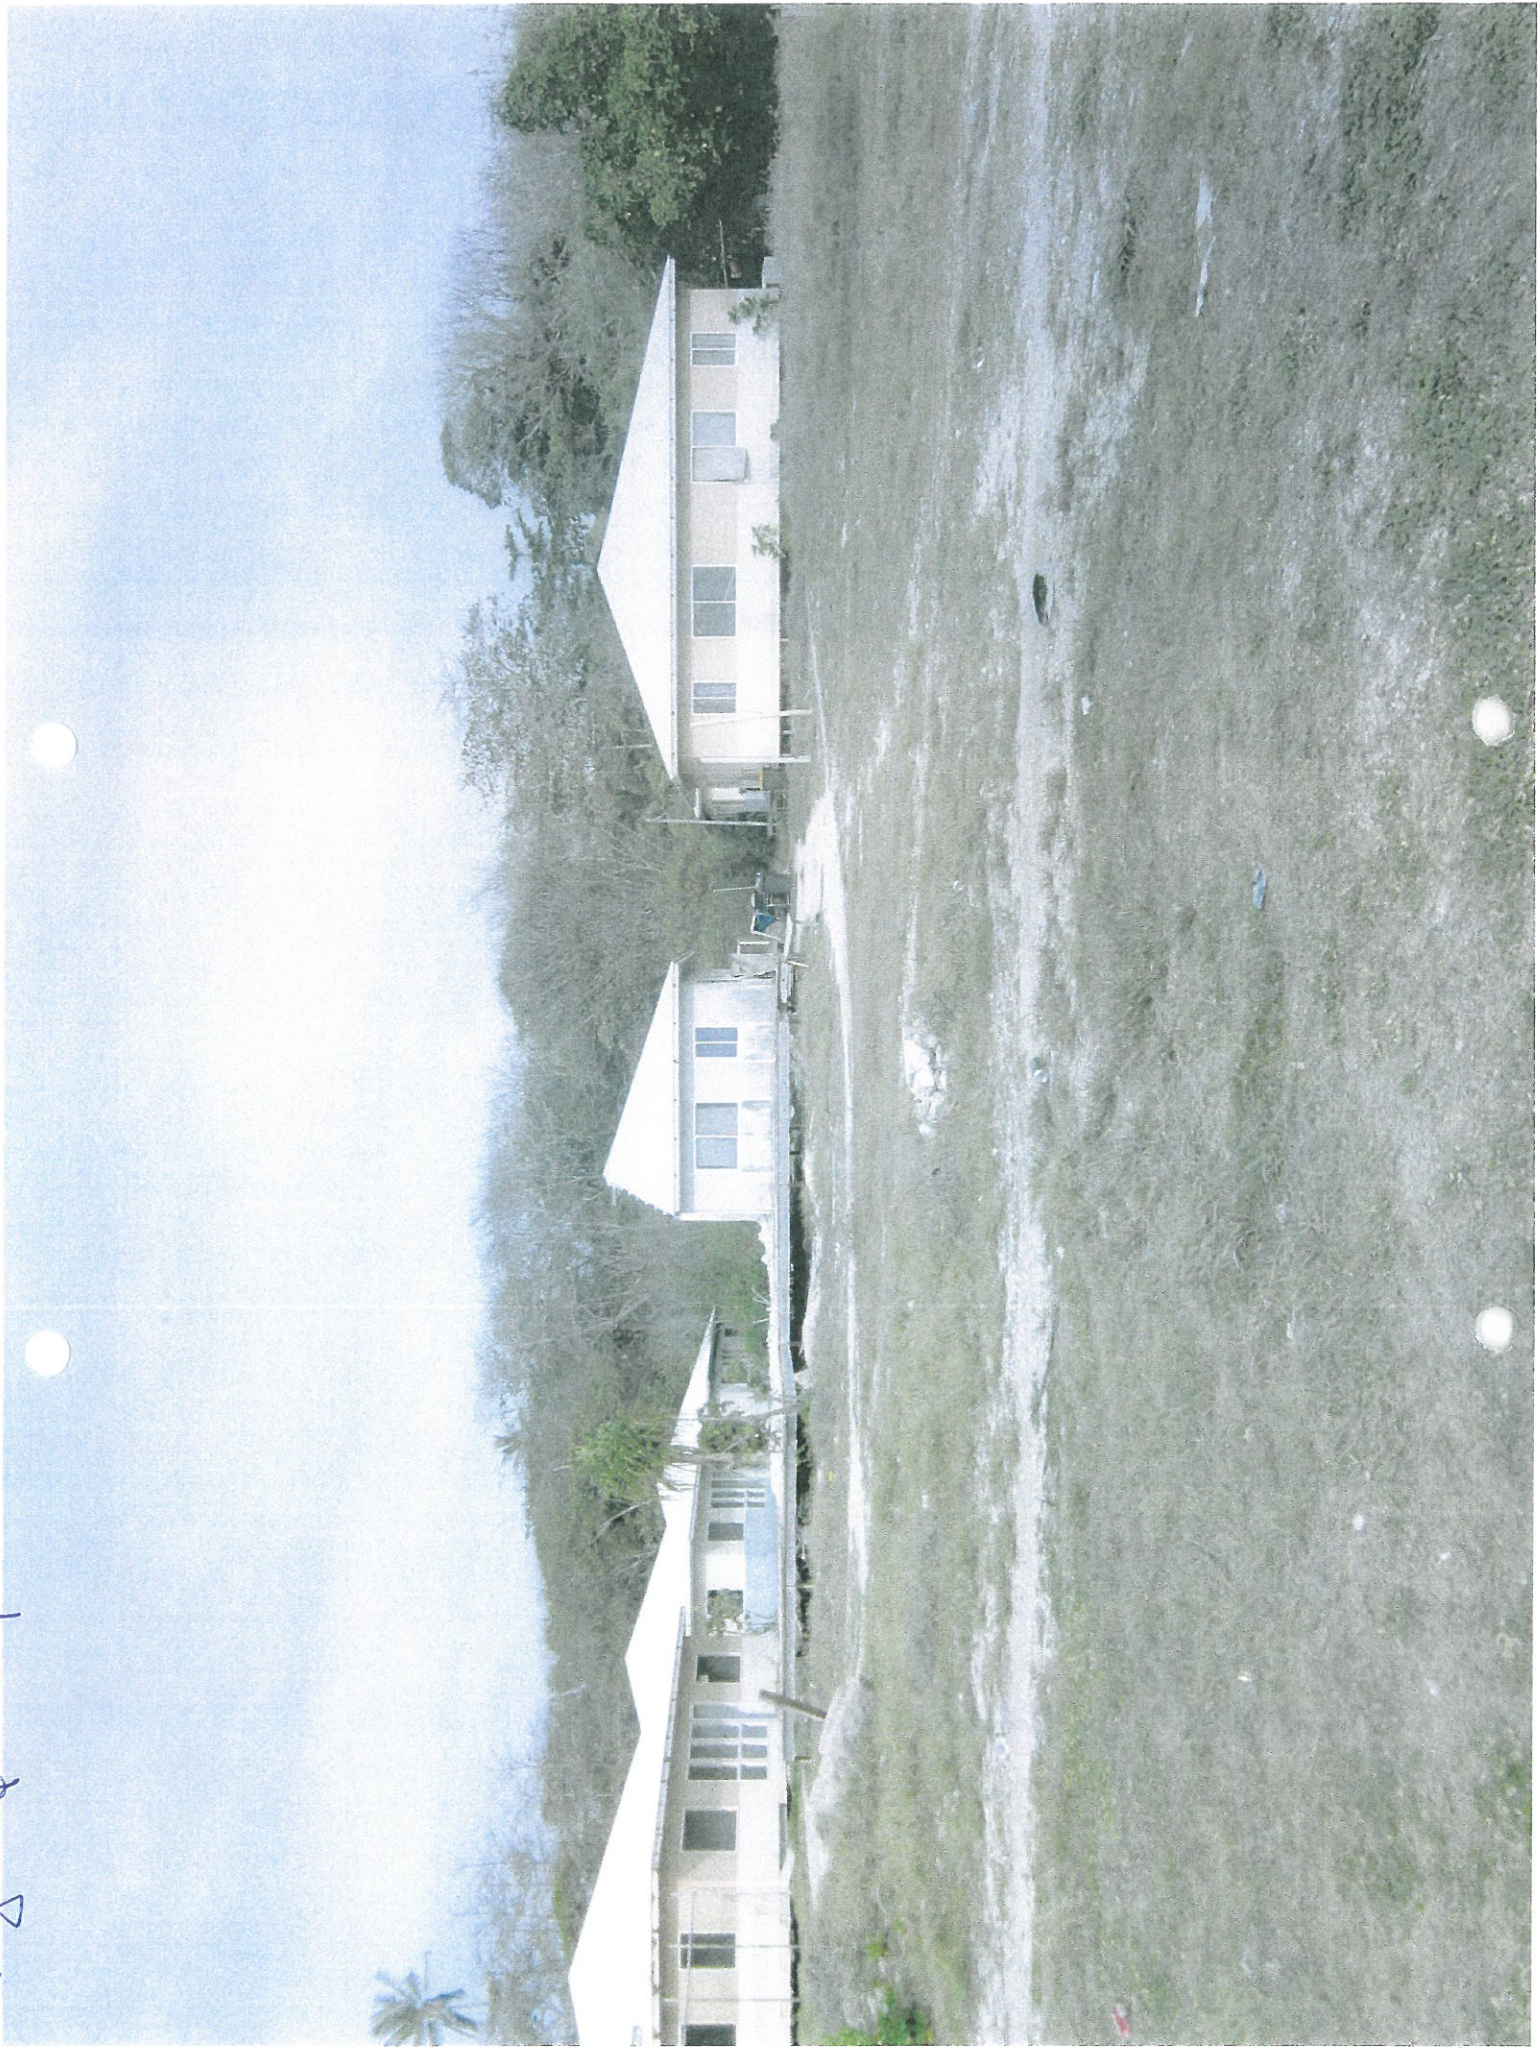
Washed up after every  
heavy rain

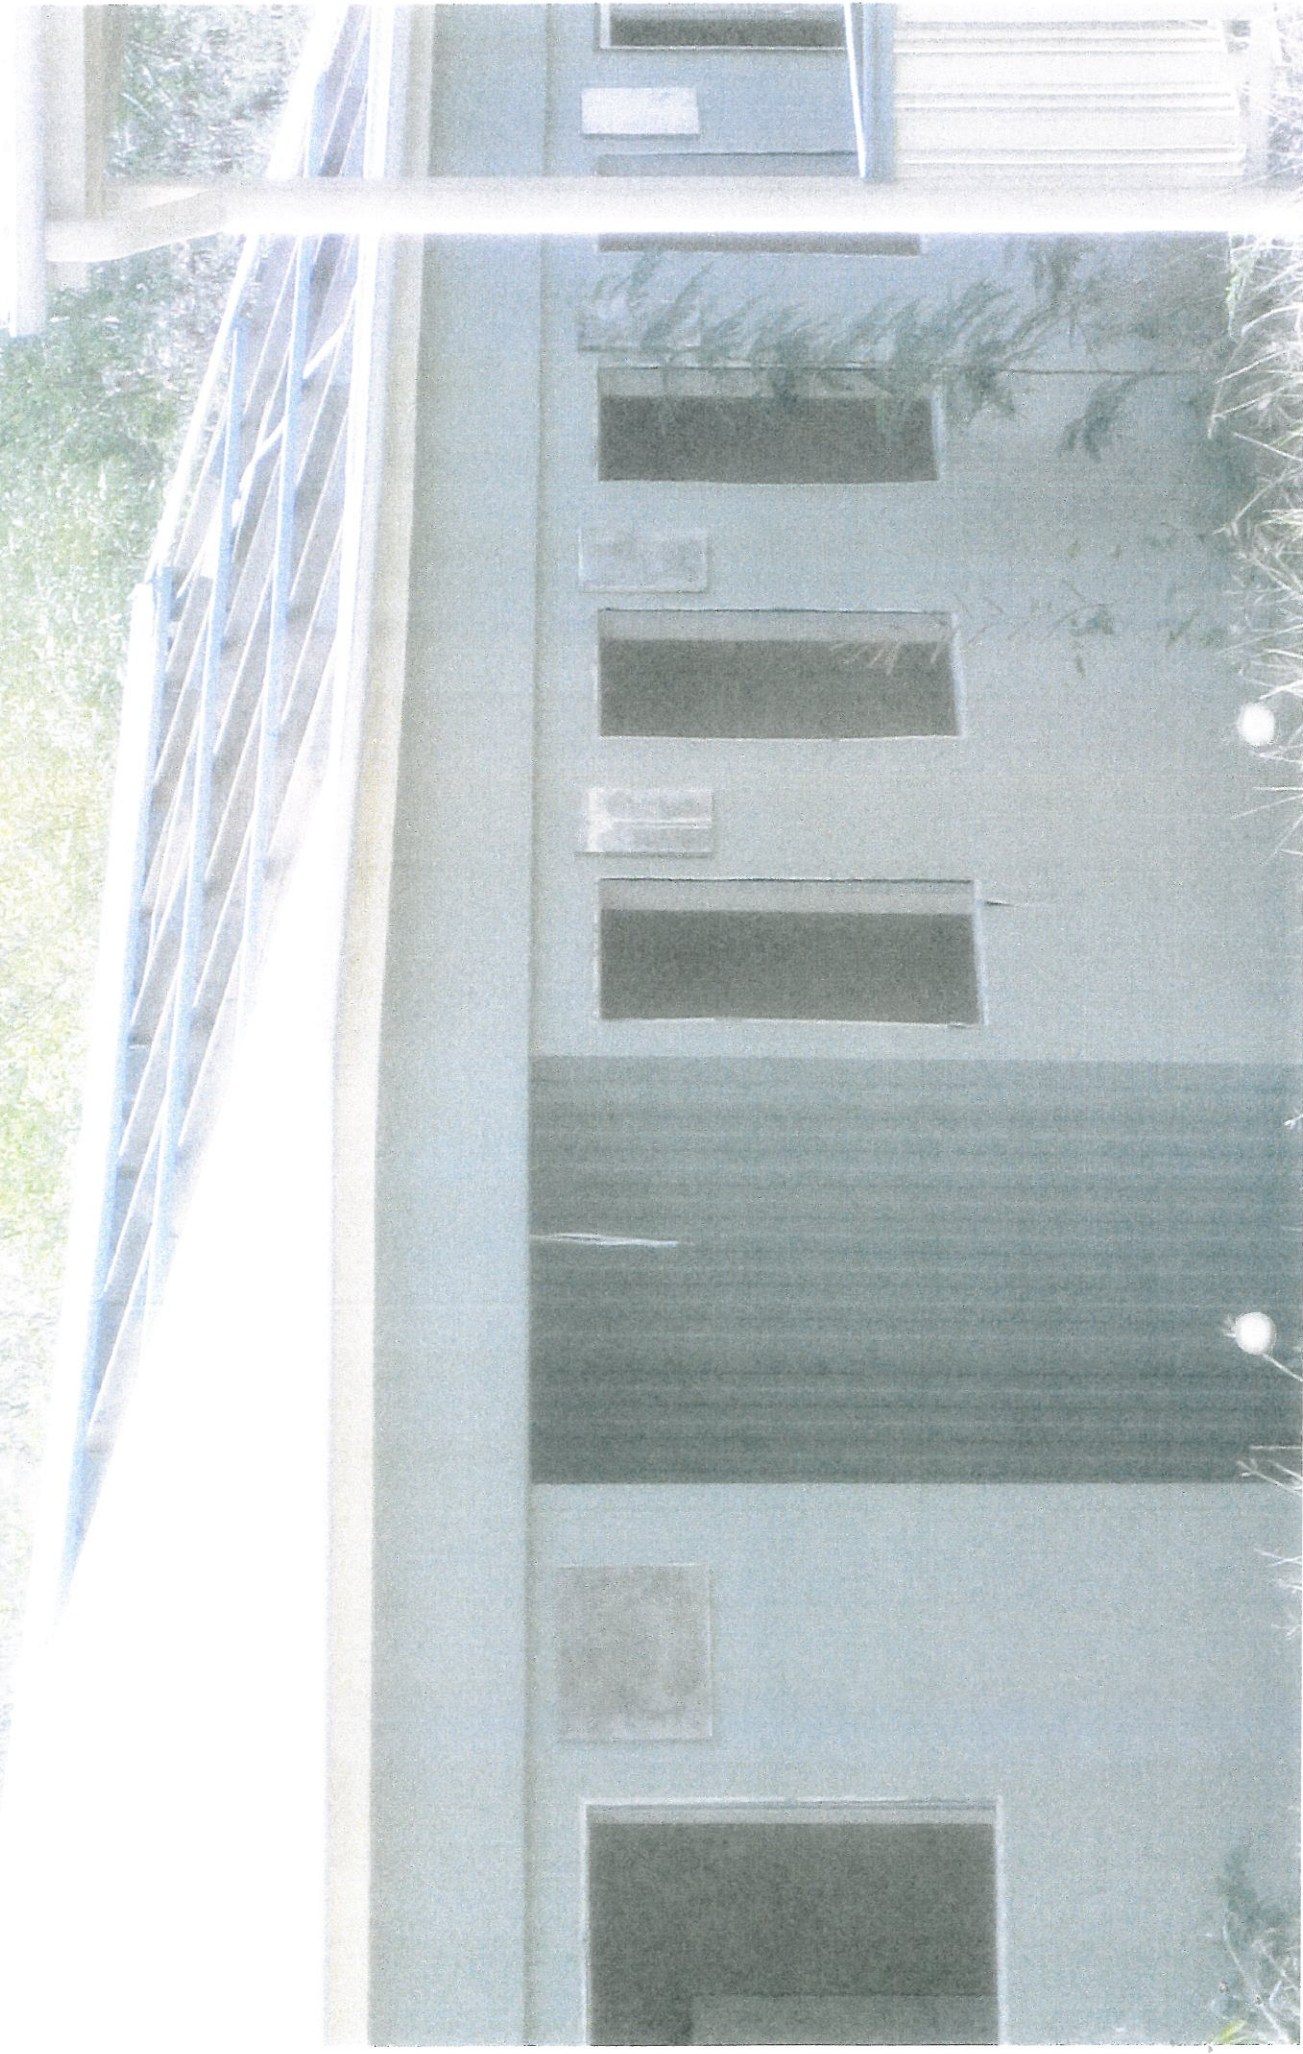
24. As with Topside the majority of all buildings will require refurbishment. The buildings, however, are in better general condition.

State House Accommodation  
roof windows doors etc missing
