MAP1: PETROLEUM EXPLORATION LICENCES IN NSW

MAP 1: COAL SEAM GAS IN THE PILLIGA FOREST

Project area and construction footprint

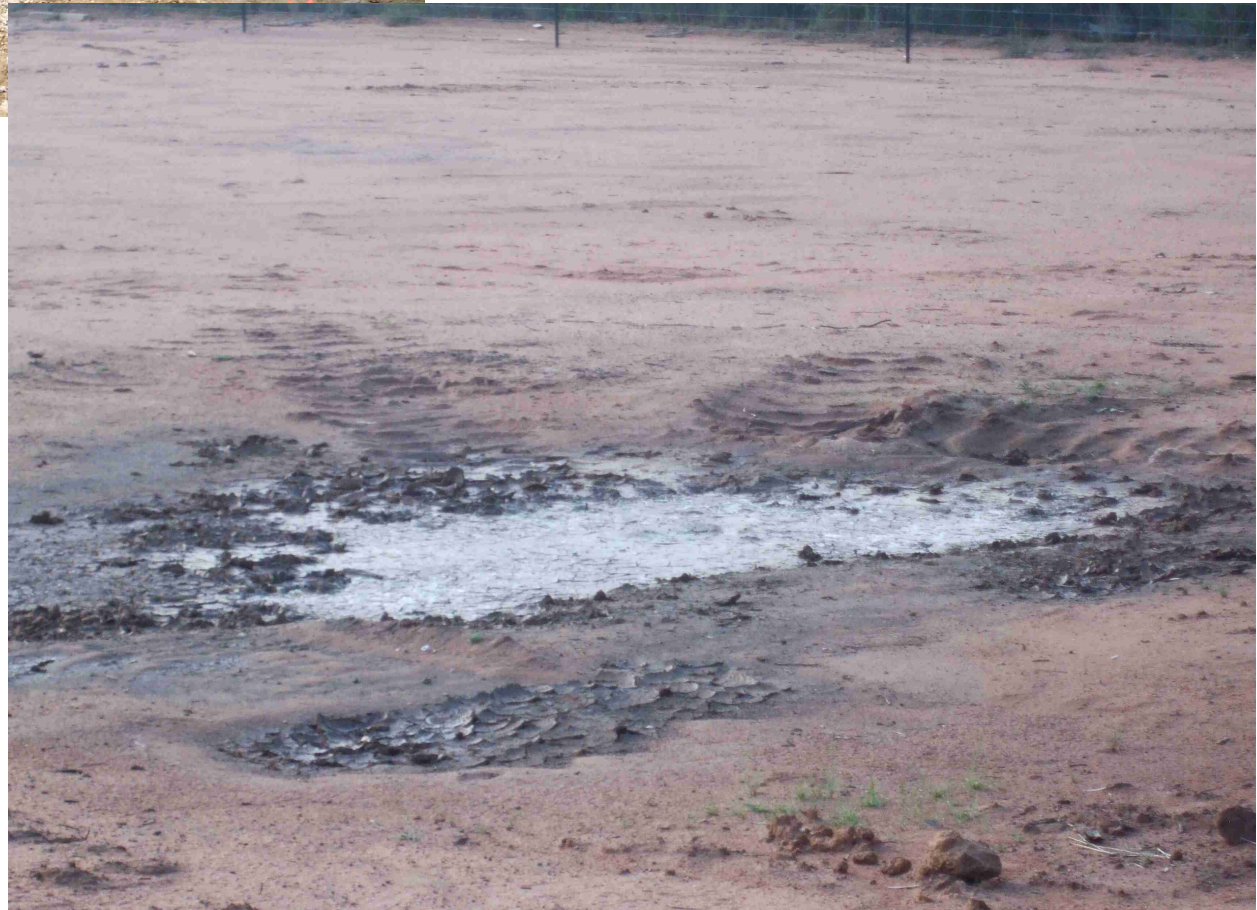
Photo 15. Bibblewindi 16 pilot production well. Salt scald adjacent to unlined drill pond, Bibblewindi SF. Photo 2011.
