AS3996 – 2006 ACCESS COVERS & GRATES

COMPLIANCE – ROAD PROJECTS vs. BUILDING PROJECTS

Current Case Studies

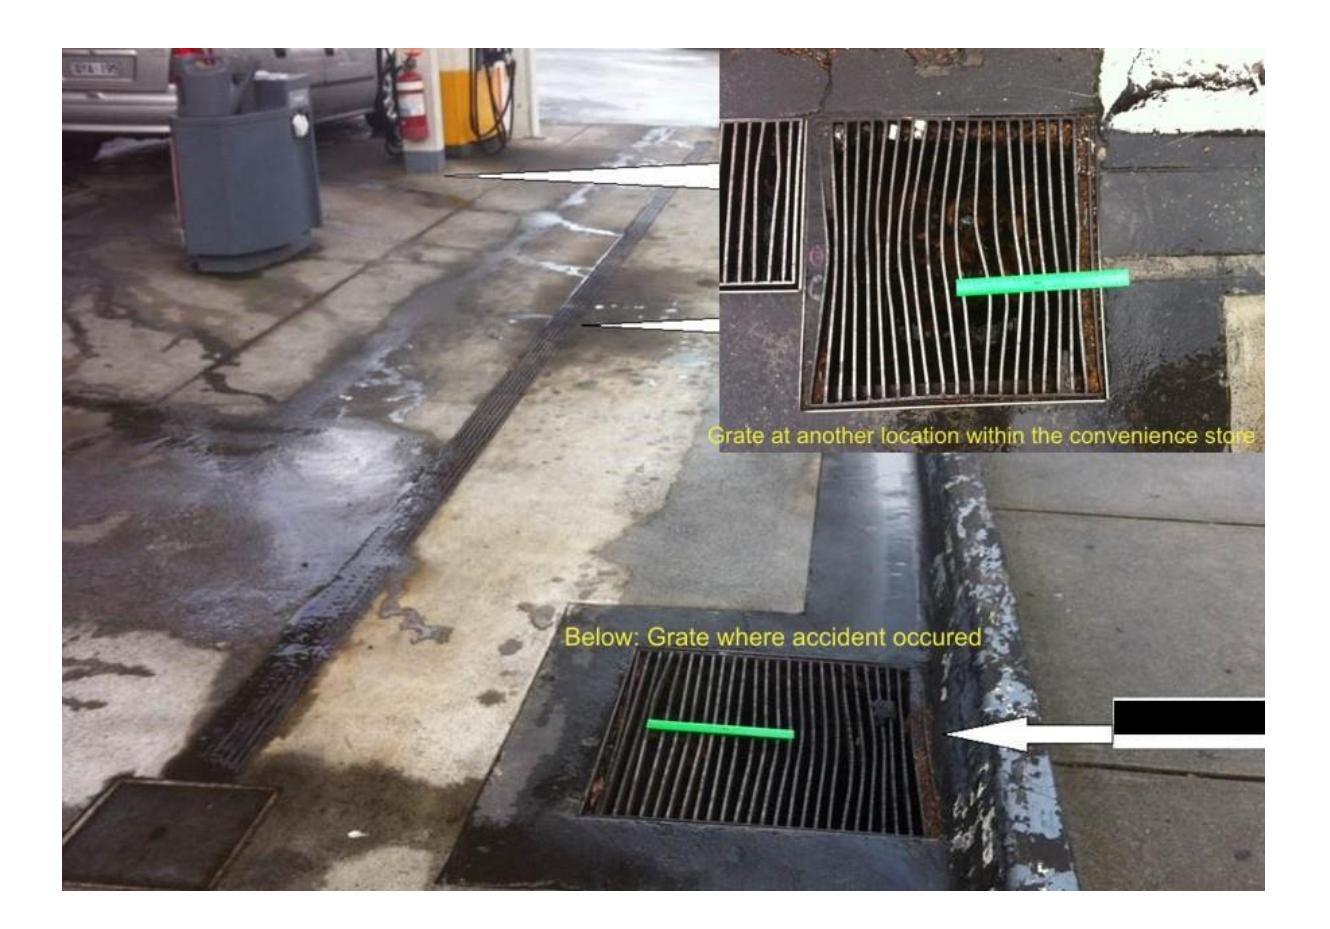
Case Study – Injured Cyclist

On-going case involving a cyclist who has received serious facial injuries as a result of a bicycle tire becoming jammed in a grate whilst traversing through a convenience store. The convenience store had undergone renovations in 2007 and additional stormwater grates were installed again after that time.

The grate shown below is in a serious state of failure and doesn't comply with AS3996-2006 in either Load Capacity, Pedestrian tolerances or Bicycle Safety. The failing grate should have been replaced once identified as failing. No action at this time has been undertaken by the site owner and the grates are still in service.

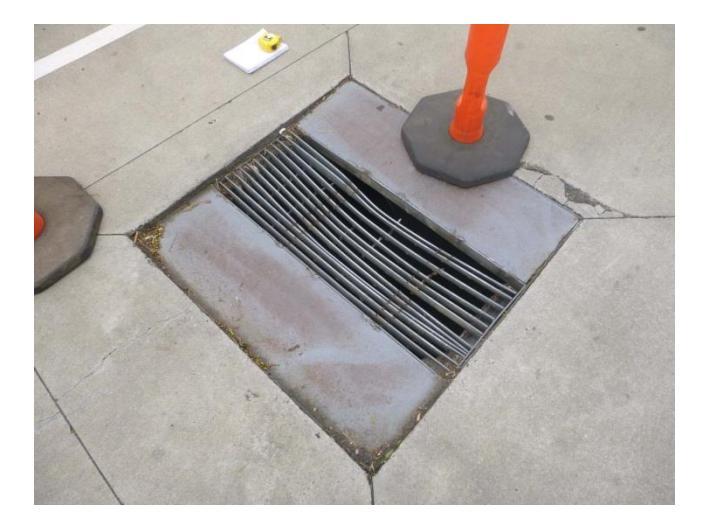
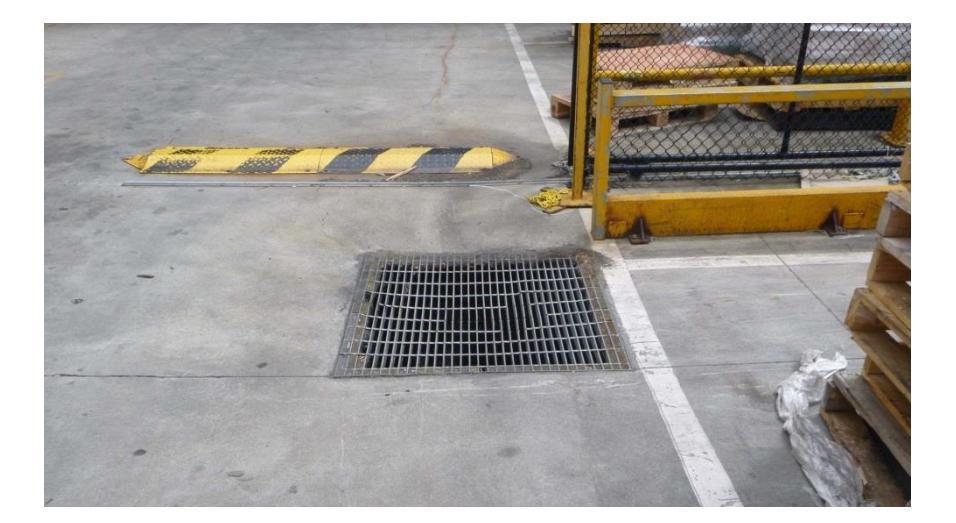
Case Study 1 – Distribution Warehouse subject to transverse impact load from low speed heavy transport

On this particular site the hardstand had 10 stormwater pit grates which were all in various stages of failure. 900mm x 900mm clear opening pits were covered with grates of an unknown load capacity. The owner, in one case, had attempted a repair, which quite obviously, had been inadequate. Had grates manufactured to AS3996-2006 Load Class D been used this would have been avoided. Replacement cost for all grates on the site could be in excess of \$10,000.00

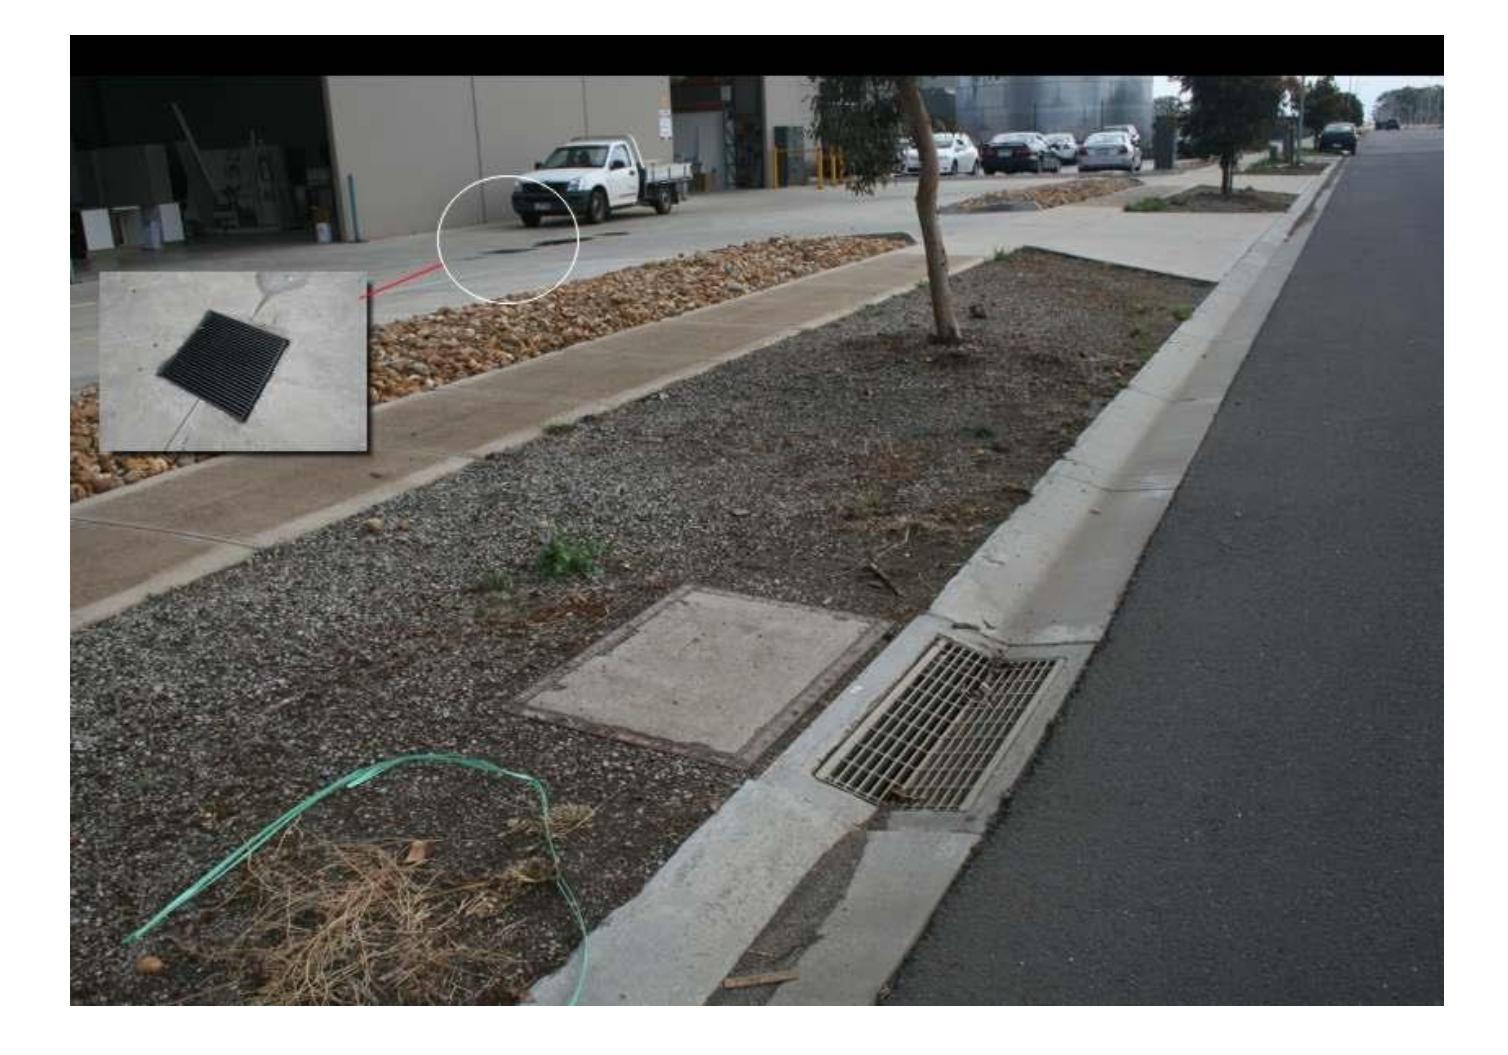
Case Study 2 – Small Manufacturing Facility

In this location, in the foreground we can see a Council Gully Grate installed as per their specification, product compliant with AS3996- 2006. In the background (and inset) we see a small painted grate, according to the owner of the factory the grates in the parking areas have been replaced 3 times due to either theft and/or failure under load. The likelihood of further replacement of these grates is high. Had the builder used grates complaint with AS3996-2006 with a Class C load capacity, lockable, they would almost certainly still be in service.

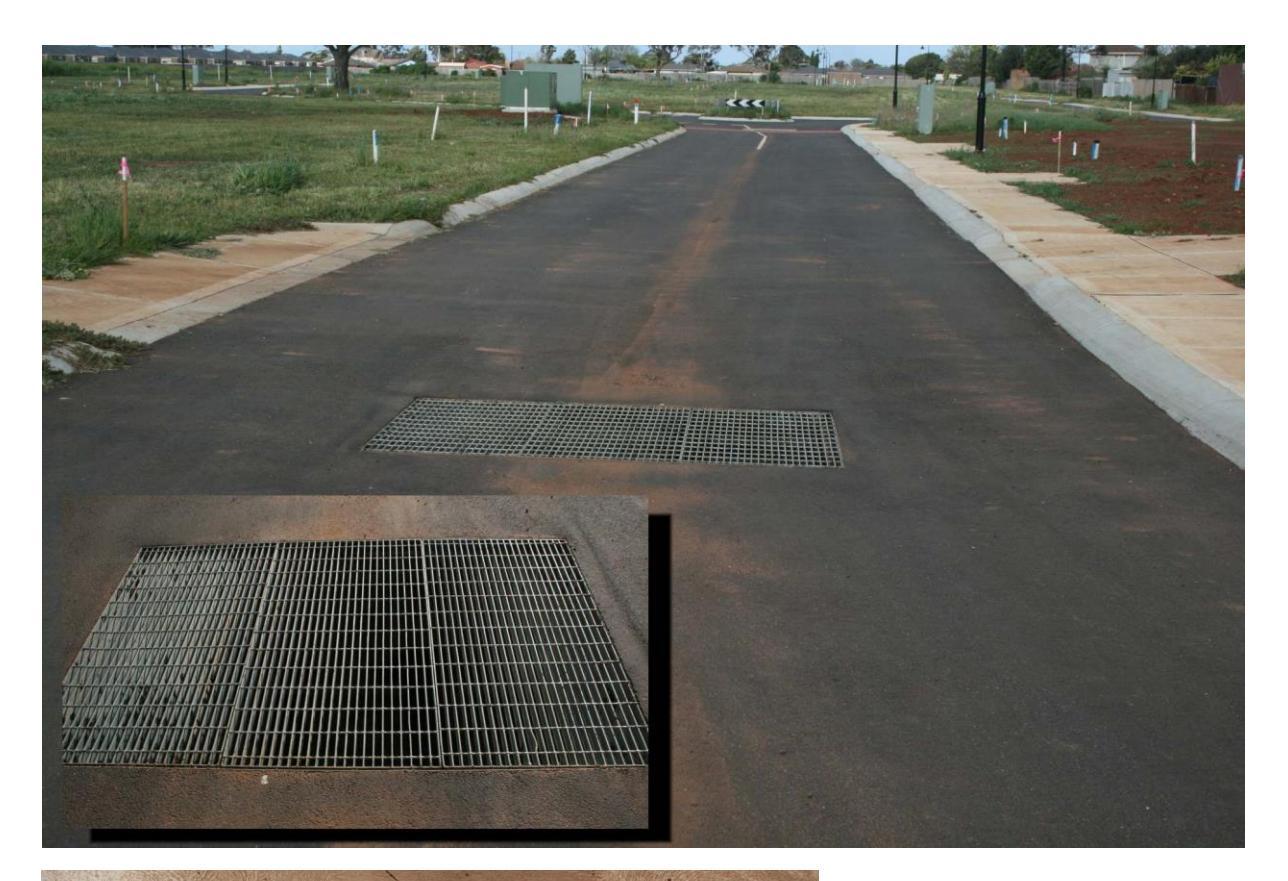
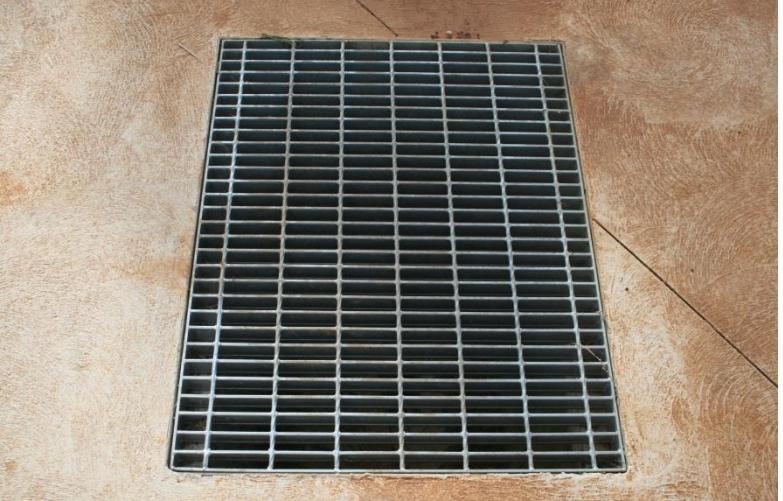
Case Study 3 - Private Body Corporate Housing Development

Clearly, in the construction of this development, the builder has not used any grates that are compliant with AS3996-2006. All grates observed at this location were non-identifiable by manufacturer. All were of insufficient structure to carry the required Class D loading. In the case of the main picture the wide span of this particular pit and the inadequacy of the grate will lead to inevitable failure under load.

None of the Stormwater grates at this location were compliant with the requirements of AS3996. All were of insufficient structural capacity and were not identifiable by manufacturer.

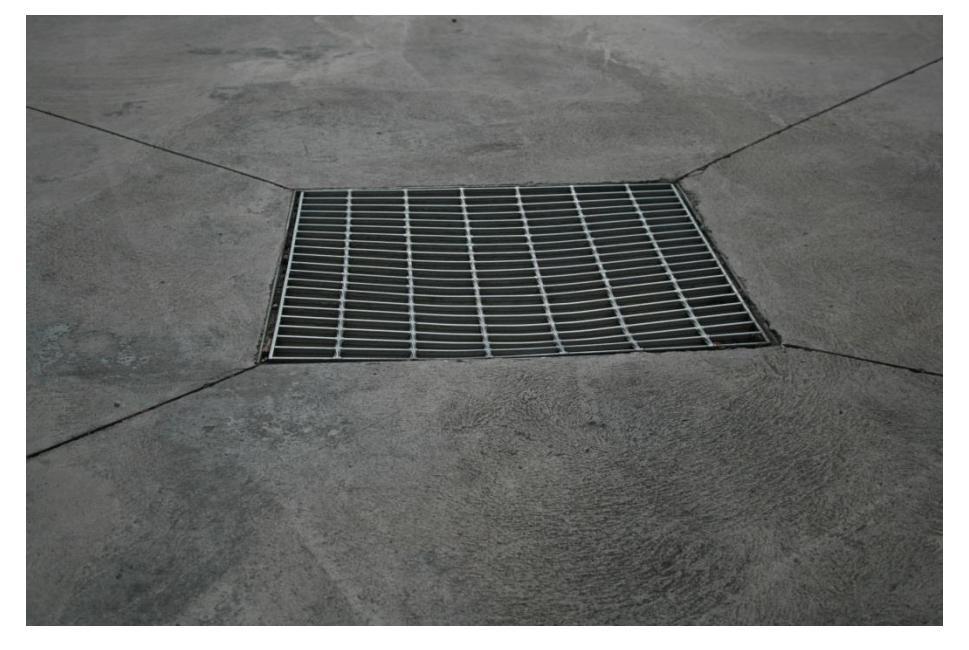
Case study--4-Commercial Car park-Sunshine-Vic

This newly constructed car park, at a commercial premises-contractor has used cheap noncompliant stormwater grates. These failed within 6 months and will require replacement. AS3996–Class C was required, but these product load capacities cannot be determined

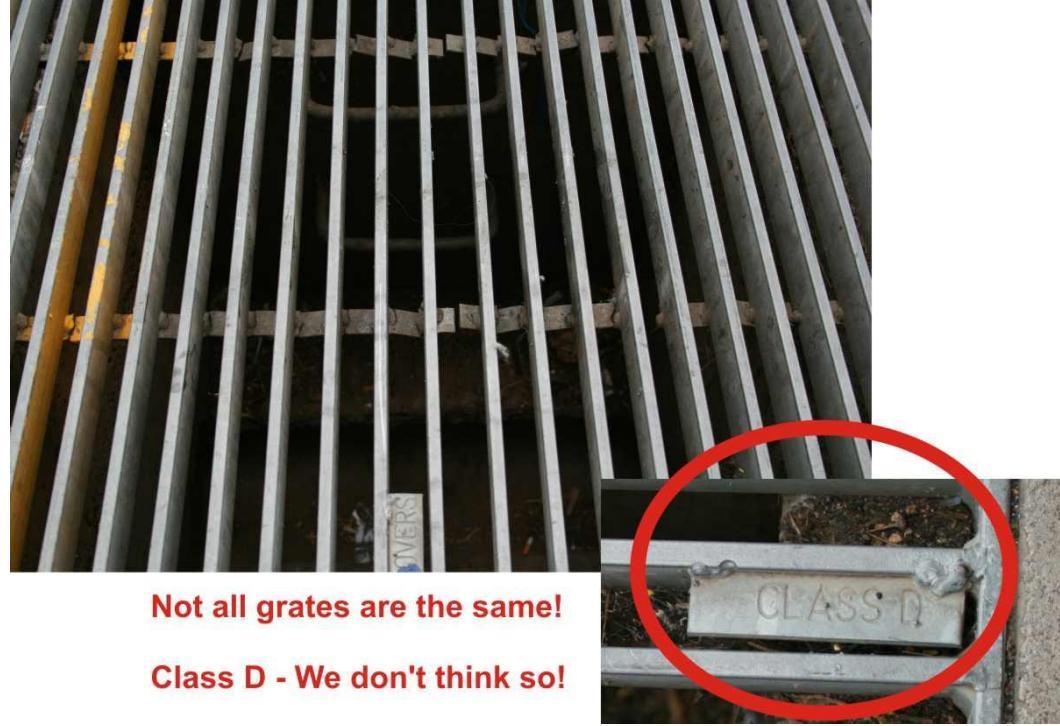
Case Study 5 - Commercial Car park, at Derrimut Victoria

Manufacturer demonstrates clear disregarded for the Australian Standard. In this case the grate has been tagged with a label indicating Class D when it is clearly not, having failed in the car park of a commercial premises. The manufacturer in this case indicated to the contractor that the Class D tag was only his "internal code" and if he wanted AS3996 compliant " he should have asked for it"

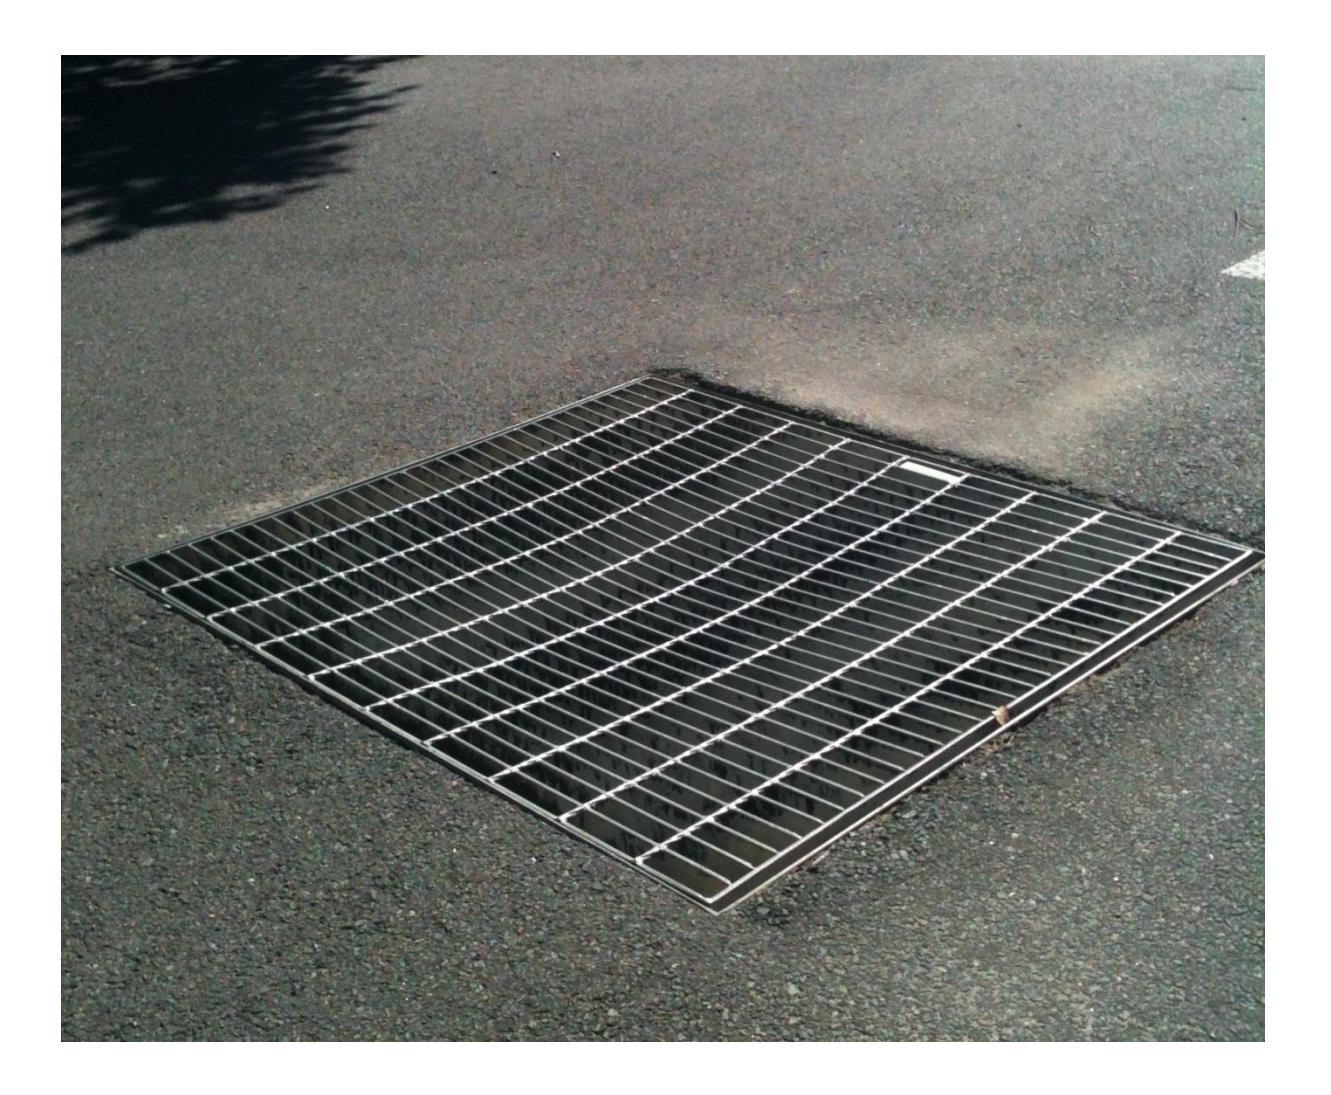
Case Study 6 - Commercial Car Park - Brisbane

As per AS3996-2006 the grate used in this application should have been Load class C, but here we have a Load Class B grate being used. However given the location and limited access to heavy vehicular traffic a Class B load grate should not sustain this type of failure leading to questions on the integrity of the manufacturers load capacity claim.

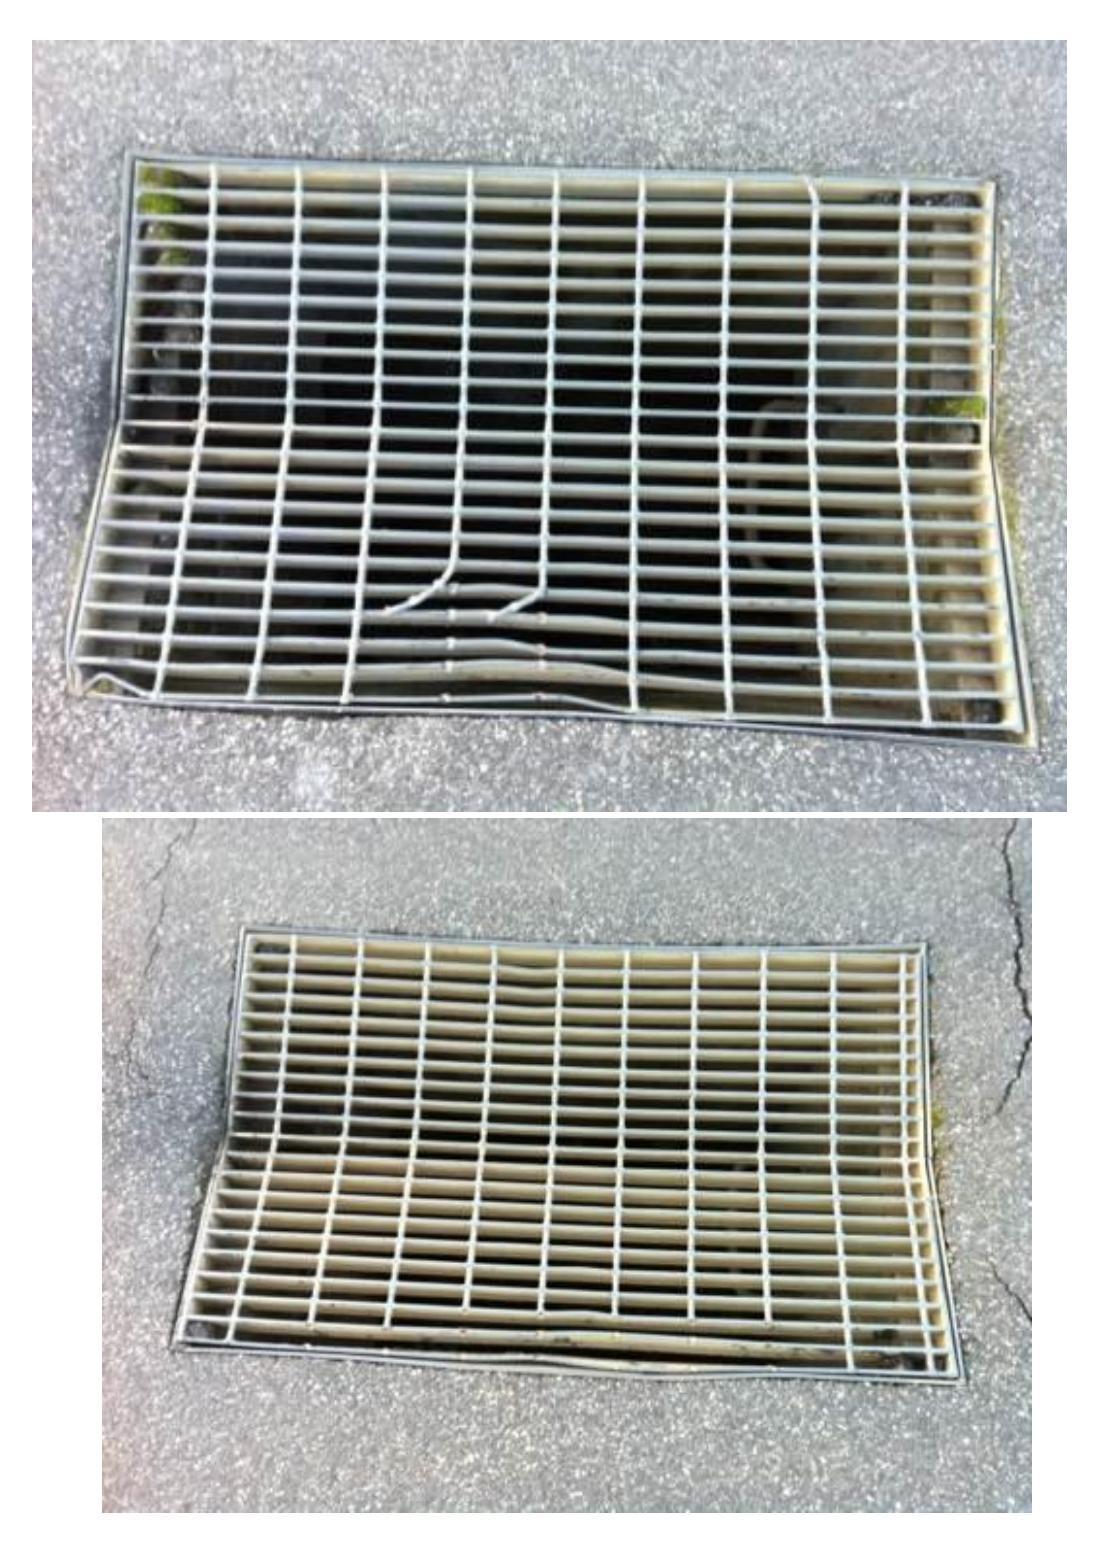
Case Study 7 – Non identifiable imports

Very large numbers of cheap, non-compliant, non-identifiable imports are being sold around Australia. This should be a cause for concern. The construction of the grating material can be quite inferior (as seen in this image) and in case of failure the supplier cannot be identified. *Whether the product is locally made or imported is not the issue but compliance to Australian Standard AS3996 2006 certainly is.*

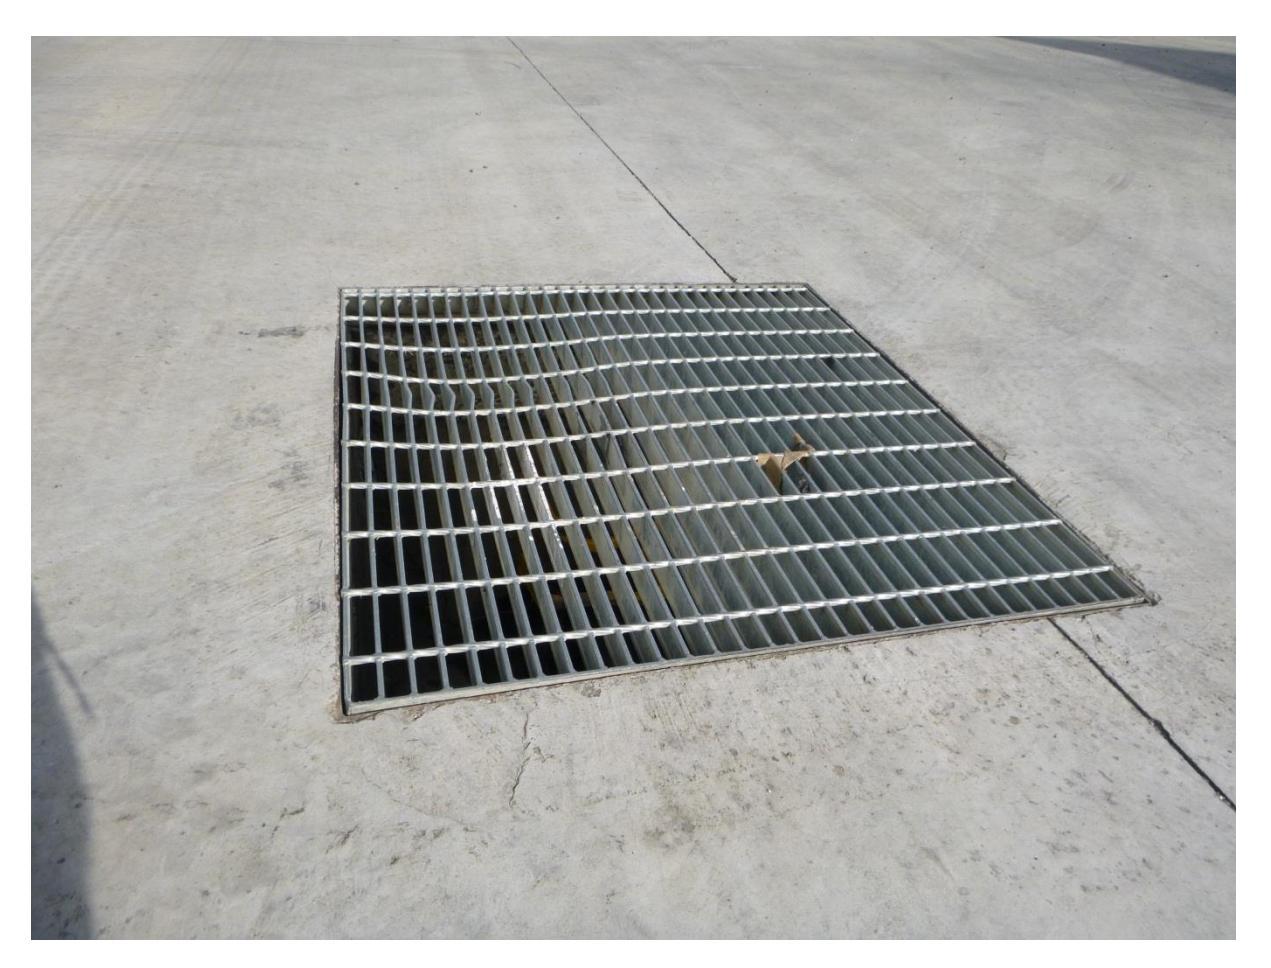
Case Study 9-Multi-Unit Commercial Development-Thomastown

This development contained grates installed from 3 separate manufactures, of which only one brand of grate was AS3996-2006 compliant. The example below of obvious insufficient load capacity, was in a state of failure and unidentifiable by manufacturer.

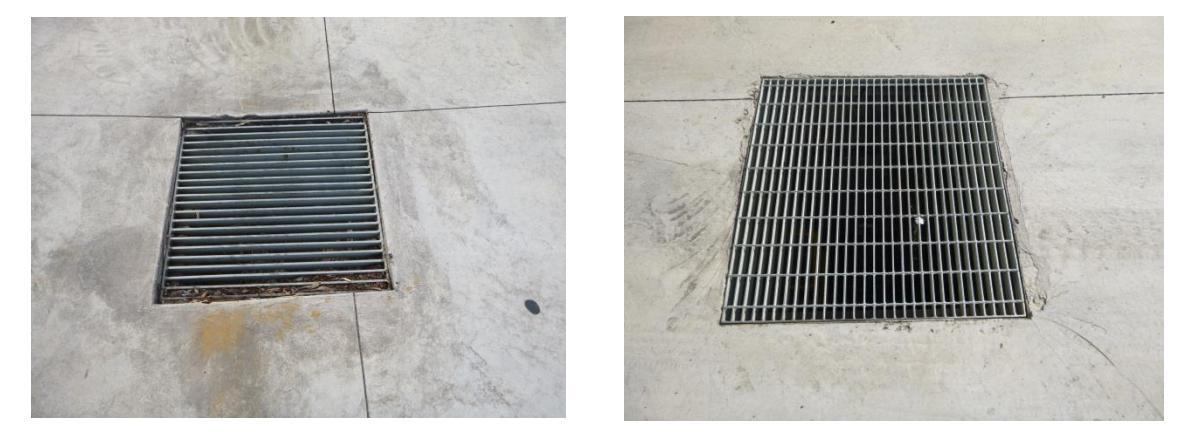
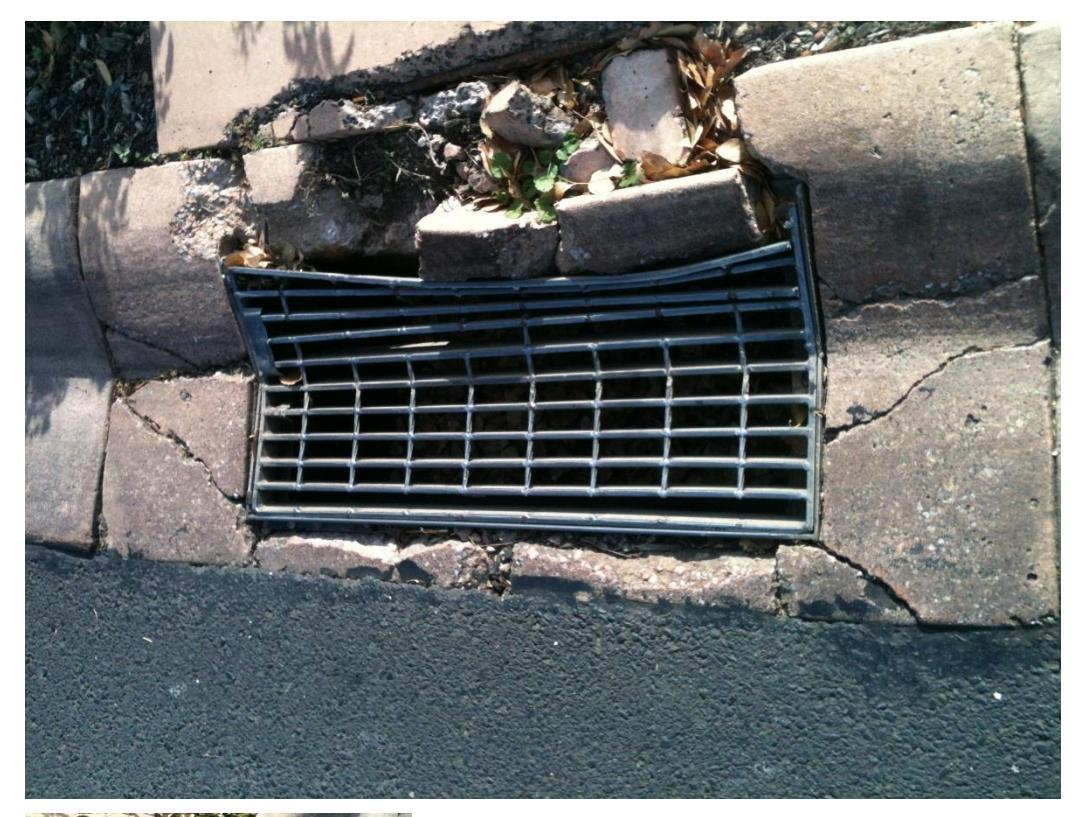
Both grates below were non-compliant and unidentifiable.

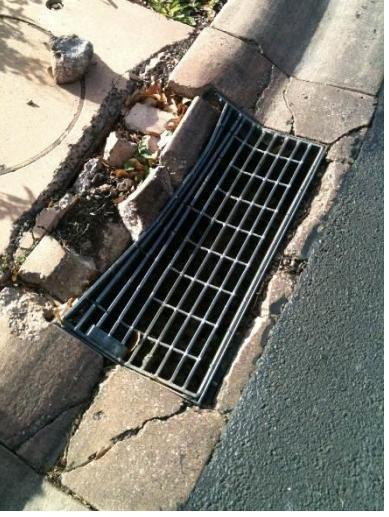
Case Study 10 - Kerb Profile Gully Grate. Sanctuary Lakes Vic

Products of inadequate load capacity will fatigue and deflect under load. In this case we see a bad imitation of an approved product that has deformed dramatically and damaged the surrounding concrete. The original specification was for a Class C grate, It is clear in this image that grate was incapable of being used in any trafficable installation. The cost of reinstatement will be 2-3 times the original cost of installation.

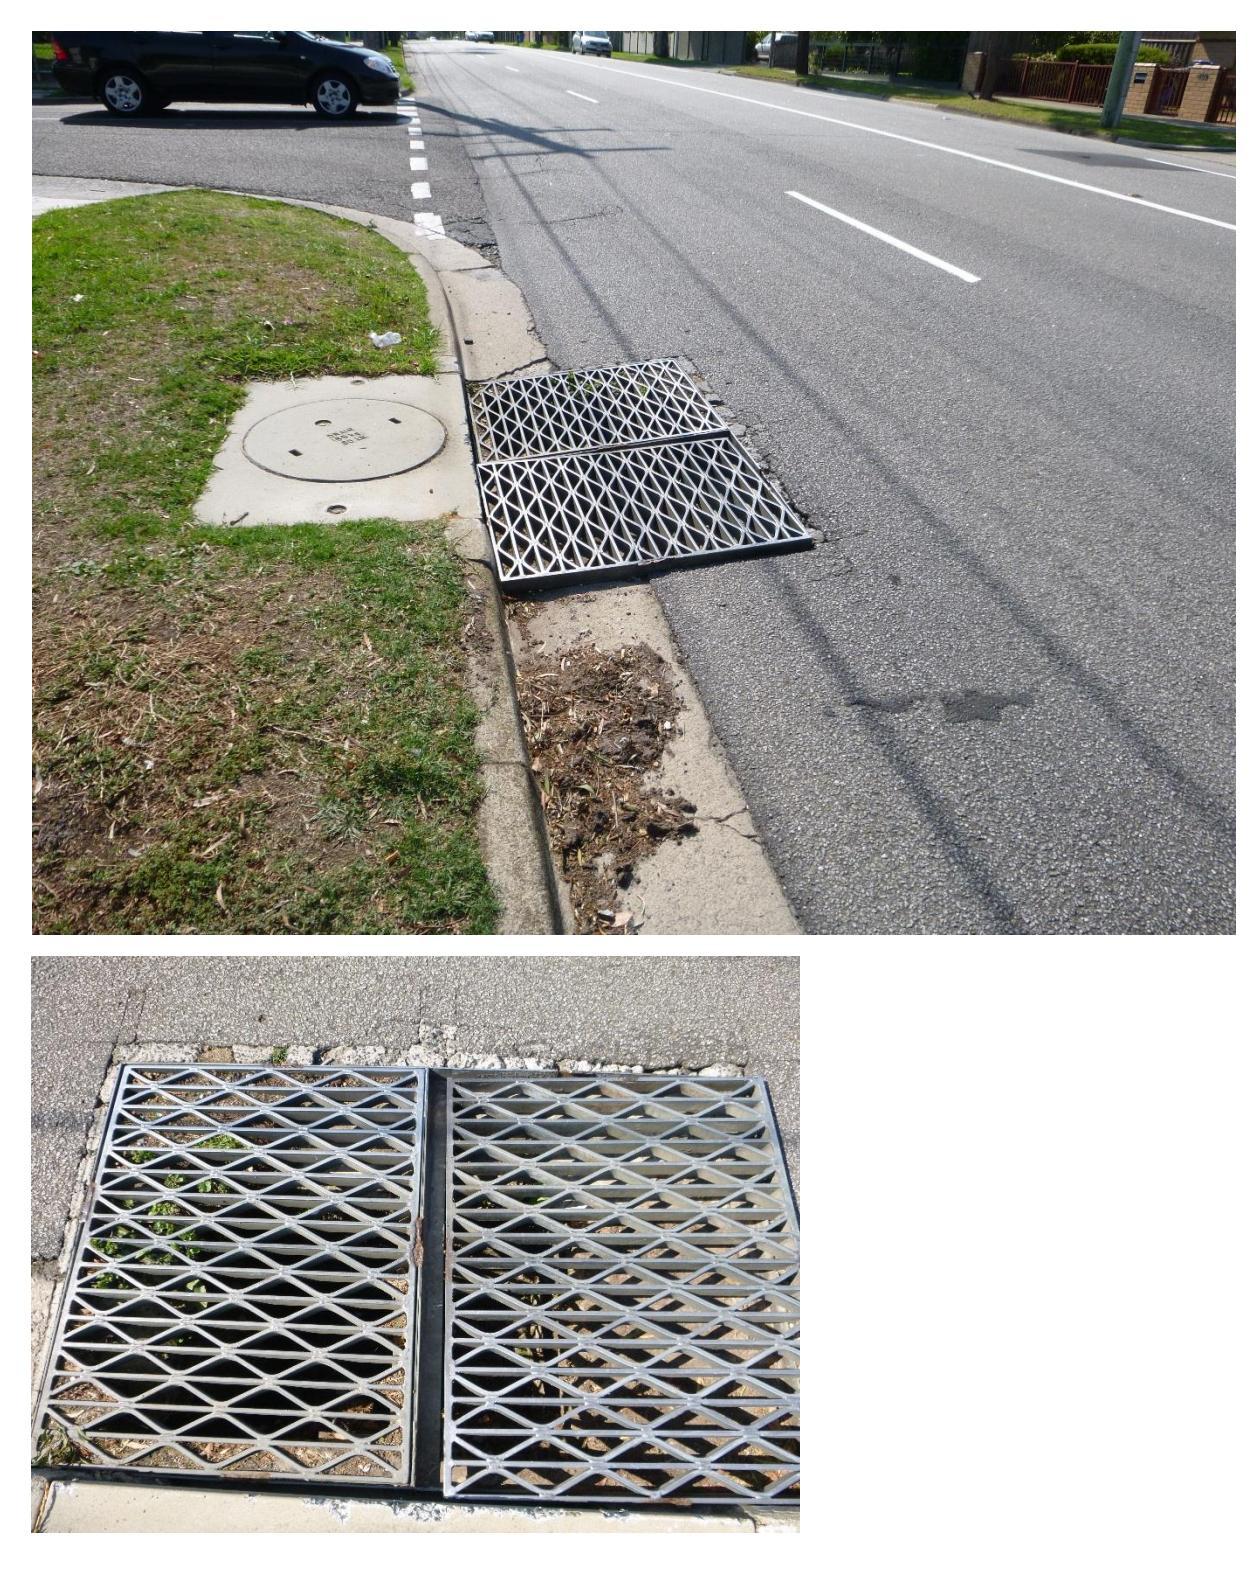
Case Study 11-Gully Grate-Vic

The installation below is a retro fit situation that has been poorly designed. The grate frames have experienced fatigue at the centre support and the grates dislodged from the frame.

The effect, had it not immediately been reported to council, would have been of, a car or truck completely dislodging the first grate and driving into the pit. These grates were not marked with any manufacturer's name and it would be unclear if they comply to AS3996 - 2006

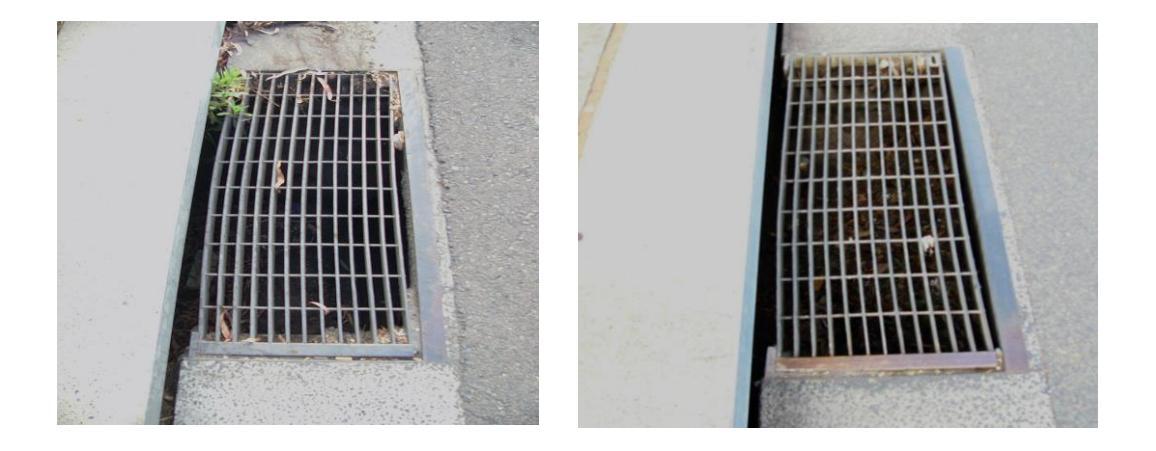
Case Study 12 - Liverpool CC - NSW

The grates below are imitations of a compliant product, but clearly do not have the load capacity of an AS3996 Class D product or this dramatic deformation would not have occurred in service. The products have no tagging, so the supplier/manufacturer cannot be traced.

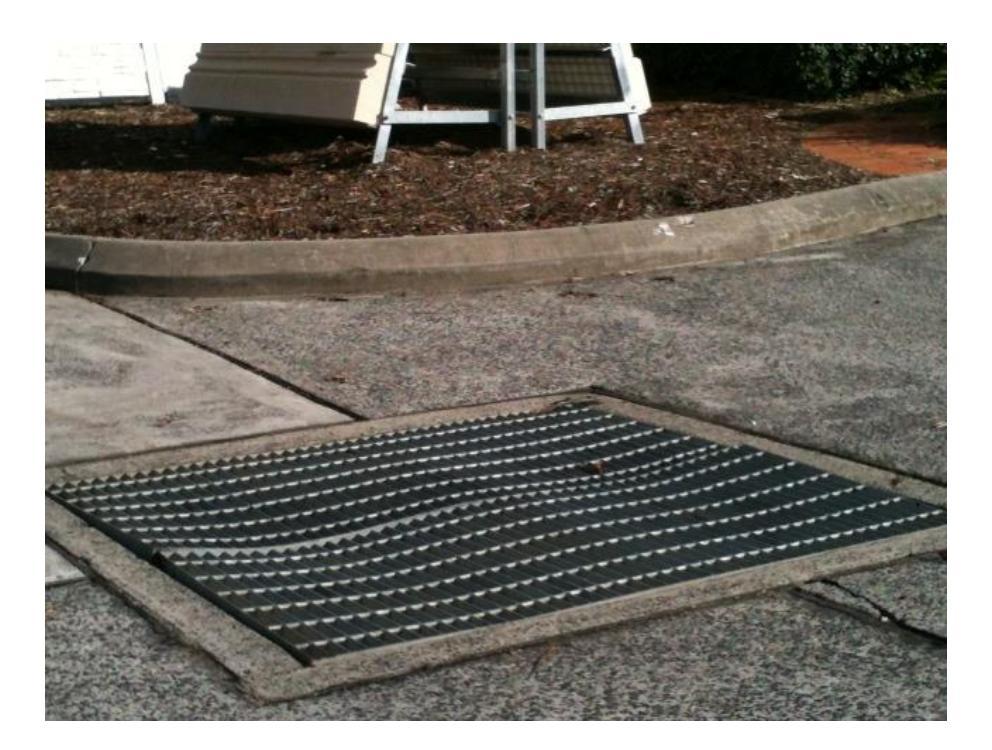
Case Study 13 - Commercial Car park - Tuggerah . NSW

The grate below again demonstrates lack of load carrying capacity for the given span. The grate has deformed dramatically and the expectation will be the failure of the welded cross bars leading to ultimate product failure.
