Work health and safety of workers in the offshore petroleum industry Submission 5 - Attachment 2

Safety alert 66

Potential for fatalities from electrical incidents

Understanding of light well intervention safety systems is critical for safe operation

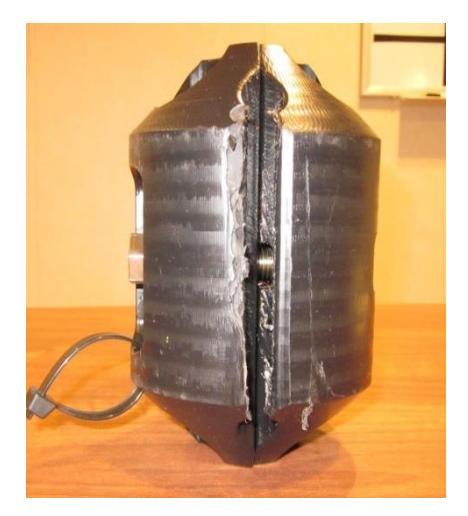
The 2-inch service hose, which remained connected to the subsea stack, is believed to have stretched under load, reducing friction with the clamp and leading to a rapid retraction of the wire by approximately 20 metres before the winch shut down on over-speed and the wire came to a halt. During the retraction of the wire, the upper two clamps collided with the sheave at the top of the tower on the vessel and parted; one of which dropped 27 metres to the deck below.

Image 1: Damaged dropped clamp

Secondary retention should be considered for all equipment (including temporary project related equipment) to be used at height and having the potential to cause harm.

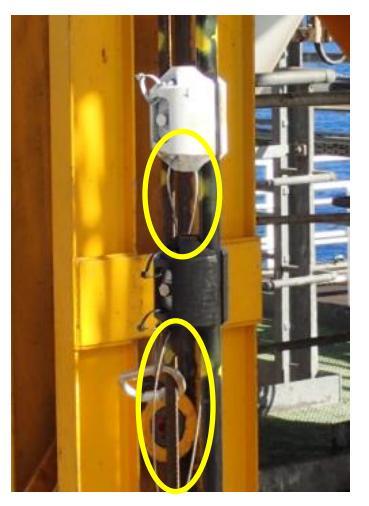
Image 2: Secondary retention subsequently fitted to the guide wire clamps

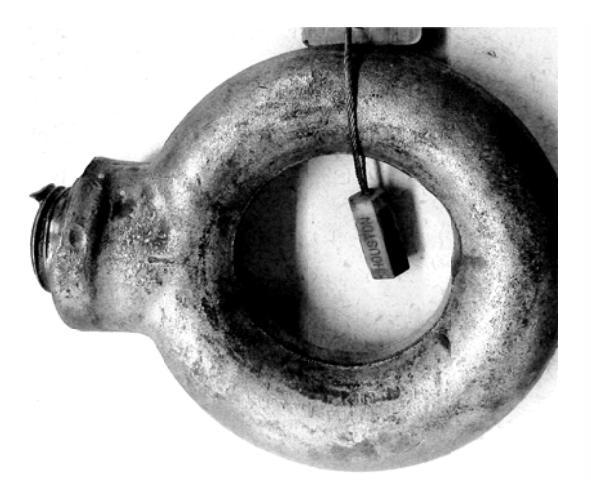
MODU crew were replacing the diverter on a MODU facility operating in Australian waters. The new diverter had been placed on its side in a cradle on the main deck for change-out of the flex-joint. Subsequently, the diverter was lifted with the intent of rotating it from the horizontal to its working, vertical axis. When the diverter had been lifted between 1.2 to 1.8 metres above its cradle, one of the two collared eyebolts used for lifting the diverter body sheared, see Figure 1 below. This caused the diverter to rotate and the second eyebolt to become dislodged from the diverter body. The diverter then fell back into the cradle on the main deck. The combined diverter and the running tool weighed approximately 21.7 tonnes and fell a distance of 1.2 to 1.8 metres. No persons were injured in the incident.

- The lifting equipment was configured such that the direction of pull was at an angle to the shaft of the eyebolt, so that a "fleet angle" from the vertical was created. An angular load such as this reduces the Working Load Limit (WLL) of the eyebolt significantly. See Figure 2 below;
- The collar of the eyebolt was not fully flush with the body of the diverter, causing a shearing force due to the fleet angle to be applied to the shaft of the eyebolt, instead of the load being spread across the eyebolt's collar and the surface of the diverter as per design.

Fig. 1: Failed eyebolt

- Lifting arrangements such as spreader bars to ensure that the lifting force is applied in line with the axis of the threaded shaft of the eyebolts should be considered when planning lifts;

- Eyebolts should be tightened fully down to the face of the lifted load. It should not be possible to fit a 0.04mm feeler gauge at any position between the collar of an eyebolt and the lifted load. However, eyebolts should not be over-tightened;

- A shim washer might be required to ensure that the direction of the load is aligned with the plane of the eye;
- Where the direction of the lifting force on the eyebolt is at an angle to the axis of the threaded shaft of the eyebolt that exceeds 5 degrees the Working Load Limit of the eyebolt will be significantly reduced. This must be taken into account when planning a lift using eyebolts;

- Collared eyebolts should only be used up to an angle of 45 degrees to the axis.

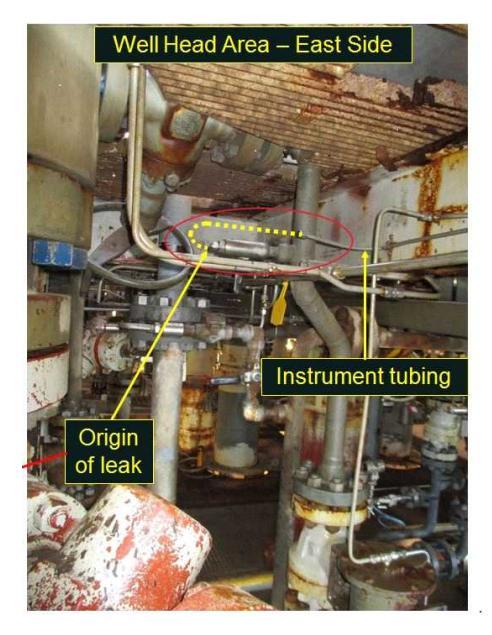
Failure of an instrument tubing line connected to a wellhead gas lift line resulted in the release of a significant volume of hydrocarbon gas from the production annulus over a time period of 3.5 hours, elevating the risk on the facility during the release. Although initiation of the surface shutdown also closed the shutdown valve fitted to the gas lift line, this did not isolate the flow of hydrocarbon gas from the production annulus as the failed instrument line had been located on the gas lift line between the wellhead production annulus and gas lift line shutdown valve, see Figure 1.

Figure 1 – Location of failed instrument line (dashed line) fitted to gas lift line between the production annulus wing valve and gas lift shutdown valve.

Locating the fitting for the instrument tubing line between the production annulus wing and gas lift shutdown valve created the potential for an unrestricted pathway from the failed instrument tubing line to the full volume of the production annulus. "This configuration is contrary to international guidelines and standards" (see References).

In this configuration, leaving the manually operated wing valve open to the production annulus to allow daily readings of the pressure in the production annulus resulted in an unrestricted pathway from the production annulus to the failed instrument tubing line as the shutdown valve was not able to safely isolate the gas inventory of the production annulus.

- Maintaining well integrity with a two barrier philosophy is considered good industry practice.
- Gas lift line shutdown valves (SDV) should be fitted as close as practicable to the wellhead and the SDV should be activated with the same signal as the surface safety valve to effect isolation of the gas lift line and any small bore take-offs.

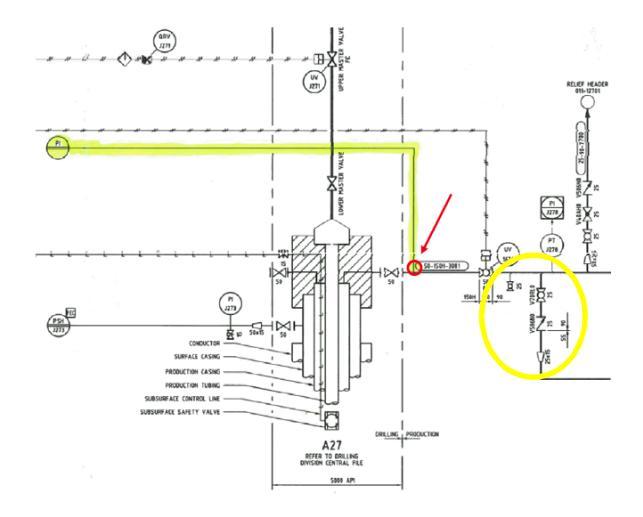
Figure 2 provides an example P&ID that shows the instrument take-off point located downstream of the UV (Multivariable) shutdown valve.

Figure 2 – Example P&ID drawing showing the instrument take-off point (arrow) incorrectly located downstream of the UV shutdown valve (circled).

Good design requires that the gas lift shutdown valve (SDV) should be as close as practicable to the wellhead with any fittings to the gas lift line on the upstream side of the gas lift SDV ensuring a barrier to gas in the production annulus in the event of any failure of fitting.
