Further information from Graeme Sawyer relating to my previous evidence.

Summary

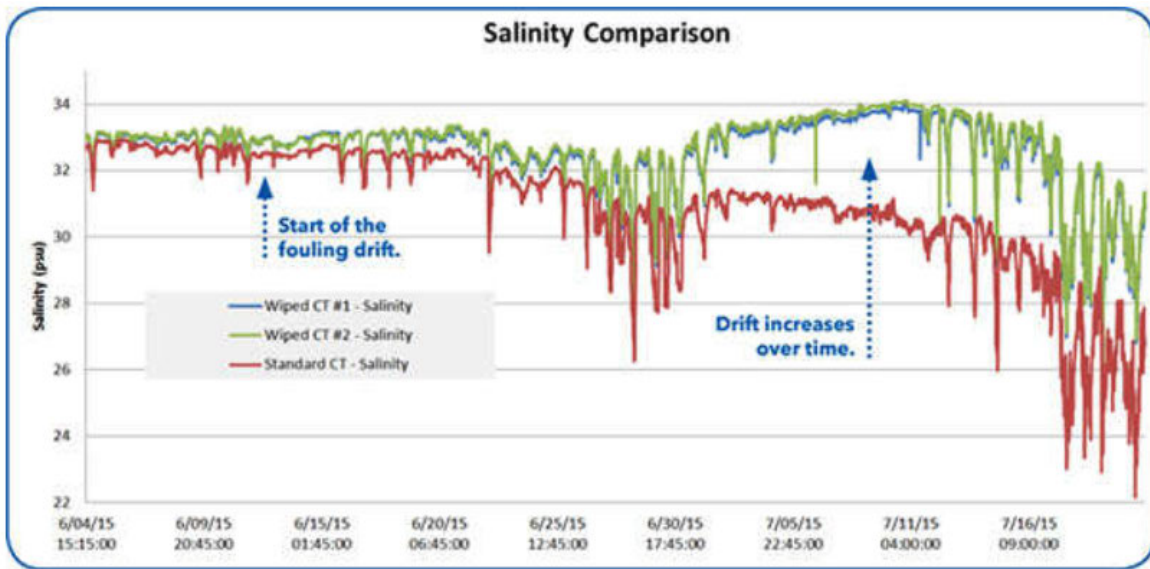
Figure 1 - Sensor fouling research data plot from salinity research.

The statement shows no evidence to support these claims and available evidence refutes them. As an example, the raw data from RN040936 shows very little drift in the readings and a slight increase if anything. This notion of fouling causing the rapid increase in EC readings does not fit with the science of the types of sensors used as fouling normally leads to a lowering of readings. It also does not fit with the significant drift claim. Fouling is a slow process and is cumulative. It doesn't usually cause sudden dramatic increases. This is because the fouling slows the electrical current flow used as the key sensor function. See figure 1 below for details

1 Sensors using an electrical current to measure micro siemens as a salinity or dissolved ions measurement typically show reduced readings when they suffer from fouling not sudden increases⁵.

2 Even when they are suffering from fouling the sensor will still show the up and down movement changes in salinity readings as can be seen from the image below where the red line, the fouling sensor plot, is still showing the peaks and troughs in synch with the green and blue plots from the self-cleaning sensors. This is clear in Figure 1 below. The 28 August 2019 EC spike looks more likely to be real when this evidence is considered.

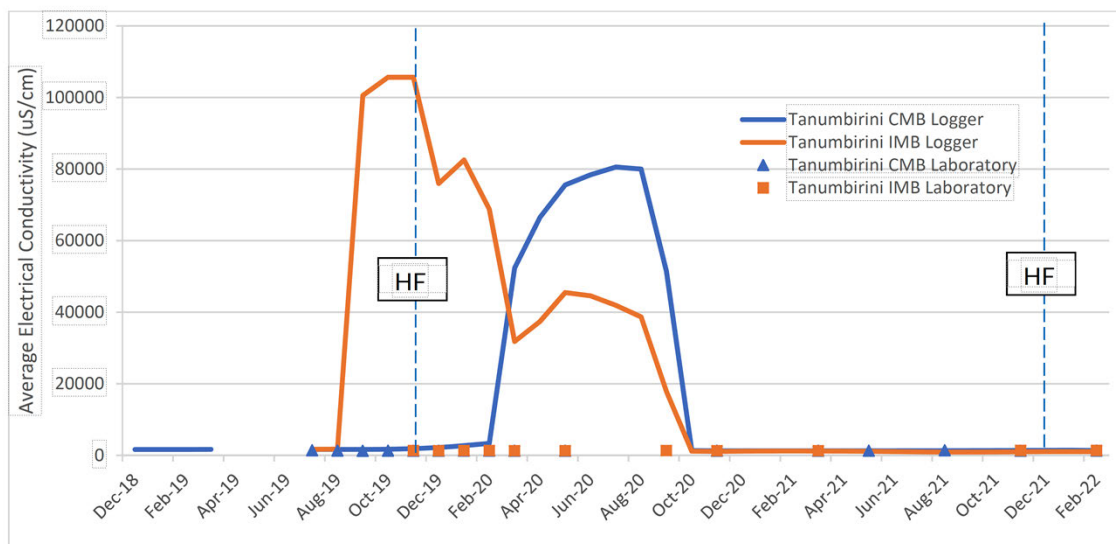
Figure 2 Data inconsistency plot from NTG Regulatory Statement- Electrical Conductivity

There is a clear and unexplained discrepancy with the manual data, which has been collected in a different manner. The regulator needs to take control of this process and use independent sources for this work to meet transparency requirements and use multiple sensors as specified to develop a clear understanding of these issues relating to the water column and bores. This must be transparent. There is no manual data from RN040936 in the period leading up to the EC reading spike in Aug 2019 that I am aware of. It is strange that this graph shows no manual data (Blue triangles) from RN040930 at the time of the EC spike in that bore's data. This needs investigation.

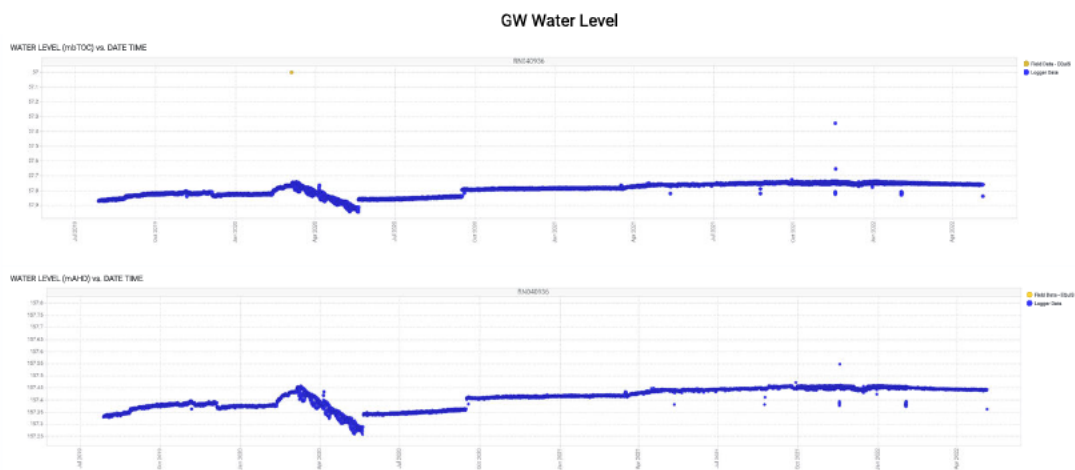
Figure 3 Water elevation data RN040936

Further there are concerns with other water elevation data that appears to roughly coincide with the salinity spikes in the bores. Figure 3 below shows a major change in the water elevation around the time the spike in RN040930 occurred. This indicates that there was fracking activity at the time of salinity spikes suggesting that the vibrations of operation at one well on a pad could be impacting the bonding on nearby wells perhaps calling into question the multi well wellpad concept. I do not have access to the Well Operations management plan WOMP to analyze this and would ask the senate inquiry to facilitate this.

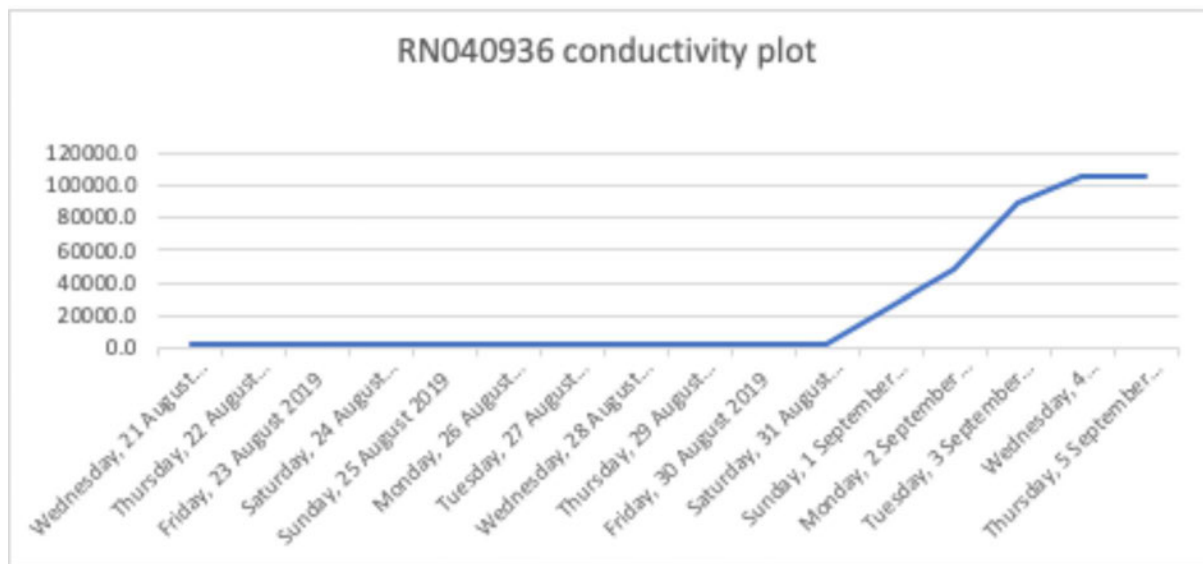
Figure 1 - Daily Average EC plot ($\mu\text{S}/\text{cm}$) from IMB RN040936 around the time of the initial increase in EC

The raw data from RN090936, also known as the impact monitoring bore, reveals an approximately 50-fold increase change in the conductivity reading microsiemens/cm ($\mu\text{S}/\text{cm}$) which is a standard measure of total dissolved ion load/salinity in water, commonly used to track the salinity of freshwater.

The conductivity $\mu\text{S}/\text{cm}$ measurements began in bore RN 040936 on the 27th July 2018 with a value of 1714.8 $\mu\text{S}/\text{cm}$. For the next 13 months, until Thursday 27th August 2019 EC readings were between 1670 $\mu\text{S}/\text{cm}$ and 1730 $\mu\text{S}/\text{cm}$.

The raw data shows that the conductivity measure went above 1800 ($\mu\text{S}/\text{cm}$) for the first time on Thursday 29th August with the early morning (0:00 hrs) reading of 1804.1 $\mu\text{S}/\text{cm}$. By that evening the reading was 1861.9 $\mu\text{S}/\text{cm}$. By Friday night, the reading was 2027.1 $\mu\text{S}/\text{cm}$, by Saturday night 5895 $\mu\text{S}/\text{cm}$, By Sunday night 34,473.8 $\mu\text{S}/\text{cm}$. By Monday night the reading was 62092.6 $\mu\text{S}/\text{cm}$ and by Tuesday night it had reached 105651 $\mu\text{S}/\text{cm}$ which is around the maximum the sensor was able to measure.
