MAP 1: COAL SEAM GAS IN THE PILLIGA FOREST

Project area and construction footprint

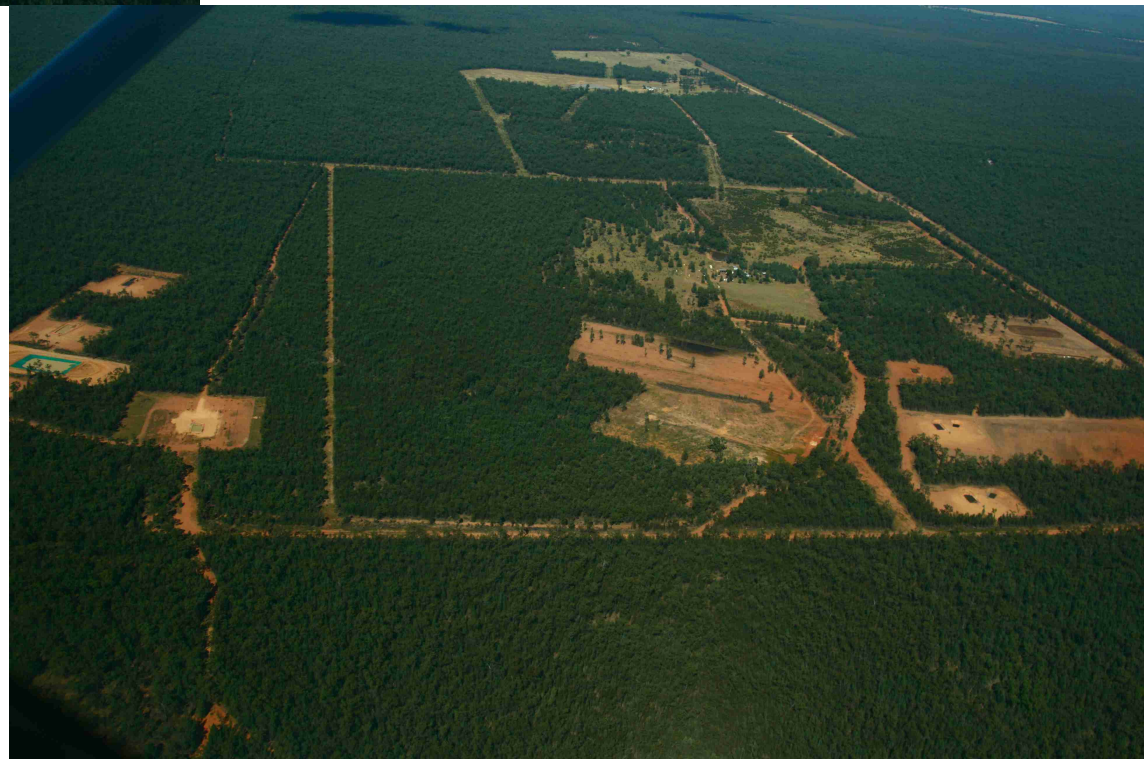
Photo 2: 'Pilot production' wells drilled under exploration licence. Dewhurst 8 complex, located on private property in the Pilliga. May 2010.

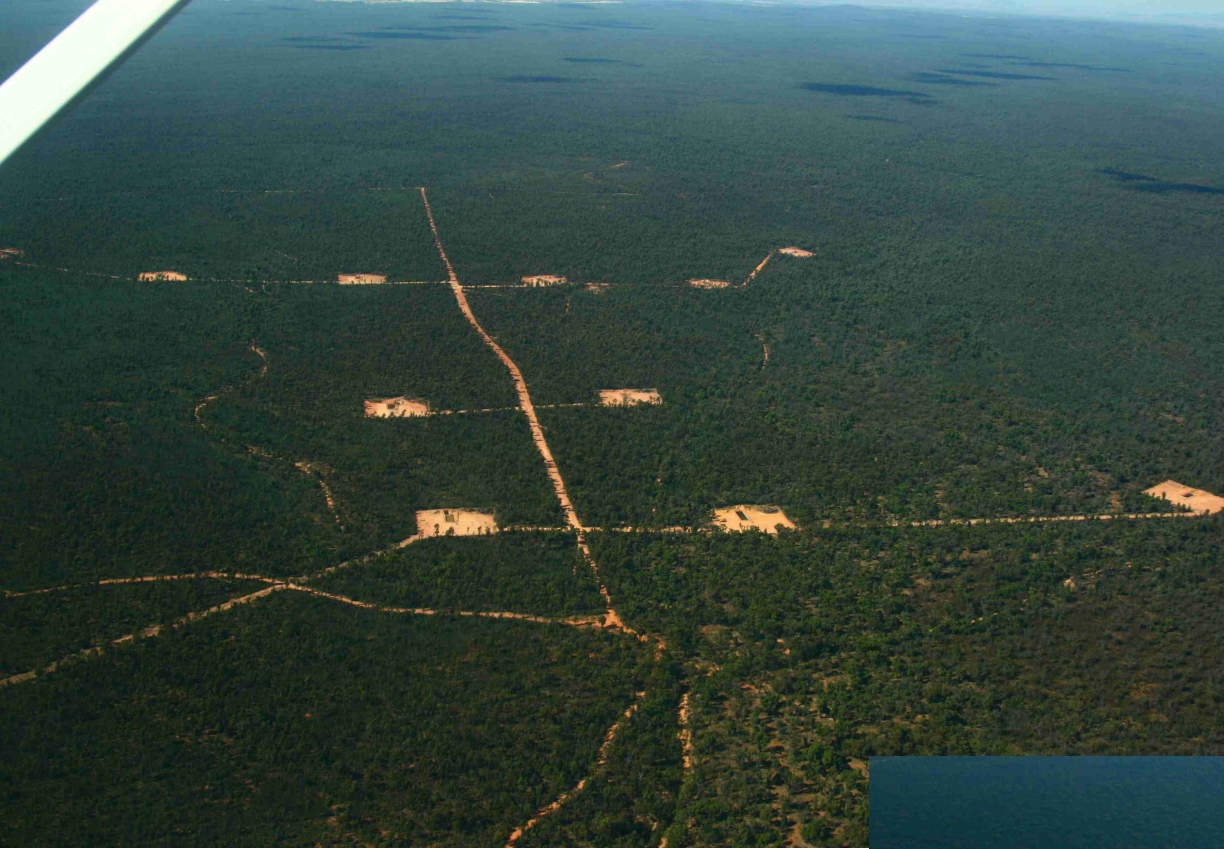
Photo 3: 'Pilot production' wells in Bibblewindi State Forest. Photo May 2010.

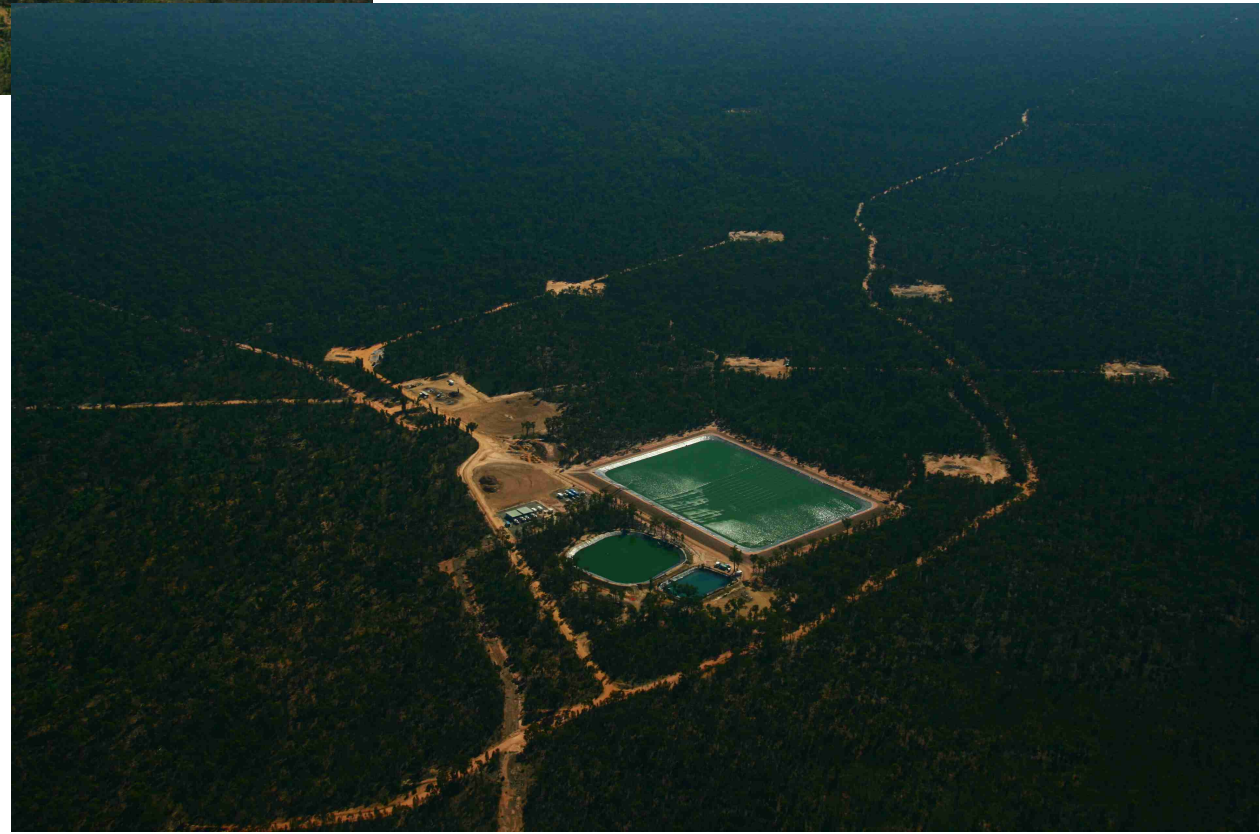
Photo 4: 'Pilot production' wells and water treatment dams in Bibblewindi State Forest. Photo May 2010.

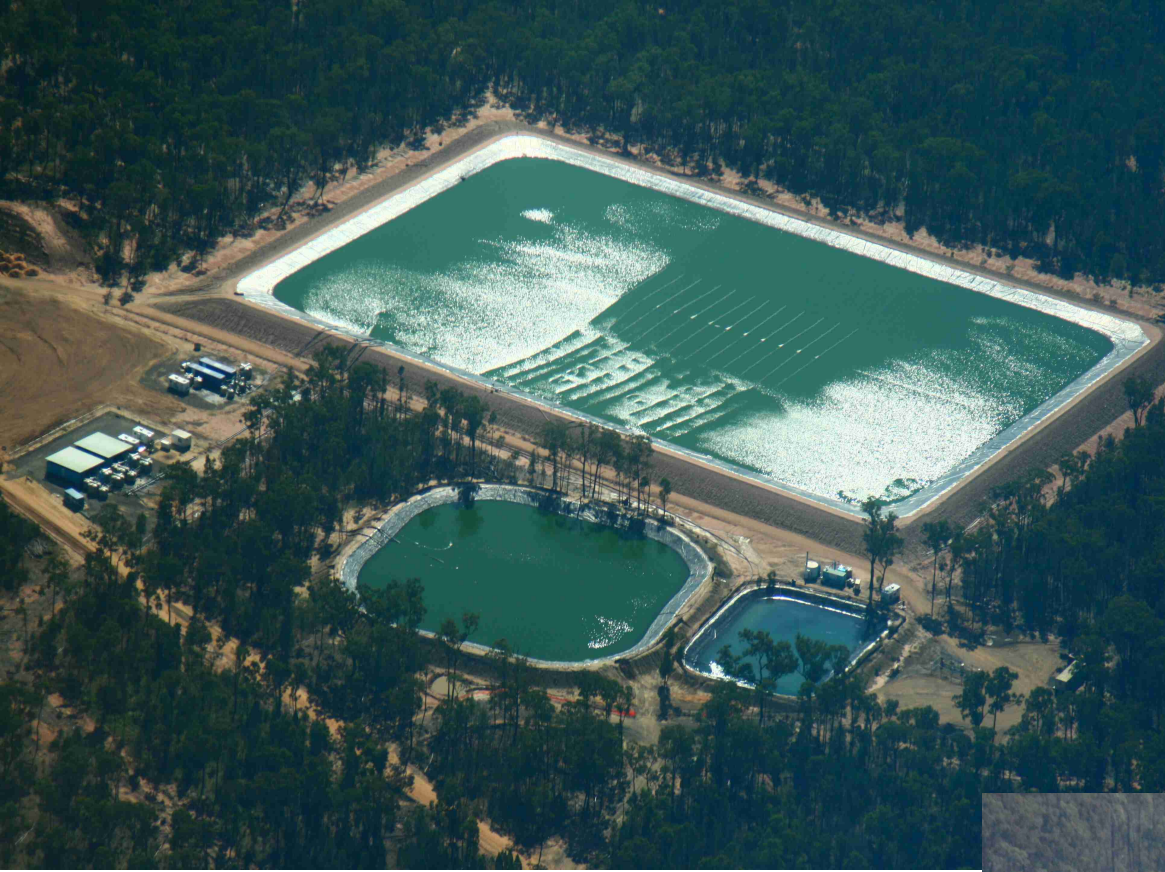
Photo 5: Bibblewindi West Water Treatment works in Bibblewindi State Forest. Photo May 2010.

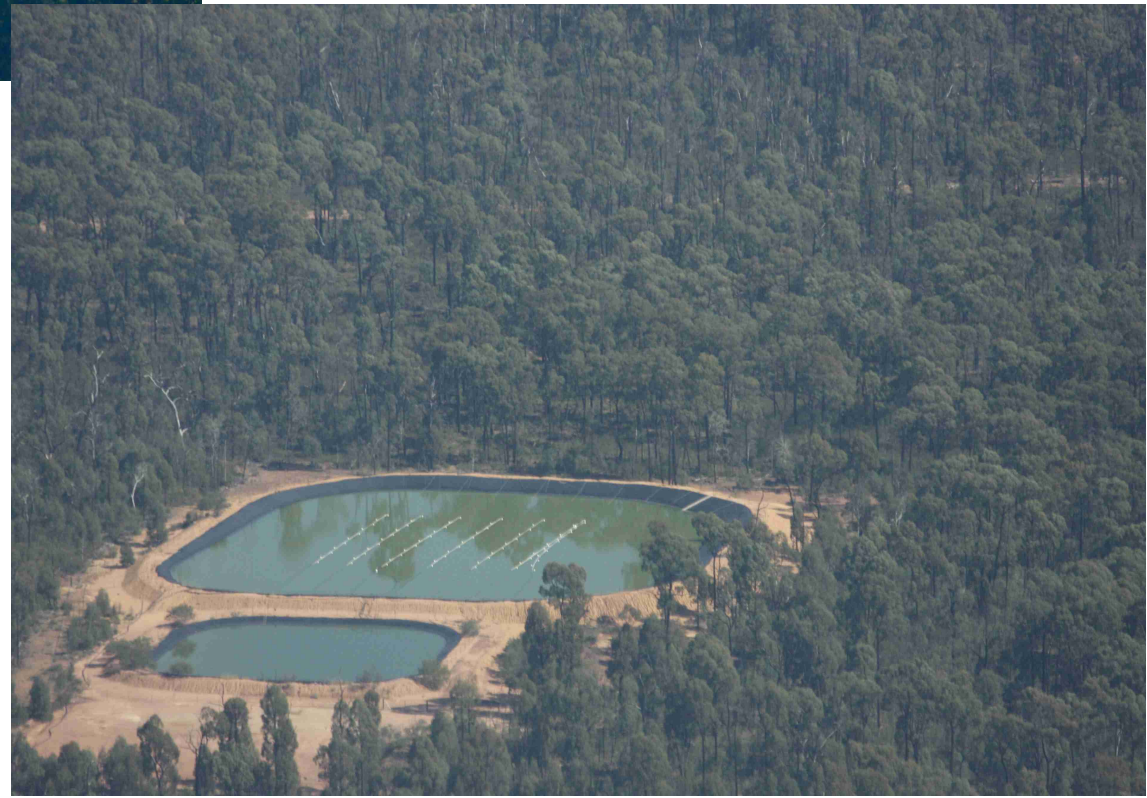
Photo 6: Bohena Evaporation ponds in Pilliga East State Forest. Photo May 2010.

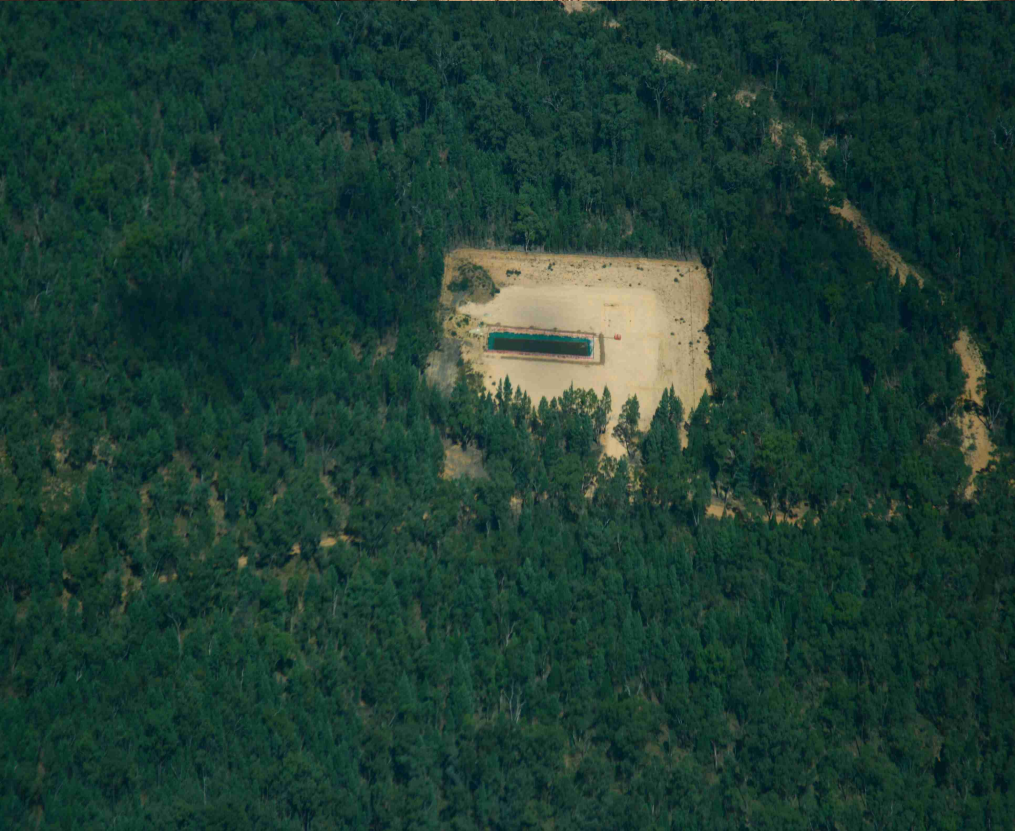
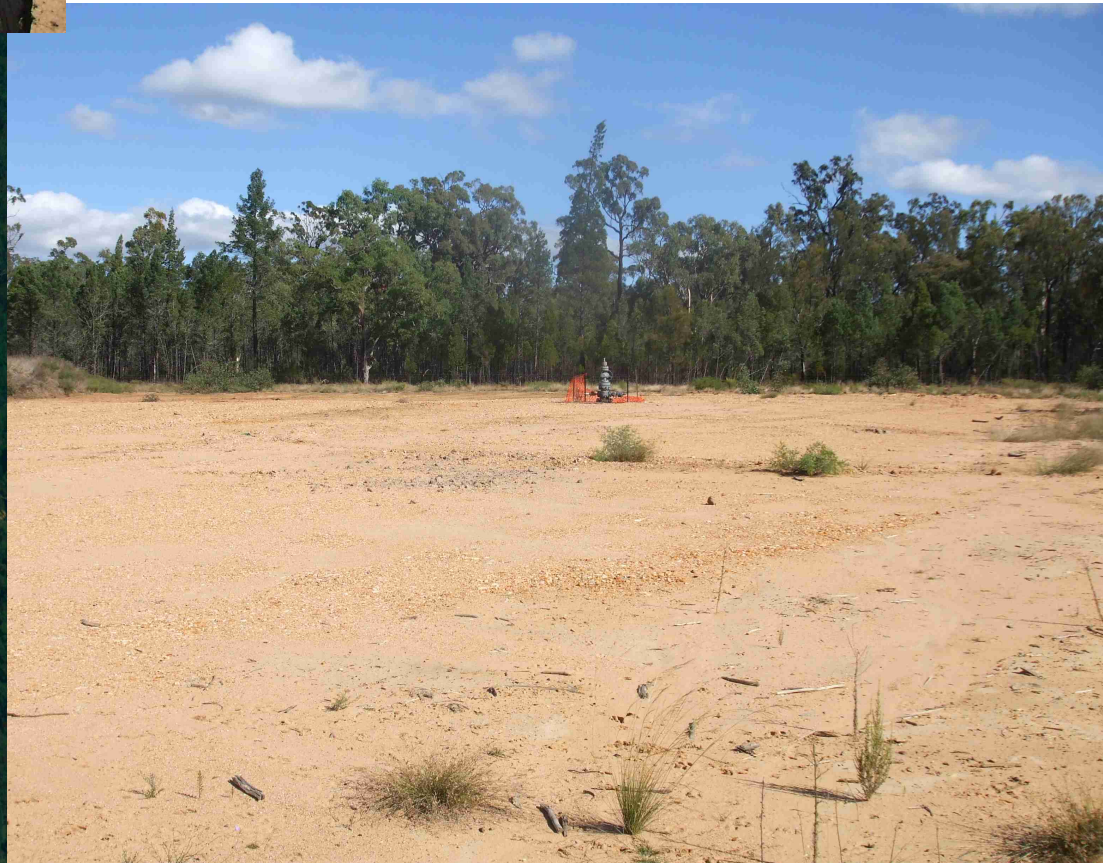
Photo 8 & 9 (below). Dewhurst 6c, exploratory corehole, Pilliga East State Forest. Abandoned, not rehabilitated. Photo 2011.

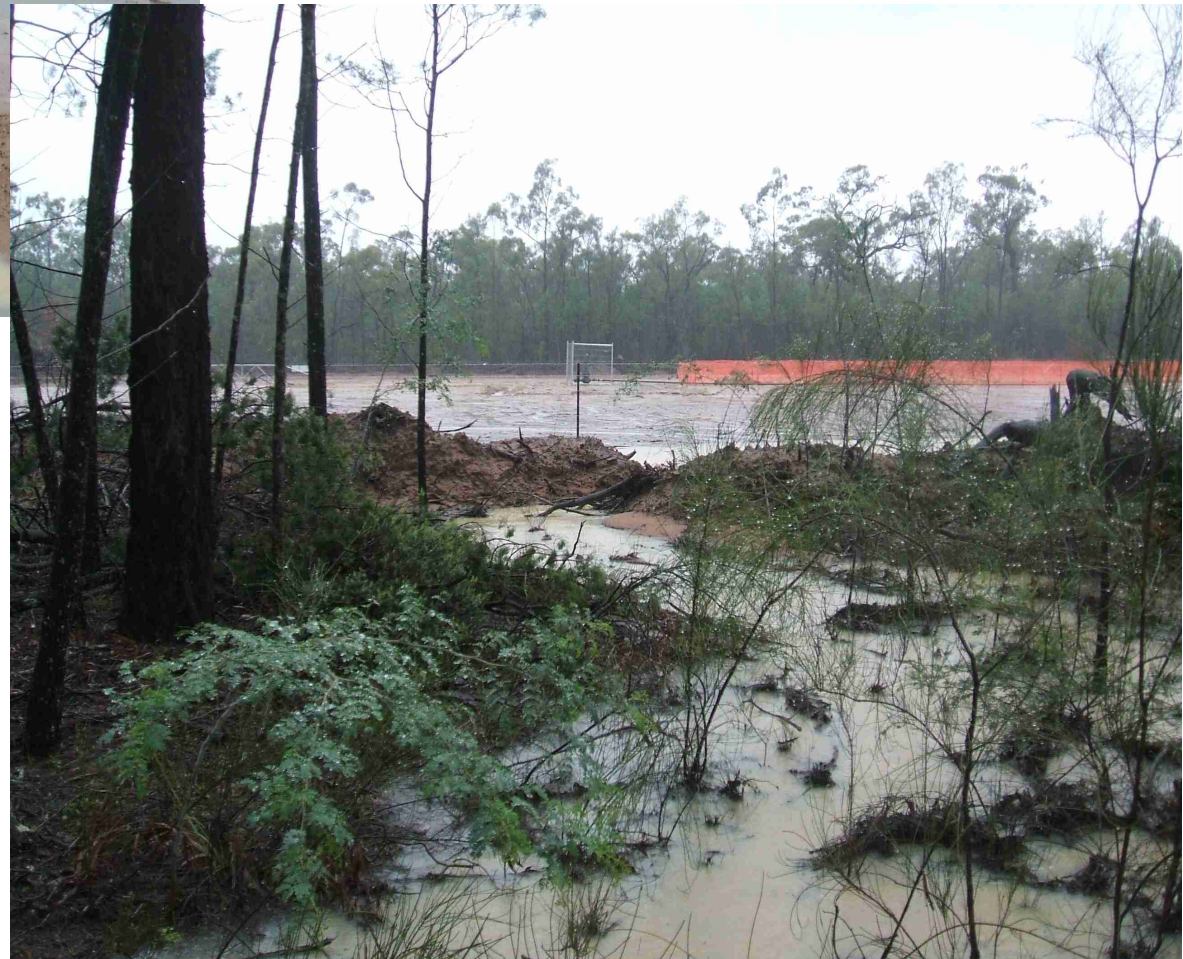
Photo 11. Dewhurst 16H exploratory
corehole. Drill pond and wellpad
flooding on private land during rain
event in the Pilliga. Taken 2010.

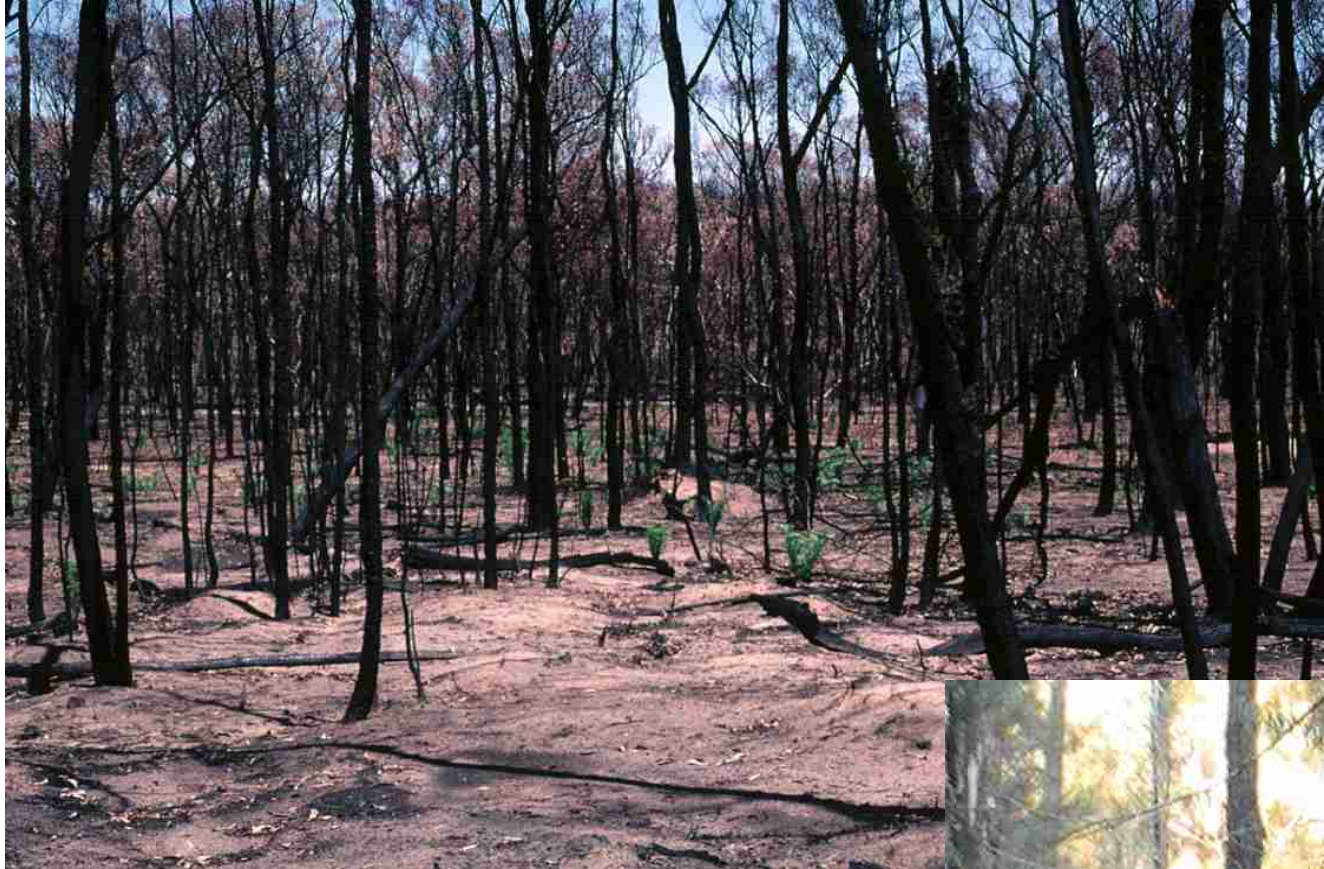
Photo 12. Bohena 2D exploratory corehole. Tree deaths from saline water spill, Pilliga East State Forest. Photo taken 2002.

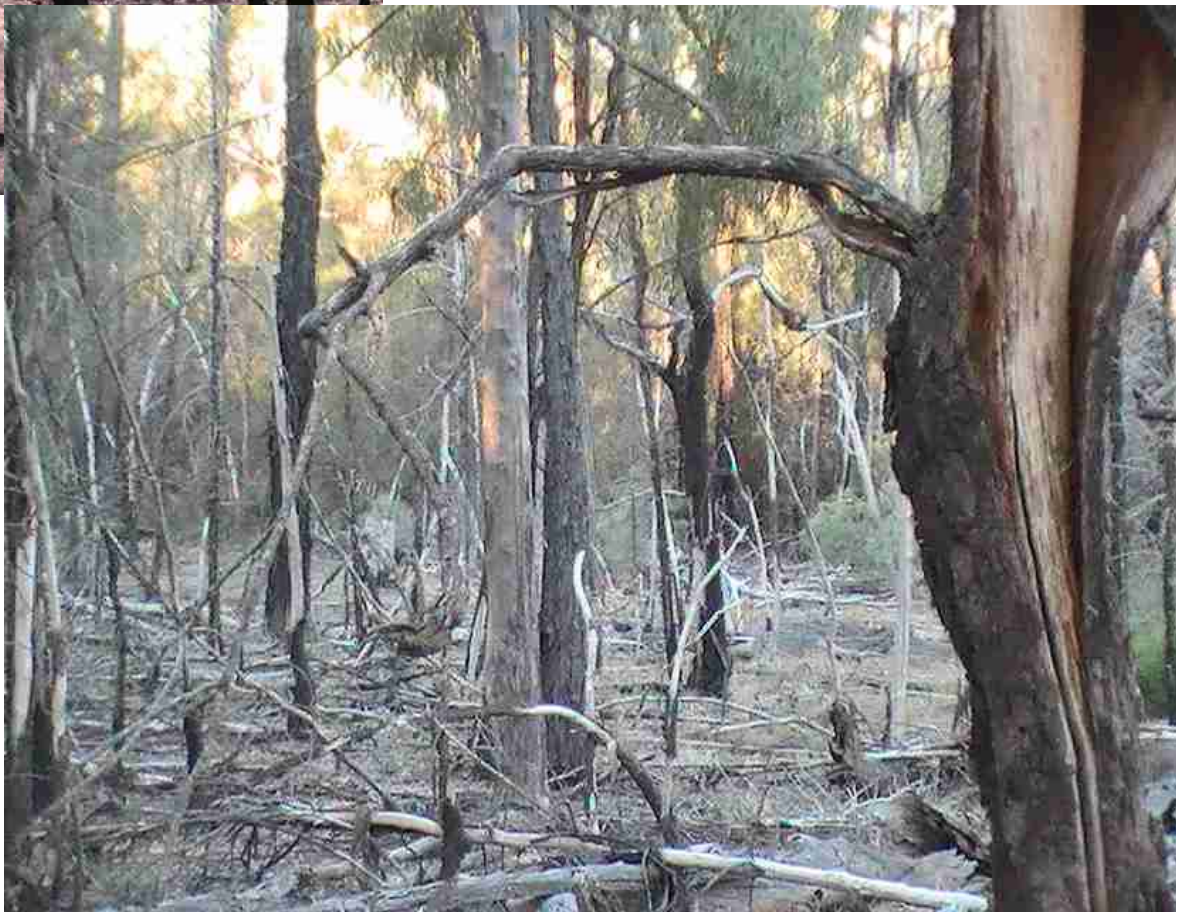
Photo 13. Bohena 2D exploratory corehole. Tree deaths from earlier saline water spill. Photo 2011. Pilliga East State Forest.

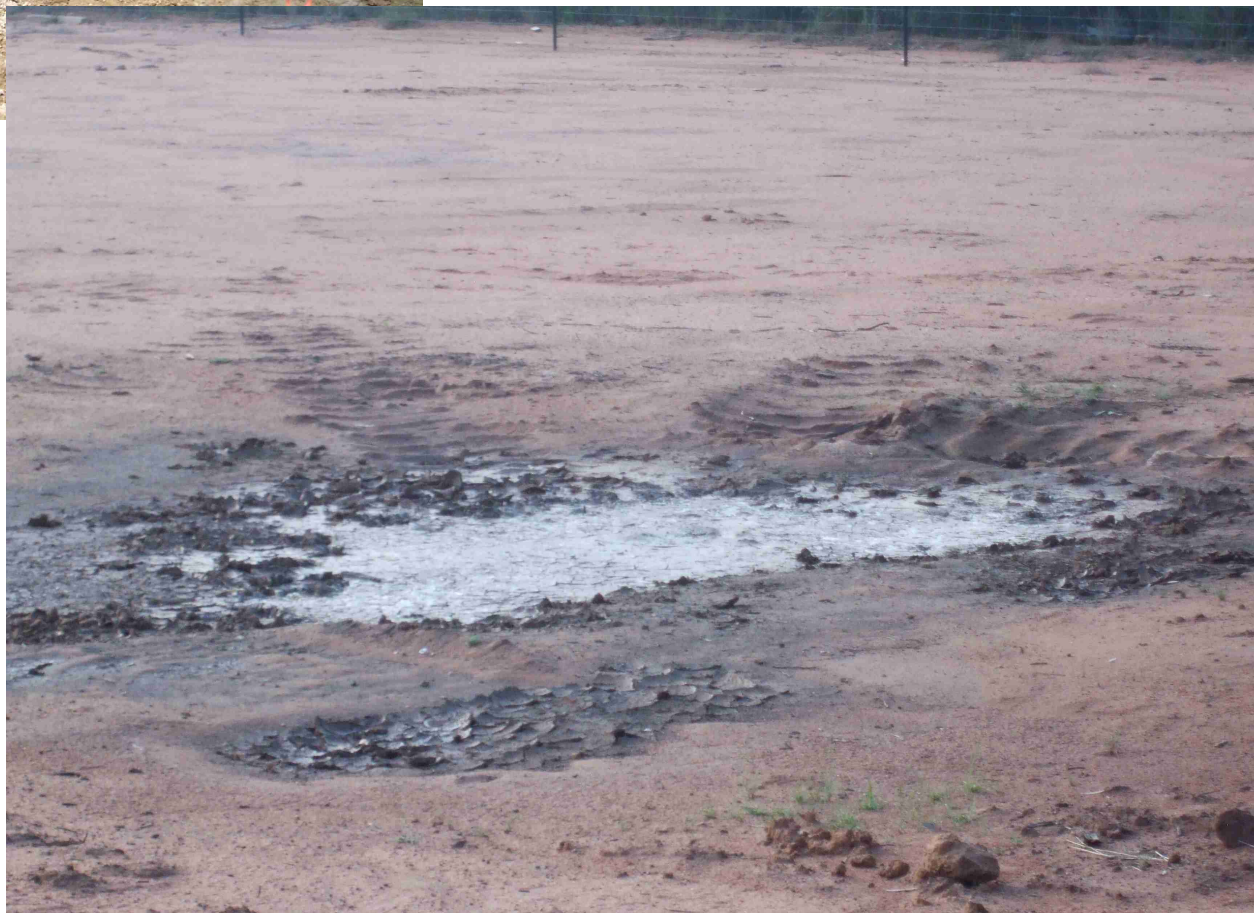
Photo 15. Bibblewindi 16 pilot production well. Salt scald adjacent to unlined drill pond, Bibblewindi SF. Photo 2011.
