# 2008 DISTRIBUTION WOOD POLE AUDIT REVIEW

## A Review of Western Power's Response to the

## 2006 Regulatory Compliance Assessment of Western Power's

May 2009

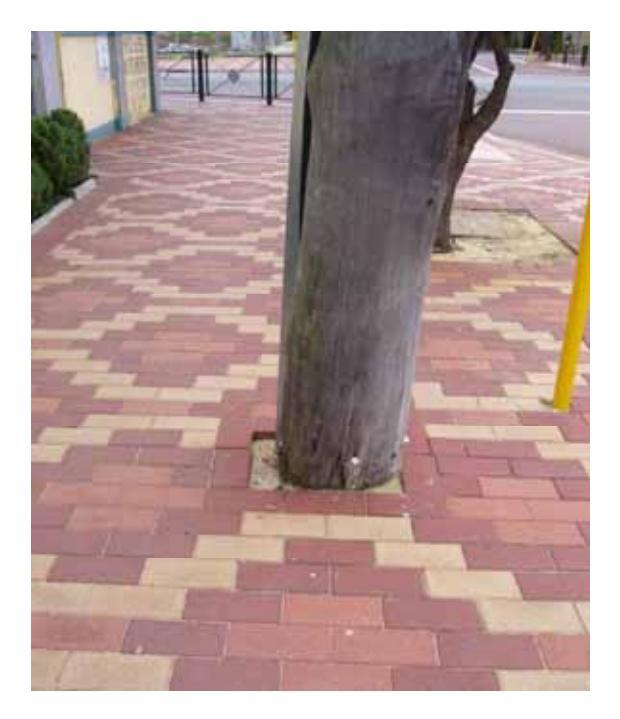
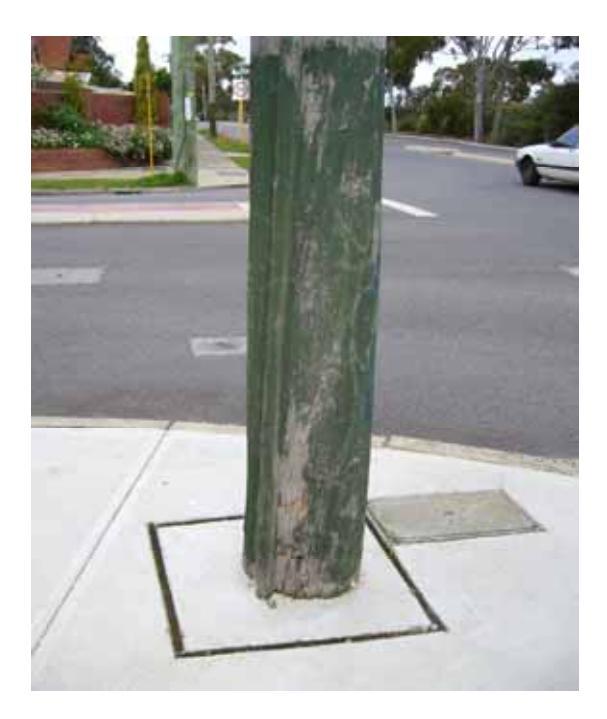
A further sample of poles surrounded by brick and concrete paving was also checked. As in the 2006 Audit, there again is no evidence that the below test results from these poles can or does represent the condition of these poles below ground.

**Recommendation 13:** Western Power should develop and implement a practice for inspecting and assessing the below ground condition and strength of wood poles installed in brick, concrete and other paving that precludes access to the pole below ground using a spade.

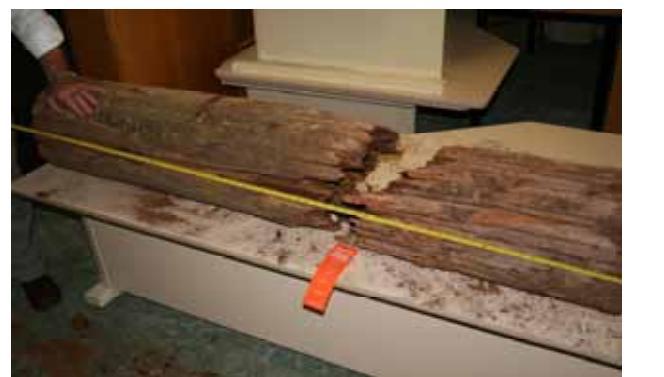
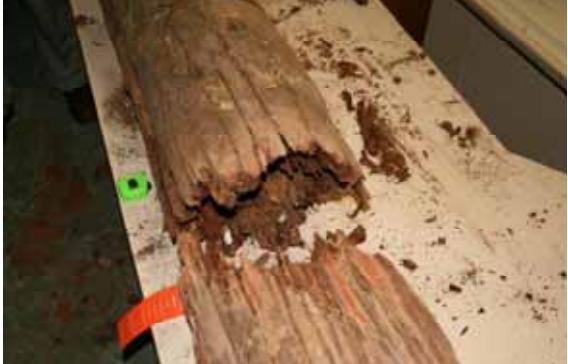
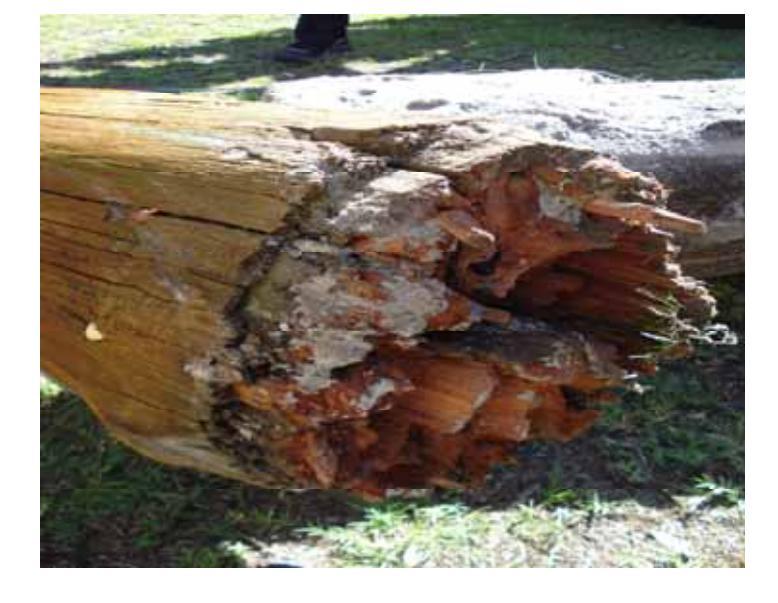
The inspection and service contract does not require the contractors to warrant their performance with respect to either the quantity or the quality of their inspection activities, or their accountability for any unassisted pole failure in the next 4-year pole

The contract does not detail the contractors' quality assurance requirements, or those used by Western Power when assessing the contractors work. The contract also does not include Western Power's 2009 improved QA processes. The contracts also do not include any specific inspection of the aerial and ground stays supporting the wood pole power lines.

It is unlikely that this inspection and service contract as it is presently structured will deliver an acceptable wood pole condition assessment, even with an effective pole inspection practice.

**Recommendation 14**: Western Power must immediately inform the existing contractors of the above deficiencies, ramp up the quality and number of the Service Delivery audits and exercise the maximum influence possible under the existing contracts to achieve an acceptable below ground pole condition assessment.

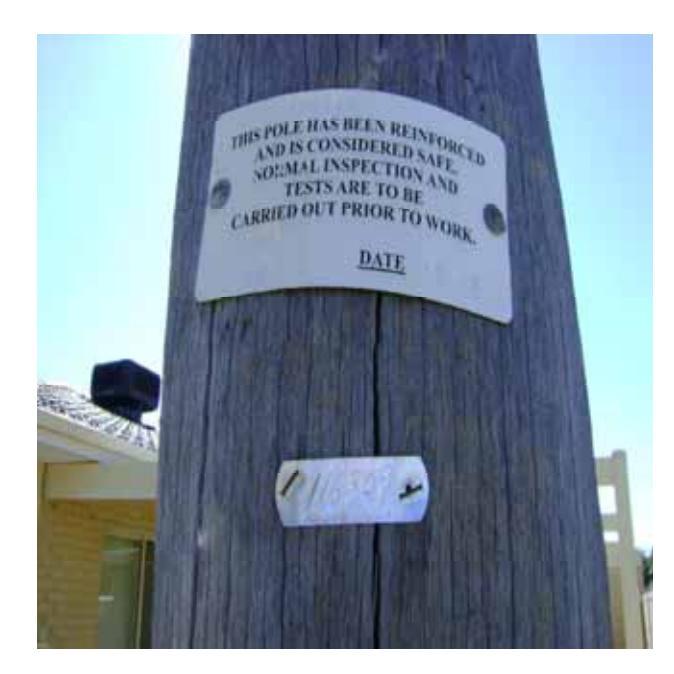
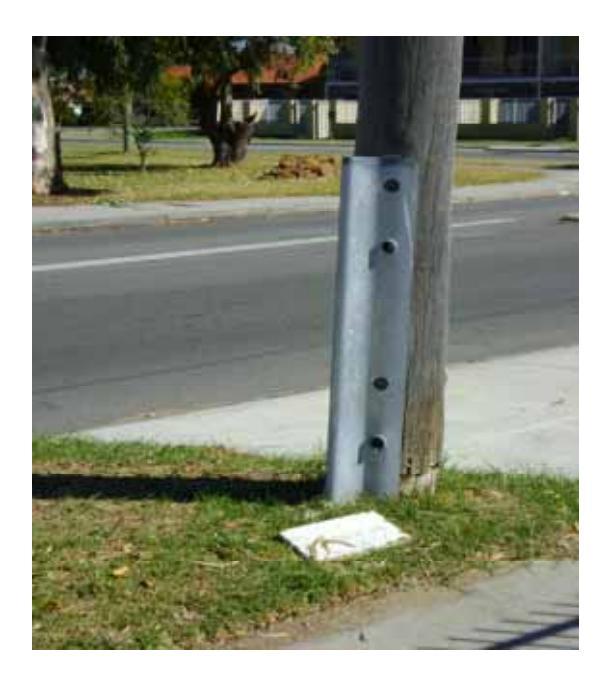
UAM confirmed that any pole being assessed for reinforcement must have a good wood annulus of at least 60mm, the RFD steel stakes can be placed at any orientation and neither welding nor grinding were required to installation."

This reassuring assessment of the structural adequacy and safety of the system was supported by the 2008 Audit Review of the UAM supplied RFD Pole Reinstatement System Testing Process and discussions with UAM's General Manager. The document is comprehensive and detailed in its description of the tests performed and the results obtained. UAM is also very committed to maintaining its 'no reinstatement failure' performance with over 200,000 pole reinstatements in service around the world. The system also has a long and sound development history commencing with the SECV almost 30 years ago.

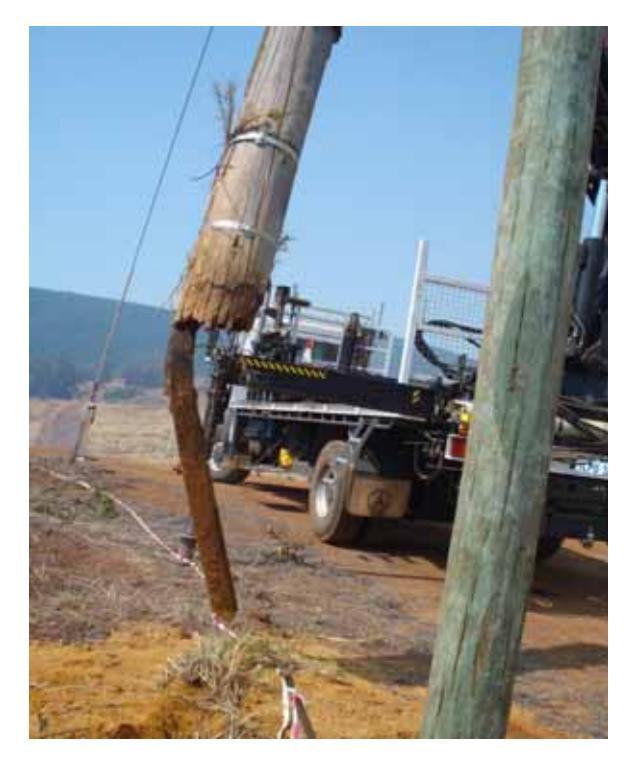
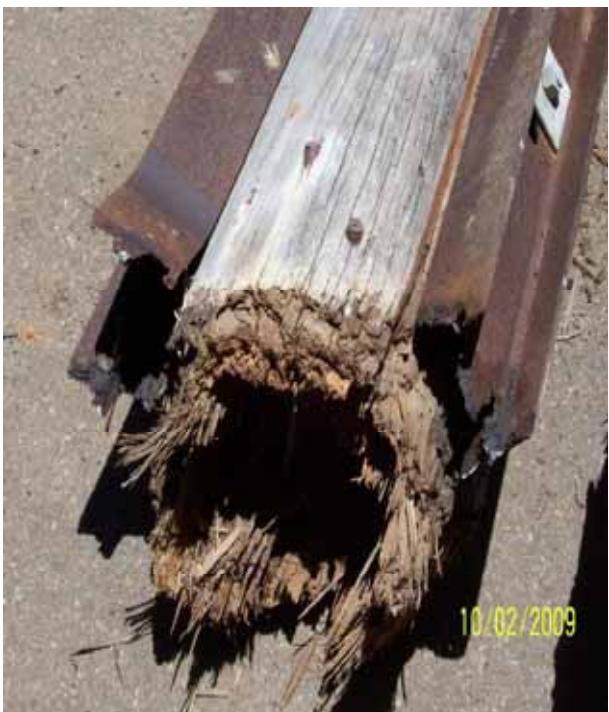
The UAM inspection recommendation above mentions termite activity, but does not identify the other "factors", or deterioration sufficient to compromise the pole reinstatement. These factors would be the criteria for identifying UAM reinstated poles no longer serviceable and requiring replacement.

**Recommendation 21**: Western Power should develop and implement prudent reinforced pole replacement criteria, which should become part of the pole inspection manual and practice. This should include the reinforced poles in the network (before UAM) that are known to be unsafe and should be replaced.

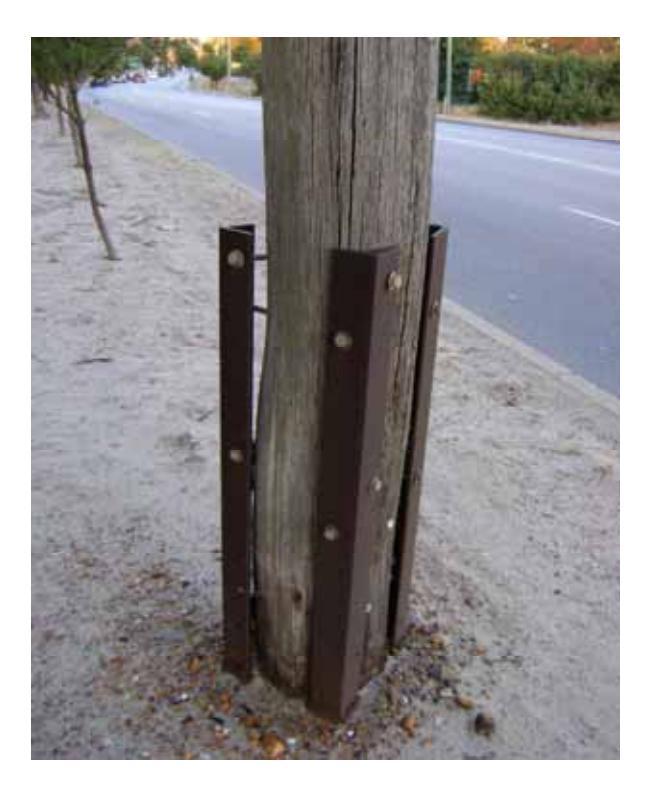
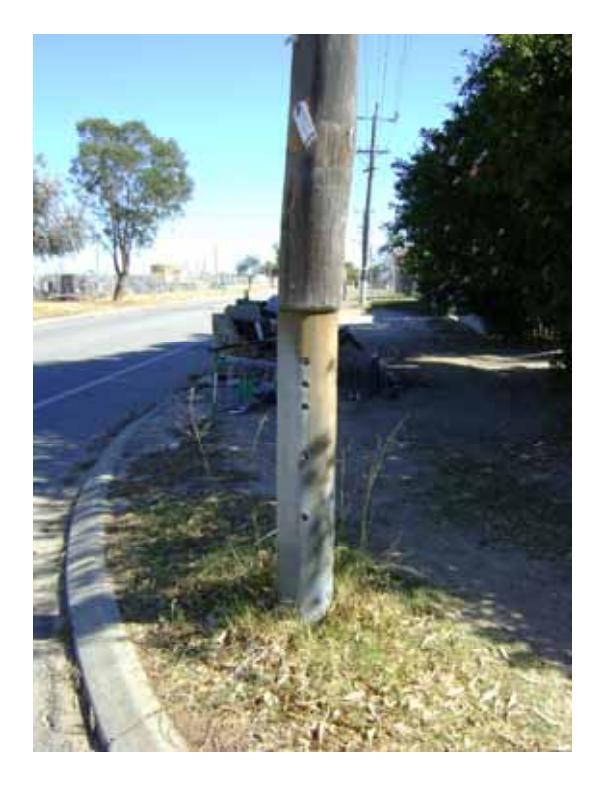
- Approximately 60 different types of pole base reinforcement systems installed in the distribution network.
- No calculations or trials to demonstrate any of these systems have the strength to ensure these reinforced poles are safe.
- No serviceability criteria to identify which reinforced poles that are no longer serviceable and should be replaced, and
- Reinforced pole failures:
  - Above the reinforcing stakes
  - o Of the pole between the reinforcing stakes
  - Of the reinforcing stakes and the pole

- Approximately half of Western Power's 620,000 distribution wood poles have been reinforced.
- Continuing reinforced pole failures.
- UAM is installing all new pole base reinforcement, which addresses the concerns with Western Power's pole base reinforcing in 2006.
