I should like to make a submission to the Environmental Regulation of Uranium Mining Inquiry.

I am a former employee of the Ranger Uranium Mine Environmental Laboratory at Jabiru. From 1993 to 1998, I was a Technical Officer with responsibility to collect and analyse samples for the purposes of statutory reporting.

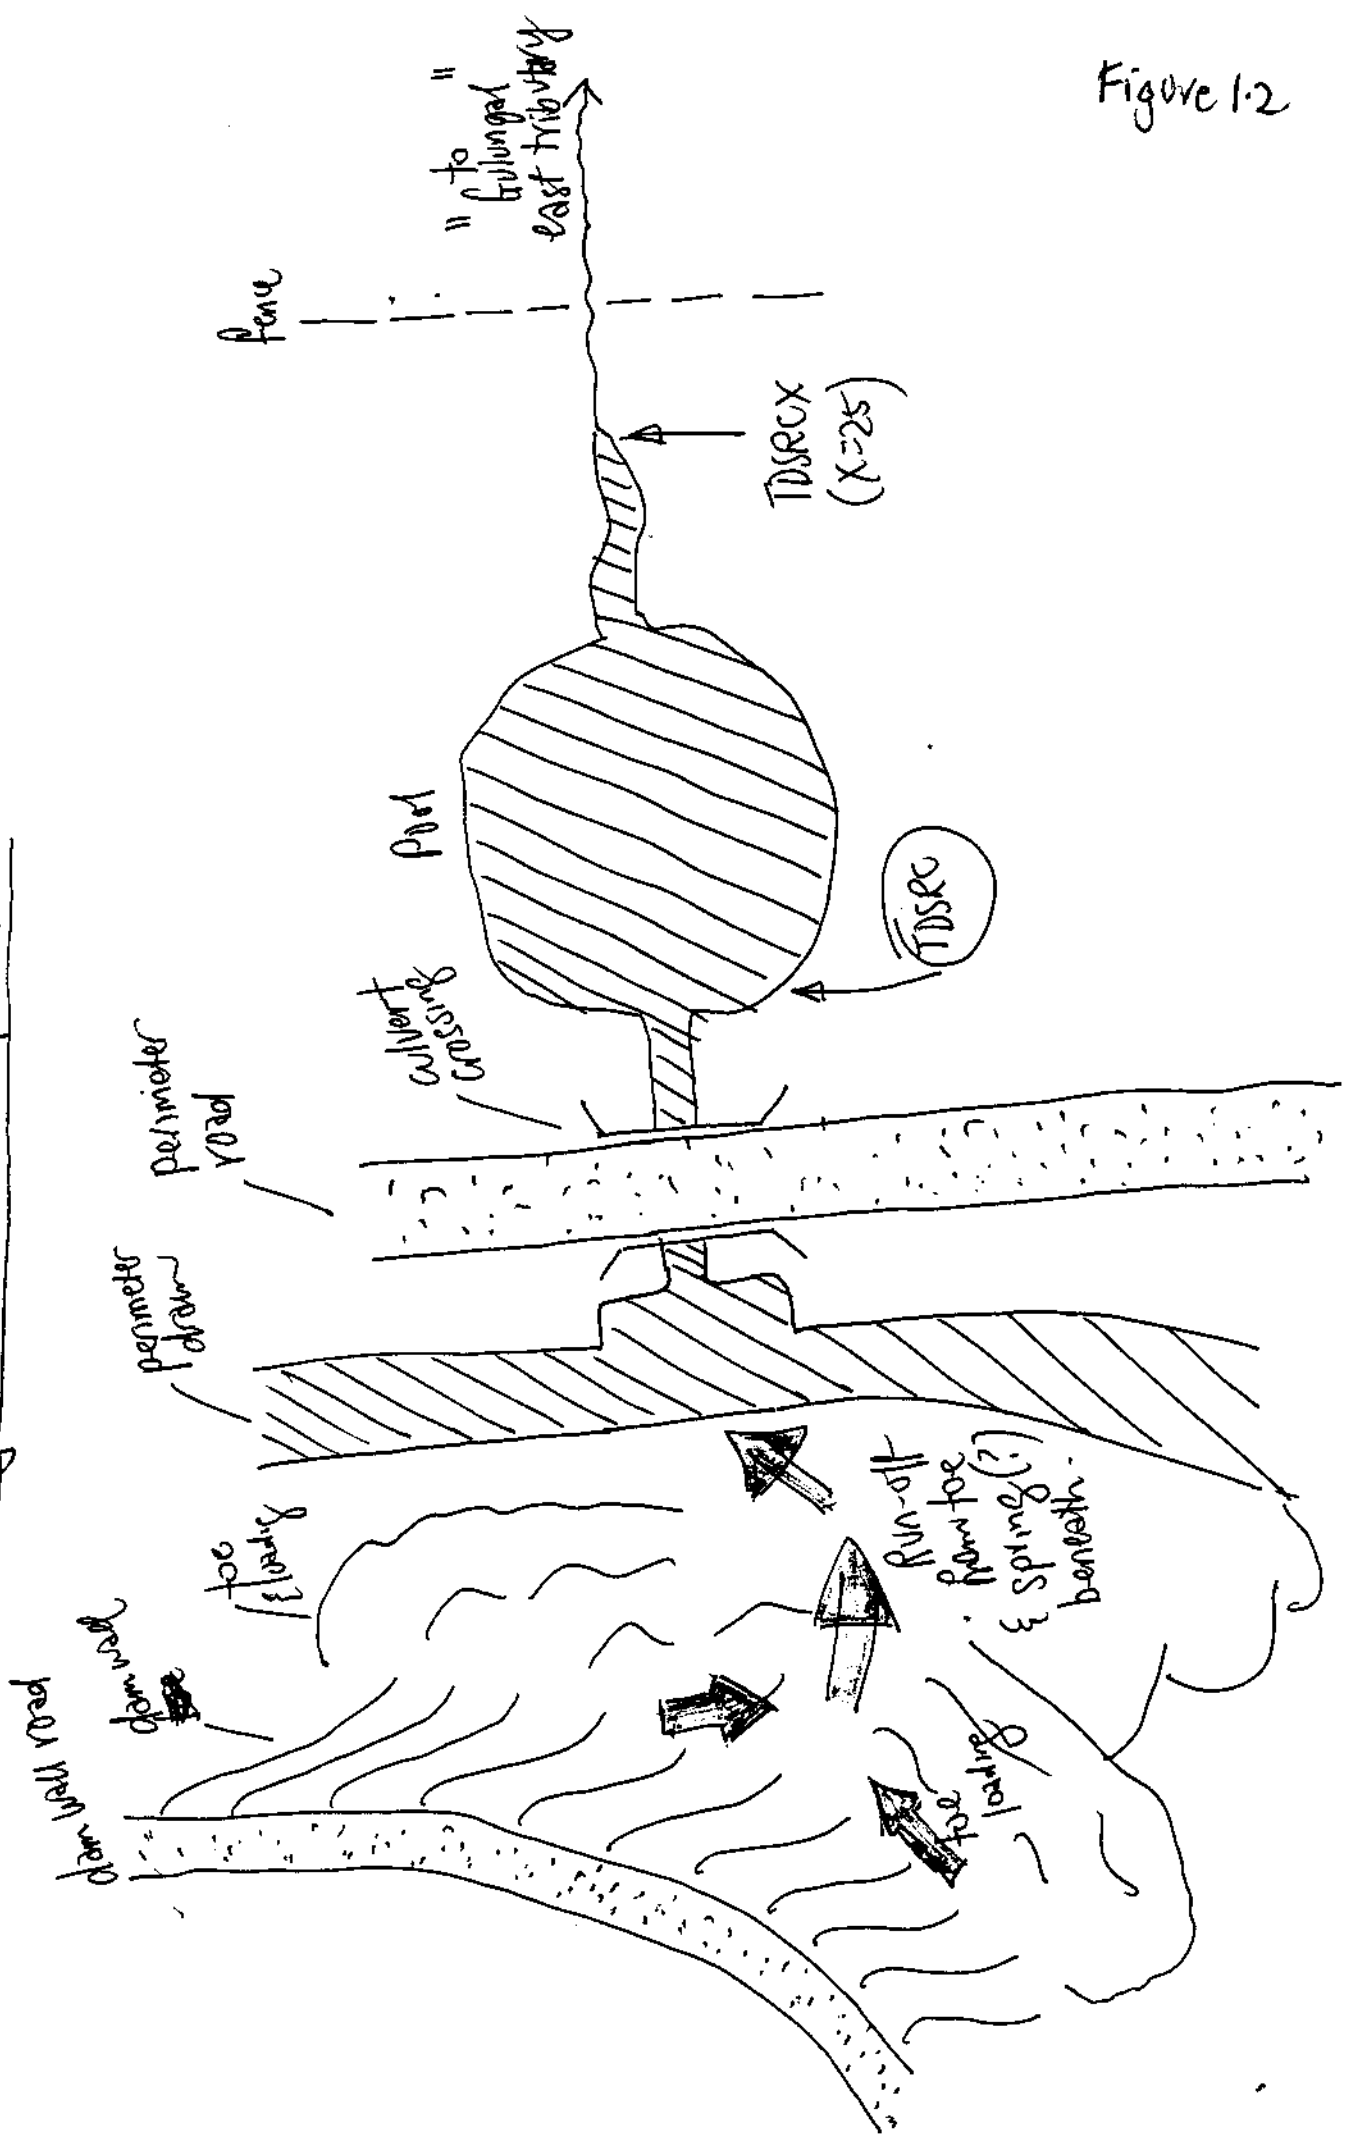
Figure 1.2 - Detail of TDSRC

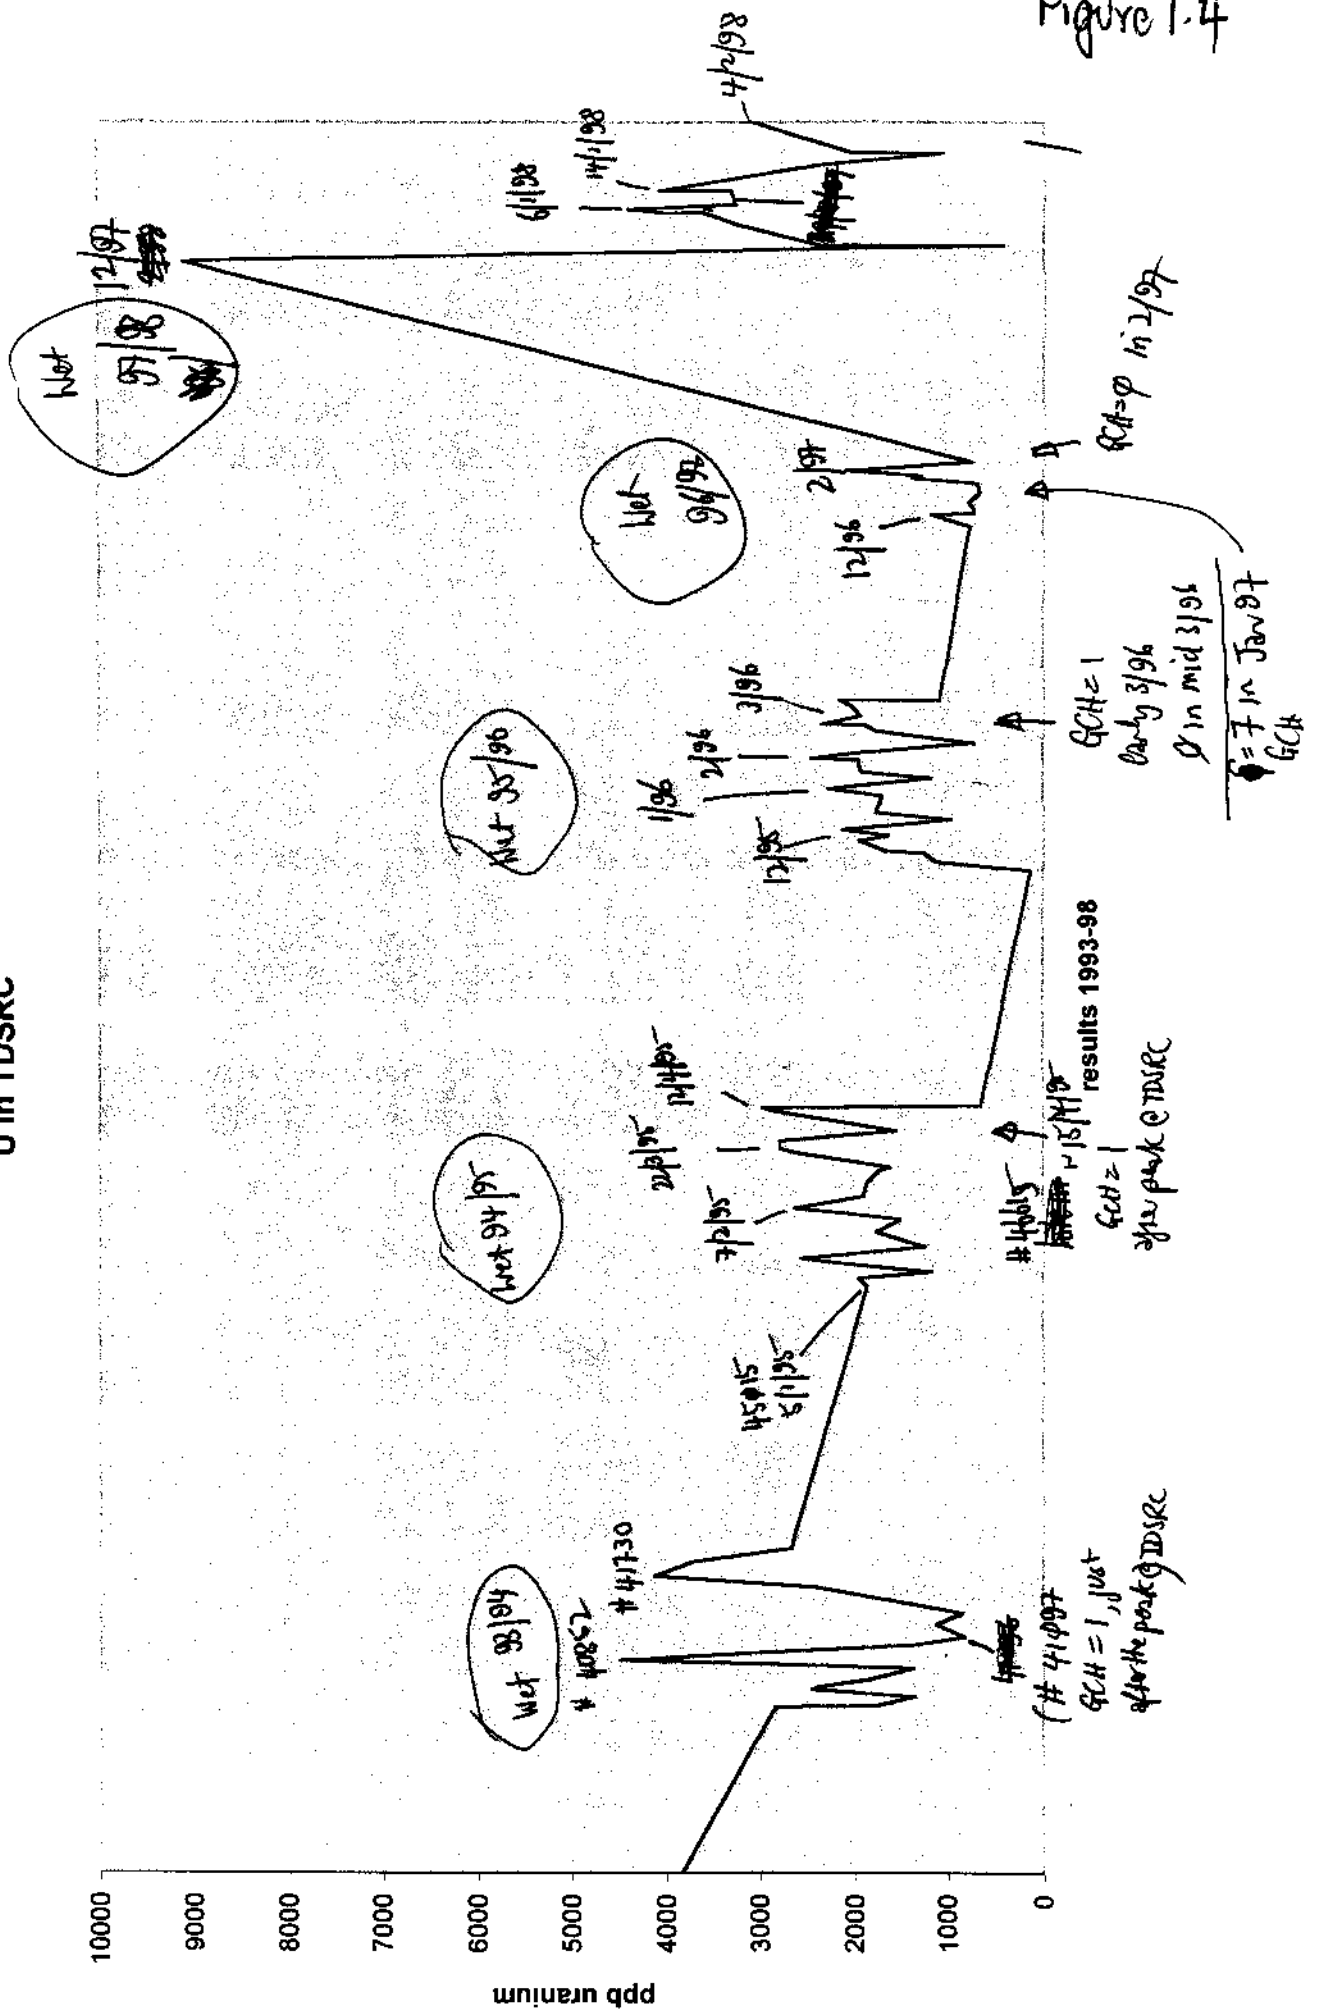
Figure 1.4

# U in TDSRC

I have looked up the history of TDSRC uranium concentrations and found that the uranium concentrations were decreasing each year up to the 1997-1998 wet season. This year the increased uranium concentrations were most likely due to the toe loading of waste rock and earth works on the southern side of the tailings dam, and the general area of TDSRC last dry season.

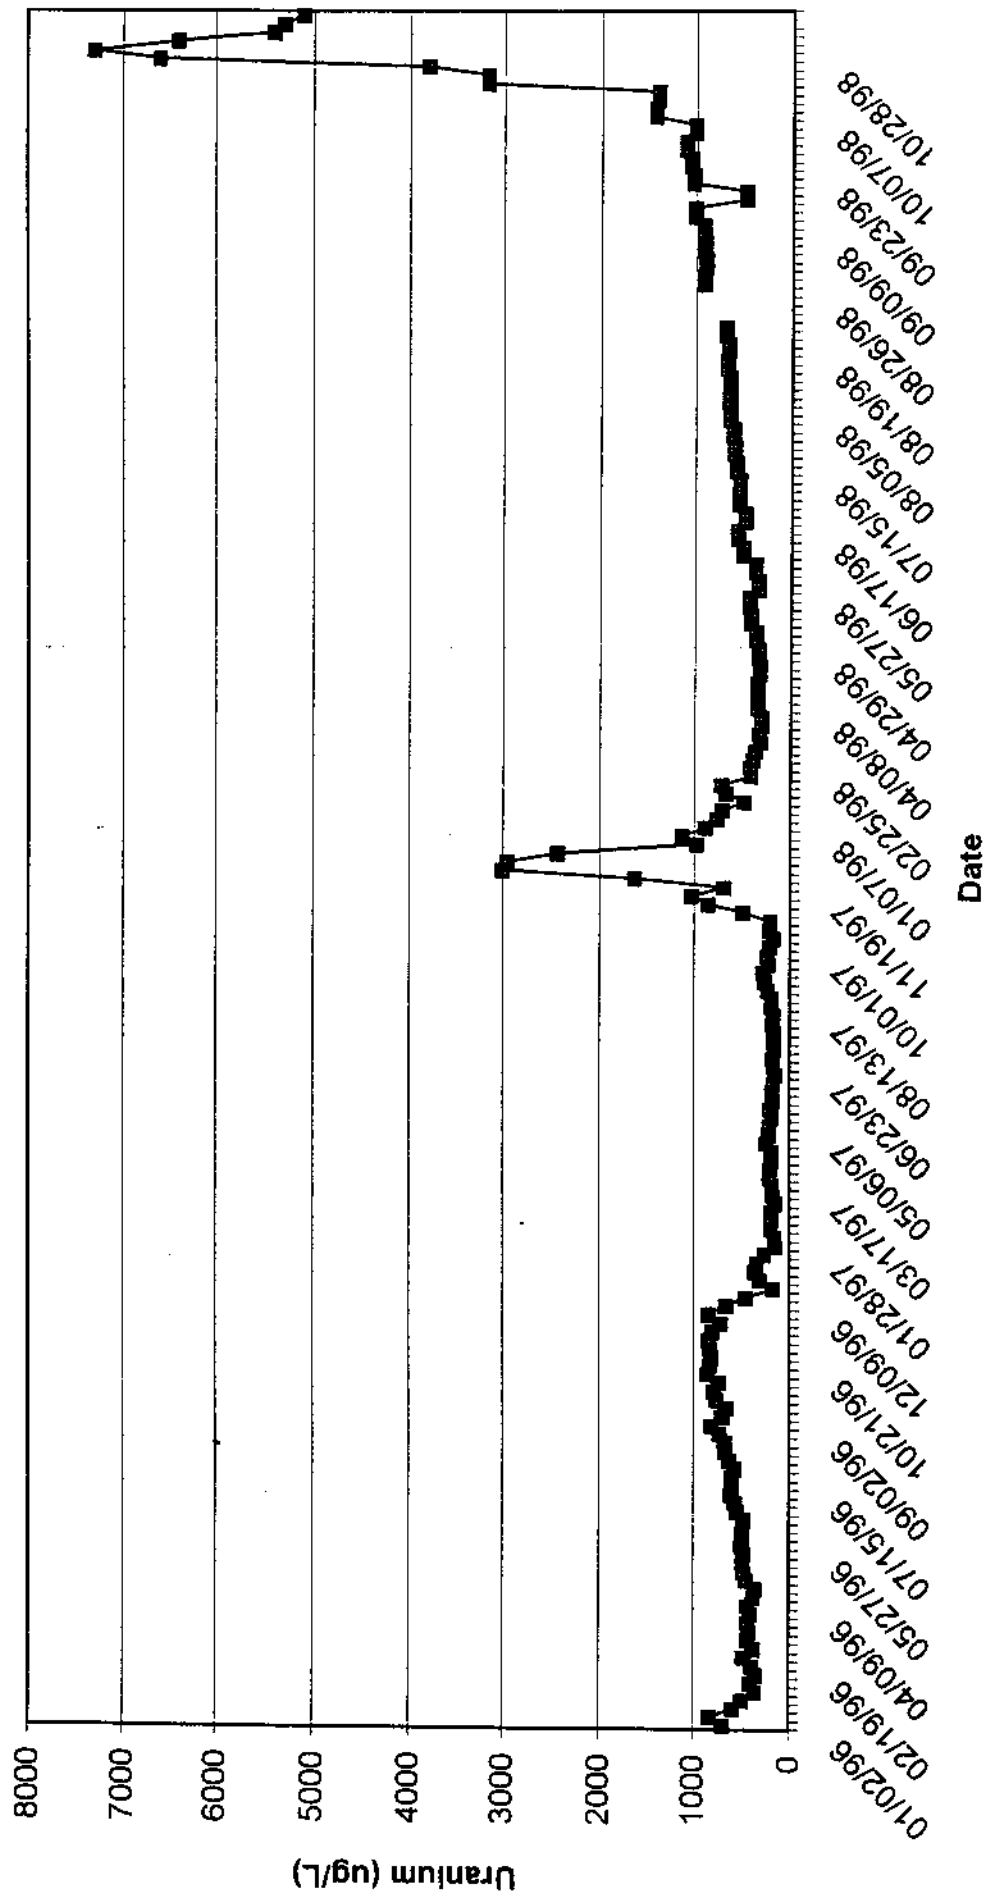
Fig 2.3

On the 28 October it was noted that the U level in RP2 had increased substantially and a sample was taken and analysed on the 29<sup>th</sup> to confirm the high value. This was confirmed and subsequently the samples were assayed by a different technique for further confirmation which did further qualify the results.

## Retention Pond 2 Water Quality
