AUSTRALASIAN CAVE & KARST MANAGEMENT ASSOCIATION JOURNAL

No. 19

June, 1995

REHABILITATION OF THE LUNE RIVER QUARRY, TASMANIAN WILDERNESS WORLD HERITAGE AREA, AUSTRALIA.

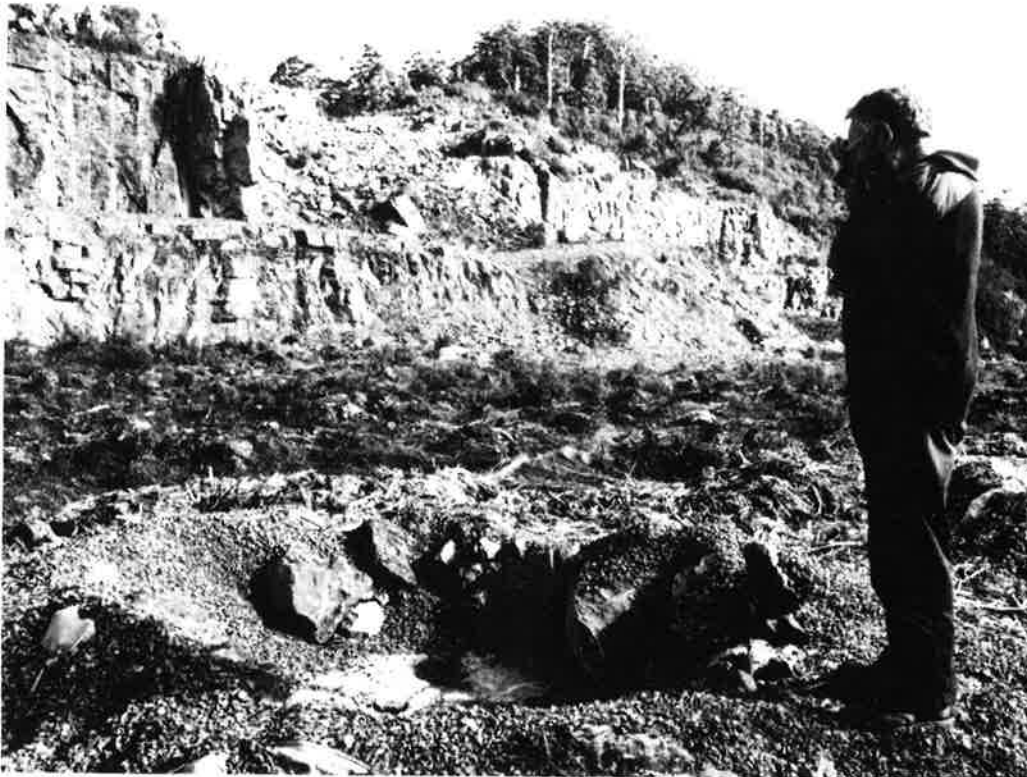
ACKMA's new Executive Officer, Andy Spate, photographs an impermeable bund constructed in the restoration program.
