AUSTRALASIAN CAVE & KARST MANAGEMENT ASSOCIATION JOURNAL

No. 19

June, 1995

REHABILITATION OF THE LUNE RIVER QUARRY, TASMANIAN WILDERNESS WORLD HERITAGE AREA, AUSTRALIA.

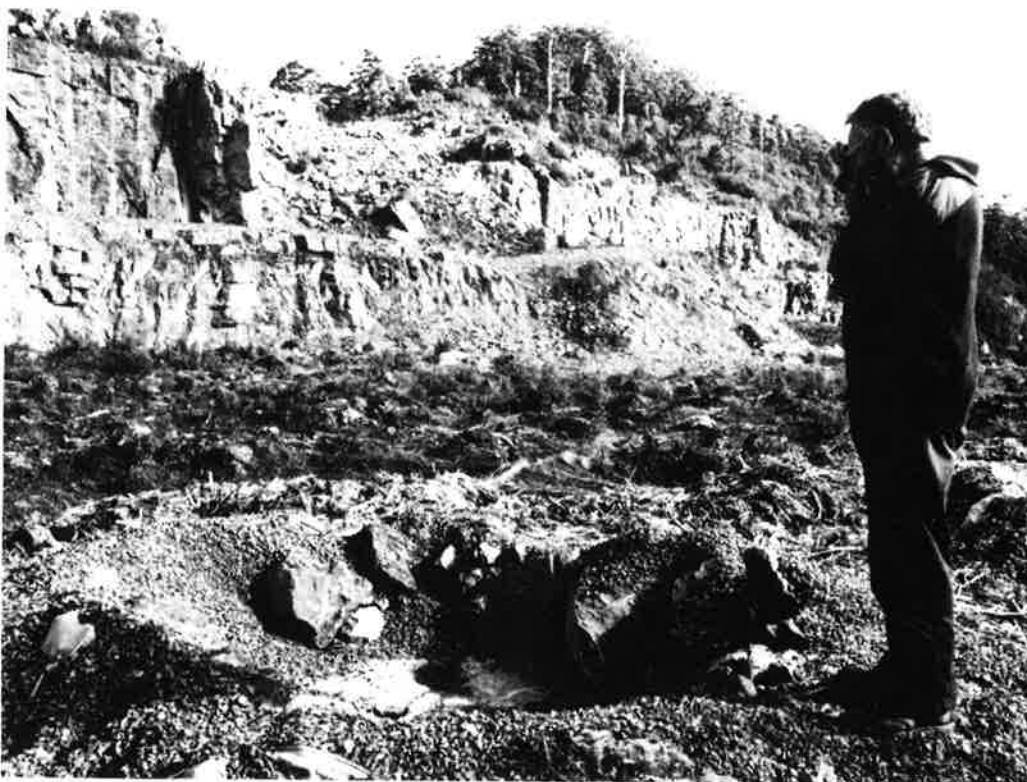
ACKMA's new Executive Officer, Andy Spate, photographs an impermeable bund constructed in the restoration program.

Drainage control has been achieved by several methods. Impermeable bunds of clay and rubble have been constructed along the outer edge of the benches, about 500-1000mm high and 1000-1500mm wide. The height of these was based on analysis of the likely runoff from the 1 in 100 year rainfall event. These have been compressed with the excavator bucket to render them impermeable. Similar bund walls have been placed to subdivide the benches into 0.1-0.2ha internal drainage basins which simulate size of the depressions of polygonal karst (Figure 2) on adjoining Marble Hill. This simulation of natural karst drainage should be adequate to restore the dispersed nature of water flow into the Exit Cave hydrological system.
