AUSTRALASIAN CAVE & KARST MANAGEMENT ASSOCIATION JOURNAL

No. 19

June, 1995

REHABILITATION OF THE LUNE RIVER QUARRY, TASMANIAN WILDERNESS WORLD HERITAGE AREA, AUSTRALIA.

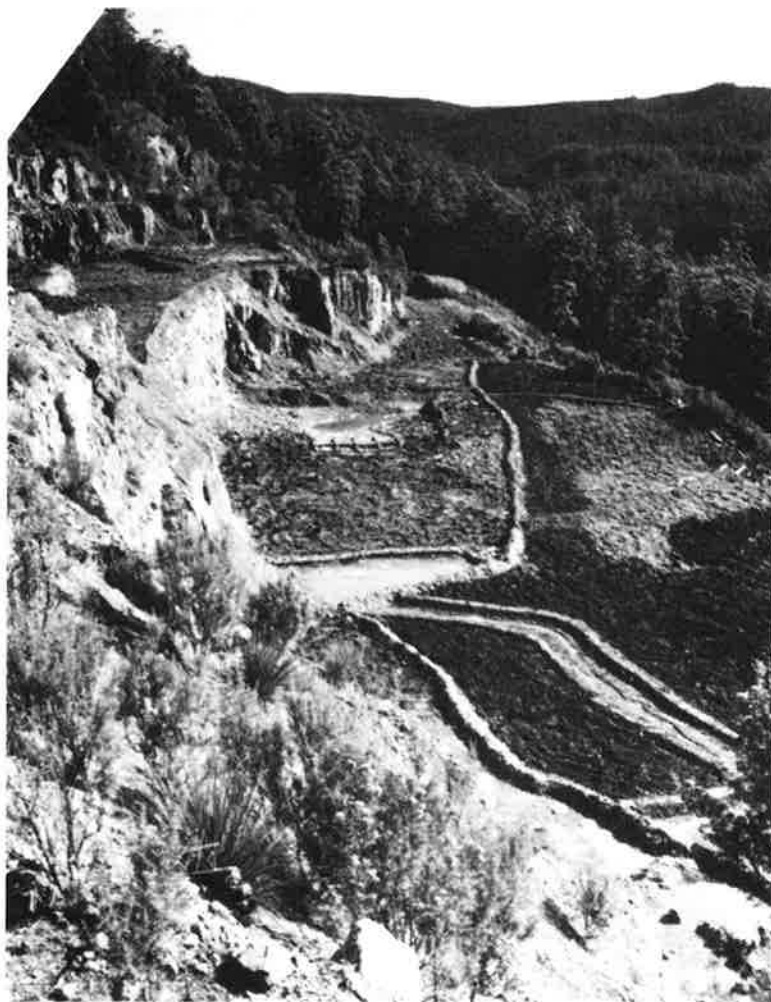
A view over the former Bender's Quarry at Ida Bay, showing rehabilitation work.
