3MLT-10 Deployment Trial Post Implementation Results and Recommendations (NBN Co Internal)

NBN Co Construction Services Group
October 2014

3MLT-10 Deployment Trial Background

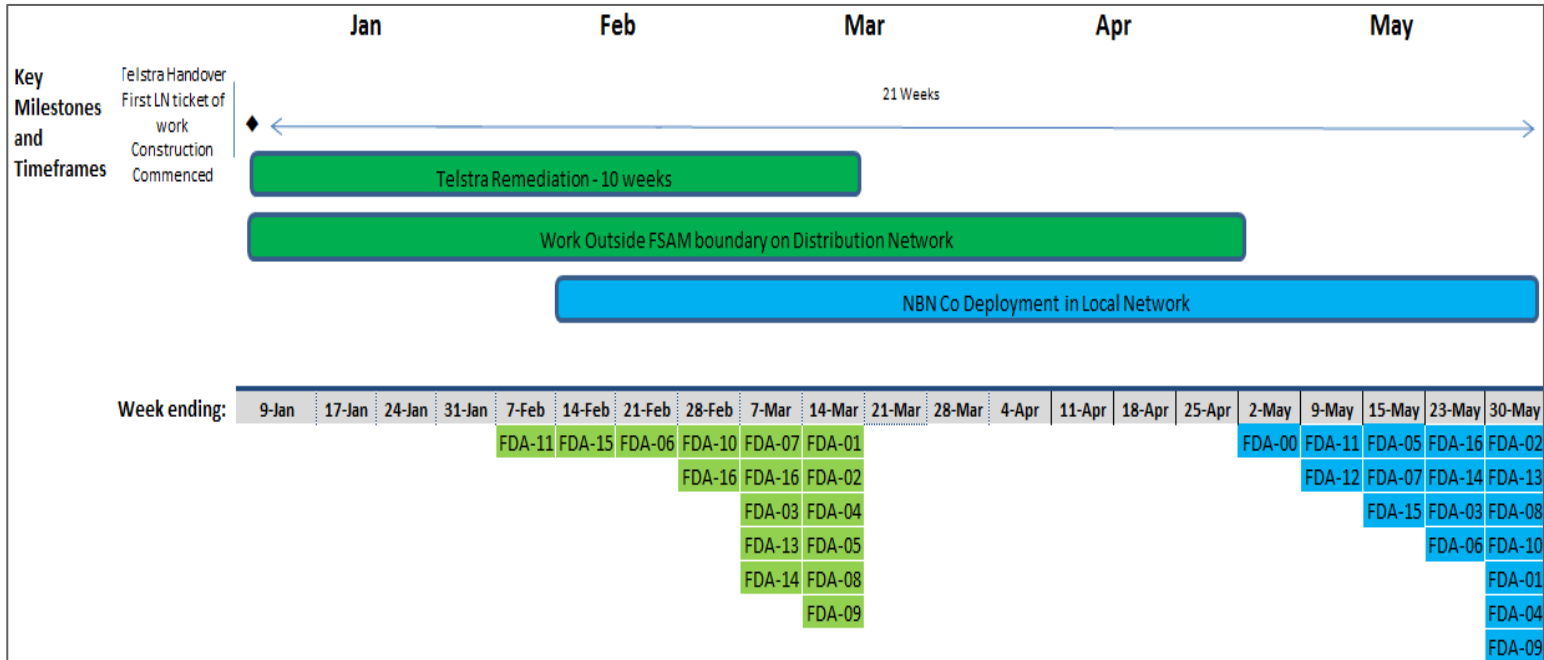
3MLT-10 Build Timeline (LN/DN)

- Build Drops:**
- Civil work commenced outside FSAM boundary on 9th Jan
 - Work commenced inside the FSAM boundary on 9th Feb after first FDA handover from Telstra.
 - Build Drops commenced in Melton on 11th Mar

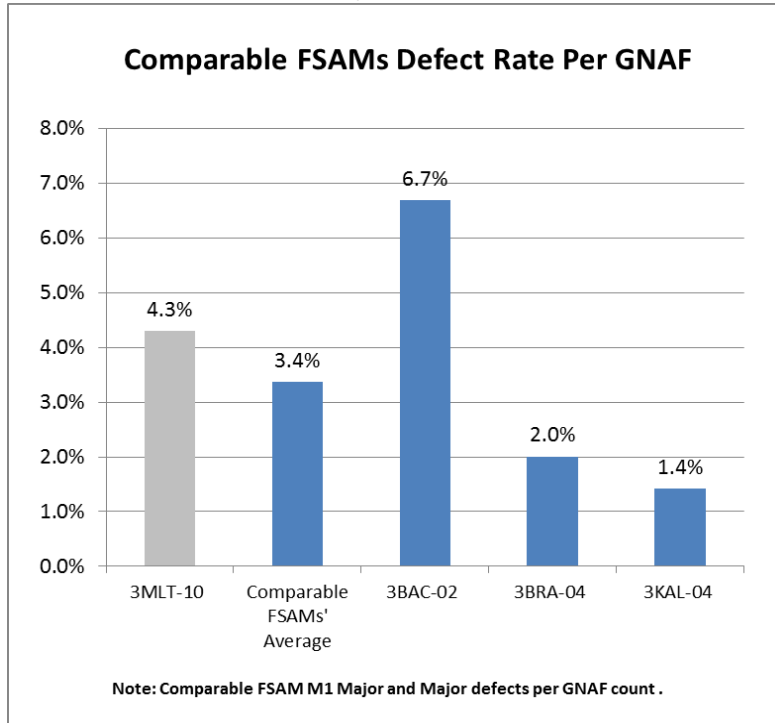
Quality of build

- 3MLT-10 defect rate per GNAF is higher than comparable FSAMs.
- 3MLT-10 cost per GNAF passed is lower than comparable FSAMs in Vic region.

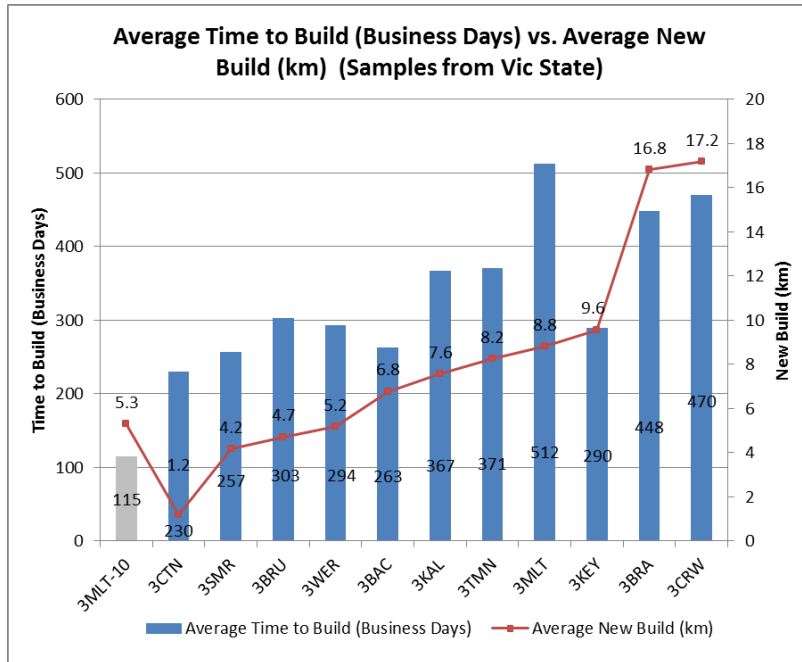
Build Time vs New build

- The above graphs indicate the time to build is directly proportional to amount of New Build required, higher the amount of new build is, longer it takes to build an FSAM.

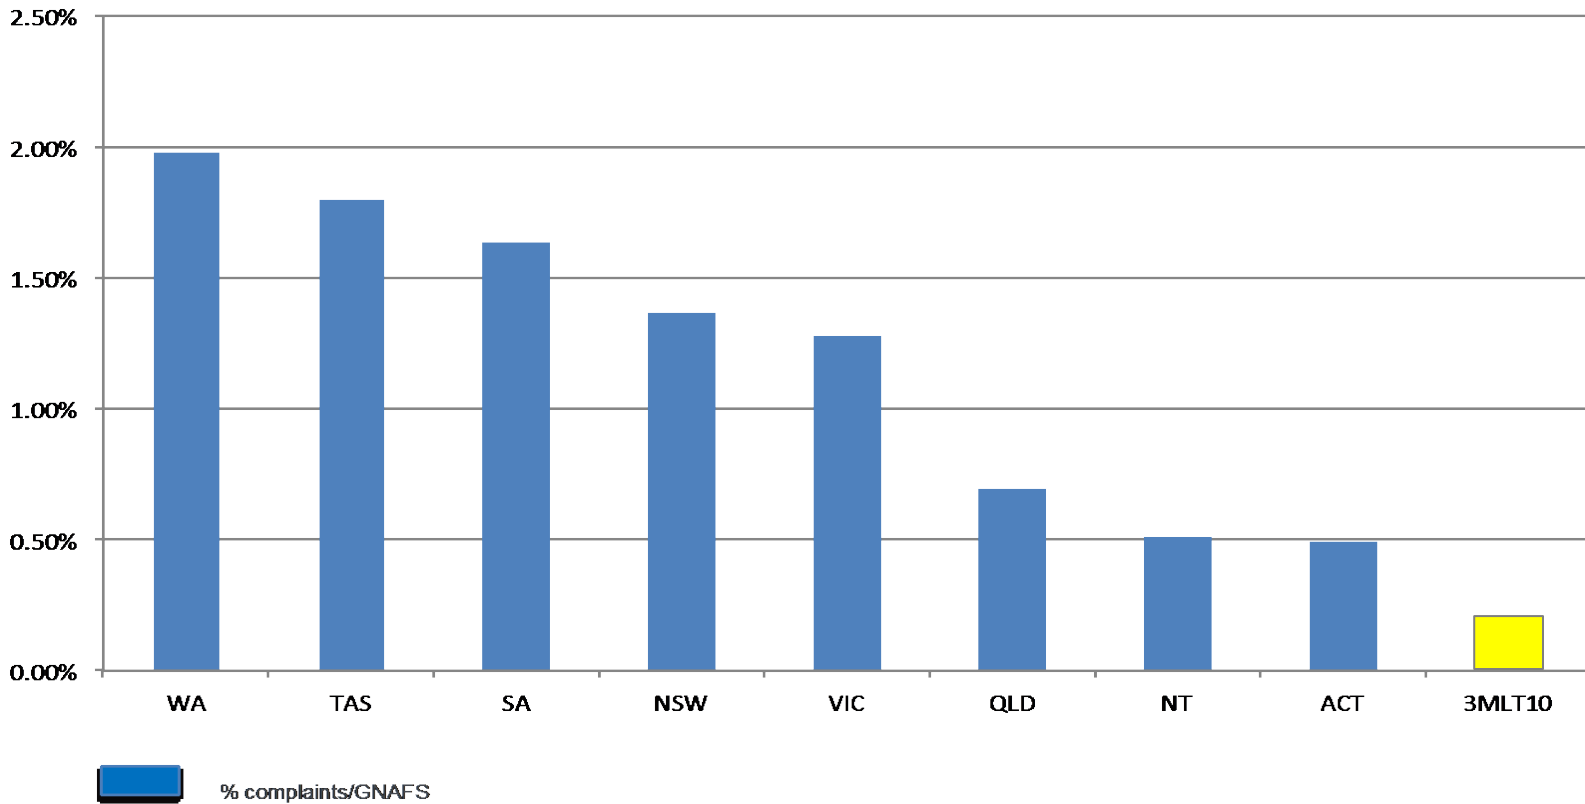
Jan 14 – May 14 average complaints per premises passed

Despite carrying out Build Drops in parallel with the LN/DN deployment, the 3MLT-10 team received a very low level of complaints from the Public. A site office was established with 2 full time resources to help maintain a healthy relationship with local residents.

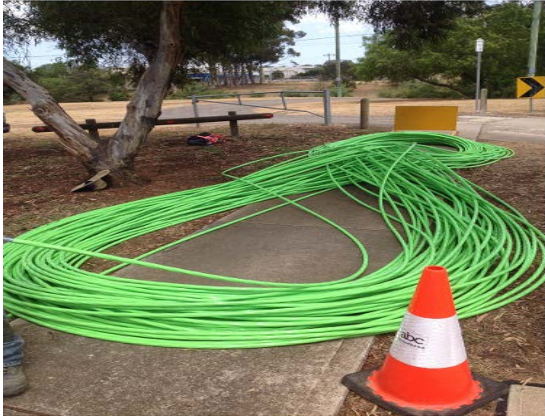
SMALL DIAMETER CABLE

Overall indications are that SDC is lighter and flexible making it faster to deploy

- Lighter and more flexible making the cable easier to handle and transport
- Easy to coil (smaller layout area required) for cable directional changes during haul, greater utilisation of Telstra infrastructure
- Less physical strain on crew, HSE benefit + reduction in crew number required for hauling

- The benefits of Small Footprint Multiports (SFMs) were further validated through the Melton10 trial since the first use in December 2013 in NSW. SFMs were trialed in Melton10 as a CTO directive to validate results from initial trials. SFMs have since been adopted as BAU practice - 85 new FSAMs have been designed using the SFMs, 2 Bulk IFDVs were issued for a total of 92 FSAMs under construction. This resulted in 1,081 pits no longer requiring remediation with 1,182 SFMs being installed instead of normal Multiports
- Small diameter cables add significant benefits to NBN Co deployment and are now adopted as BAU practice. Since January 2014, 64 FSAMs have been designed using the SDCs.

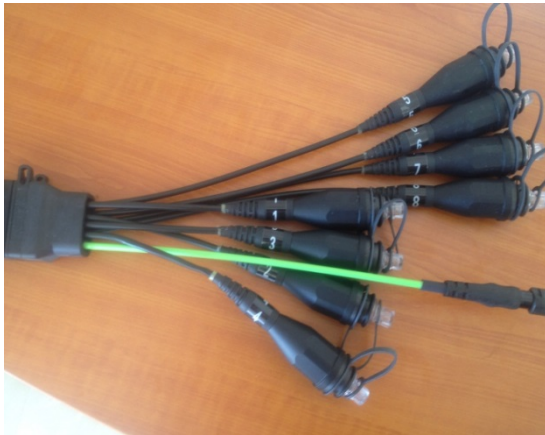
SMALL FOOTPRINT MULTIPOINT

Significantly increased installation efficiency – 5 mins install vs. 15 minute install for traditional multipoint

- No requirement to mount the multipoint
- Can be used in smaller pits, reducing the need for Telstra pit remediation which significantly reduces HSE risk associated with Asbestos Containing Material (ACM)
