ANSWERS TO QUESTIONS ON NOTICE

Infrastructure and Regional Development

Topic: Recommendations made by Mr Greg Cavanagh SM in the 2013 Coronial inquest into the death of Kevin Taylor, Lena Yali and Gregory McNamara 011 [2013] NTMC 1

Airservices Australia Pty Ltd
Gold Coast Airport
Preliminary Site Investigation

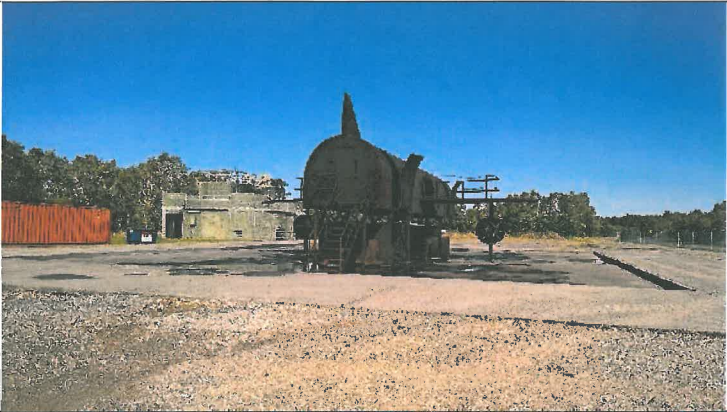
A photograph of a fire training ground. In the center, there is a large, dark, cylindrical structure, possibly a fire engine or a training vehicle, parked on a gravel surface. To the left, there is a small, light-colored building and a red container. The background shows some trees and a clear blue sky.	Plate 5 – Fire training ground

Fire training has been undertaken at the current fire training ground location since fire services operated at the site. It is noted that clearing in this area is not visible until the 1960 historical aerial photographs. It is reported that approximately 99% of fire training is undertaken here. Historically, remote access training, involving the discharge of foam was also undertaken in isolated locations of the GCA in close proximity to the MFS and FTG. In addition, there was historically a daily foam test and 6 monthly valve and foam consistency test which was completed on each vehicle. These discharges were typically done in the area surrounding the fire station and the grassed area east of the FTG.

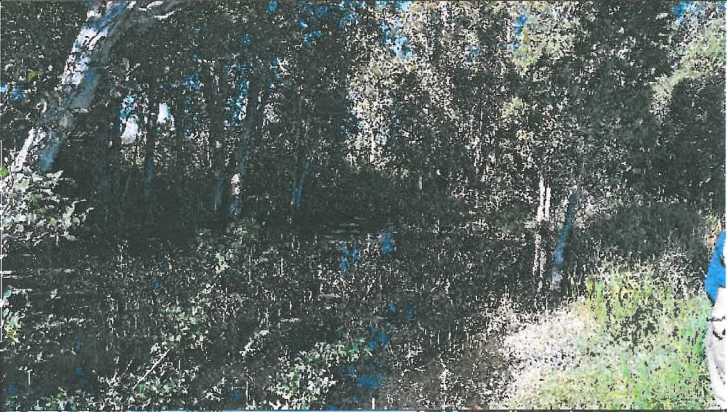
A photograph of a pond surrounded by dense, green vegetation and trees. The water is calm, reflecting the surrounding foliage. The scene is lush and appears to be a natural area adjacent to the training ground.	Plate 6 – Pond adjacent to fire training ground

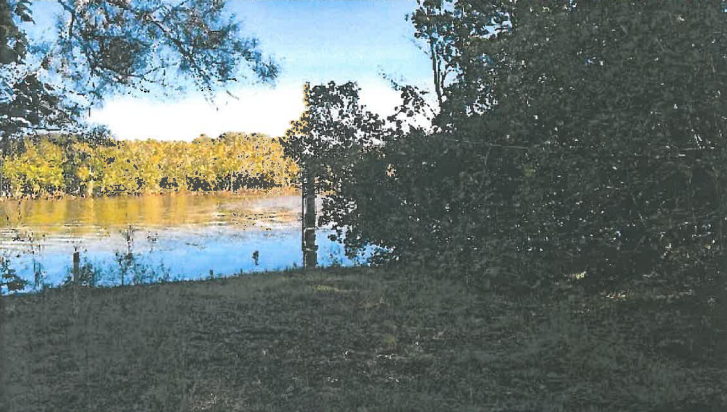
A photograph of the Cobaki Broadwater, a body of water surrounded by trees and vegetation. The water is calm, reflecting the sky and the surrounding greenery. The scene is peaceful and scenic, showing the natural environment of the site.	Plate 7 - Cobaki Broadwater from the western perimeter of the site

- Surface water samples from Cobaki Broadwater reported PFAS concentrations below the laboratory limit of reporting, however it is noted that the HISL for consumption of fish is lower than the laboratory limit of reporting.

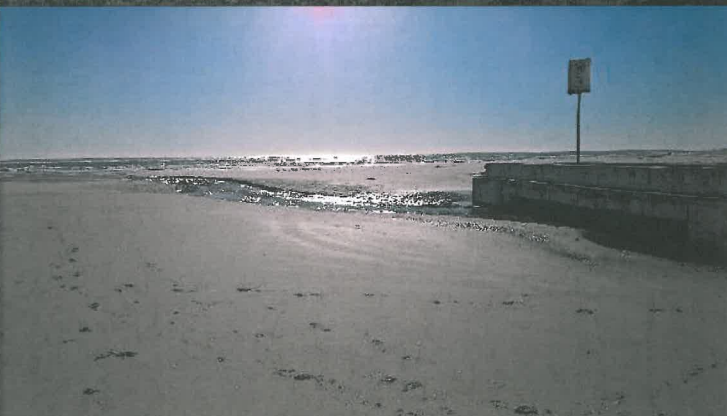
A photograph of a sandy beach area with a concrete structure in the foreground. In the background, there is a body of water (the Pacific Ocean) and a clear blue sky. The scene shows the surface water outflow from the site to the ocean.	Plate 8 – Surface water outflow to Pacific Ocean

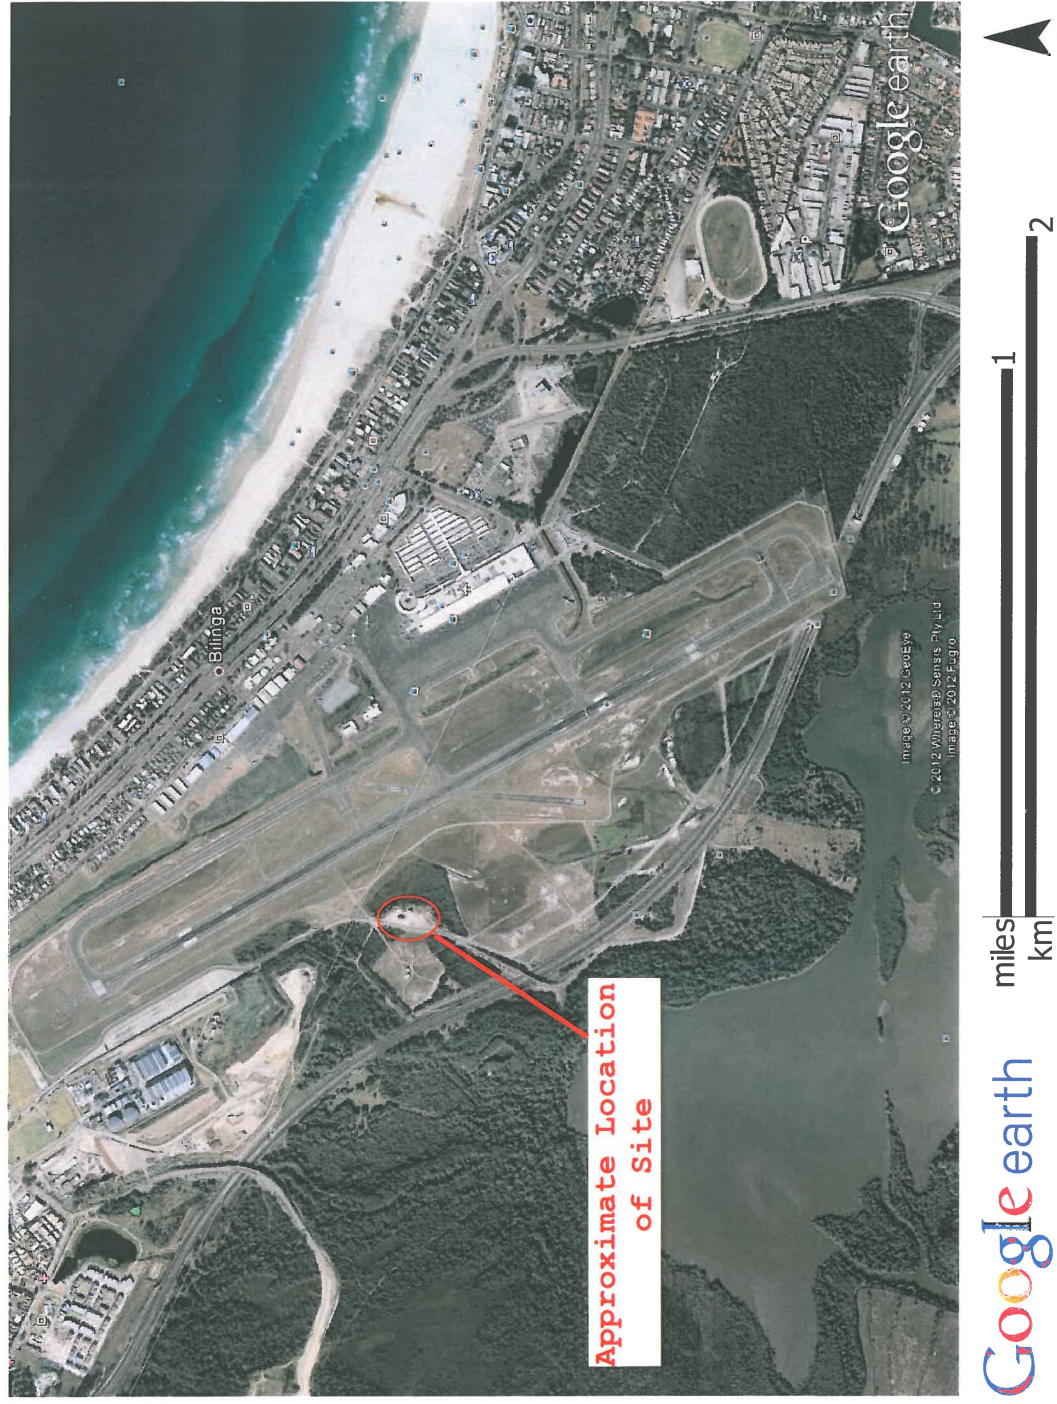
Figure 1. Site Locality Map

Parsons Brinckerhoff Australia (Parsons Brinckerhoff) is pleased to provide this letter report to Airservices Australia (Airservices) summarising the April 2015 groundwater monitoring event (GME) undertaken at the Aviation Rescue and Fire Fighting (ARFF) fire training ground, Gold Coast Airport, Bilinga, QLD (the site). The site location is shown on Figure 1, Attachment A.

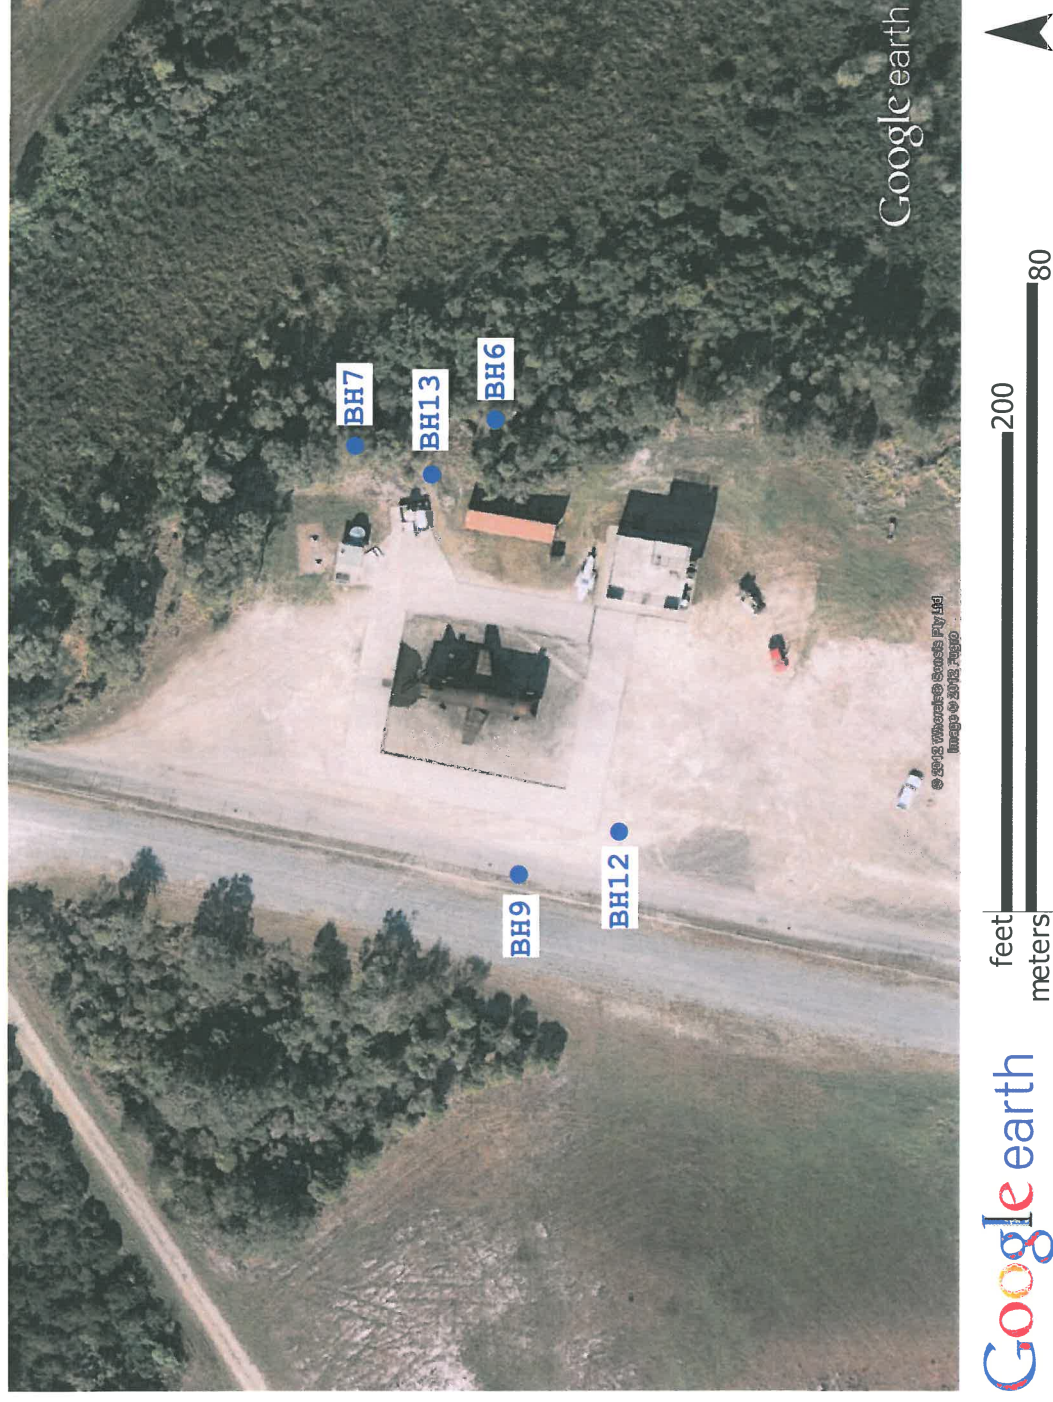
Figure 2. Groundwater Monitoring Well Locations

Five existing groundwater monitoring wells (BH6, BH7, BH9, BH12 and BH13) were sampled on 2 April 2015 using the methodology summarised in Table 4.1. The approximate locations of the groundwater monitoring wells are shown on Figure 2, Attachment A.
