**NATIONAL
RADIOACTIVE
WASTE MANAGEMENT
FACILITY**

Technical Report - Site Characterisation, Napandee

Client: Commonwealth Department of Industry, Innovation and Science

AECOM Australia Pty Ltd

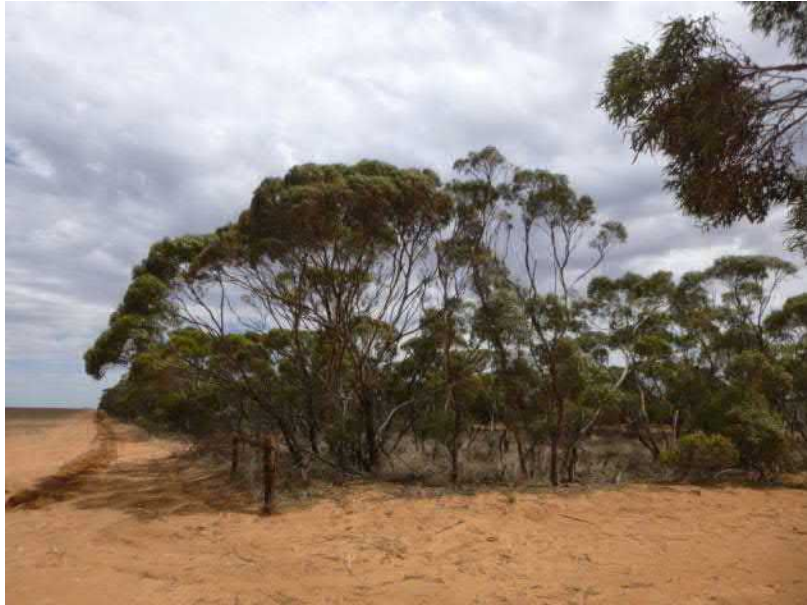
Mallee Woodland and understory species along the western site boundary

Native vegetation within the Napandee site is restricted to linear corridors of Eucalypt mallee woodland and shrubland. Condition of vegetation varies dependent on the exposure to grazing, historical clearing, erosion and invasion of weed species. The linear native vegetation form important fauna habitat corridors linking areas of remnant native vegetation in the local and regional area. They also act as wind barriers which prevent erosion.

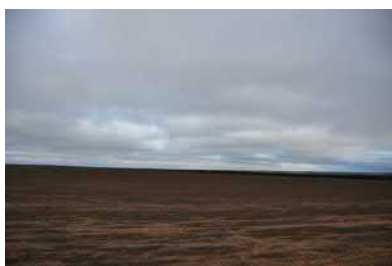
Open farmland

Open farmland was the dominant habitat type within the proposed site footprint and much of the adjoining paddocks. This area was almost entirely denuded of living vegetation and was dominated by a mixture of bare ground and crop stubble (dead organic matter). No current farming activities were identified. This area was not observed to support any fauna species, and in its observed condition, would be of negligible habitat value. Discussion with the landholder / managers revealed that, in recent times, the land had been subject to cropping, intense grazing (sheep) and finally spraying to kill off all vegetation and suppress weeds. This land use approach is understood to be used across cropped land within the farmers land holding.

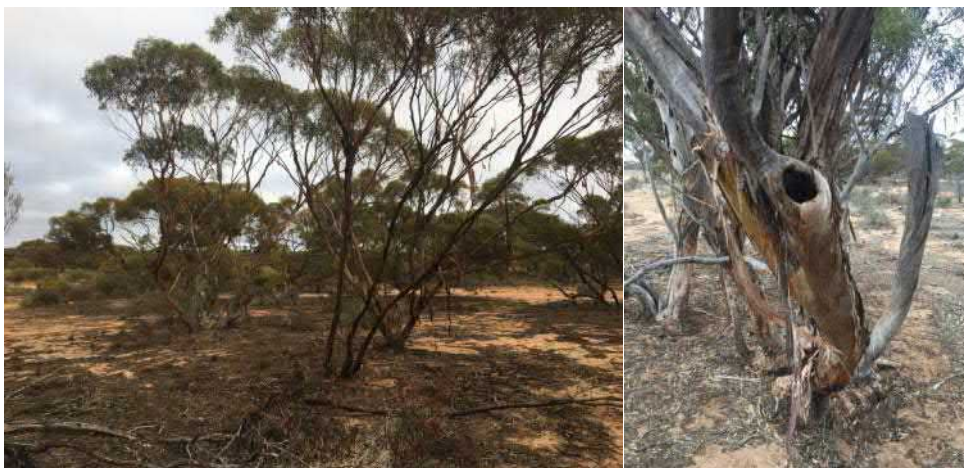
Mallee vegetation to the south west corner of the subject paddock

Whilst the centre of the paddock itself was devoid of habitat, the south-west corner of the paddock and its perimeter consisted of Mallee vegetation (referred to as A1 in Table 5). Mallee vegetation in the southwest corner of the paddock formed a block of vegetation approximately two and a half hectares in size and is included within the site footprint. This area of vegetation which aligns with vegetation code A1 was continuous with road side vegetation connecting to potential wildlife corridors to the north and east of the site. The area was dominated by tall, and in many cases, large old hollow bearing Mallee eucalypts. However, understorey was disturbed with prevalent bare ground and a sparse cover of saltbush and sedges. Grass cover and soil crust was sparse to absent. Habitat features of this area included the aforementioned tree hollows, peeling bark, large woody debris and logs (some of which contained hollows) and organic leaf litter with the area providing good opportunities for foraging and breeding birds and some habitat value for ground dwelling fauna such as reptiles and small mammals. Whilst not present in the paddock at the time, signs of past livestock access (sheep) were prevalent and grazing is likely to have compromised understorey diversity and thus habitat values.

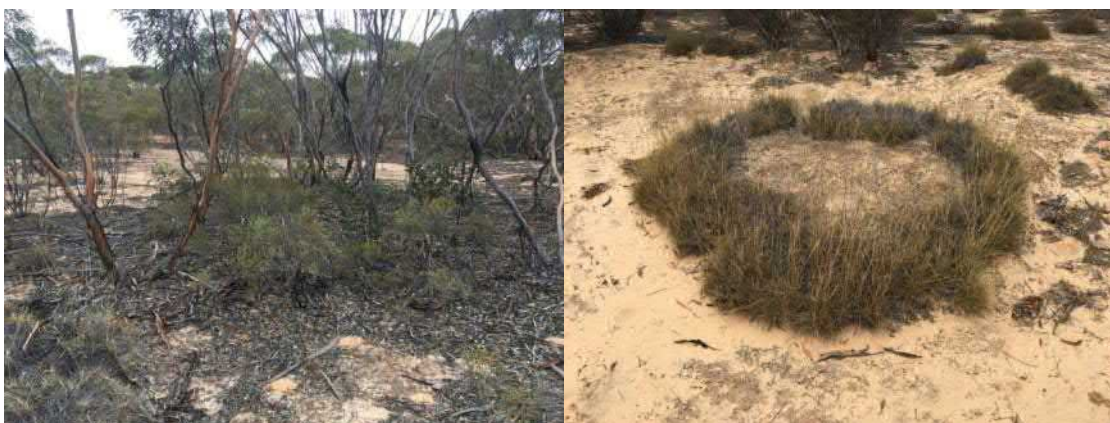
Intact Mallee vegetation showing shrub and spinifex cover

To the south of the site's boundary and along roadsides, vegetation was similar to that described above with minor differences. For instance, an assessment of vegetation to the south-west of the subject paddock and to the south of the intersection of Tola Road and Larwood Road, revealed a similar canopy cover but increased understorey diversity with soil crust and additional lifeforms such as the presence of spinifex grass and Broombush adding additional habitat complexity with an absence of grazing by livestock the likely cause of these differences. Whilst vegetation lining the boundary of the site was typically more disturbed with these thin linear areas often completely devoid of understorey lifeforms and habitat complexities.

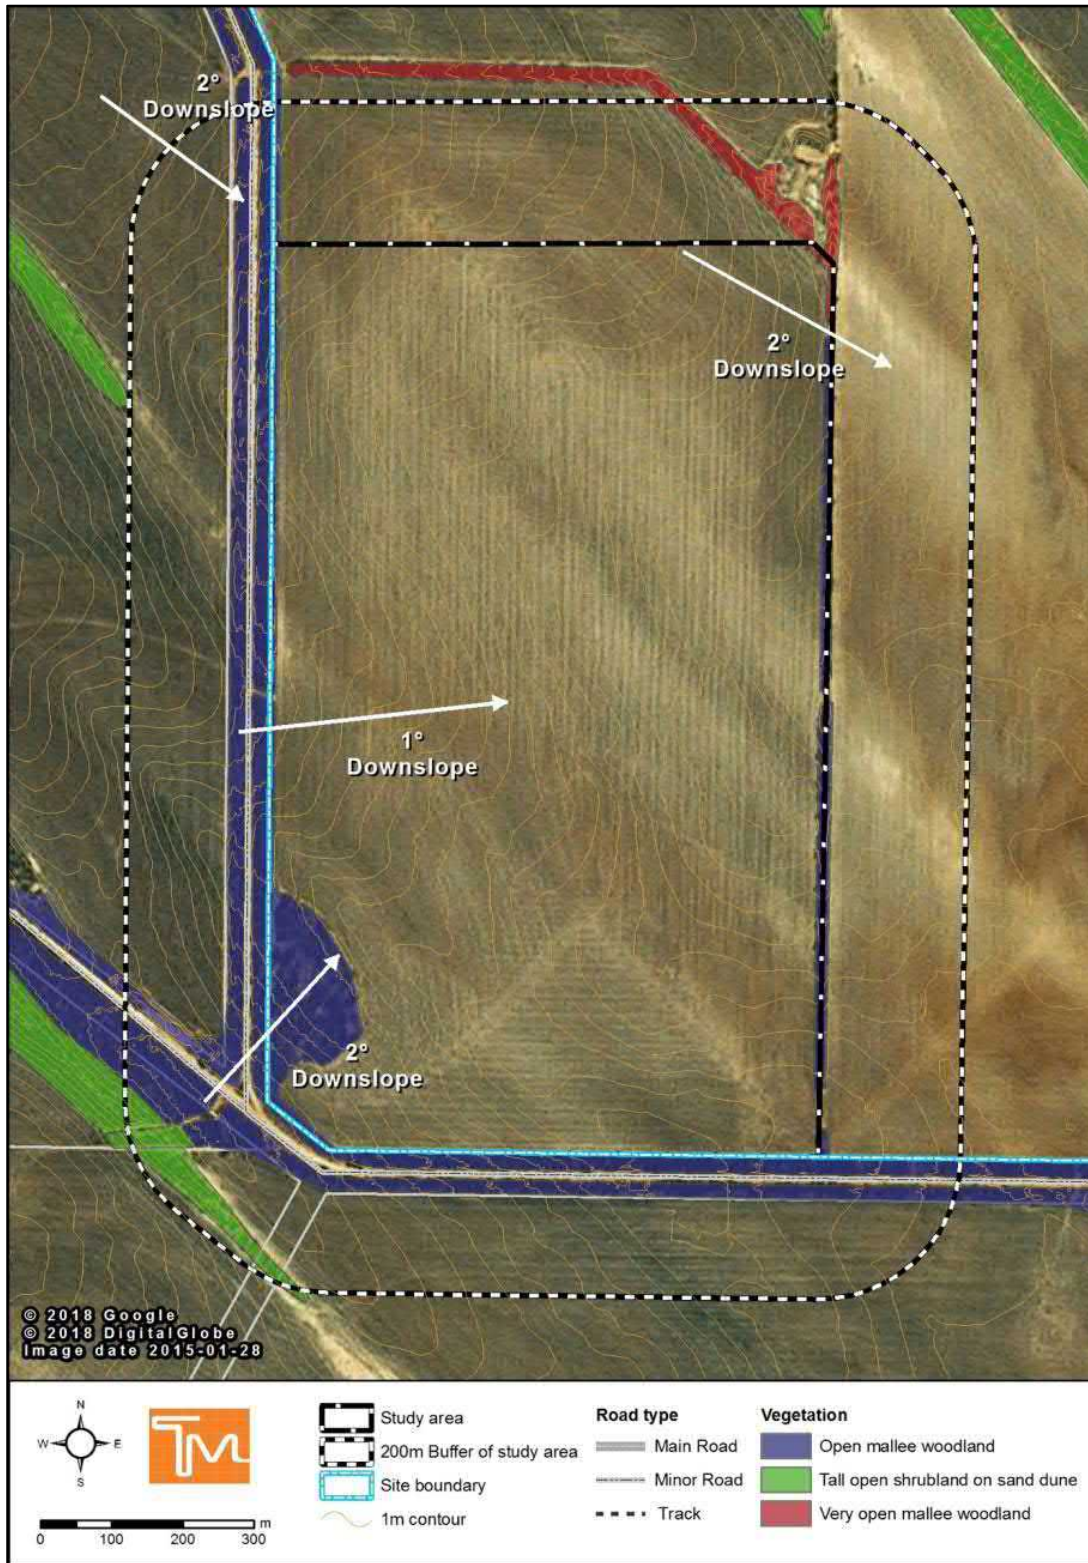
Figure 10 Napandee –site assessment zone for bushfire hazard assessment.

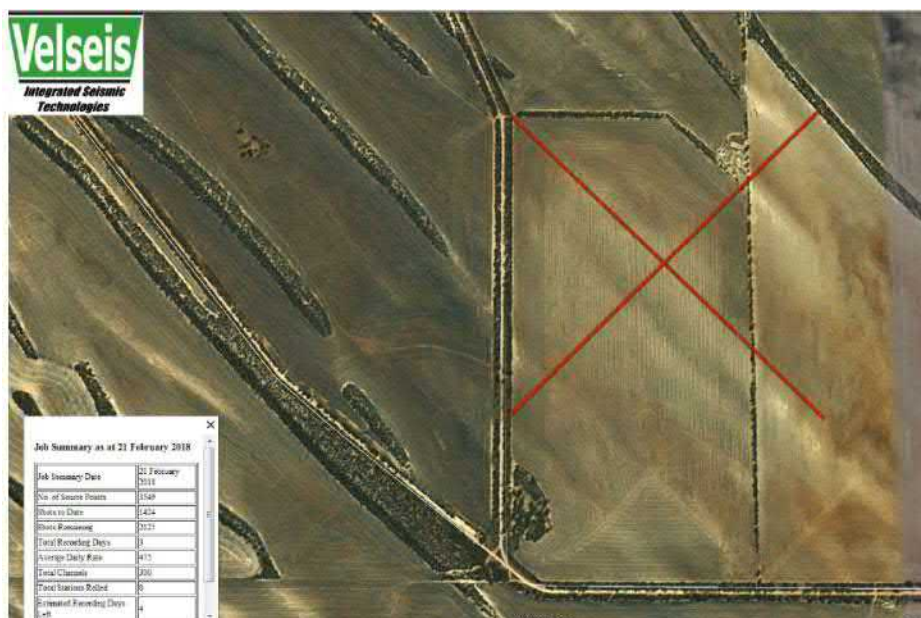
Figure 23 Napandee seismic line data acquisition

Once the data was acquired Velseis output a refraction solution to provide an indication of the depth to the weathered / un-weathered boundary. Velseis then provided a preliminary interpretation of the processed data which is attached as Appendix C. It is noted that given the lack of borehole control available at the time of the survey, only more prominent potential structures have been inferred and given the complexity of the data smaller scale structures are also likely to be present.

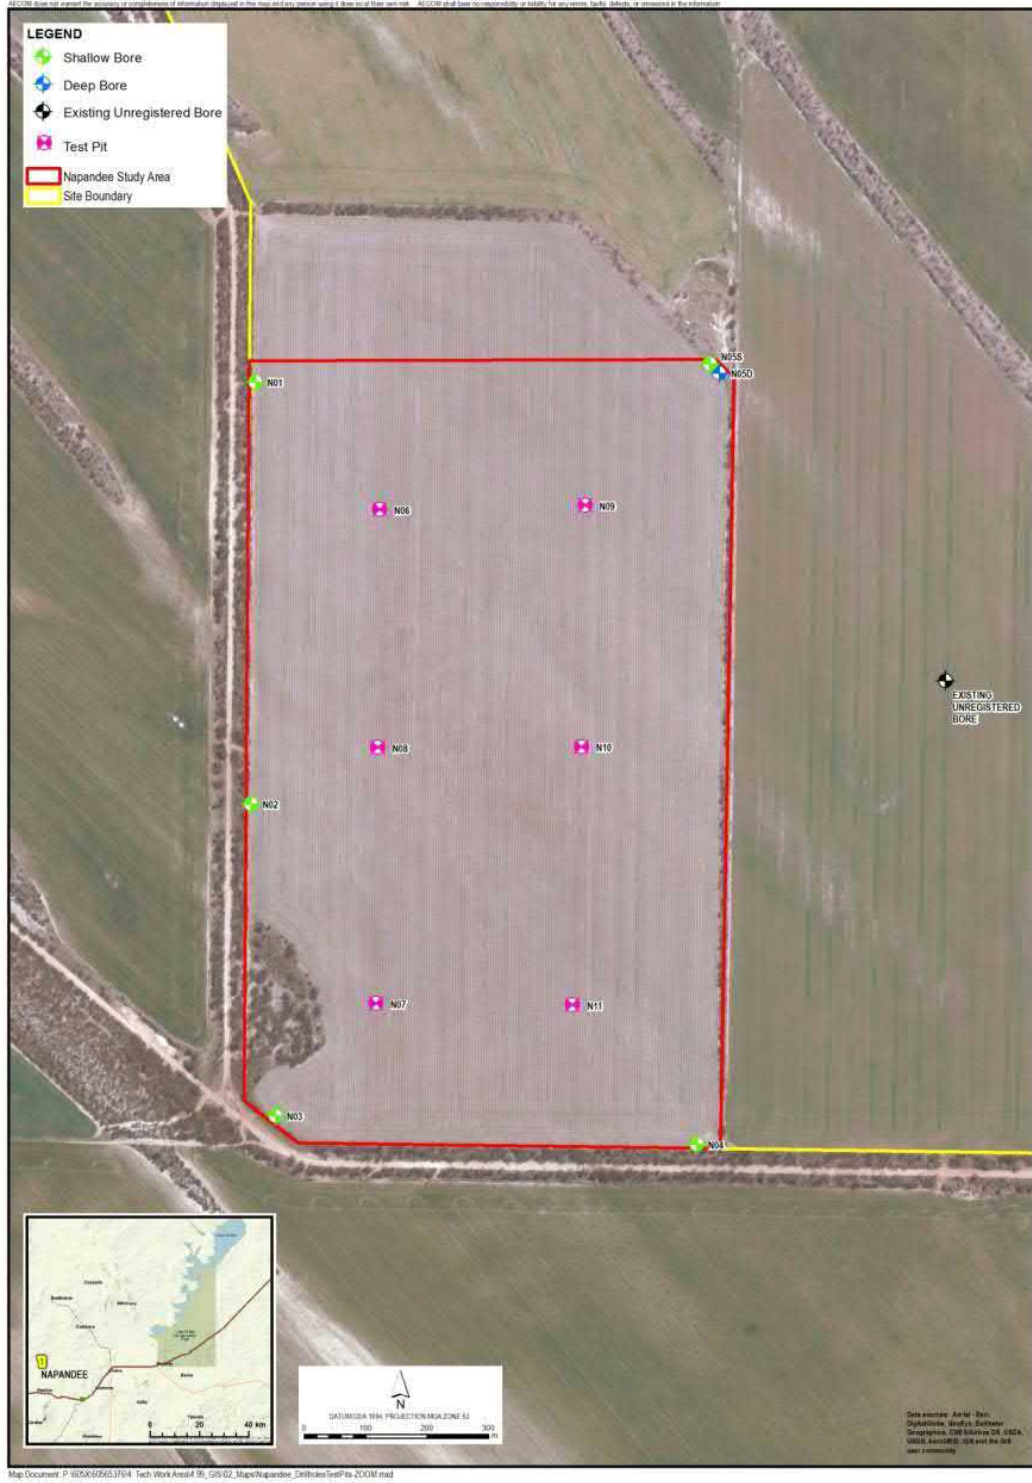
Figure 24 Location of investigation bores and test pits within Napandee site
