**NATIONAL
RADIOACTIVE
WASTE MANAGEMENT
FACILITY**

Site Characterisation Technical Report - Lyndhurst

Client: Commonwealth Department of Industry, Innovation and Science

AECOM Australia Pty Ltd

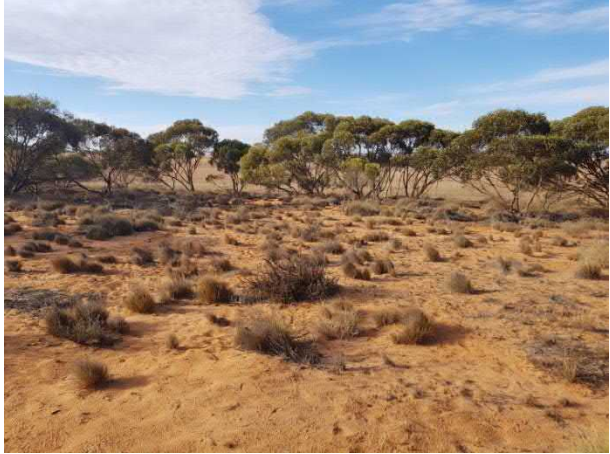
| Code | Vegetation Description | Photograph |
|---|---|--|
| A1 | <p>Open mallee woodland over <i>Triodia</i></p> <p>Open mallee of <i>Eucalyptus socialis</i> subsp. <i>viridans</i> over <i>Melaleuca lanceolata</i>, <i>Acacia hakeoides</i> and <i>Eremophila deserti</i> tall open shrubland over <i>Olearia muelleri</i>, <i>Lomandra leucocephala</i> subsp. <i>robusta</i> and <i>Triodia irritans</i> low shrubs and hummock grassland.</p> <p>Recorded on sandy soils on dune systems. Diversity of native species varied as a result of historical impacts of grazing and isolation. Vegetation type represented by Lyn 1, 2, and 3.</p> | |

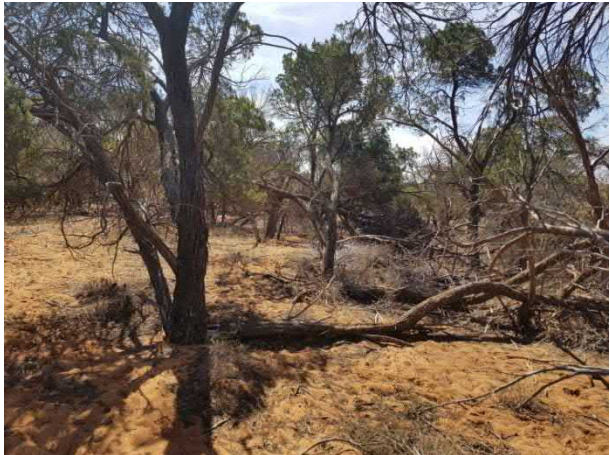
| Code | Vegetation Description | Photograph |
|---|---|--|
| A2 | <p>Low Woodland <i>Callitris gracilis</i> over Chenopods</p> <p>Low woodland <i>Callitris gracilis</i> and <i>Eucalyptus incrassata</i> over <i>Enchylaena tomentosa</i> var. <i>tomentosa</i>, <i>Rhagodia spinescens</i>, <i>Dianella revoluta</i> and sparse grasses.</p> <p>Disturbed sandy patch of <i>Callitris</i> with evidence of dieback in trees. Understorey appears more susceptible to impacts from grazing. Vegetation type represented by Lyn 6.</p> | |

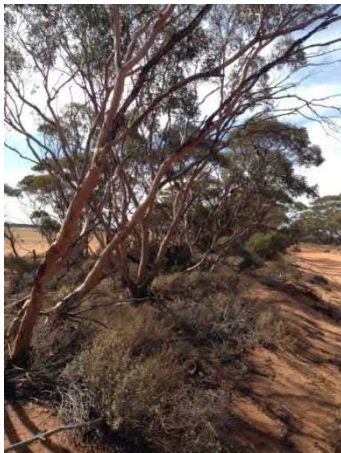
| Code | Vegetation Description | Photograph |
|---|---|--|
| A3 | <p>Mallee</p> <p>Mallee woodland of <i>Eucalyptus socialis</i> over mixed shrubs including <i>Enchylaena tomentosa</i>, <i>Cratystylis conocephala</i>, <i>Maireana</i> sp., and <i>Atriplex</i> sp.</p> <p>Vegetation in linear corridors varying in condition due to extensive clearing. Likely weed invasion present following rain. Vegetation type described from observations only.</p> | |

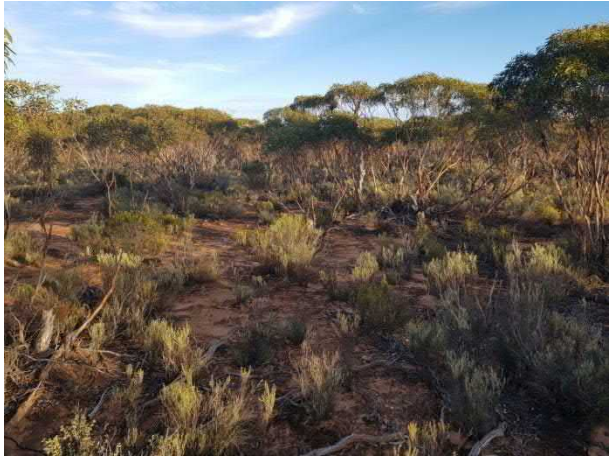
| Code | Vegetation Description | Photograph |
|---|--|--|
| B1 | <p>Mallee woodland over sclerophyllous shrubs</p> <p>Low mallee woodland of <i>Eucalyptus socialis</i>, <i>Eucalyptus gracilis</i>, <i>Eucalyptus porosa</i> and <i>Eucalyptus brachycalyx</i> over <i>Eremophila scoparia</i> and <i>Olearia muelleri</i>, <i>Westringia rigida</i> mid shrubland.</p> <p>Excellent condition vegetation in large block of native remnant vegetation on undulating flats. Vegetation type represented by Lyn 4.</p> | |

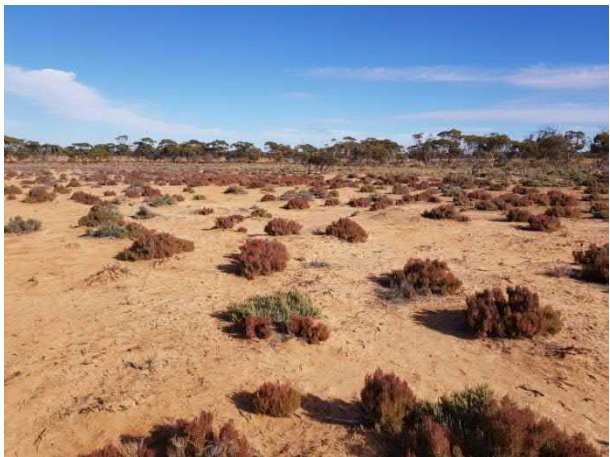
| Code | Vegetation Description | Photograph |
|---|--|--|
| C1 | <p>Tecticornia saltpan</p> <p>Low open shrubland of <i>Tecticornia indica</i> and <i>Tecticornia halocnemoides</i> with isolated <i>Maireana Astrotricha</i> and <i>Tecticornia pergranulata</i>.</p> <p>Located on clay soils with salt residue on surface. Isolated dead trees throughout. Vegetation type represented by Lyn 7.</p> | |

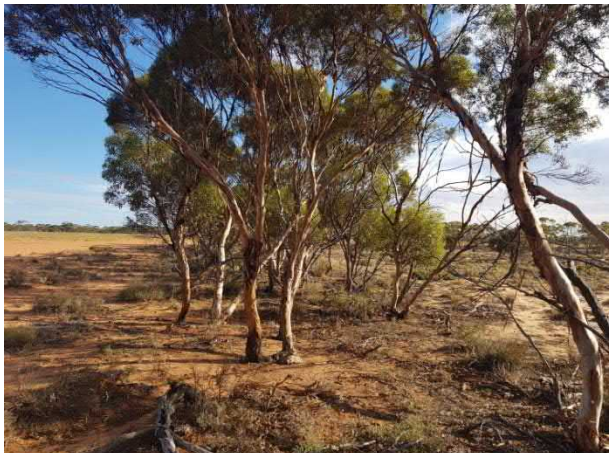
| Code | Vegetation Description | Photograph |
|---|--|--|
| C2 | <p>Mallee woodland over Chenopods</p> <p>Open mallee woodland of <i>Eucalyptus incrassata</i> over <i>Enchylaena tomentosa</i> var. <i>tomentosa</i>, <i>Rhagodia spinescens</i> low open shrubland with sparse dead grasses.</p> <p>Ecotone community represents the edge of the Tecticornia saltpan. Patches of dead trees and further characterised by sparse understorey. Vegetation type represented by Lyn 5.</p> | |

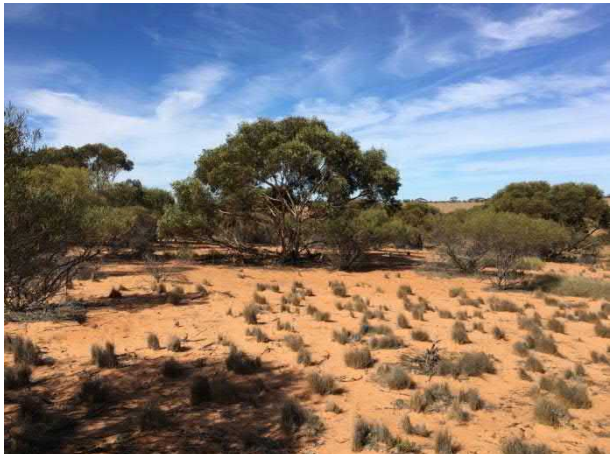
| Code | Vegetation Description | Photograph |
|---|---|---|
| D1 | <p><i>Acacia</i> shrubland</p> <p>Mid shrubland of <i>Acacia</i> and <i>Eremophila</i> over sterile grasses.</p> <p>Isolated to one occurrence, this community appears to represent potential rehabilitation or restoration of the area as evident by lack of mallee trees and age of species. Isolated to corner of survey area.</p> | |

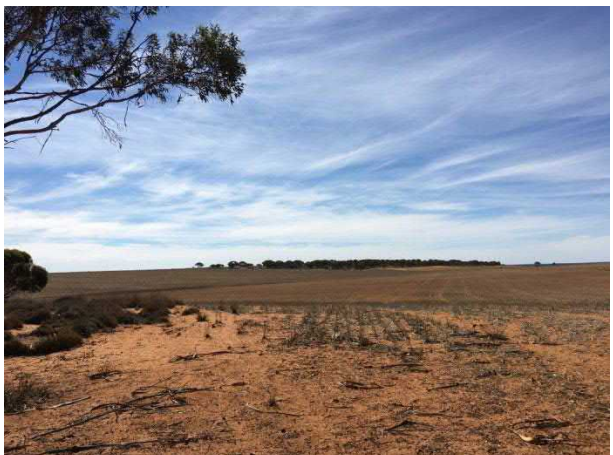
| Code | Vegetation Description | Photograph |
|---|---|---|
| Paddock | <p>Open farmland of undulating terrain supporting introduced grass and herb species.</p> | |

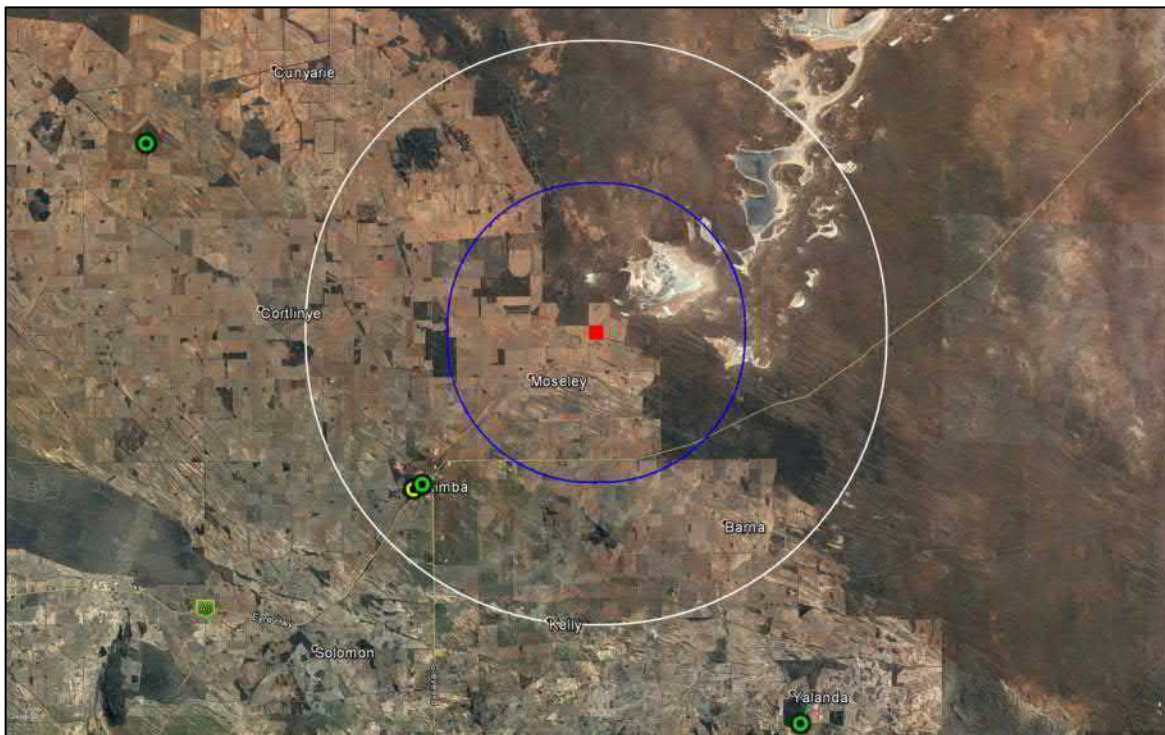
Figure 9 The landscape surrounding the Lyndhurst 100ha site and expanded Study Area (show in red fill)

A 10km buffer of the site is shown in blue outline and a 20km buffer is shown in white outline. The yellow circle shows the location of the BOM weather station from which weather data was obtained and analysed (see Section 2.4.2.3). Green circles identify the locations of the nearest CFS brigades (see Section 2.4.2.4.4).

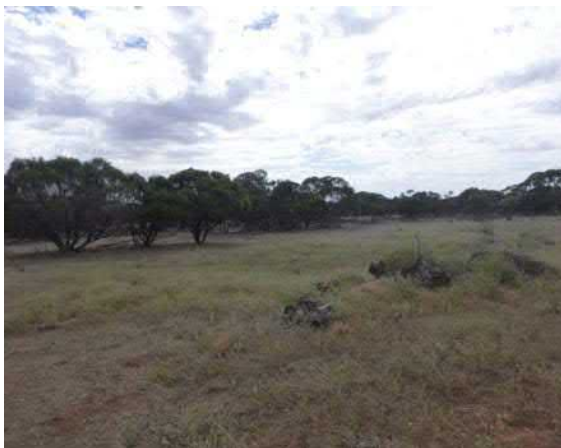
Low lying area to the south of the site (mapped as H2 soil subgroup) where ponded water has previously been observed.

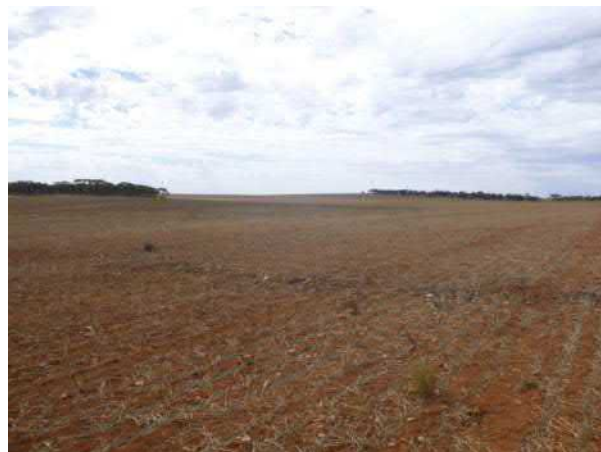
Majority of site showing red-brown soils (D3 soil subgroup) with nodular calcrete. Vegetated dunes in the distance.

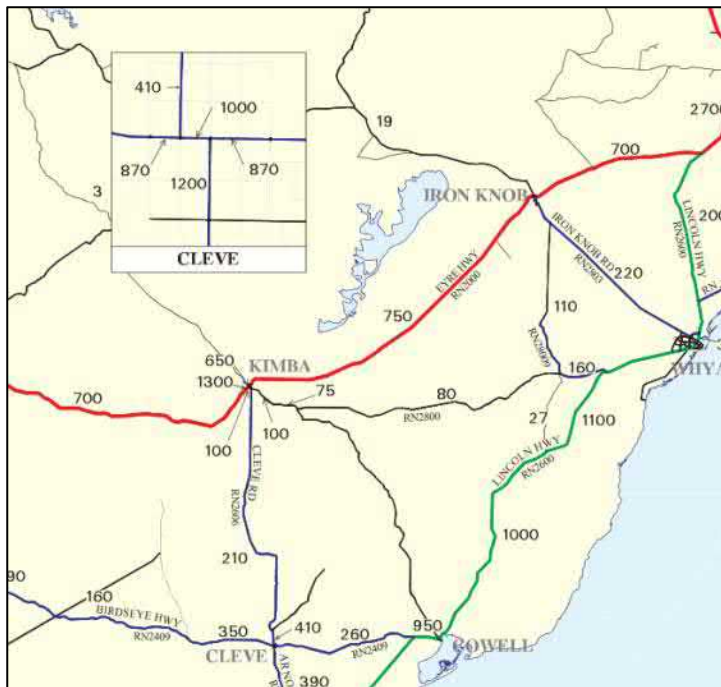
Figure 38 Annual Average Daily Traffic Estimate 24 hour two way flows (Department of Planning, Transport and Infrastructure, 2015)

The Eyre Highway is a two-way, sealed and marked road with a designated speed limit of 110 km/h. Annual Average Daily Traffic (AADT) estimates are provided for the state-managed arterial roads in the vicinity of the site, as shown in Figure 38. The Eyre Highway has a low estimated AADT, with traffic flows of 750 vehicles /day along the section between Iron Knob and Kimba.

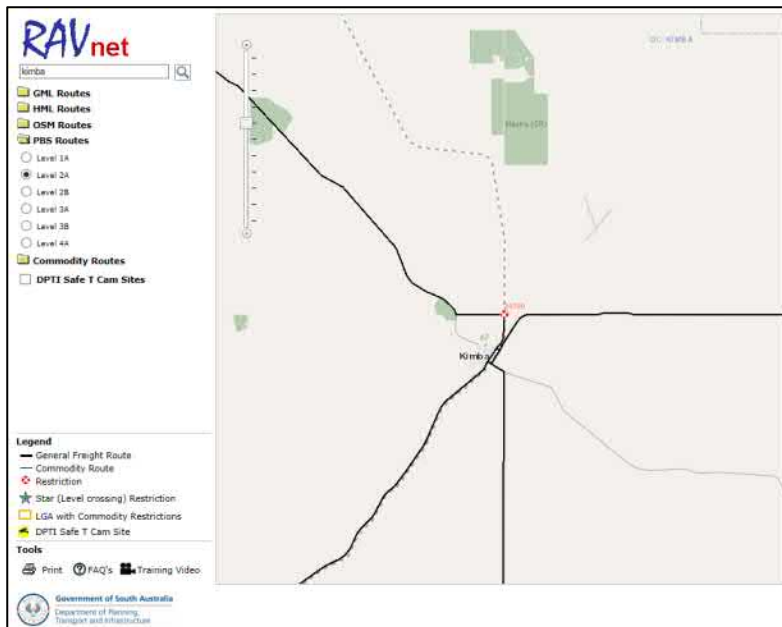
Figure 39 Approved restricted access vehicle routes approved under PBS Level 2A – 26m B-double (Department of Planning, Transport and Infrastructure, 2018)

Figure 39 indicates the access routes for the PBS category of level 2B vehicles, such as 26m B-double configurations which would be the largest type of vehicles used for most of the construction and operational activities (with the exception of the over-weight loads transporting the TN81 Containers which occurs very infrequently). Eyre Highway is the only road in the vicinity of the site that is classified as a PBS approved route.

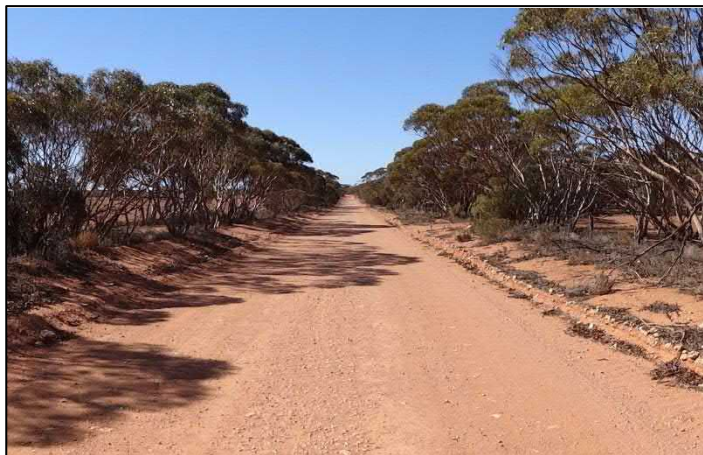
Figure 40 Bindawalla Gate Road

The area surrounding the potential site has a local road network mostly consisting of unsealed, low trafficked roads. Some are all-weather roads however may be less appropriate for carrying heavy loads during the winter months as a result of rainfall. The Lyndhurst site is bounded to the south by Bindawalla Gate Road and to the east / west by unnamed vehicle tracks (see Figure 40 below).

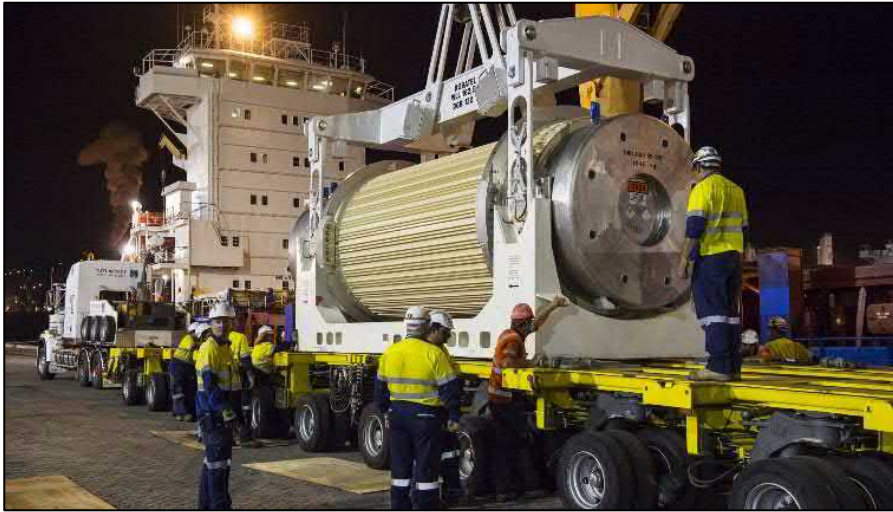
Figure 42 TN81 Container being transported (Department of Industry, Innovation and Science, 2016)

An aspect of the operation phase for the facility is the movement of TN81 Containers used to transport intermediate level waste. The TN81 Containers are 6.5 metres long, 3 metres in diameter and weigh approximately 100 tonnes when empty (Australia Nuclear Science and Technology Organisation, 2011). Therefore, the use of an over-dimensional / mass vehicle is required.

Further investigations into the type of vehicle required and appropriate transport routes will be performed as part of the Stage 2 works. As shown in Figure 42, it is likely that a prime mover and low loader combination will be necessary to transport the container over the road network.

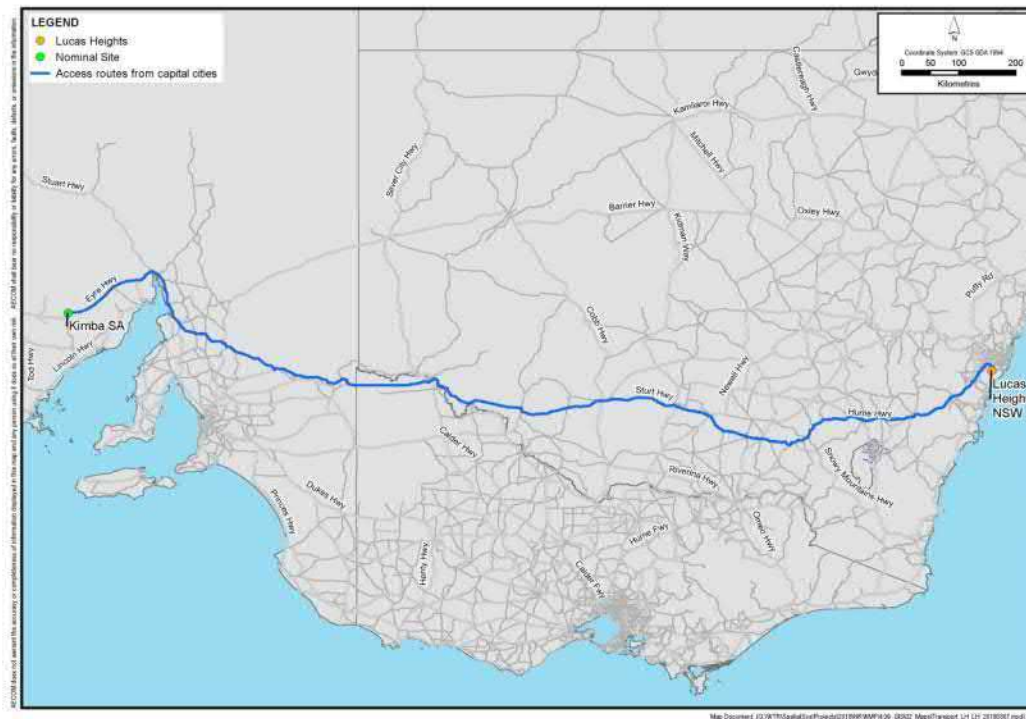
Figure 44 Access routes from Lucas Heights

1. Hume Highway (M31)
2. Sturt Highway (A20)
3. Goyder Highway (B64)
4. Clare Highway (B64)
5. Princes Highway (A1)
6. Eyre Highway (A1)

Further investigations will need to consider the local road network through key towns and cities along the proposed route to determine if there are approved heavy vehicle routes that will allow shipments to bypass these towns. Future investigations will further narrow down this route to minimise the number of towns / cities that are travelled through.

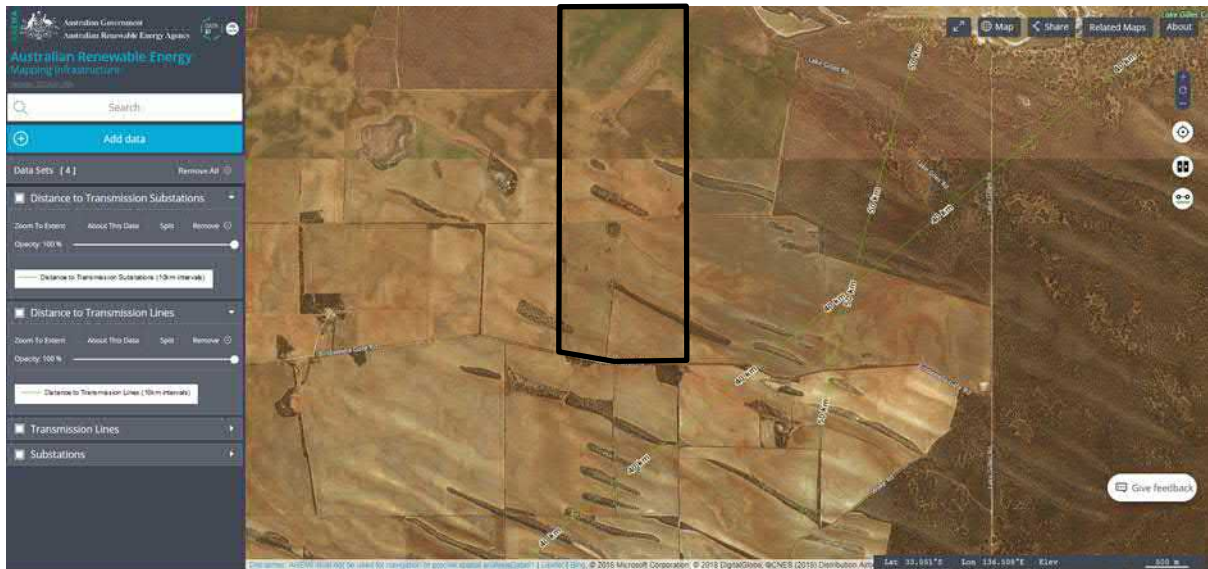
Figure 48 AREMI – Site Map

The Lyndhurst site is approximately 55km from the closest transmission substation (Middleback Tee) and approximately 45km from any transmission line (132kV Cultana to Yadnarie). This can be seen in the image below from AREMI showing in green both the distances from the 132kV transmission line and the transmission substation.

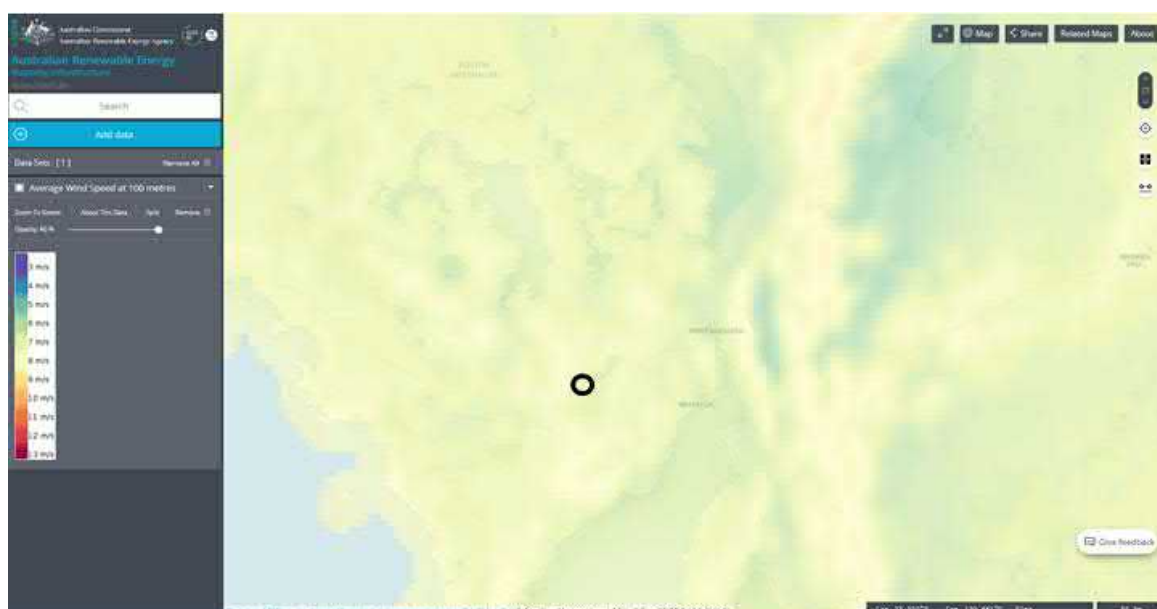
Figure 53 Wind resource at Lyndhurst sites [1]

The area for Lyndhurst shows a moderate wind resource area as outlined in Figure 53 below (Lyndhurst is the black circle). Lyndhurst is in a region of yellow colour (moderate). This resource is typical in the region surrounding Lyndhurst. Similarly to solar PV, some turbines derate at high temperatures and some stop operating at temperatures between 40°C and 45°C. This region reaches these temperatures and must be considered for the annual output.

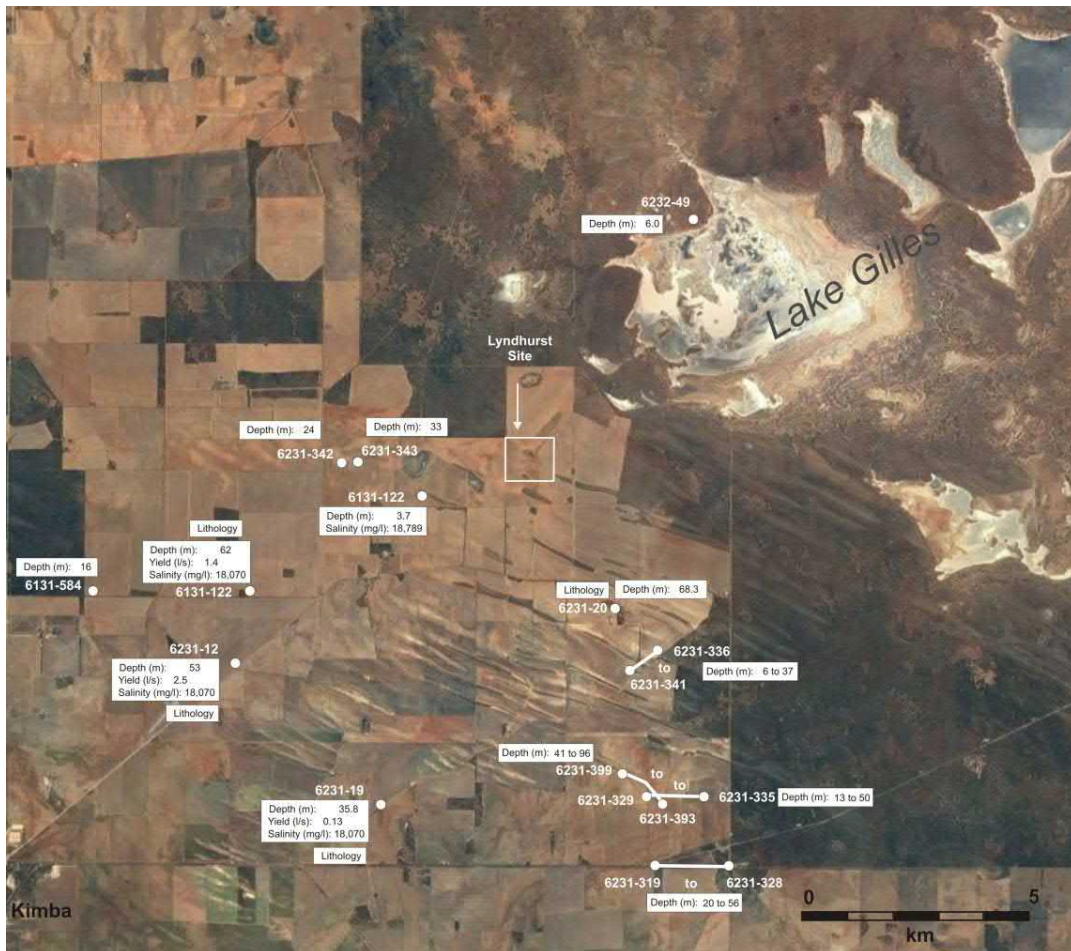
Figure 55 Registered Groundwater Bores & Summary Data – 10 km Radius of Site (source WaterConnect)

Figure 55 (main text) identifies the registered wells within a 10 km radius of the site including Unit No. 6131-105 located approximately 5 km south.

Well detail summary information from the bore search is attached as a table with the figure below showing available well depth and salinity information for wells in the general vicinity of the site.

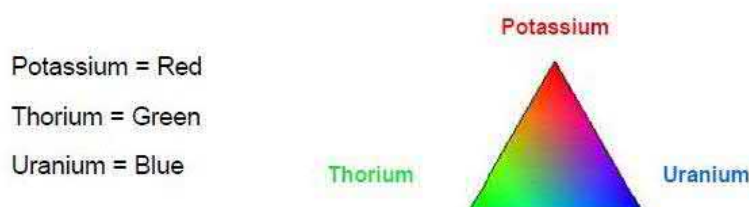
A composite image of all three elements is termed a Ternary image and may range from black (low) to white (high). In the ternary display the ternary ratio provides the relative proportion of potassium, thorium and uranium by assigning the colours red, green and blue to each channel (element).

The relative proportion is useful in mapping the variations in the surface materials and shows a strong correlation to geology and soils.
