**NATIONAL
RADIOACTIVE
WASTE MANAGEMENT
FACILITY**

Site Characterisation Technical Report - Lyndhurst

Client: Commonwealth Department of Industry, Innovation and Science

AECOM Australia Pty Ltd

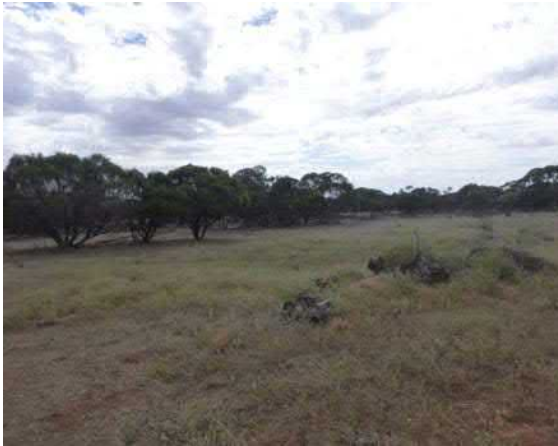
Low lying area to the south of the site (mapped as H2 soil subgroup) where ponded water has previously been observed.

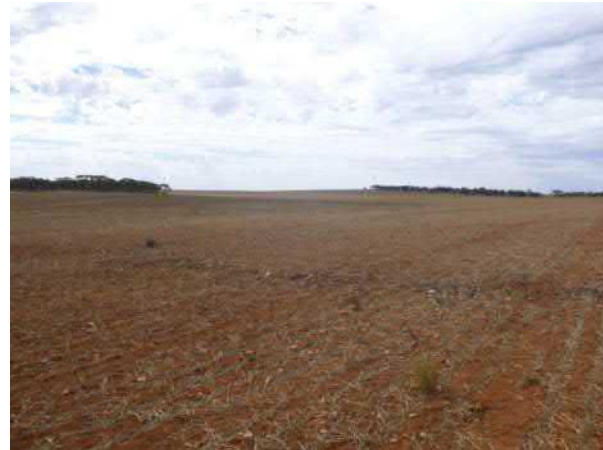
Majority of site showing red-brown soils (D3 soil subgroup) with nodular calcrete. Vegetated dunes in the distance.

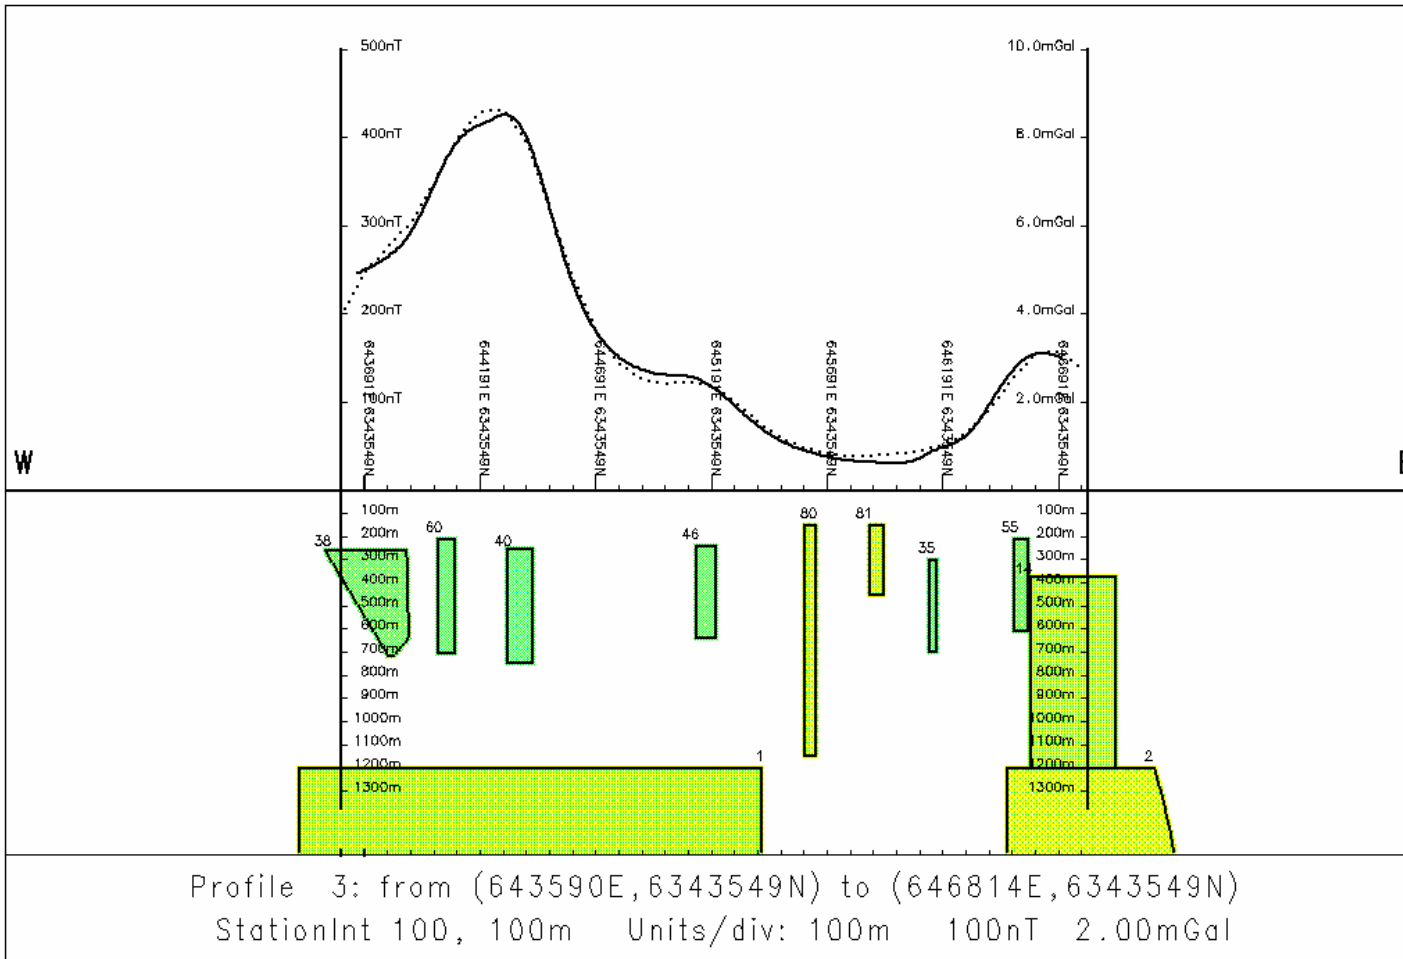
MAGNETIC PROFILES:
 Solid: data
 Dotted: model response
