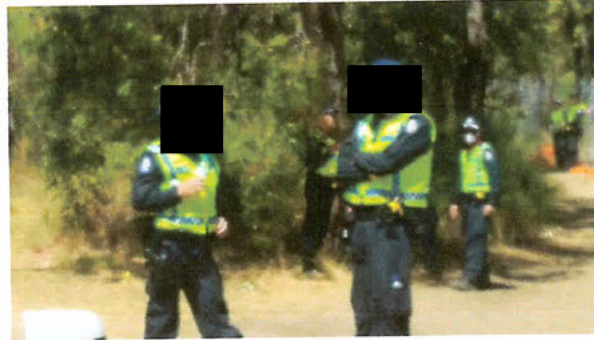
Police wearing ppe after residents advised them to at Mulvolio Road site.

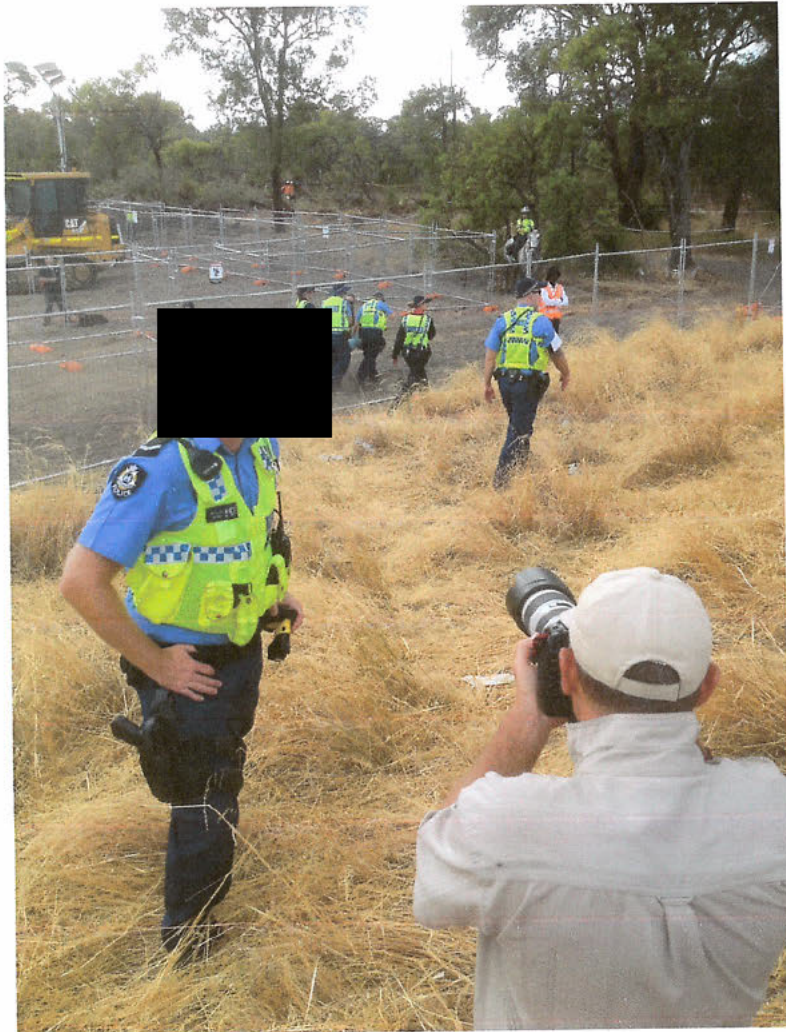
**Police inside the compound at Nth Lake Road, both on foot and on horseback, shown not wearing respirators. Also shows a security guard not wearing a respirator. This is contrary to Section 20 of the Occupational Safety and Health Act 1984 and shows a clear breach of the law.**

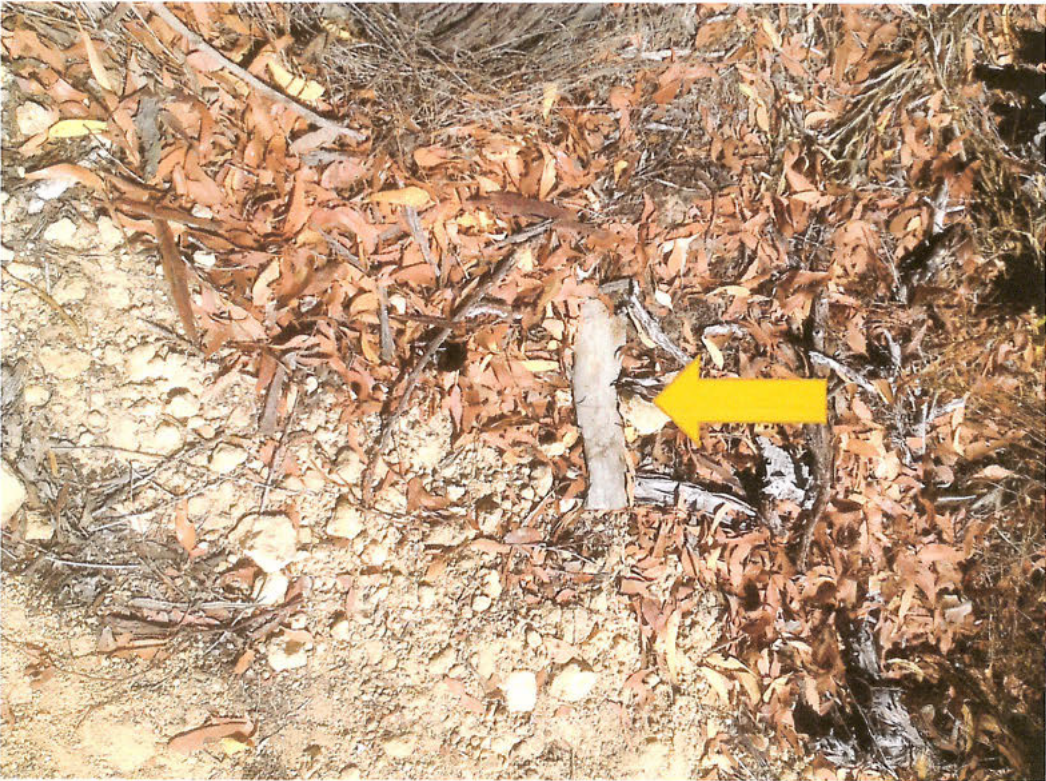
Asbestos piece inside the fenced area after the alleged clean-up of asbestos.

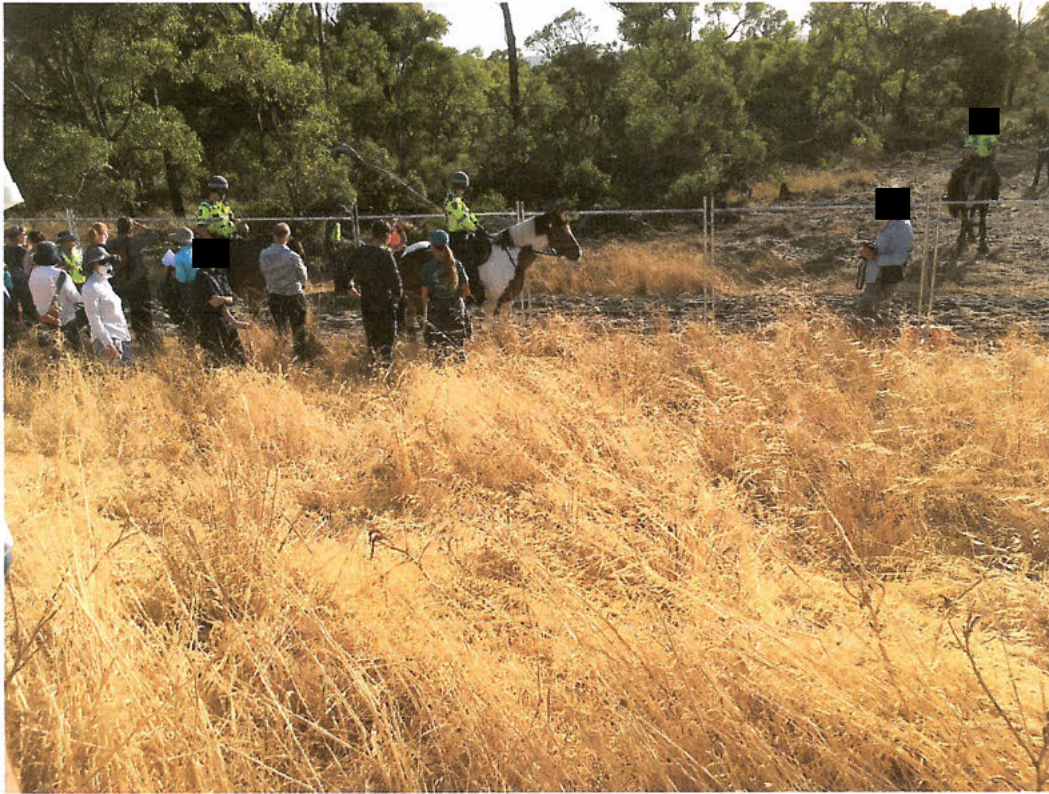
Police on horseback not wearing masks in a known contaminated area.

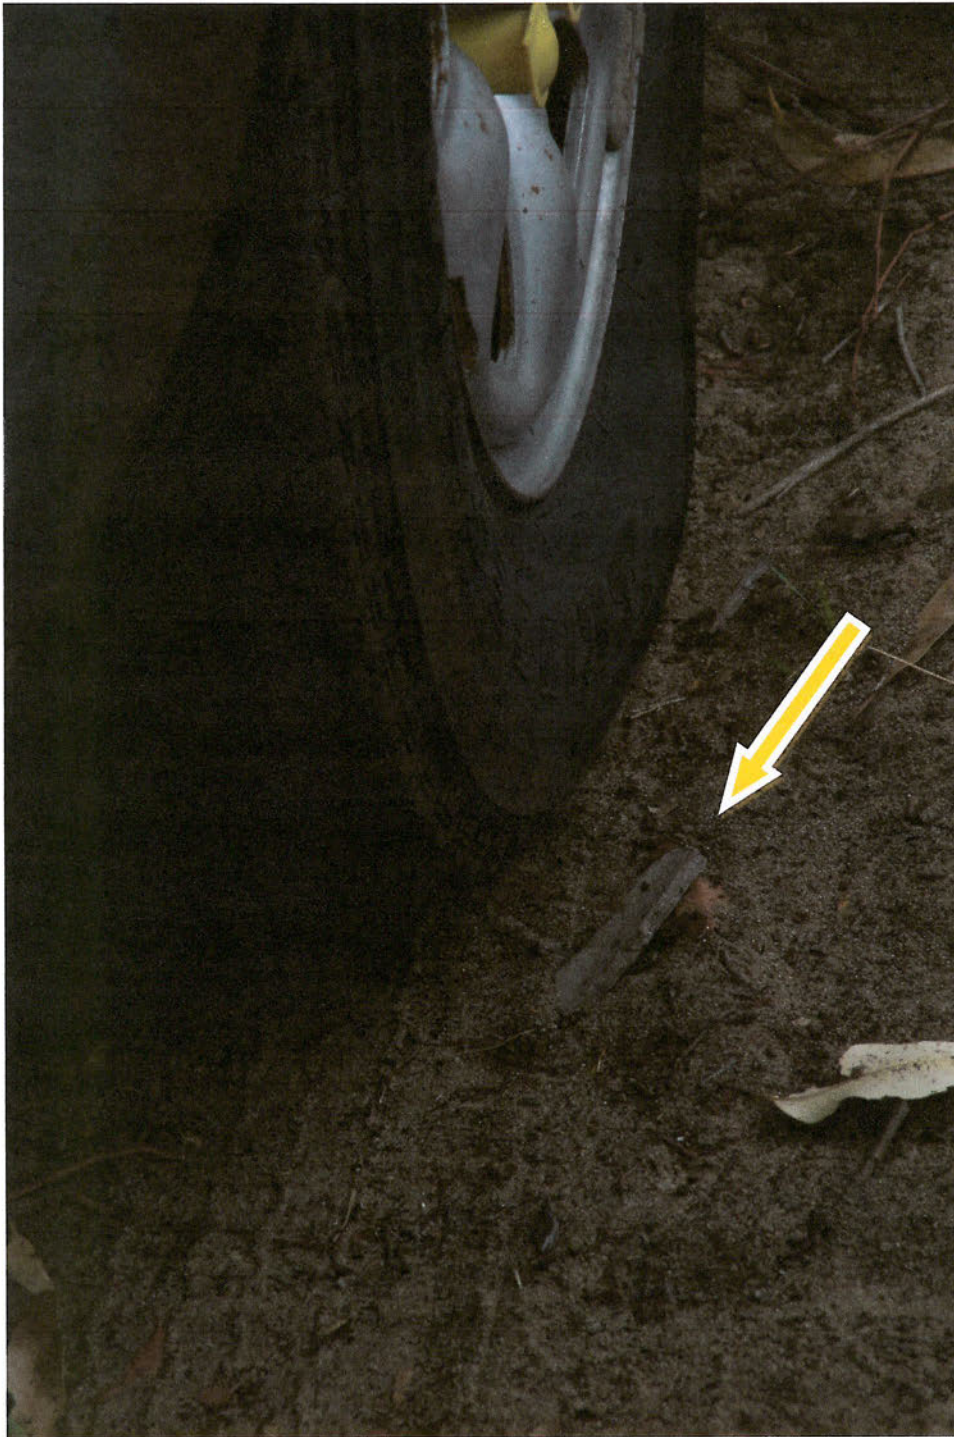
Piece of broken asbestos beside a well - used track by the construction vehicles. As can be seen it has been run over by the vehicle.

The asbestos clean-up has not been conducted in a proper manner here, and maybe elsewhere in the bushland where it may be less obvious

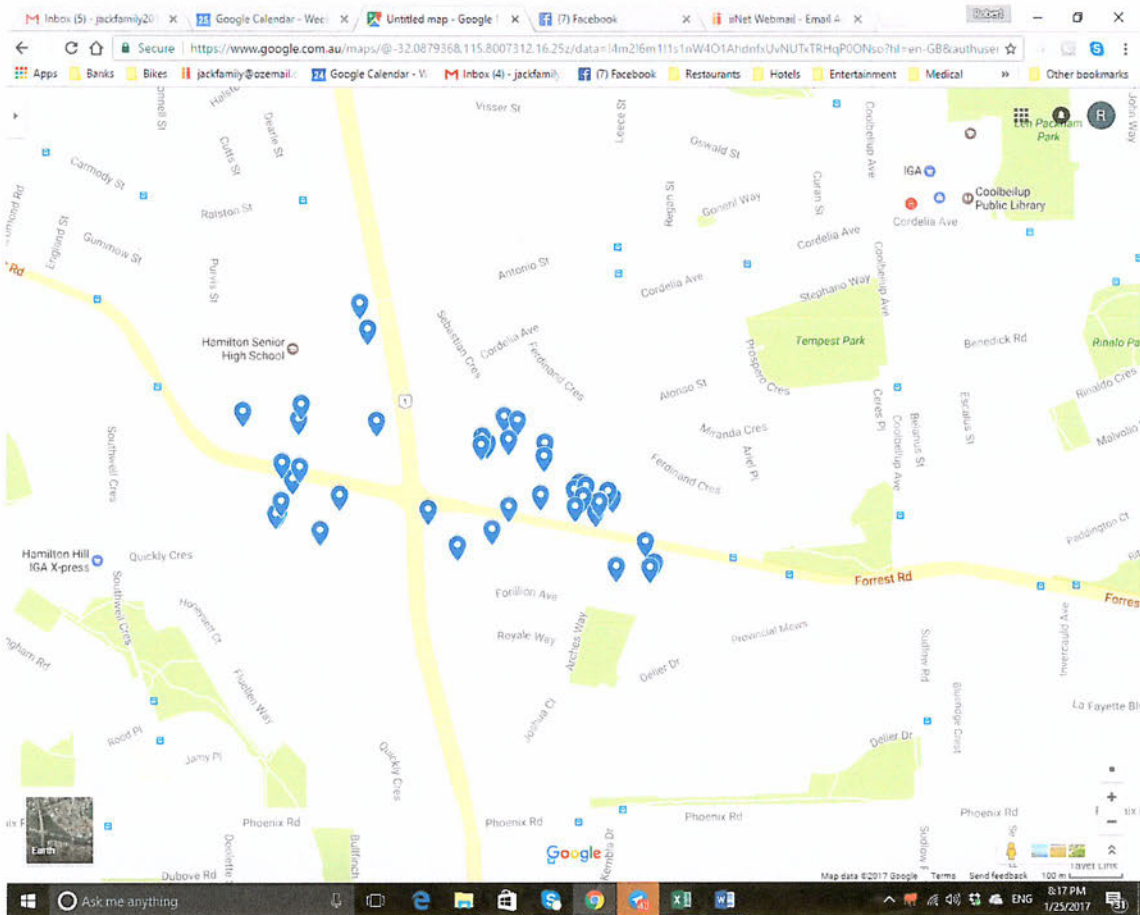
GPS plotting of tested samples along parts of the Roe 8 project.

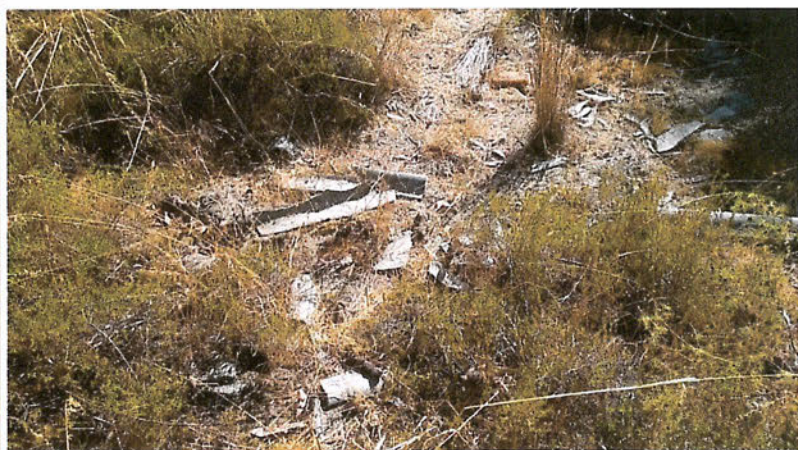
Asbestos laying intermittently on the ground surface. Photos taken by Phillip Eva JP of Cockburn Council on January 24, 2017, east of the Women's Army Camp. Much of the ground in the surrounding area was littered with broken asbestos. These photos were sent to Minister for the Environment on 25/01/2017.

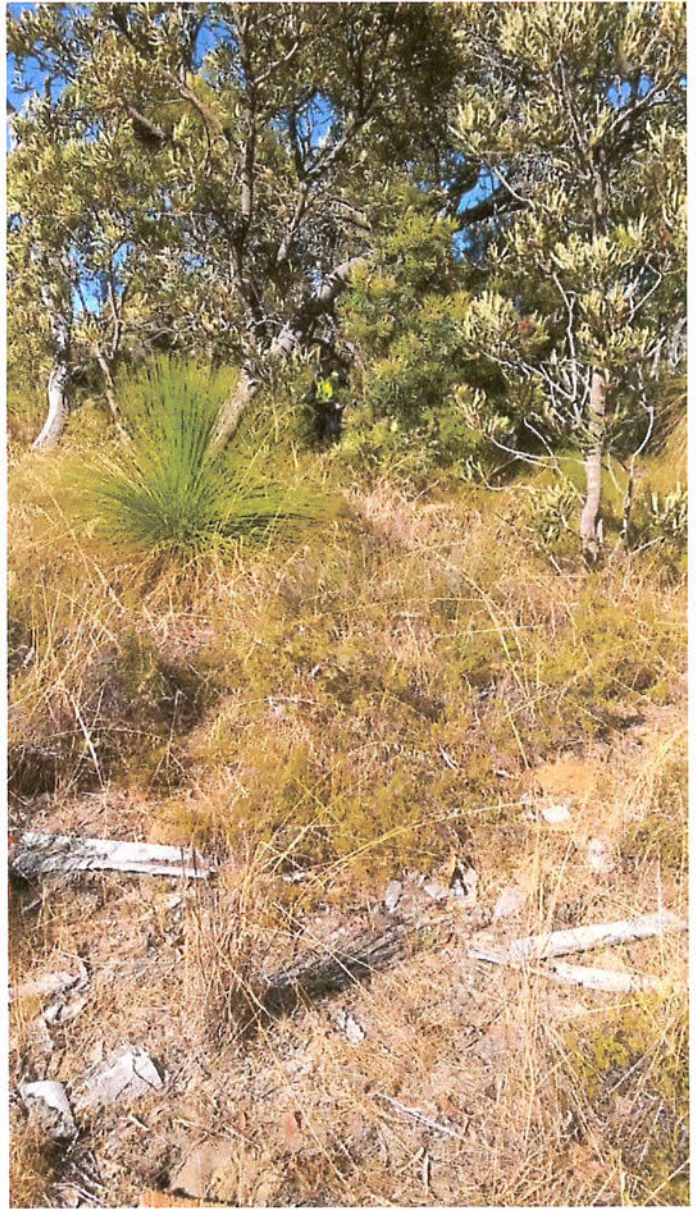
Photos taken by Phillip Eva JP of Cockburn Council on January 24, 2017, east of the Women's Army Camp. Much of the ground in the surrounding area was littered with broken asbestos. These photos were sent to Minister for the Environment on 25/01/2017.

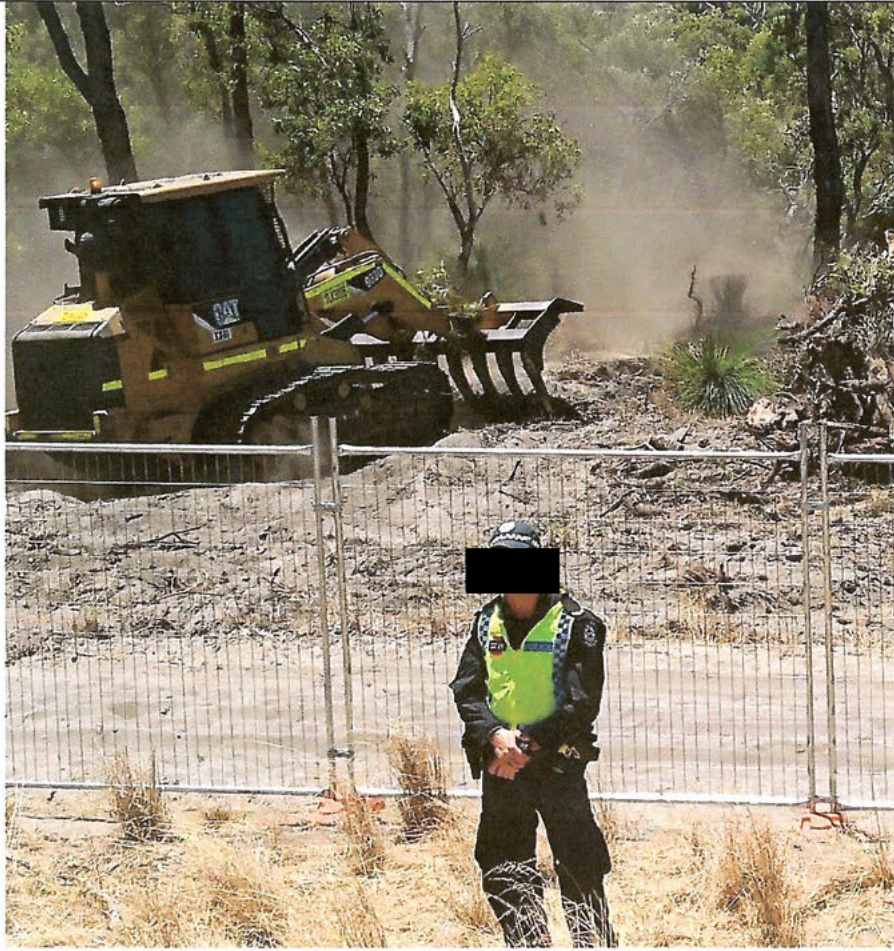
These photos were taken by Shona Ann Hunter and show the dust being generated by the machines in light winds with NO watering of the area performed prior to this work commencing. Also shows a police officer in close proximity to this equipment not wearing any personal protective equipment to prevent asbestos exposure. Such behaviour is contrary to Section 20 of the Occupational Safety and Health Act 1984 to which the police are covered by the provisions of this Act.

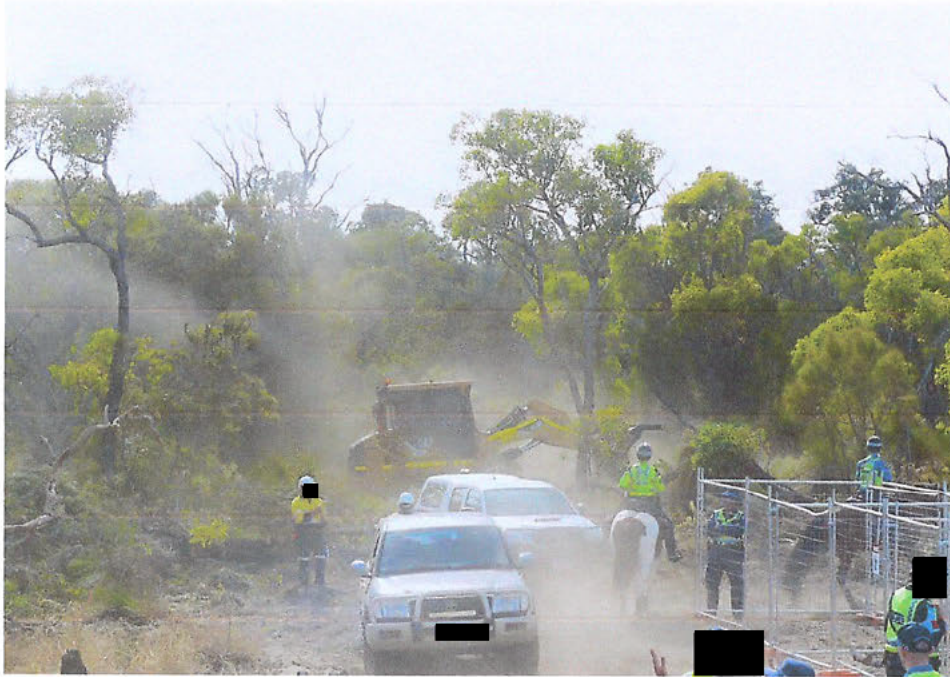
**Police, mounted police, workers and vehicles in the contaminated area. NO dust suppression and windy conditions carrying the dust plume through the bushland. Note that no one is wearing a respirator contrary to the OSH Act of 1984 Section 20 Duty of Care.**

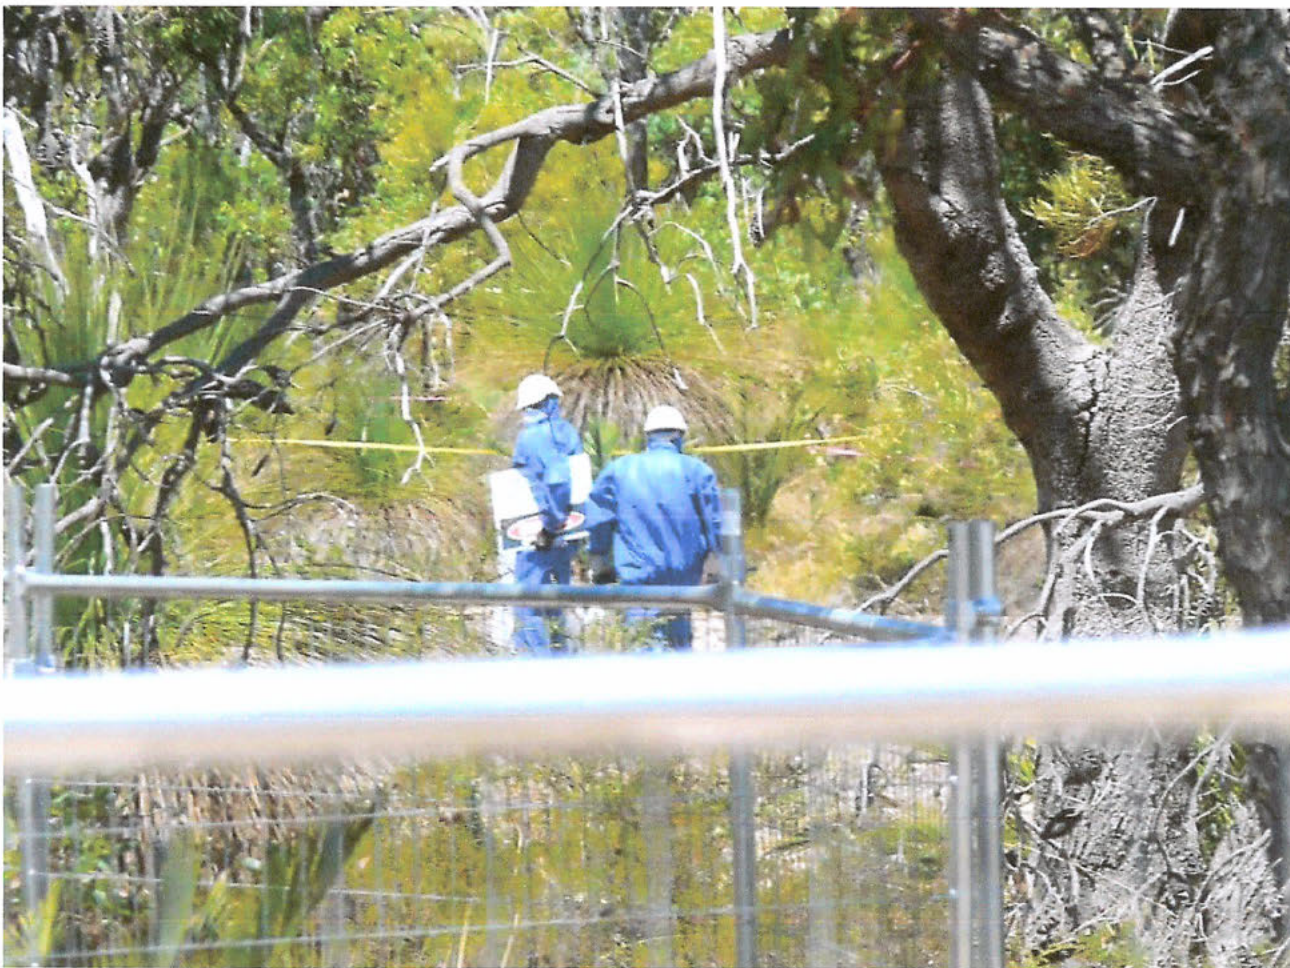
Asbestos removalists at a later stage of the Roe 8 project wearing their ppe.

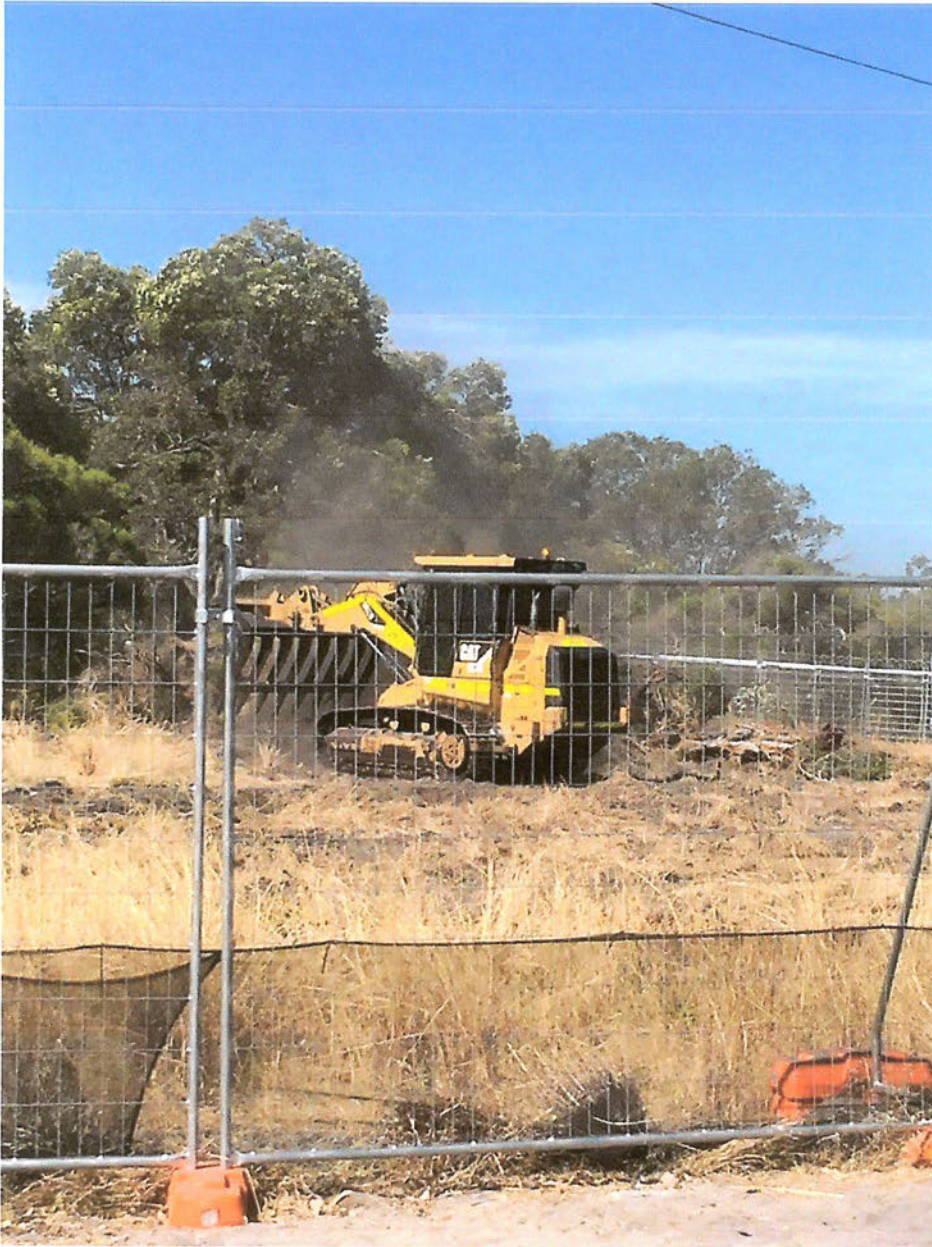
Dust being generated by this track mounted machine. NO wetting of the area prior to work being undertaken and this was done in light windy conditions.

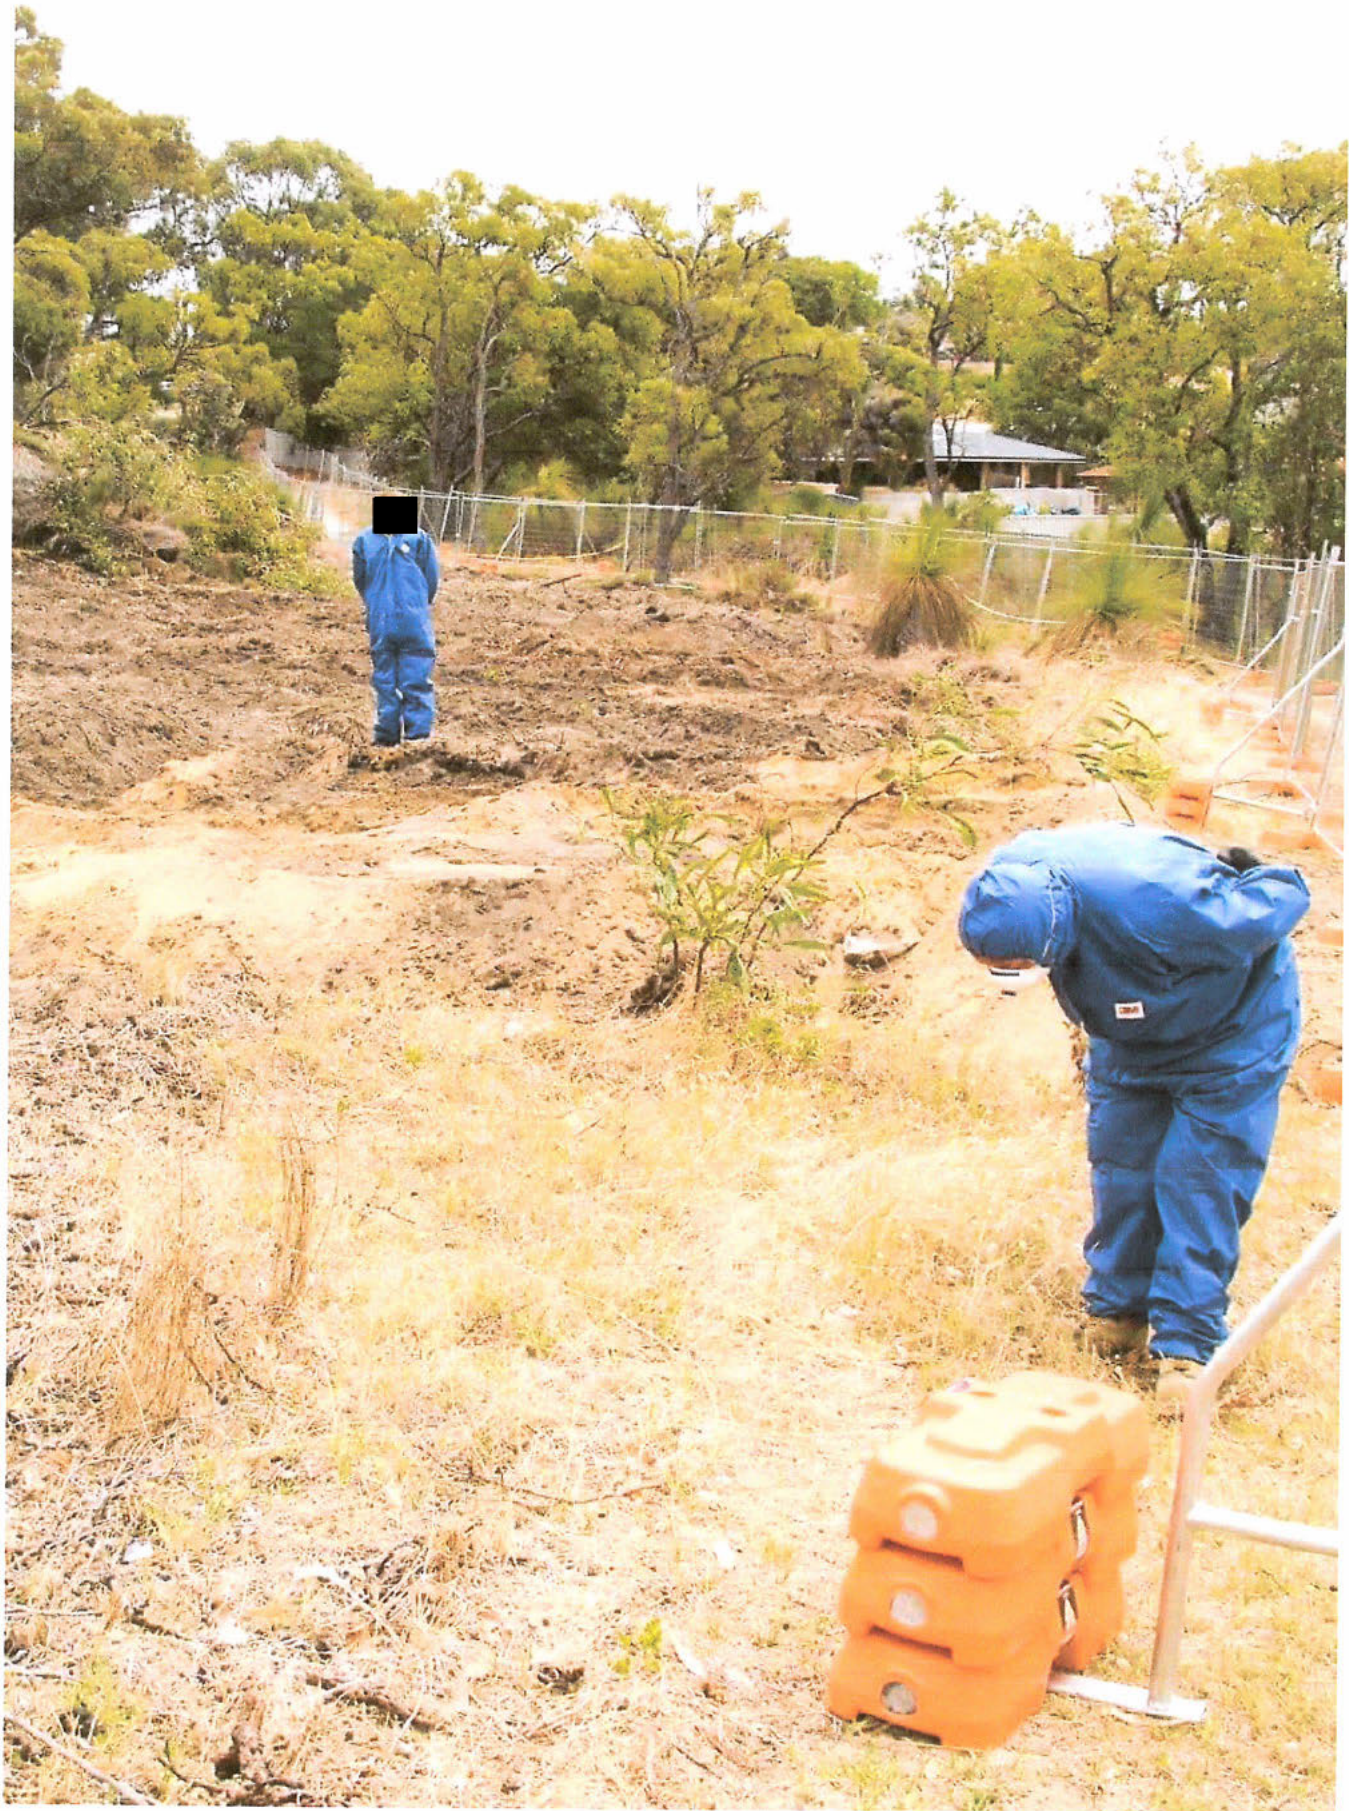
Note: One asbestos removalist is not wearing a hood as an integral part of the appropriate personal protective equipment. This is a clear breach of Section 20 of the Occupational Safety and Health Act 1984.

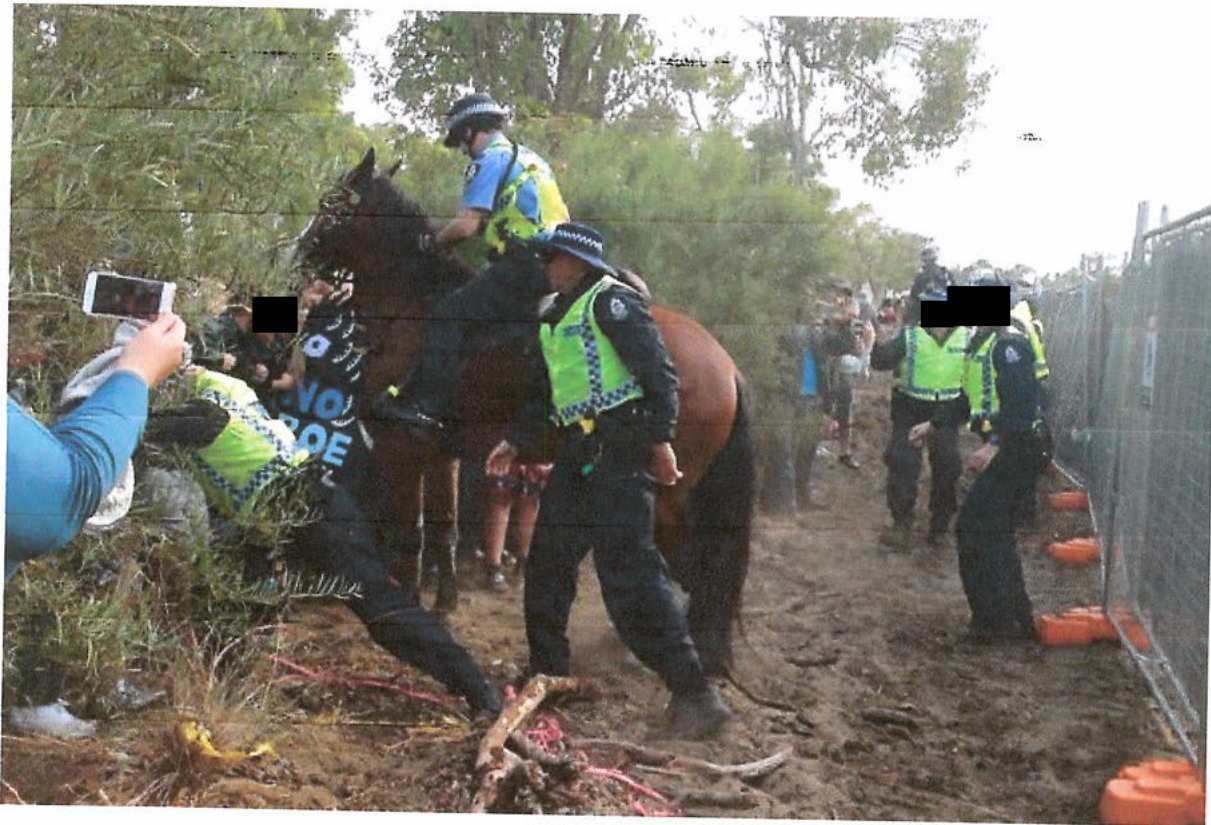
Police inside the contaminated area without wearing approved respirators to prevent asbestos exposure.

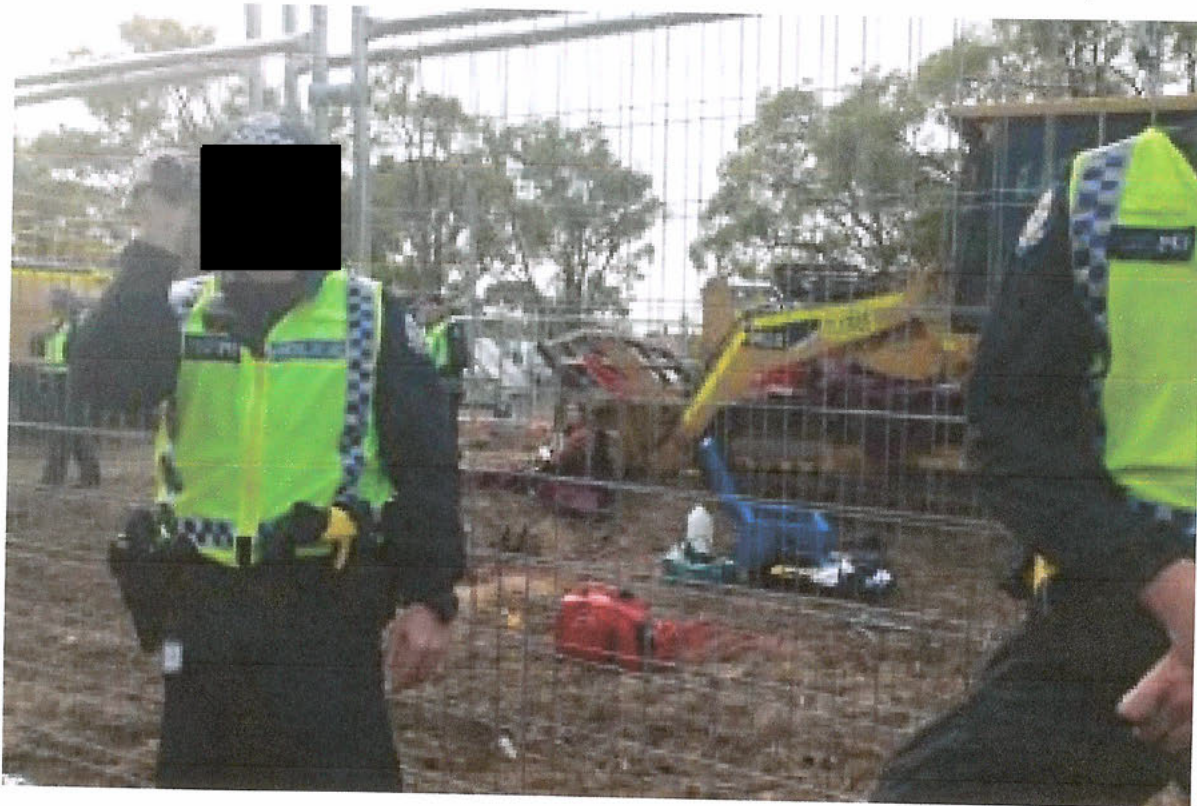
Police inside and outside the contaminated area not wearing appropriate respirators to protect them from asbestos exposure.
