AUSTRALASIAN CAVE & KARST MANAGEMENT ASSOCIATION JOURNAL

No. 19

REHABILITATION OF THE LUNE RIVER QUARRY, TASMANIAN WILDERNESS WORLD HERITAGE AREA, AUSTRALIA.

- David Gillieson

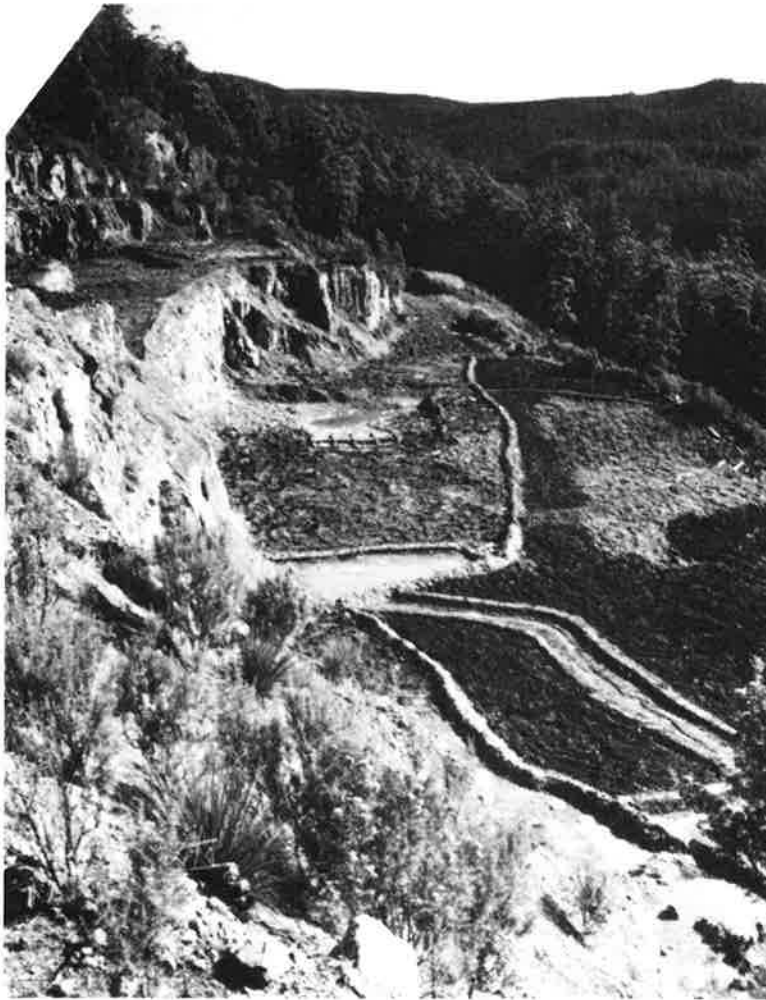
A view over the former Bender's Quarry at Ida Bay, showing rehabilitation work.

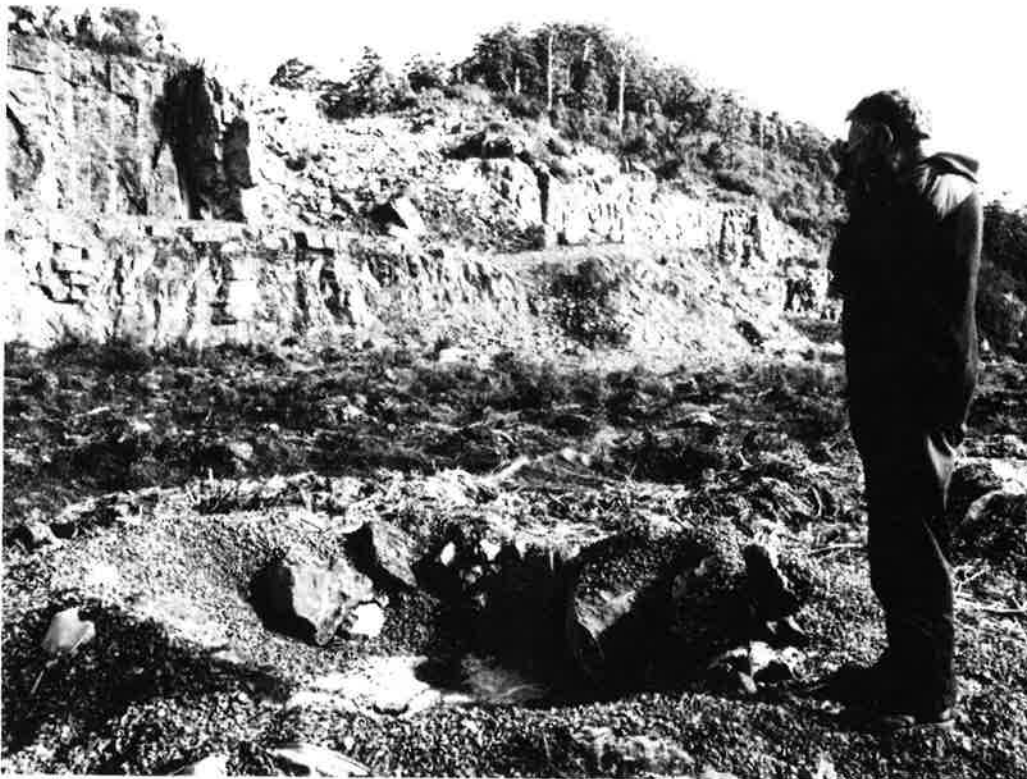
ACKMA's new Executive Officer, Andy Spate, photographs an impermeable bund constructed in the restoration program.

Drainage control has been achieved by several methods. Impermeable bunds of clay and rubble have been constructed along the outer edge of the benches, about 500-1000mm high and 1000-1500mm wide. The height of these was based on analysis of the likely runoff from the 1 in 100 year rainfall event. These have been compressed with the excavator bucket to render them impermeable. Similar bund walls have been placed to subdivide the benches into 0.1-0.2ha internal drainage basins which simulate size of the depressions of polygonal karst (Figure 2) on adjoining Marble Hill. This simulation of natural karst drainage should be adequate to restore the dispersed nature of water flow into the Exit Cave hydrological system.
