Email 2 of submission to Senate Committee for GBR Bill.

## **NOTICE TO MARINERS**

#### **GLADSTONE PILOTAGE AREA**

### 1.2 Project Area

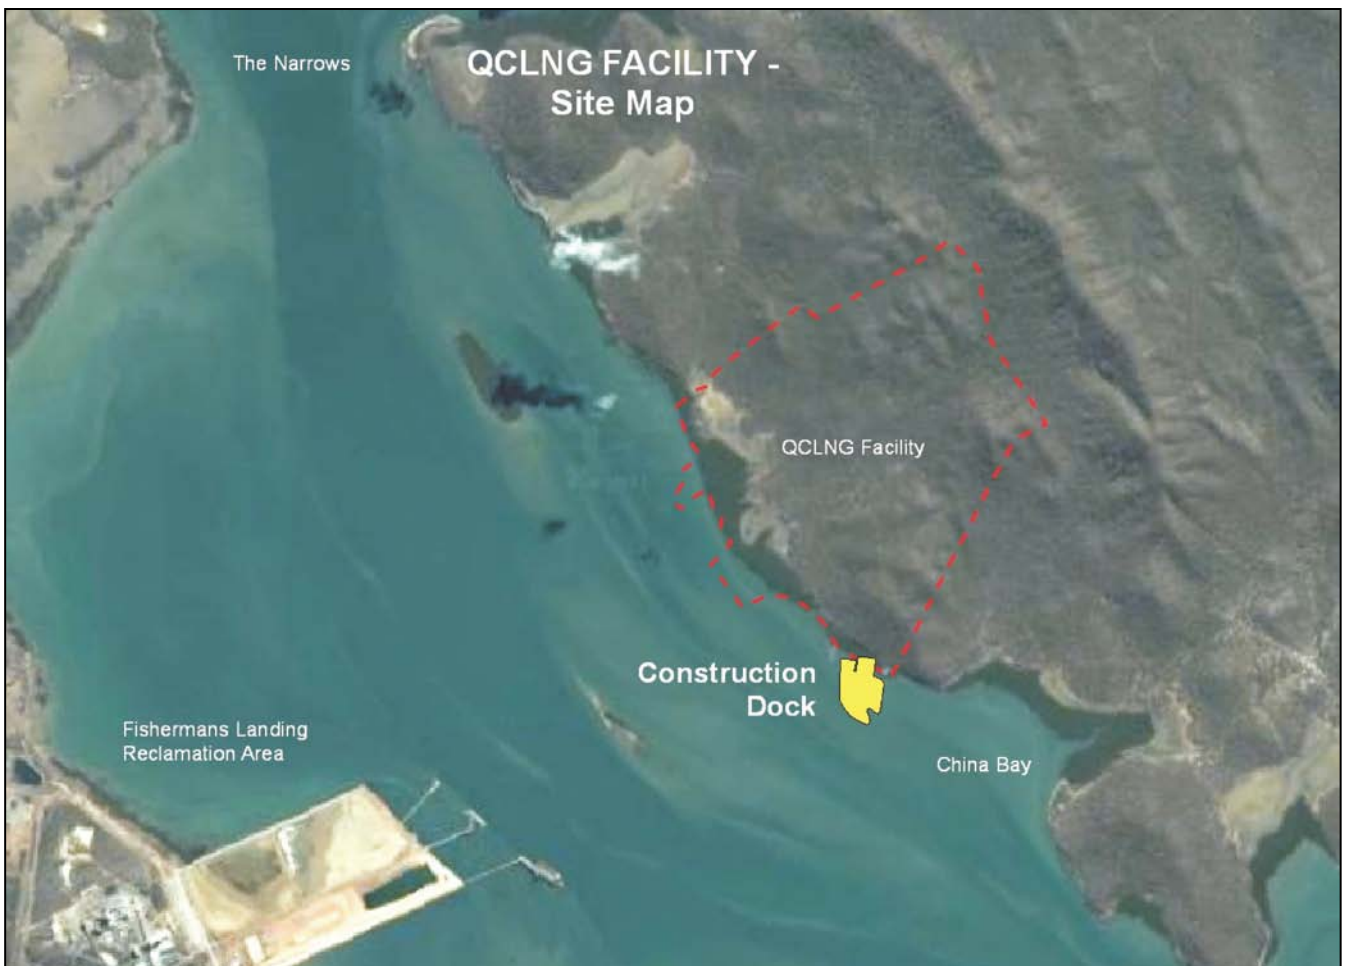
*Figure 2 : Site Location*

Construction of this facility will entail excavation of sediments both in the immediate offshore and within the intertidal zone to provide vessel access to the facility. The location of the Construction Dock in relation to the QCLNG Facility site is shown in **Figure 2**.

The Construction Dock is within the QCLNG Facility site, located in the Curtis Island Industry Precinct of the Gladstone State Development Area (GSDA). It is located approximately 6 km north-east of the city of Gladstone on the south-western side of Curtis Island immediately north of China Bay (**Figure 2**).
