# Post Incident Analysis Report

Lacrosse Docklands  
673-675 La Trobe Street, Docklands  
25 November 2014

Report No: **1403134A**

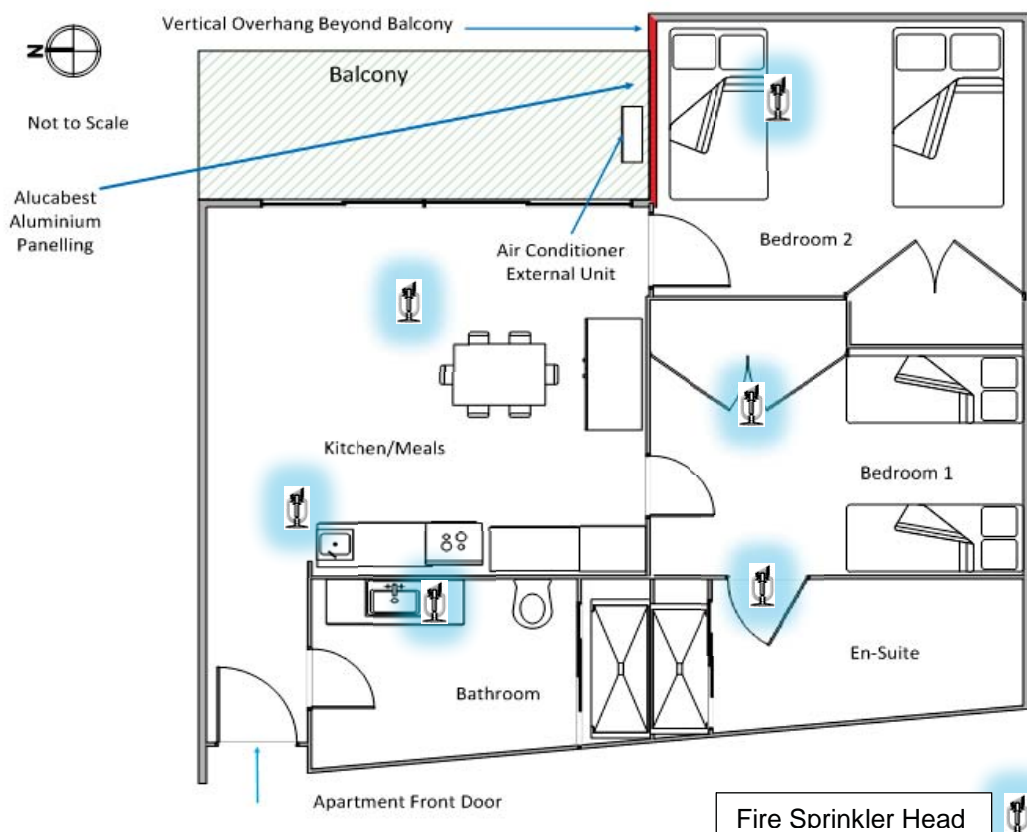
Figure 1 – General floor layout of apartment 805

At approximately 01:30 hours on the morning of Tuesday 25 November 2014, an occupant from Apartment 805 of the building, claims he investigated the smell of smoke. After checking the kitchen and making sure the gas stove was turned off, he returned to bed. Sometime later, the same occupant was woken by two other house mates who had discovered the fire burning on the balcony.

From inside the apartment, he could see a fire on the right hand side (south) of the balcony. The occupants of the apartment unsuccessfully attempted to extinguish the fire using a container of water.

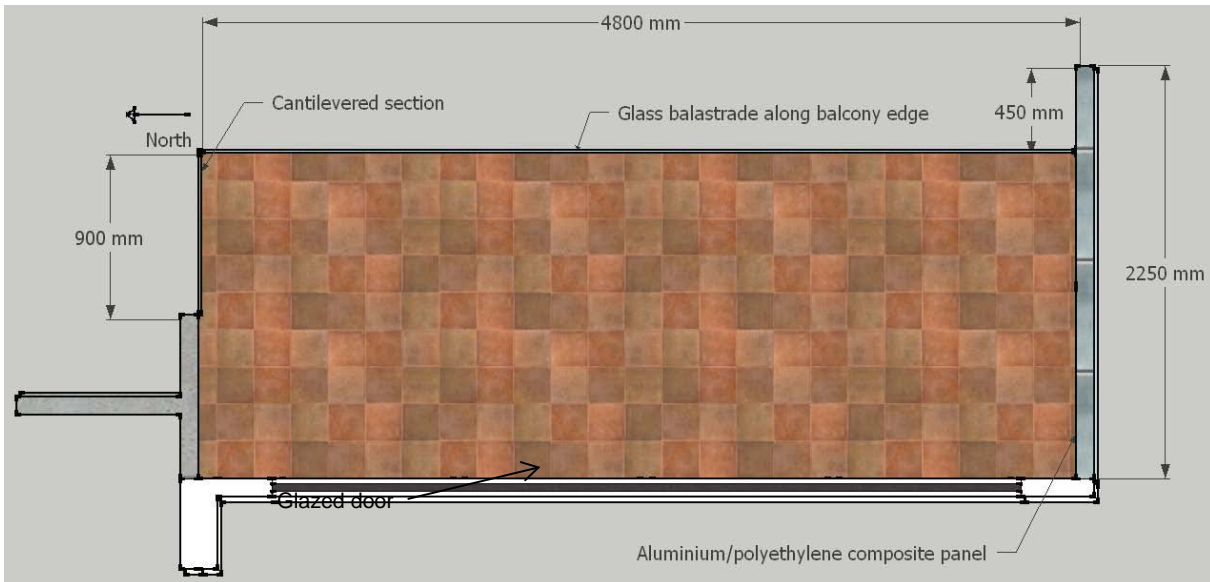
Figure 7 - Balcony Plan view

The apartments known as Apartments 605 to 2105 are located in vertical alignment from the 6<sup>th</sup> floor to the 21<sup>st</sup> floor on the east façade of the building. They include suspended concrete balconies of approximately 1.8 metres deep x 4.7 metres wide. A double-glazed sliding door assembly is fitted in the external wall of the building and provides access to the balcony.

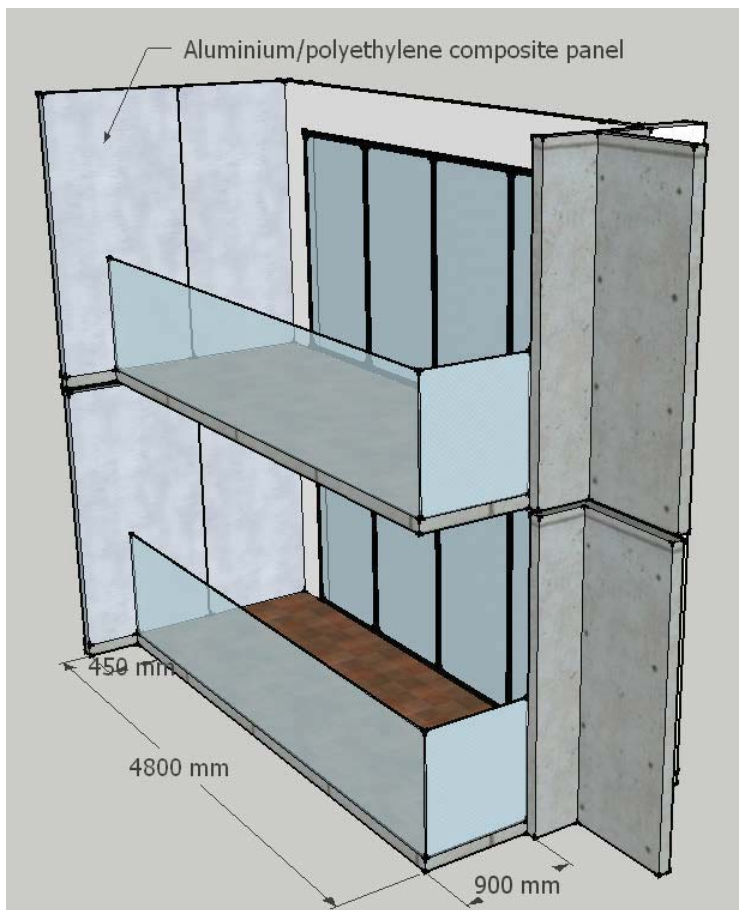
Figure 8 - Simplistic 3D interpretation of the balcony layout

The northern end of these balconies are bounded by 900mm concrete panels, which leaves the remaining 900mm balcony depth cantilevering out beyond the building face. A 1 metre high glazed balustrade is fitted to the remaining northern edge of the balconies and returns along the length of the eastern edge and butts into the southern wall.

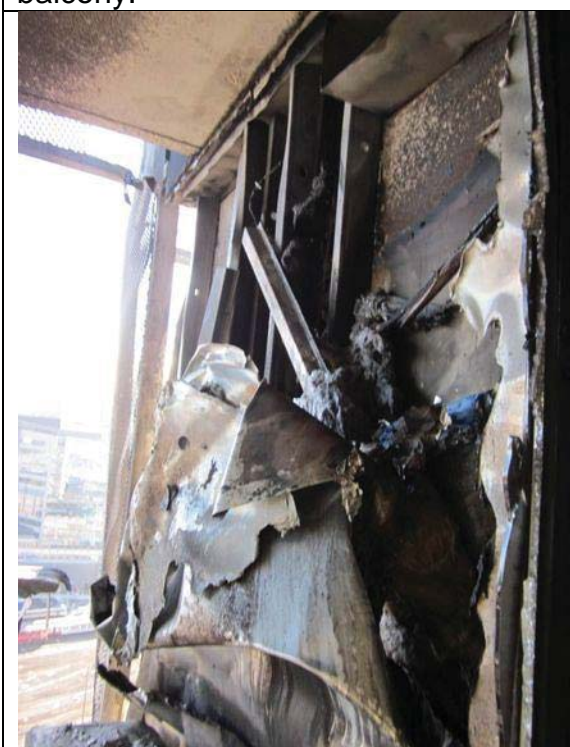
External wall at upper height

Wall between bedroom and balcony. Construction lightweight wall with steel studs, aluminium type external cladding plasterboard to internal. Material stored on balcony.

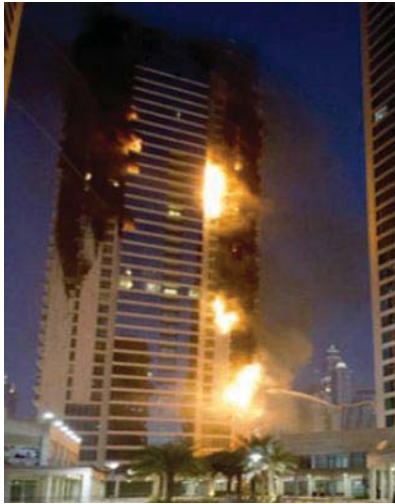
- 34 storey residential building (contains mixed use)
- Aluminium/polyethylene composite panel façade;
- Fire origin – roof level
- Fire description - “spread down the exterior of the building.”

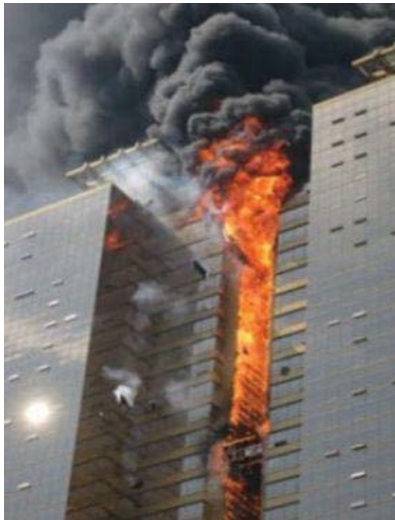
- 42 storey residential building (contains mixed use);
- Aluminium/polyethylene composite panel façade;
- Fire description - “spread vertically upward on the façade reaching the top of the building”
- Fire origin - fourth floor;
