Post Incident Analysis Report

Lacrosse Docklands
673-675 La Trobe Street, Docklands
25 November 2014

Report No: **1403134A**

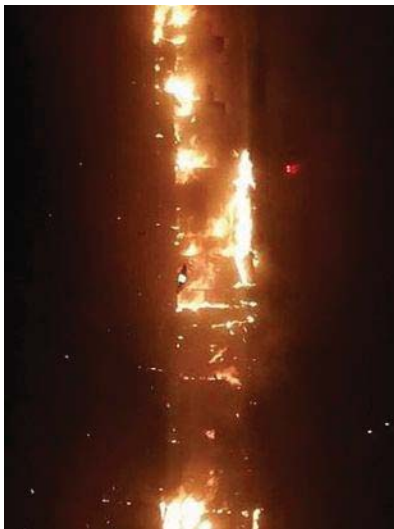
Torch Tower Dubai 21 February 2015

- 79 Storey residential;
- Reported as same façade material as the other Dubai fires shown - Aluminium/polyethylene composite panel facade;
- Fire Origin 52nd floor
- Rapid vertical spread up the façade of the building and significant flaming falling debris
