# Post Incident Analysis Report

Lacrosse Docklands  
673-675 La Trobe Street, Docklands  
25 November 2014

Report No: **1403134A**

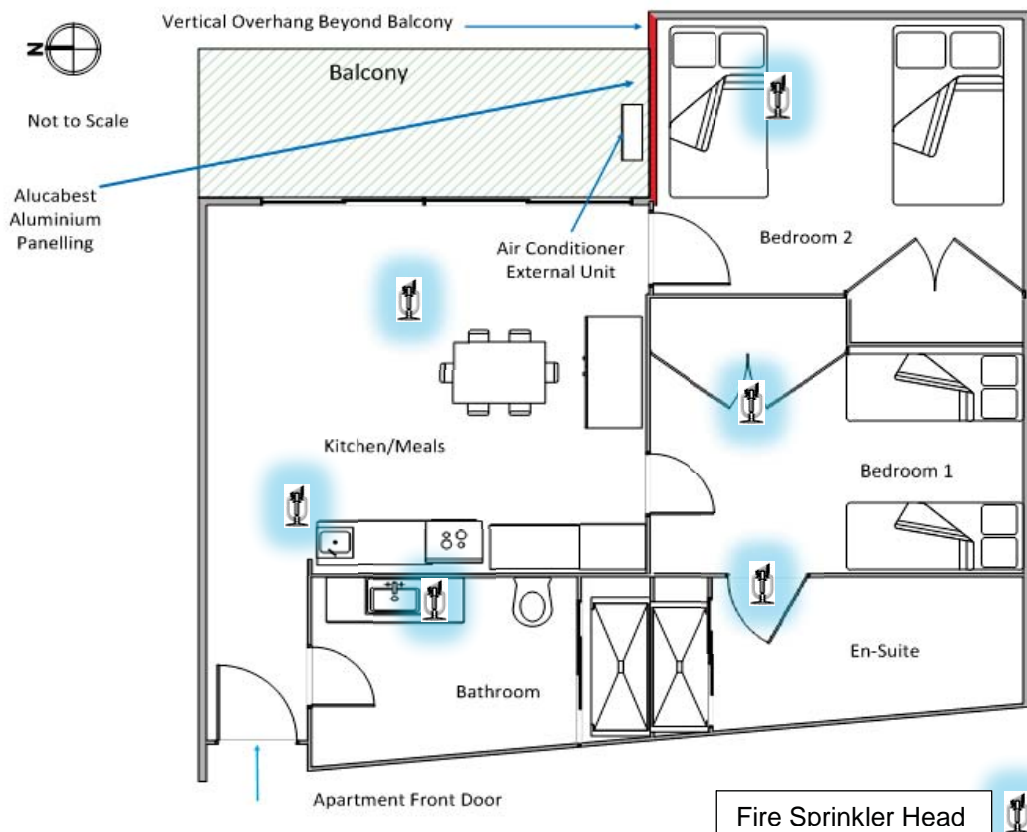
Figure 1 – General floor layout of apartment 805

At approximately 01:30 hours on the morning of Tuesday 25 November 2014, an occupant from Apartment 805 of the building, claims he investigated the smell of smoke. After checking the kitchen and making sure the gas stove was turned off, he returned to bed. Sometime later, the same occupant was woken by two other house mates who had discovered the fire burning on the balcony.

From inside the apartment, he could see a fire on the right hand side (south) of the balcony. The occupants of the apartment unsuccessfully attempted to extinguish the fire using a container of water.

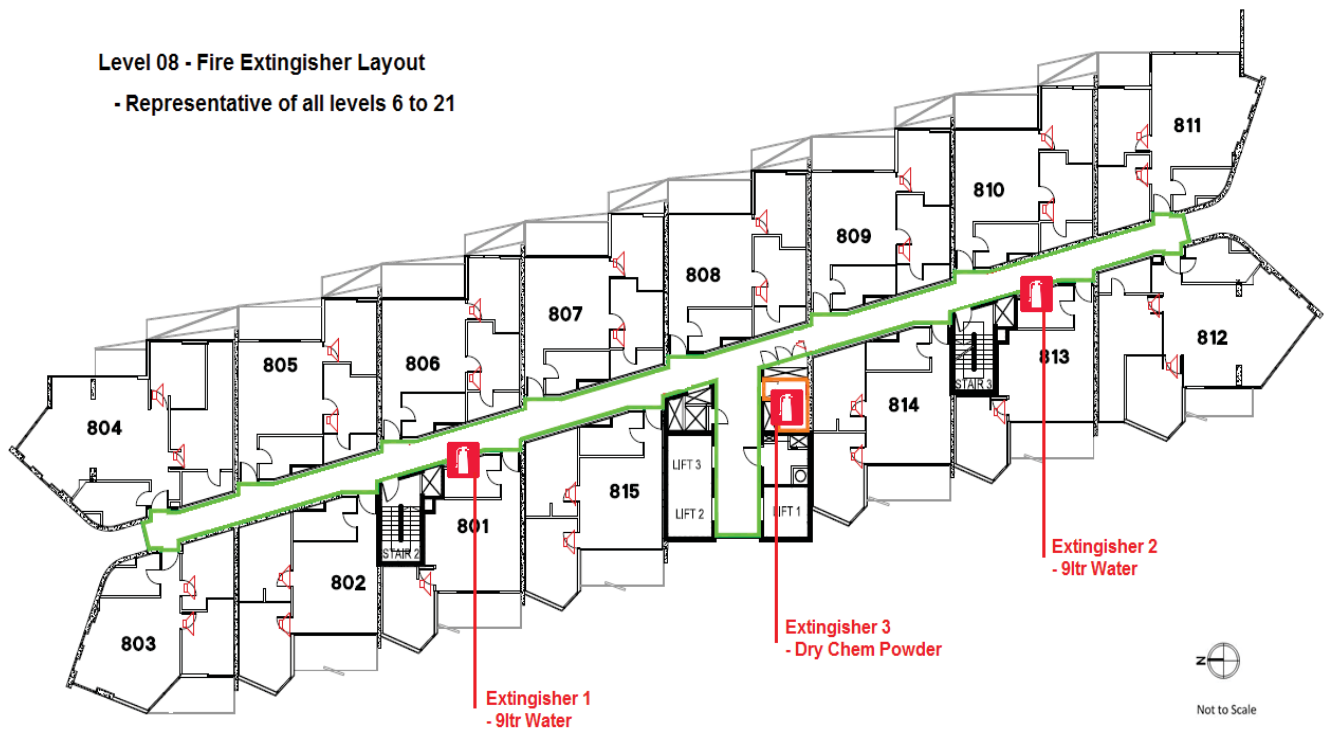
Figure 12 - Fire extinguisher layout

As discussed in the '[Installed Fire Safety Equipment](#)' section of this report, there are three fire extinguishers installed on each residential level. These extinguishers are required to be installed in accordance with Australian Standard AS2444-2001.

This Standard states that each extinguisher shall be located in a conspicuous and readily accessible position and extinguishers shall not be located in positions where access could present a hazard to the potential user.

In this instance, a number of the purposely designed extinguisher enclosure housing Extinguishers 1 and 2 shown in [Figure 12 \(refer previous page\)](#), were being used by occupants as storage areas thus blocking access to the extinguishers.

It was noted during investigations that extinguisher three (as shown in [Figure 12](#)) on all residential levels was locked within a service room where they were inaccessible to occupants and fire-fighters.

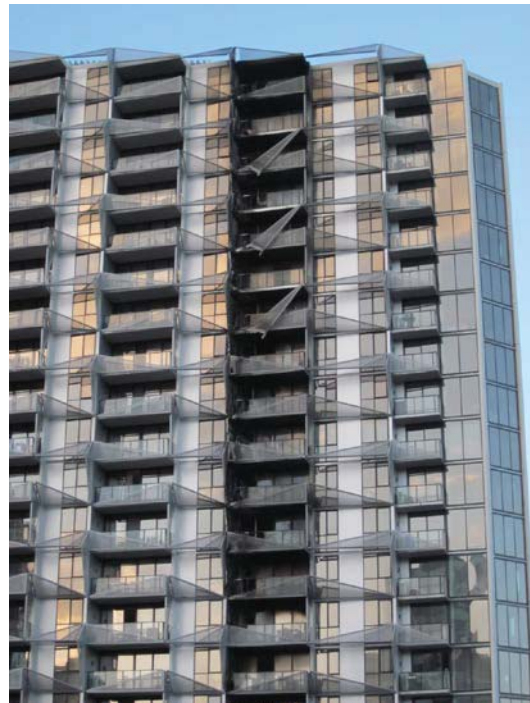
Photo Post Fire

Fire damage was essentially restricted to the façade and external balcony area adjacent to Apartment 605 and Apartments 805 to 2105. Please refer to the [Fire Cause and Origin section](#) of this report for further information on fire damage.

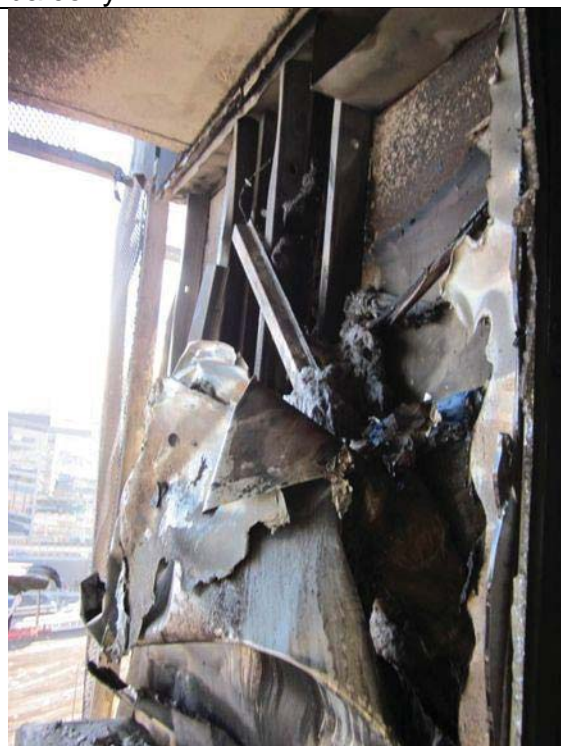
Wall between bedroom and balcony. Construction lightweight wall with steel studs, aluminium type external cladding plasterboard to internal. Material stored on balcony.

External wall at upper height

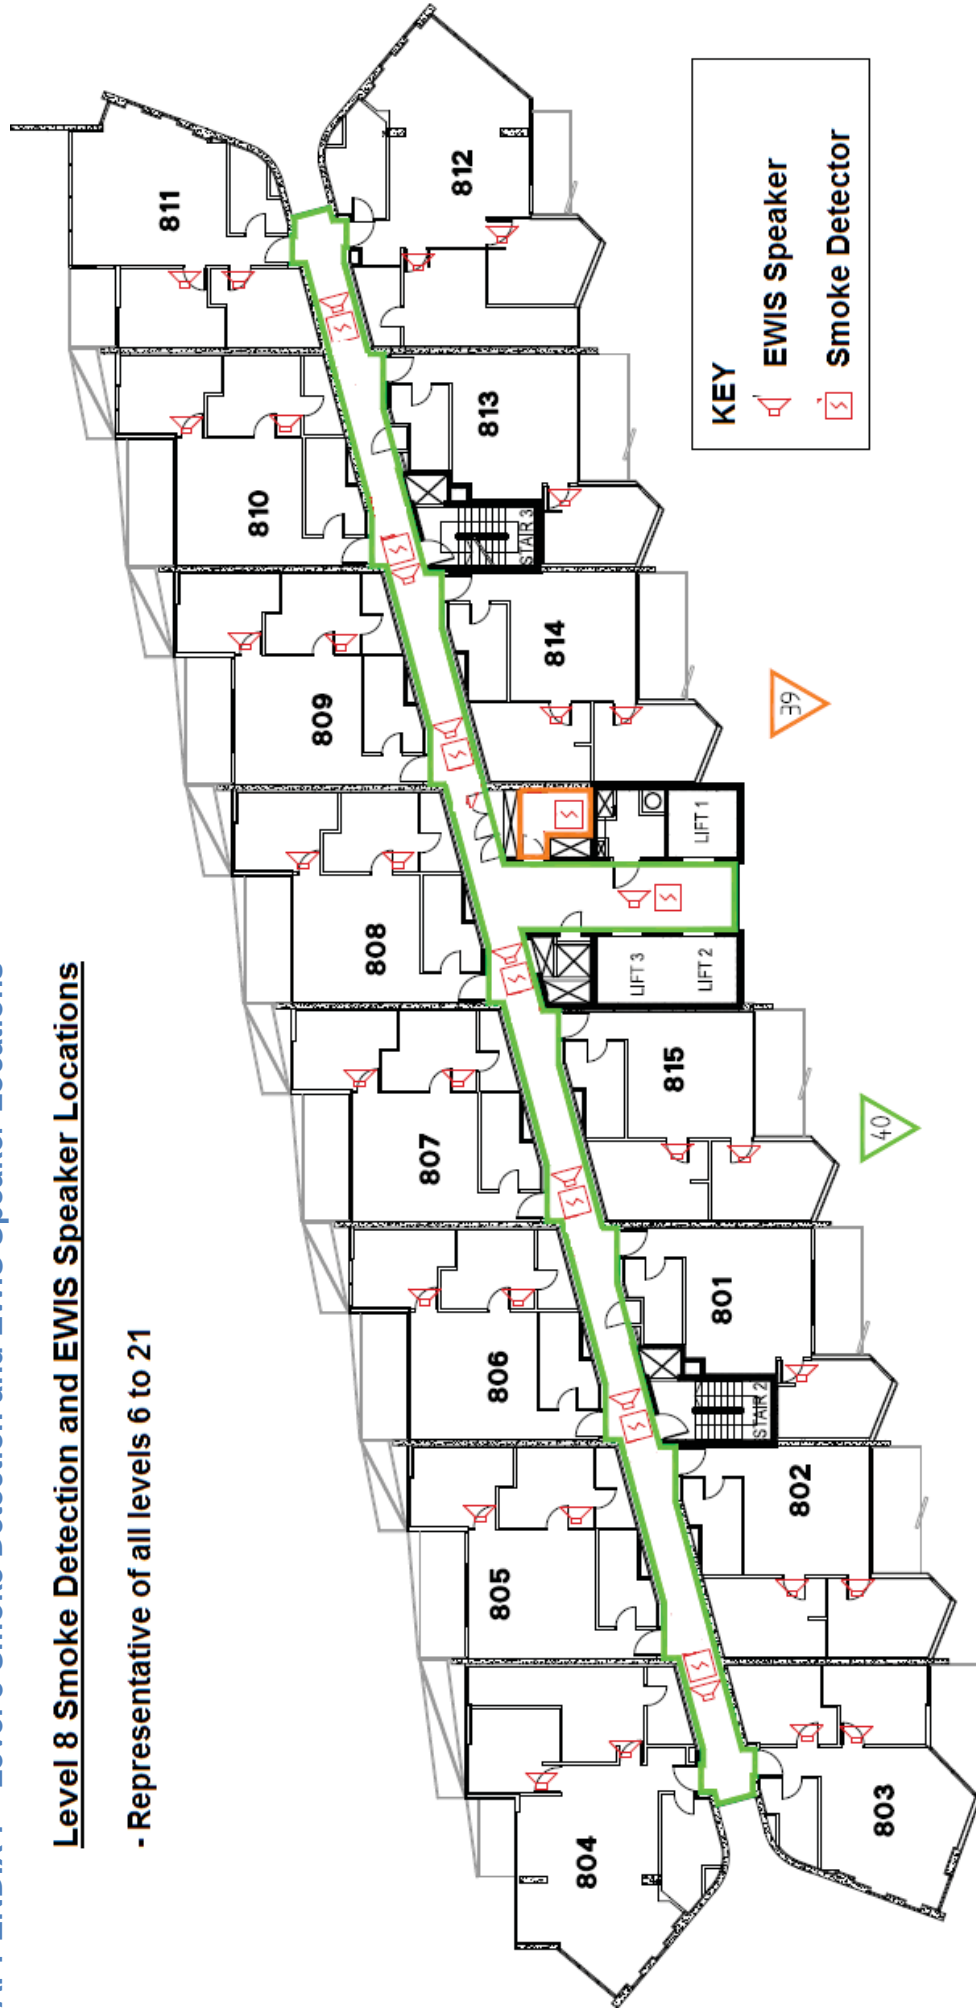
**Figure 18 - Level 8 Smoke Detection and EWIS Speaker Locations**

This building incorporates a smoke detection system throughout the common areas as required by the BCA. During investigations, it was observed that a typical apartment level consisted of eight photo-optical smoke detectors, installed throughout the corridor and an additional smoke detector located in the electrical riser cupboards at every level.

In total, 13 smoke detectors activated throughout levels 3, 6, 8, 9, 12 and 18. The FIP printout indicated that 25 minutes after the initial detector activated, the system started to log detector faults. Over 55 faults were logged, all of which are likely to be attributed to water damage from the operating sprinkler system.

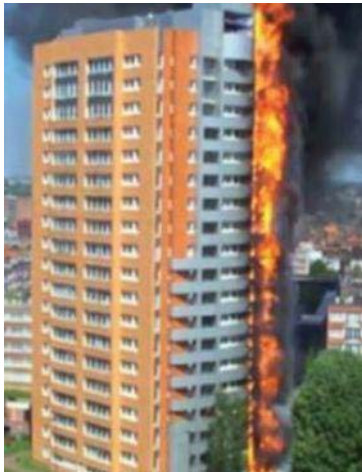
Photo – care of NFPA website

- 18 storey residential building;
- Aluminium/polyethylene composite panel facade;
- Fire origin – 2nd storey balcony;
- Fire description - “rapid vertical flame spread to the top of the building within a few minutes”.
