# Post Incident Analysis Report

**MFB Burnley Complex  
450 Burnley Street  
Richmond VIC 3121**

Lacrosse Docklands  
673-675 La Trobe Street, Docklands  
25 November 2014

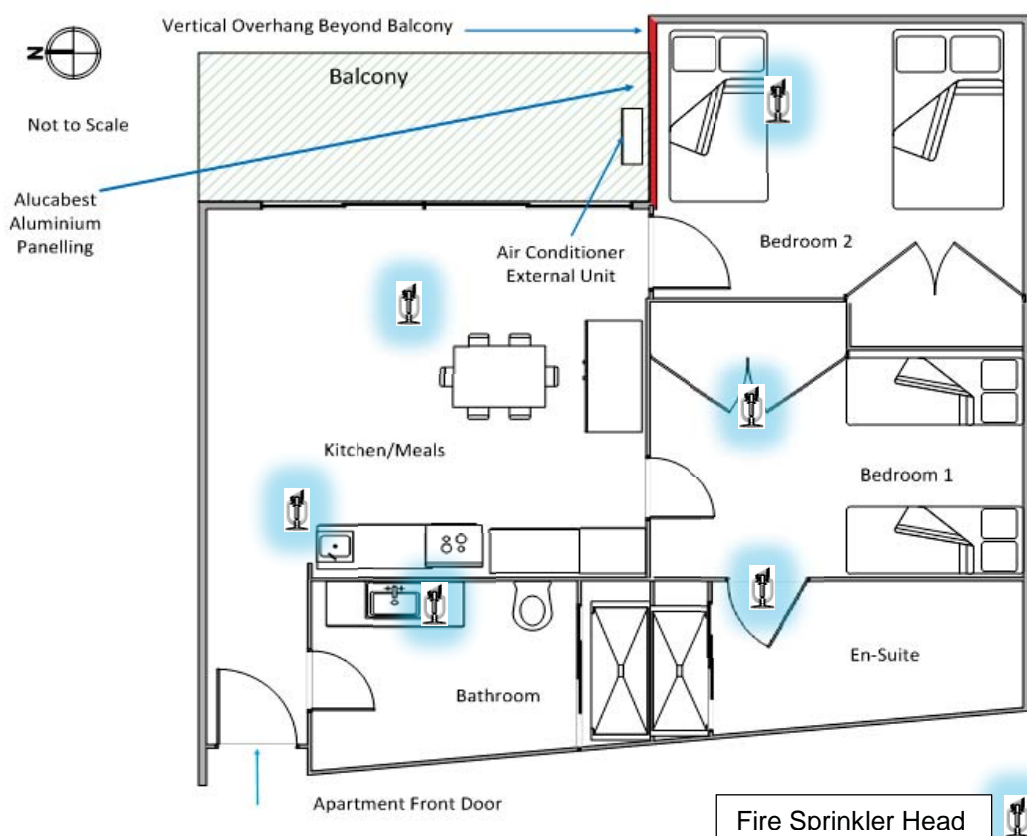
Figure 1 – General floor layout of apartment 805

At approximately 01:30 hours on the morning of Tuesday 25 November 2014, an occupant from Apartment 805 of the building, claims he investigated the smell of smoke. After checking the kitchen and making sure the gas stove was turned off, he returned to bed. Sometime later, the same occupant was woken by two other house mates who had discovered the fire burning on the balcony.

From inside the apartment, he could see a fire on the right hand side (south) of the balcony. The occupants of the apartment unsuccessfully attempted to extinguish the fire using a container of water.

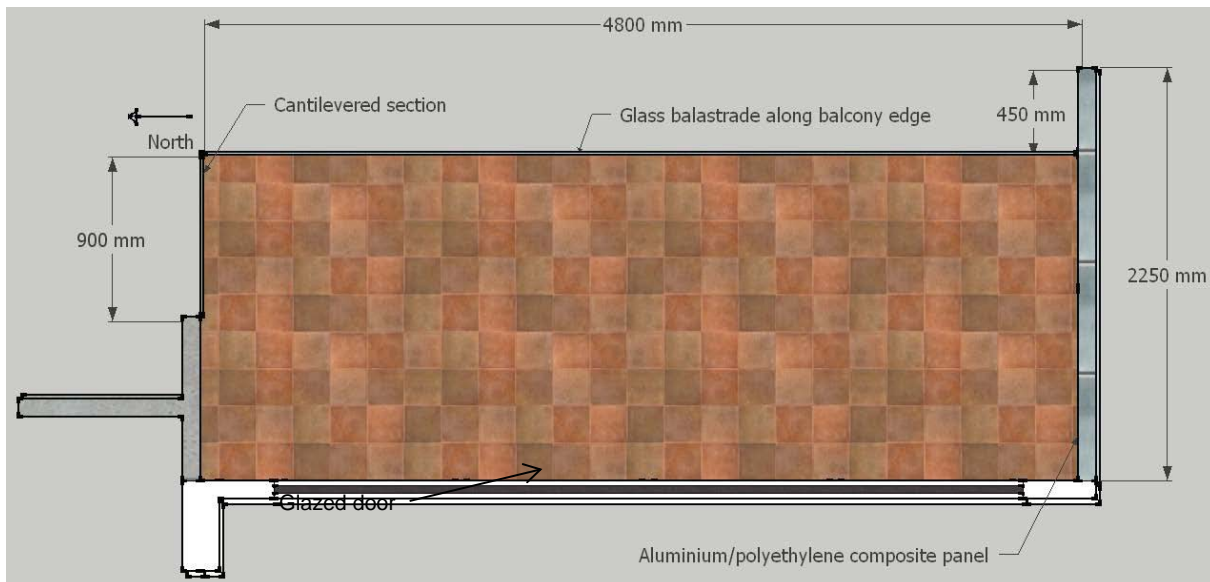
Figure 7 - Balcony Plan view

The apartments known as Apartments 605 to 2105 are located in vertical alignment from the 6<sup>th</sup> floor to the 21<sup>st</sup> floor on the east façade of the building. They include suspended concrete balconies of approximately 1.8 metres deep x 4.7 metres wide. A double-glazed sliding door assembly is fitted in the external wall of the building and provides access to the balcony.

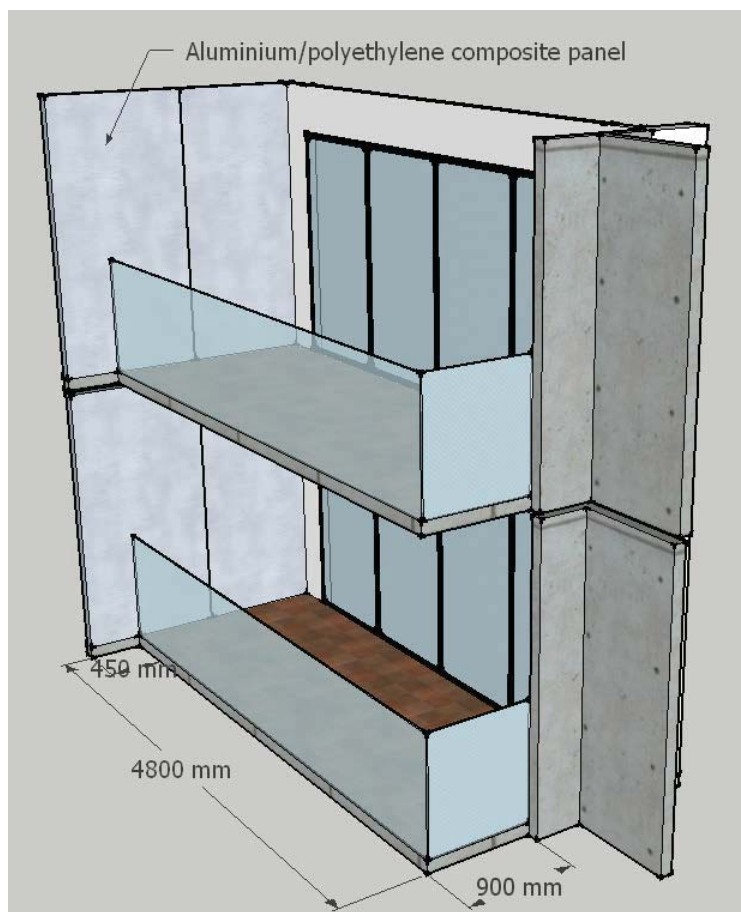
Figure 8 - Simplistic 3D interpretation of the balcony layout

The northern end of these balconies are bounded by 900mm concrete panels, which leaves the remaining 900mm balcony depth cantilevering out beyond the building face. A 1 metre high glazed balustrade is fitted to the remaining northern edge of the balconies and returns along the length of the eastern edge and butts into the southern wall.

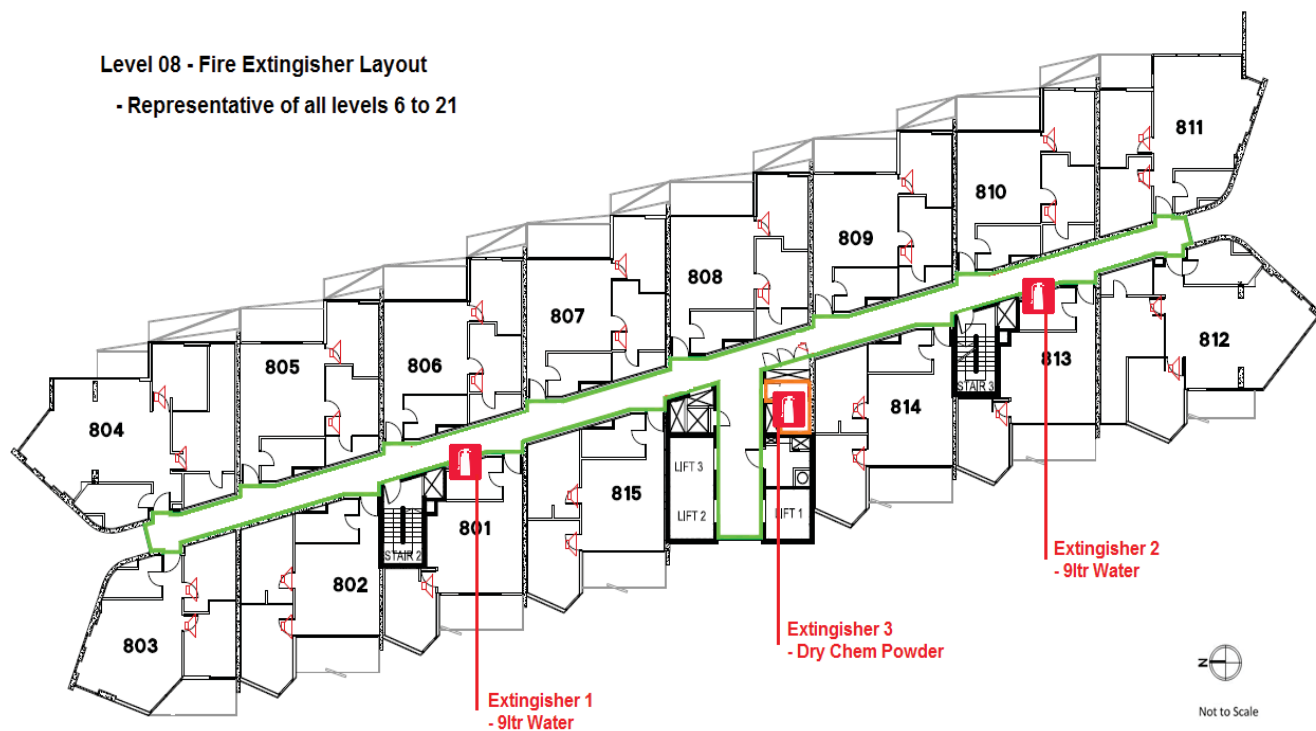
Figure 12 - Fire extinguisher layout

In this instance, a number of the purposely designed extinguisher enclosure housing Extinguishers 1 and 2 shown in [Figure 12 \(refer previous page\)](#), were being used by occupants as storage areas thus blocking access to the extinguishers.

It was noted during investigations that extinguisher three (as shown in [Figure 12](#)) on all residential levels was locked within a service room where they were inaccessible to occupants and fire-fighters.

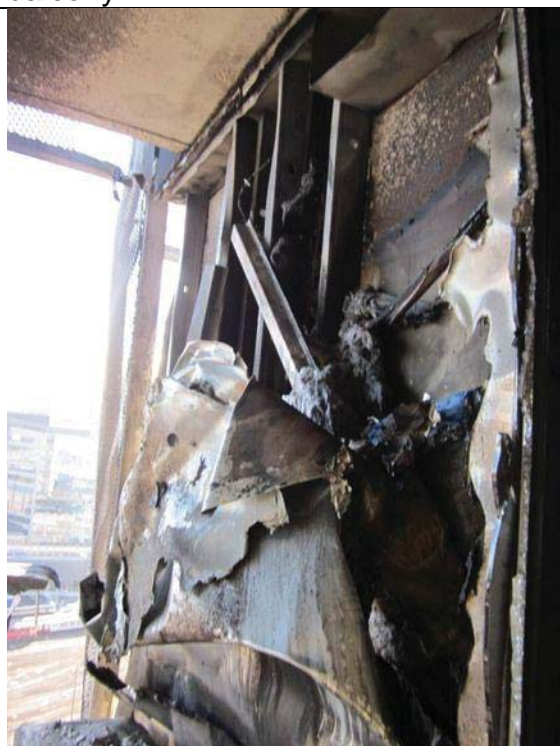
External wall at upper height

Wall between bedroom and balcony. Construction lightweight wall with steel studs, aluminium type external cladding plasterboard to internal. Material stored on balcony.

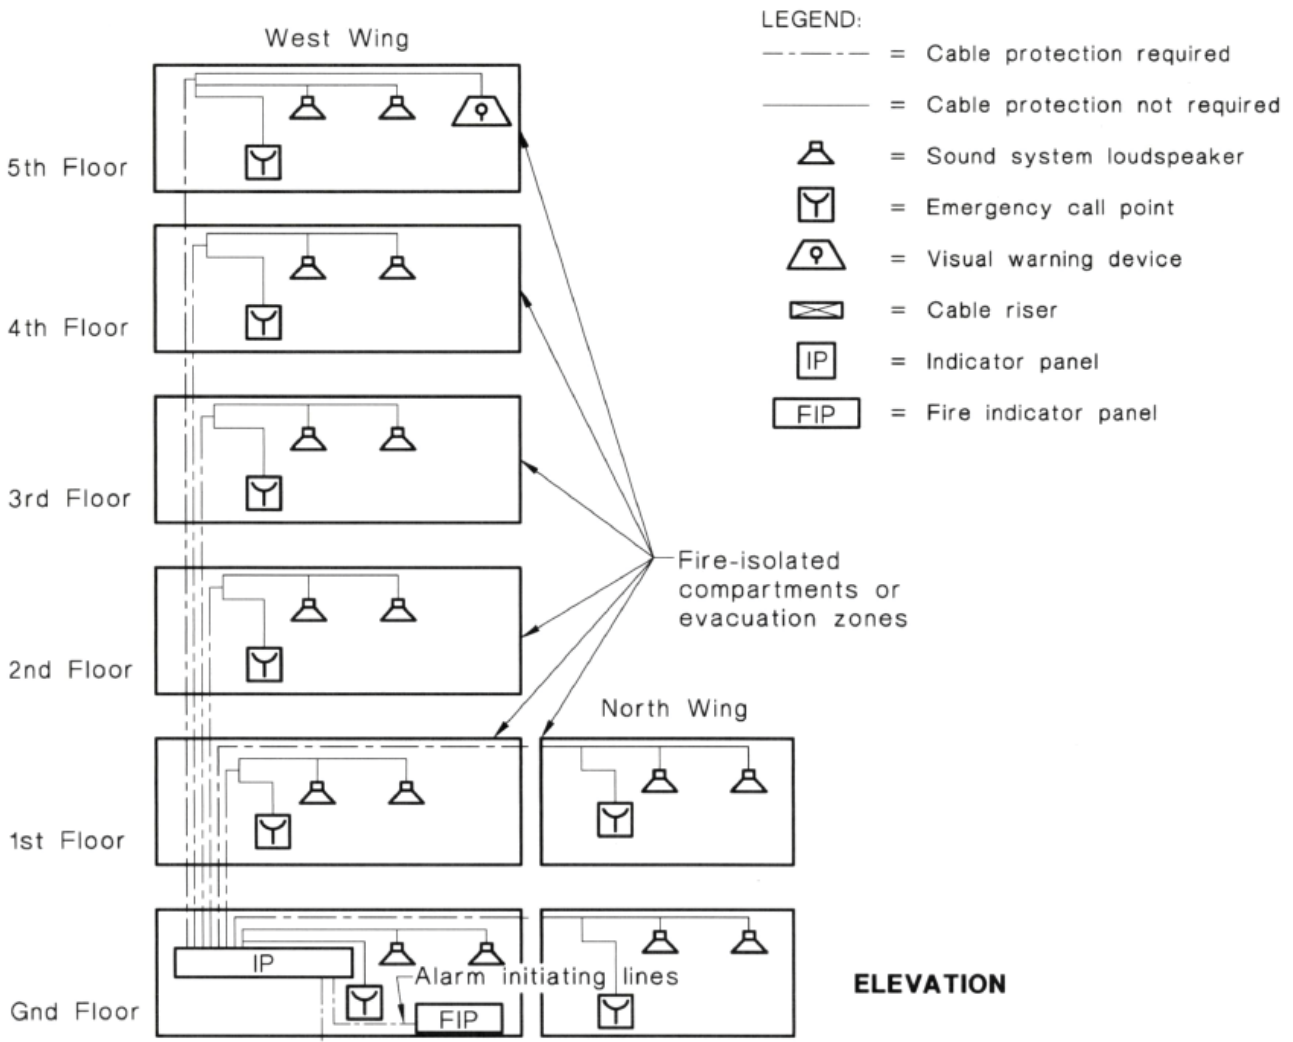
Figure 17 - Wiring diagram for EWIS

The EWIS system is designed and installed as per Australian Standard AS1670.4. This Standard requires all wiring between the EWIS's main panel and the evacuation zone to be fire rated. The zone wiring itself is not required to be fire rated, instead non-fire rated thermal plastic sheath (TPS) wire is used. Refer to [Appendix 6 figure 17](#).

This figure is an extract from Australian Standard AS1670.4-2004 (page 20 Figure 4.1). The figure depicts which EWIS wires are required to be protected from fire and which are not required to be protected.

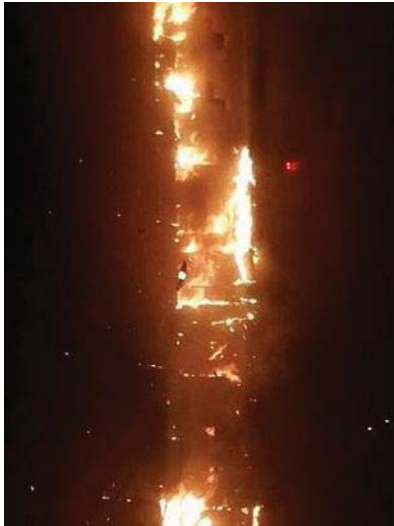
### Torch Tower Dubai 21 February 2015

- 79 Storey residential;
- Reported as same façade material as the other Dubai fires shown - Aluminium/polyethylene composite panel facade;
- Fire Origin 52nd floor
- Rapid vertical spread up the façade of the building and significant flaming falling debris

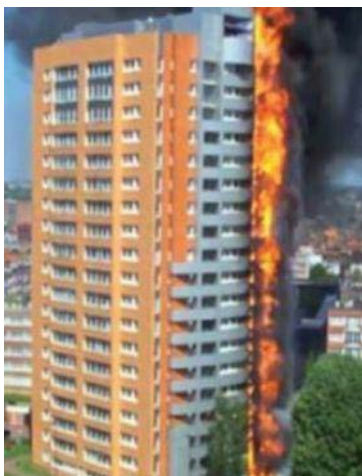
### Mermoz Tower, Roubaix, France, 2012

- 18 storey residential building;
- Aluminium/polyethylene composite panel facade;
- Fire origin – 2nd storey balcony;
- Fire description - “rapid vertical flame spread to the top of the building within a few minutes”.

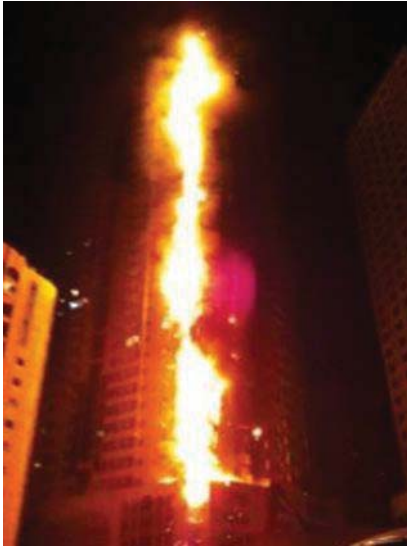
### Al Tayer Tower, Sharjah, 2012

- *40 storey residential building containing 6 carpark levels;*
- *Aluminium/polyethylene composite panel façade;*
- *Fire origin – 1st storey balcony;*
- *Fire cause – “discarded cigarette landing on the balcony which contained cardboard boxes and plastics”;*
- *Fire description – “vertical fire spread on the metal composite cladding to the top of the building”;*

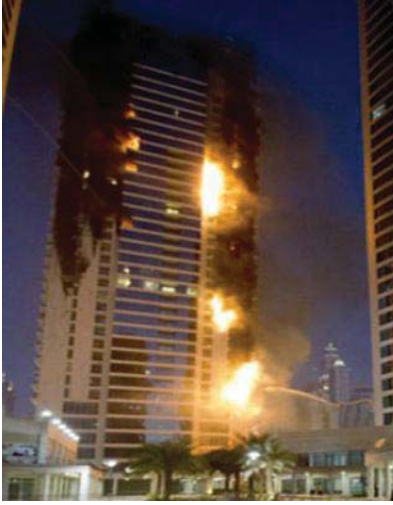
### Tamweel Tower, Dubai, 2012

- 34 storey residential building (contains mixed use)
- Aluminium/polyethylene composite panel façade;
- Fire origin – roof level
- Fire description - “spread down the exterior of the building.”

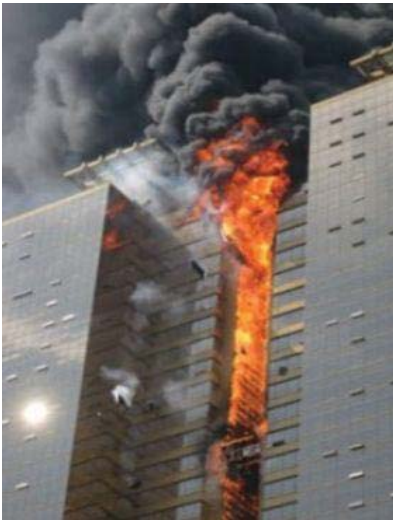
### Wooshin Golden Suites, Busan South Korea

- 42 storey residential building (contains mixed use);
- Aluminium/polyethylene composite panel façade;
- Fire description - “spread vertically upward on the façade reaching the top of the building”
- Fire origin - fourth floor;

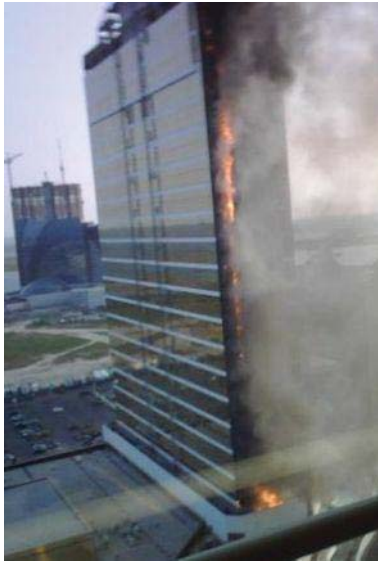
### Water Club Tower, Atlantic City, USA

- *41 storey building under construction;*
- *Aluminium/polyethylene composite panel façade;*
- *Fire origin - internal fire on the 3rd floor;*
- *Fire description – “fire spread vertically and rapidly reached the top of the building”.*
