Senate Rural and Regional Affairs and Transport References Committee

**Questions on Notice – Monday, 19 November 2012
Committee Room 2S1, Parliament House, Canberra**

Inquiry into aviation accident investigations

Ditching – Israel Aircraft Industries Westwind 1124A, VH-NGA

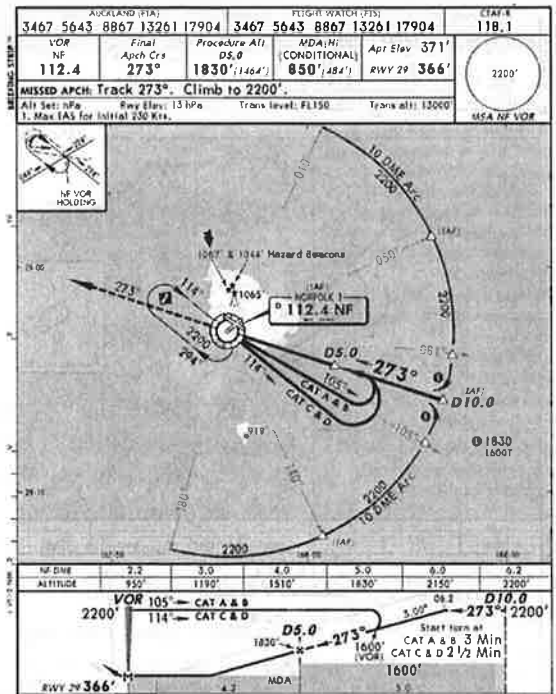
Figure 1: Runway 29 VOR/DME instrument approach procedure

Upon arrival at Norfolk Island, the copilot conducted a very high frequency omnidirectional radio range/distance measuring equipment (VOR/DME) instrument approach procedure⁶ for a landing on runway 29 (Figure 1). However, the flight crew was not 'visual' at the missed approach point,^{7,8} and a missed approach was carried out at 1004. At that time, it was dark and raining with low cloud and poor visibility.

Following the missed approach, the pilot in command assumed control of the aircraft as the handling pilot. A second instrument approach was conducted for runway 29; however, the crew were again unable to visually acquire the runway, and initiated a second missed approach at about 1013.

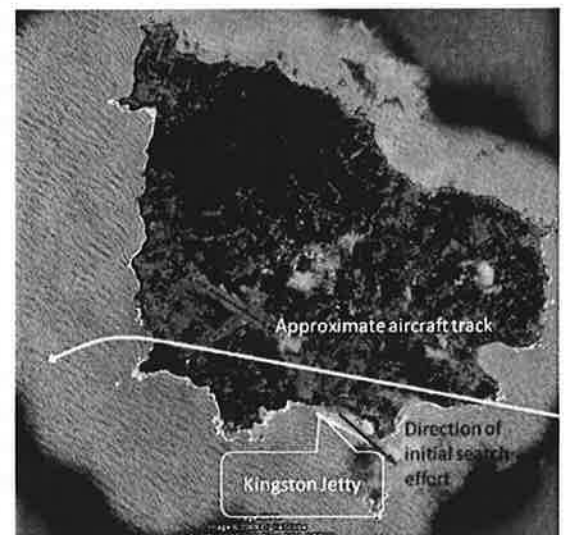
Figure 4: Approximate runway 29 VOR/DME final approach and overshoot track (Kingston Jetty highlighted)

The Norfolk Unicom operator had alerted the Norfolk Island emergency response agencies to a local standby condition when the weather first deteriorated to the extent that the Unicom operator felt it might be difficult for an aircraft to land. The Unicom operator subsequently initiated a deployment of the emergency services following the aircraft's second missed approach. In addition, two local boat owners prepared to launch their fishing vessels at Kingston Jetty to search for the ditched aircraft and its occupants (Figure 4).

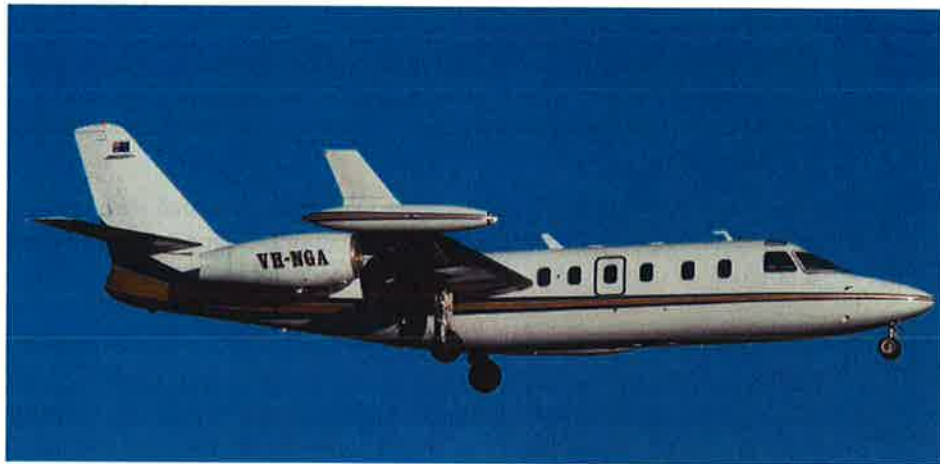
Figure 1: VH-NGA

At 1026:02 Coordinated Universal Time (UTC)¹ on 18 November 2009, an Israel Aircraft Industries Westwind 1124A (Westwind) aircraft (Figure 1), registered VH-NGA and operating under the instrument flight rules (IFR), was ditched 3 km south-west of Headstone Point, Norfolk Island after a flight from Faleolo Airport, Apia, Samoa. The two flight crew, doctor, flight nurse, patient and one passenger all escaped from the ditched aircraft and were rescued by boat crews from Norfolk Island.

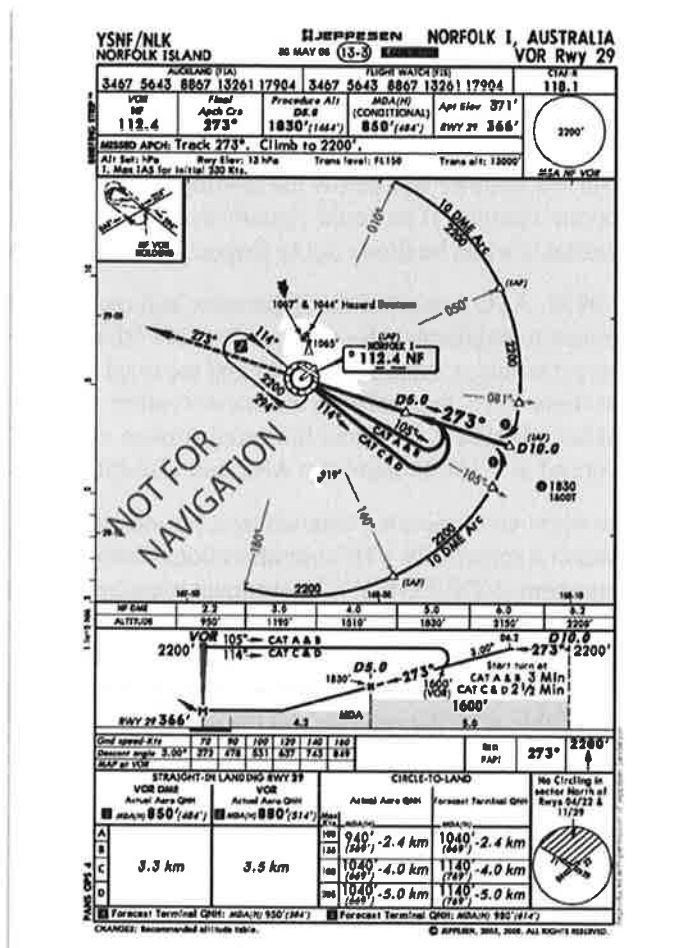
Figure 3: Runway 29 VOR instrument approach

The flight crew reported conducting a pre-descent brief. The copilot planned to conduct a runway 29 VHF omnidirectional radio range/distance measuring equipment (VOR/DME)^{24,25} instrument approach (Figure 3), which enabled the aircraft to descend safely to a height of 484 ft above the runway 29 threshold. The instrument approach would align the aircraft to land if visual reference was obtained with the runway threshold, approach lighting or other markings identifiable with the runway and the visibility was 3,300 m or greater.

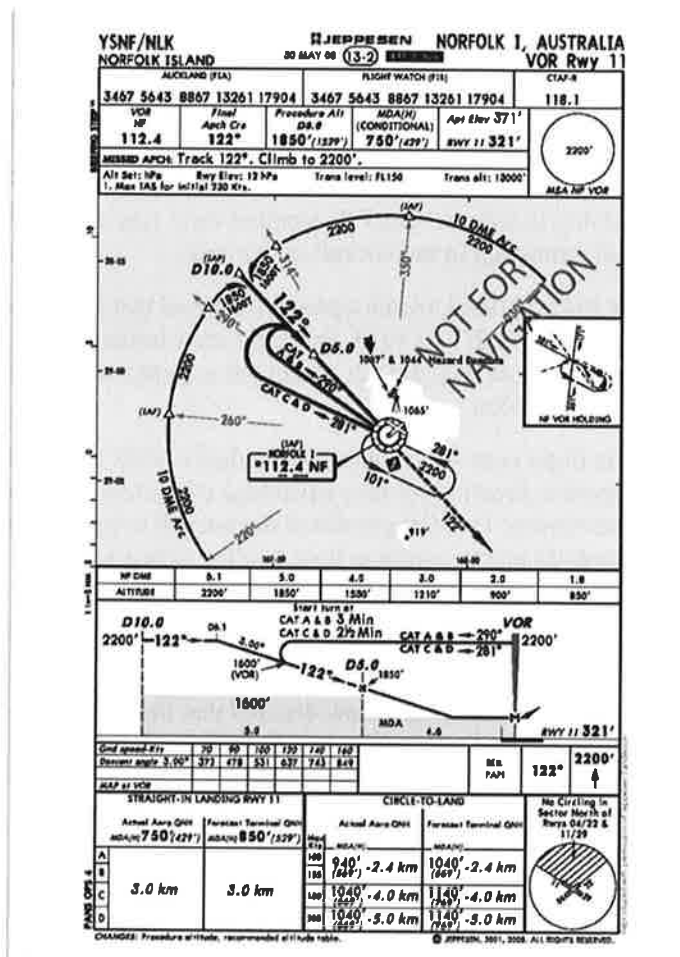
Figure 4: Runway 11 VOR instrument approach

The flight crew then elected to conduct a VOR approach to runway 11 (in the opposite direction) to take advantage of the lower landing minima for that approach. The runway 11 VOR permitted the aircraft to be flown to 429 ft above the runway threshold and to continue for a landing with a visibility of 3,000 m (Figure 4); however, there was a tailwind of up to 10 kts for operations to runway 11. The crew did not obtain the required visual references from the approach and initiated a missed approach procedure at 1019.

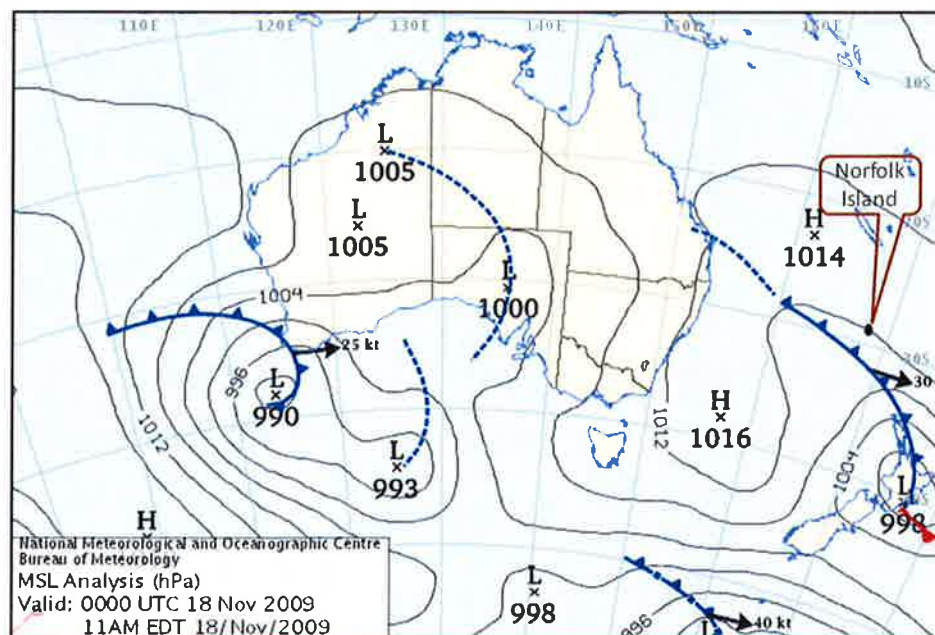
Figure 9: Mean sea level analysis 10 hours before the aircraft's arrival at Norfolk Island

Between 0800 and 0830 the aerodrome weather reports indicated the wind direction had changed 70° from just north of west to just west of south. During this period, the ambient air temperature dropped by 1°. The change in wind direction was consistent with the passage of the cold front, which would have created the rain and low cloud that existed at the time of the aircraft's arrival at Norfolk Island (an indication of the position of the front 10 hours prior to, and 2 hours after the aircraft's arrival at Norfolk Island are at Figures 9 and 10 respectively). The presence of the front would have had a greater cloud-producing effect than the lifting mechanism that had influenced the weather on the previous night, and would not have provided a mechanism for cloud dissipation to the south-east of the aerodrome as had happened on the previous night.

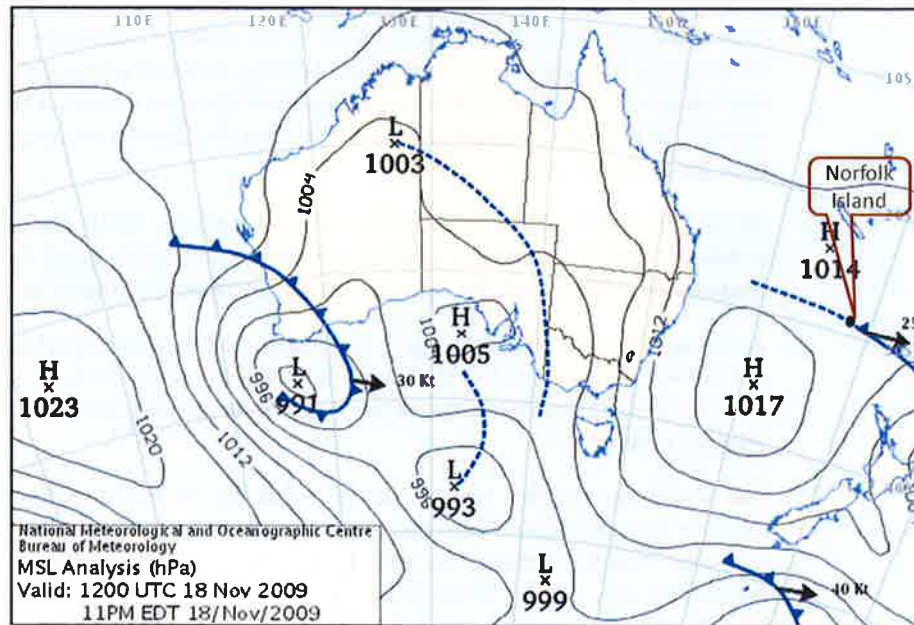
Figure 10: Mean sea level analysis 2 hours after the aircraft arrived at Norfolk Island

The aerodrome weather reports indicated that the weather conditions started to improve shortly before 1100, and the crew should have been able to obtain a visual reference with the runway that would have enabled a safe landing from an instrument approach by 1110. The rain stopped at around this time, with a total rainfall of 3 mm in the previous 90 minutes.
